**REPORT**

HCLJ510-2013-181	Serious incident	
Aircraft:	ATR 72-212	Registration: E7 - AAD
Engines:	2 - PW 127	Flight: Scheduled, IFR
Crew:	4 - no injuries	Passengers: 38 – no injuries
Place:	Copenhagen Airport, Kastrup (EKCH)	Date og time: 14.1.2013 at 09:17 UTC

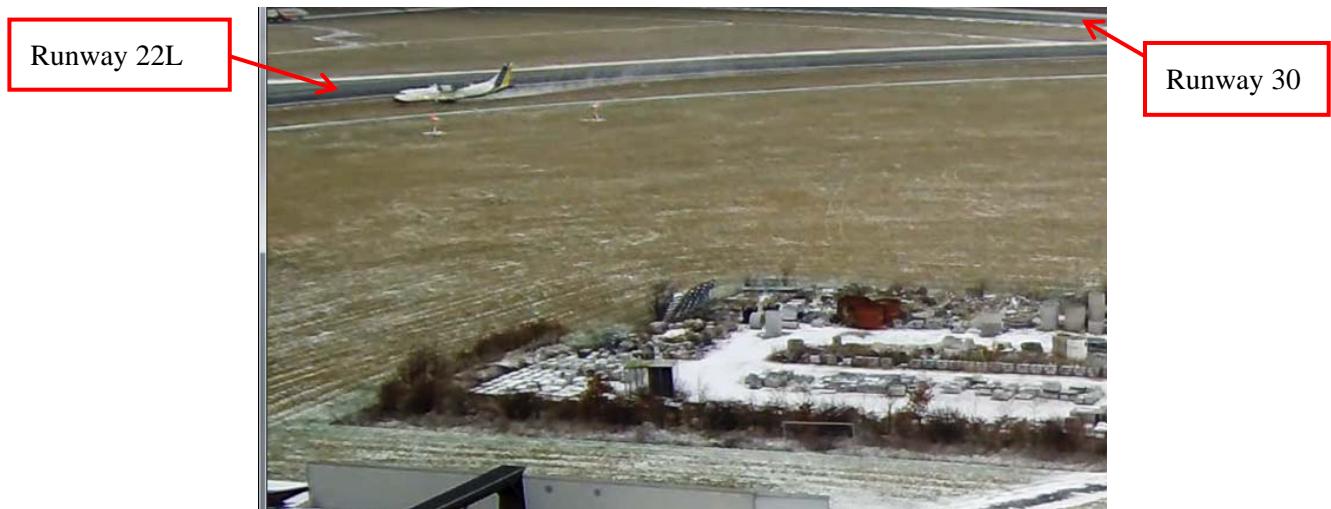
As the aircraft continued to veer to the left the PF tried to regain directional control by right hand (RH) rudder input and the use of right wheel brakes. The aircraft continued to veer to the left and ran off the side of the runway and entered the safety zone (short grass) with the left hand runway marking lights to the right of the aircraft.

After approximately 350 meters in the safety zone the PF regained control of the aircraft and entered runway 22L again.

The aircraft exited the runway about 1250 meters from the runway 22L threshold and the lateral deviation reached about 60 meter to the left of the center line. It corresponded to a lateral excursion of about 17, 5 meters beyond the left border of runway 22L.

With low taxi speed the aircraft returned to the runway about 1600 meters from the runway 22L threshold.
