**REPORT**

HCLJ510-2011-46	Accident	
(HCLJ510-000835)		
Aircraft:	Boeing 777F	Registration: B - 2078
Engines:	2 – GE90 – 110B	Flight: Cargo, IFR
Crew:	4 – no injuries	Passengers: 1 – no injuries
Place:	Copenhagen Airport, Kastrup (EKCH)	Date and time: 17.4.2011 at 1300 UTC

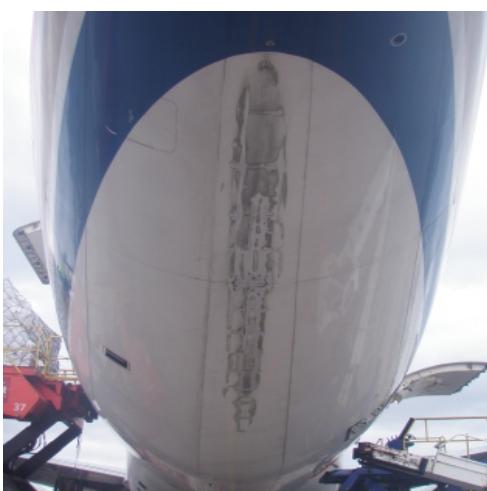
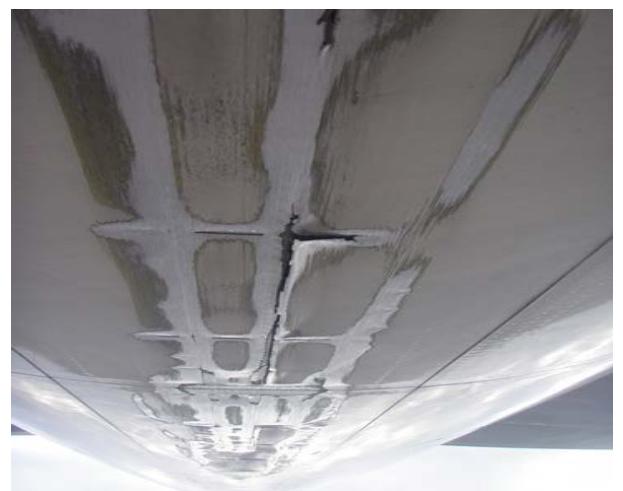
The damage in the belly section 47 and 48 was substantial and covered the area between stations 1980 in the front to station 2286 in the rear (approximate 8 meters). Several places on the fuselage skin were broken up and the inside of the aircraft was visible. The area at the aft dome pressure bulkhead was worn into the frame of the dome pressure bulkhead and there was visible damage in the frames and structure inside the aircraft.

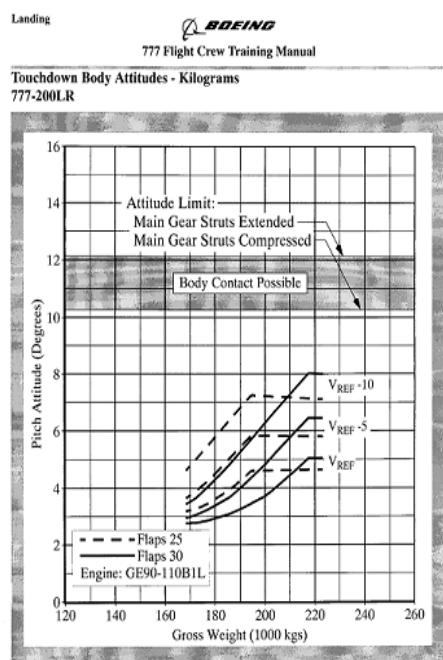
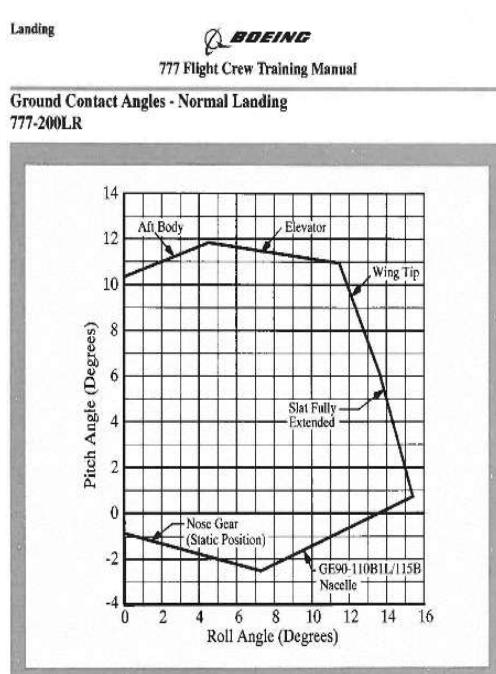
Info: The Boeing 777 Freighter has identical Principal Dimension as the Boeing 777-200LR

At first tailstrike the pitch angle was 10, 5° with a roll angle of – 0. 1°

At the second tailstrike, the pitch angle was 11, 9° with a roll angle of 3, 8°

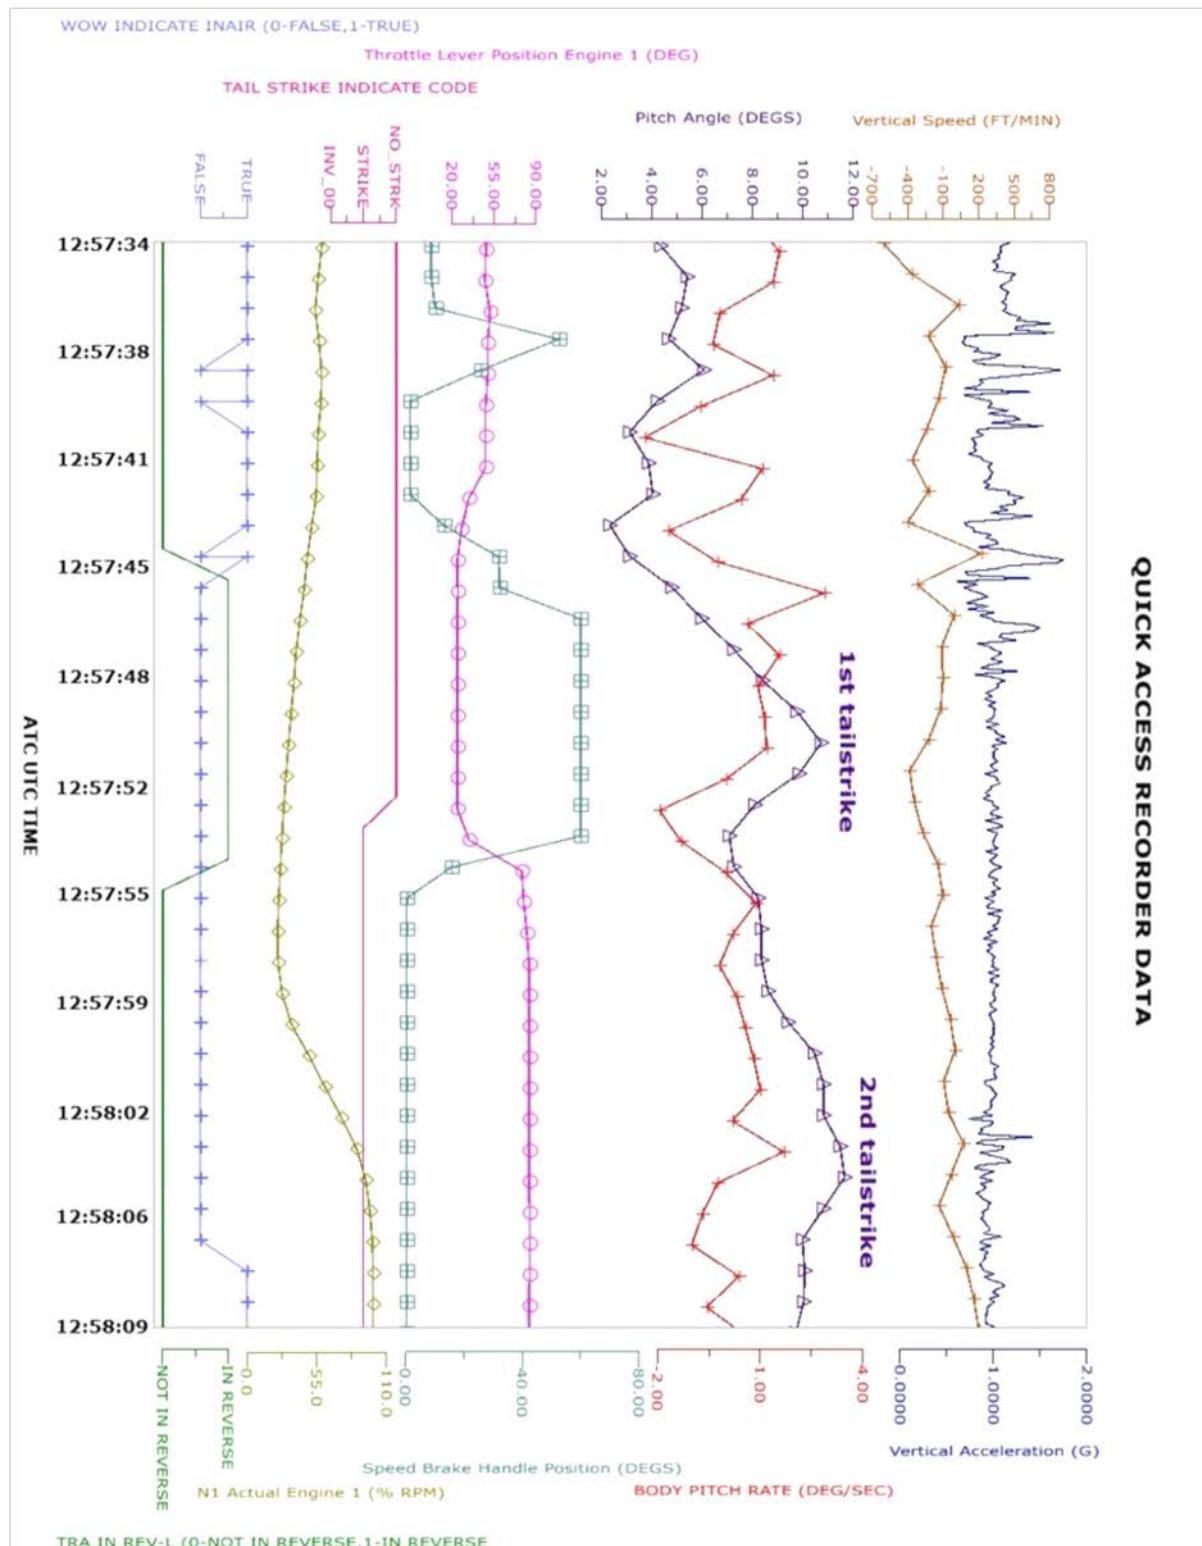
The data from the QAR was of good quality and was used in the investigation.
(See Appendix 1 (Quick Access Recorder Data))
