**ACCIDENT**

<b>Aircraft Type and Registration:</b>	Cessna 310Q, G-BXUY	
<b>No &amp; Type of Engines:</b>	Two Continental IO-470-VO piston engines	
<b>Year of Manufacture:</b>	1970 (Serial No: 310Q-0231)	
<b>Date &amp; Time (UTC):</b>	15 November 2013 at 1158 hrs	
<b>Location:</b>	Hawarden Aerodrome, Chester	
<b>Type of Flight:</b>	Private	
<b>Persons on Board:</b>	Crew - 1	Passengers - 1
<b>Injuries:</b>	Crew - 1 (Fatal)	Passengers - 1 (Fatal)
<b>Nature of Damage:</b>	Aircraft destroyed	
<b>Commander's Licence:</b>	Commercial Pilot's Licence	
<b>Commander's Age:</b>	58 years	
<b>Commander's Flying Experience:</b>	1,645 hours (of which 261 were on type) Last 90 days - 18 hours Last 28 days - 6 hours	
<b>Information Source:</b>	AAIB Field Investigation

**Synopsis**

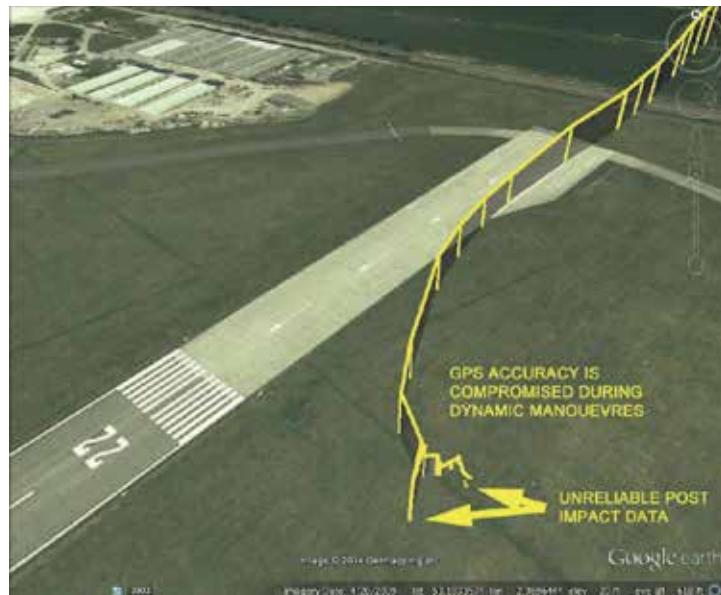
**Figure 1**

The aircraft was not fitted with a Flight Data Recorder, nor was it required to be. However, the pilot was known to use a flight planning and navigation application on his tablet computer and apparently did so for the accident flight. Although the tablet suffered extensive damage, track points associated with the accident flight had been recorded and were successfully downloaded for analysis. The nature of the system that was gathering the position data is such that it can use different sources of data for position fixes. However, recorded accuracy figures indicate that the system was using GPS satellite data as the source of the positional information. The flight path of the final approach and accident sequence is shown in Figure 1.

Recorded flight path: final approach and accident sequence

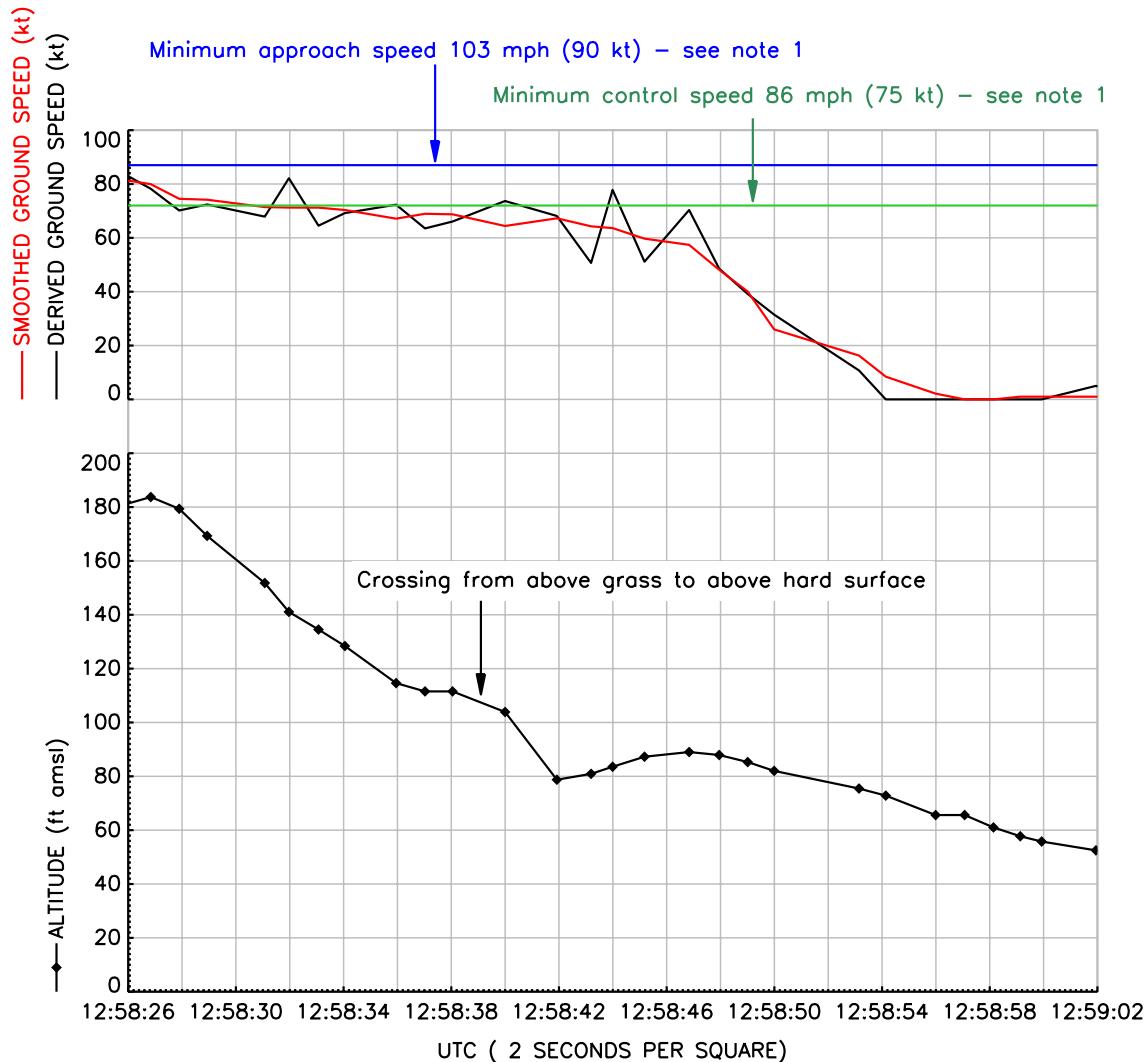
**Figure 2**  
Recorded altitude data and derived speed

Recorded data from the pilot’s tablet computer allowed a speed analysis of the latter stages of the flight. Speed and altitude data for the final approach and accident sequence is shown at Figure 2.

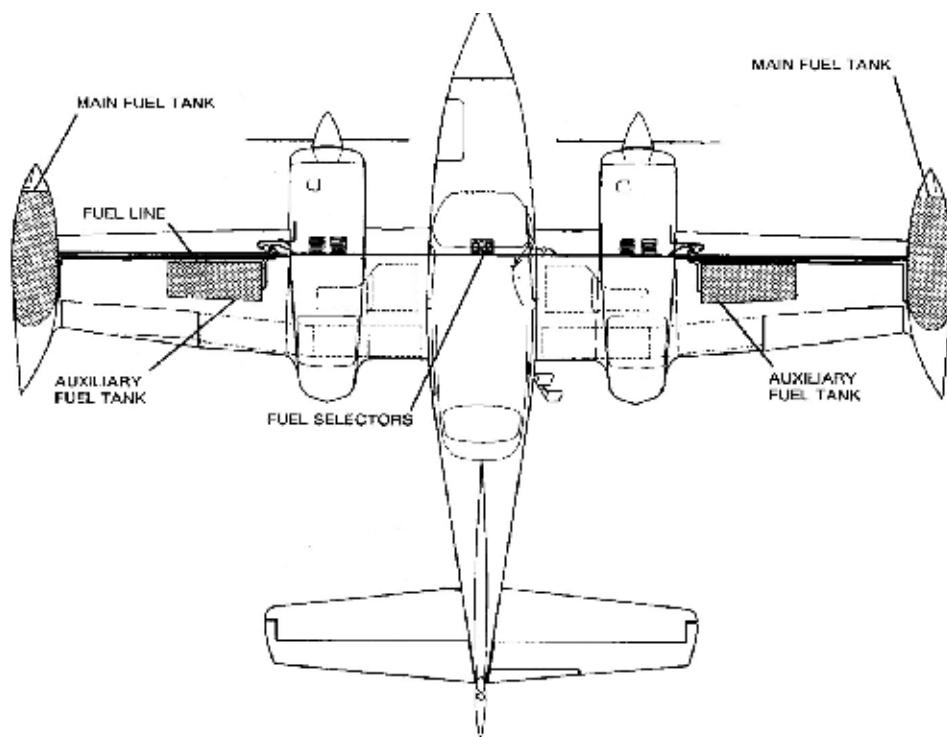
**Figure 3**  
G-BXUY fuel system

The aircraft was a Cessna 310Q powered by two Rolls Royce Continental IO-470-VO engines. The fuel system for the aircraft consisted of four fuel tanks: two 51 US gallon (193 litre), wingtip-mounted, main fuel tanks and two 20.5 US gallon (78 litre) auxiliary fuel tanks in the outboard section of each wing (Figure 3). A pair of fuel selector switches, mounted on the cockpit floor, operated a fuel selector valve immediately outboard of each engine, which allowed each engine to receive fuel from its respective main or auxiliary tank, or to cross-feed fuel from the other main tank. The cross-feed, which was intended for emergency use, was the only interconnection between the left and right fuel systems.

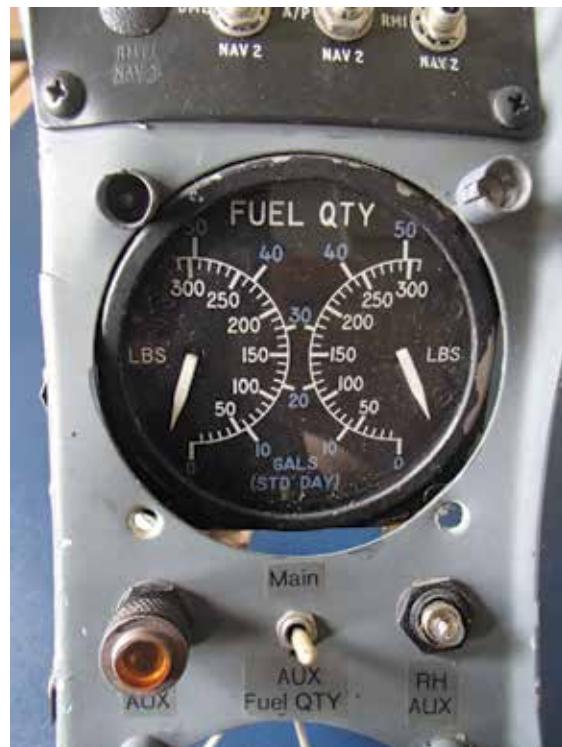
**Figure 4**  
G-BXUY fuel quantity gauge  
(electrical power not applied)

Each fuel tank is fitted with a capacitive sensor which provides fuel quantity readings to a pair of gauges in the cockpit. The gauges (Figure 4) automatically provide an indication of the fuel quantity in the fuel tanks selected by the fuel selector. A self-centring switch below the gauges allows the pilot to verify the contents of the other, non-selected tanks. Auxiliary tank indicator lights below the gauges illuminate when the associated auxiliary tank is selected for engine feed. The optional main fuel tank low quantity warning lights had not been fitted to G-BXUY. A dual fuel flow gauge was also fitted.

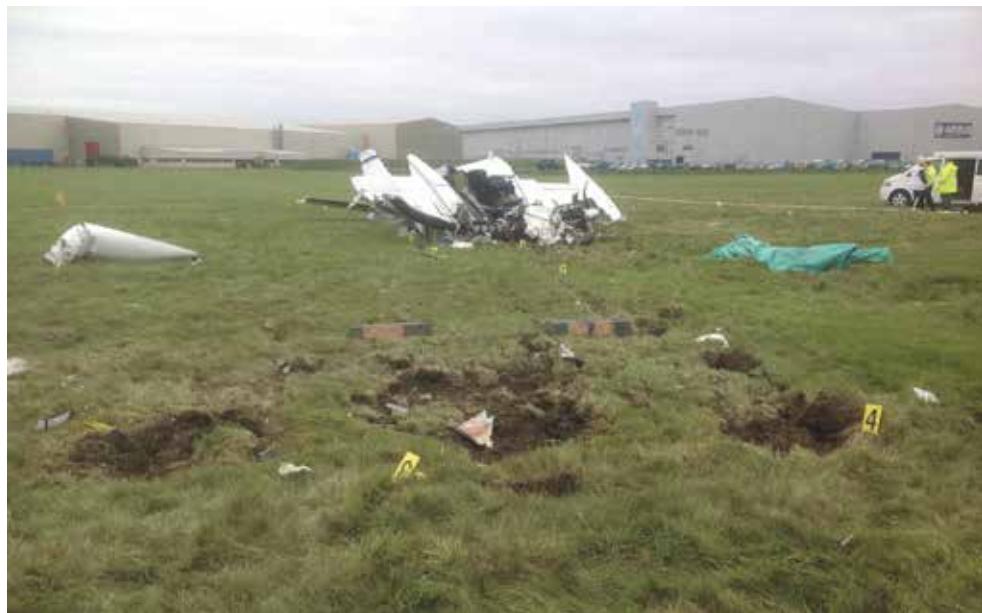
**Figure 5**  
Accident site

Ground marks indicated that the aircraft first struck the ground inverted, in a steep nose-down attitude 115 m beyond the left edge of Runway 22 and 15 m before the threshold markings. After the initial impact the aircraft travelled backwards on its main landing gear for approximately 20 m before coming to rest (Figure 5). The fuselage of the aircraft had failed immediately aft of the main spar and the nose of the aircraft had been severely damaged. The right tip tank had ruptured and separated from the wing and the right wing exhibited compression damage to the outboard leading edge. The right propeller had dug into the ground during the initial impact which had resulted in a failure of the engine crankshaft and separation of the propeller. The left propeller remained attached to its associated engine.

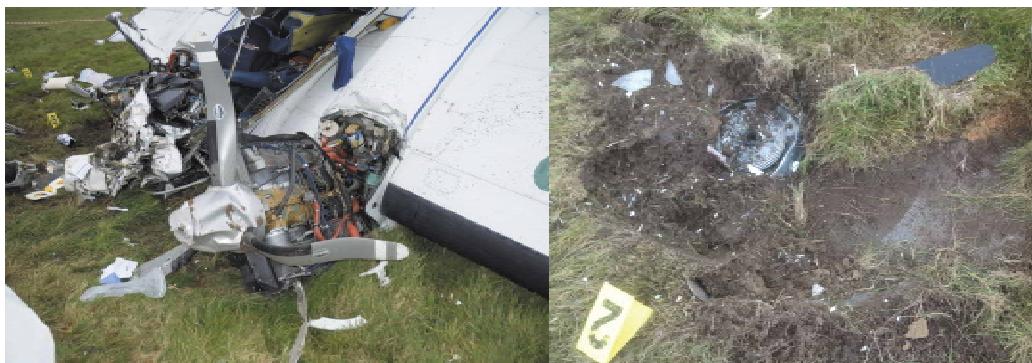
**Figure 6**  
Left and right propellers

Examination of the right propeller showed that rotation of the propeller during the initial impact had caused all three blades to dig into the ground; two of the blades exhibited significant rearwards bending of the blades at approximately half span as a result of rotation through the soil (Figure 6). The left propeller exhibited significantly different damage from the right; one blade had been bent backwards and the remaining two blades had been bent forward at mid-span. There was little evidence of rotational damage to any of these blades.

Two of the blades fitted to the right propeller showed chordwise witness marks and exhibited significant twisting and rearward bending along the span of the blade. One of these blades, the first to enter the ground, was found to be at a higher pitch setting when compared to the other two blades, which appeared to be at or close to the FINE pitch position.

The damage to the left propeller showed significant differences from that observed on the right. Damage to the propeller spinner was restricted to one third of the circumference, corresponding to the position of the propeller blade which had been bent backwards and little evidence of rotational damage was observed. All three of the blades on the left propeller appeared to be at or close to the FINE pitch position.

The witness marks observed on the faces of the right propeller preload plates indicted that all three propeller blades were at the same pitch angle of 15° at the start of the impact sequence. The damage observed to the right propeller blades and the failure of the right engine crankshaft was consistent with the engine operating at high rpm at impact. Analysis of the blade pitch angle data by the propeller manufacturer confirmed that a blade pitch angle of 15° was consistent with a Continental IO-470-VO engine operating at its maximum governed speed of 2,625 rpm, as may be expected during the early stages of a go-around. Given that the No 3 blade of the right propeller was the first blade to enter the ground, it is thought that the forces acting on the blade were sufficient to twist the blade in the hub, resulting in the failure of the pitch change knob and an increase in blade pitch when compared to the remaining two blades.

The lack of rotational damage to the left propeller, and the deformation of its blades, was consistent with the left engine operating at low power at impact despite all of the engine controls being in the 'full power' position. The closure of the left propeller blade pitch locks
