# Loss of separation involving a Boeing 717, VH-NXL, and a vehicle

Perth Airport, Western Australia on 26 July 2014

**ATSB Transport Safety Report**  
Aviation Occurrence Investigation  
AO-2014-133  
Final – 26 February 2015

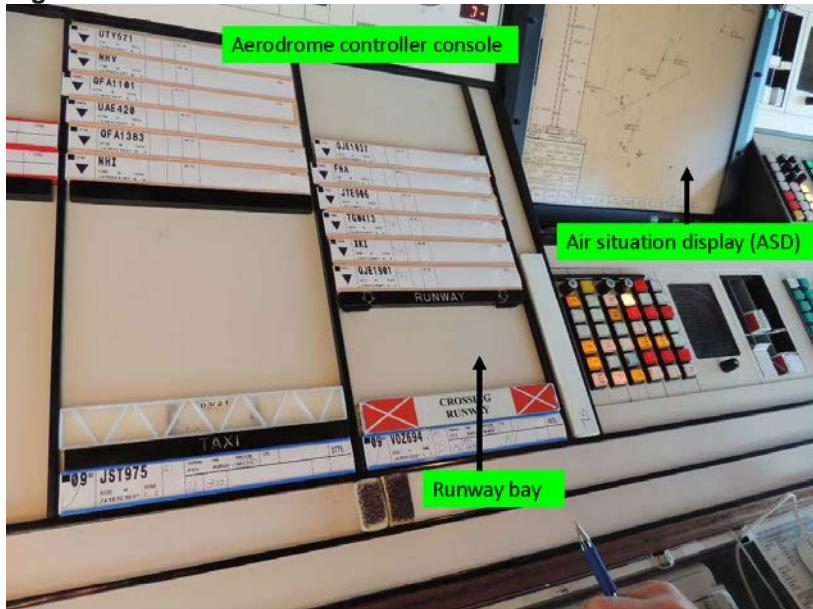
**Figure 2: Perth aerodrome controller console**

At about 1203, the ADC cleared a Fokker 100 (F100) aircraft for take-off from runway 21. After observing that aircraft pass through the intersection of runway 24, the ADC picked up the flight progress strip for NXL, scanned the runway but did not see the vehicle on it. The ADC then moved the strip into the console runway bay (Figure 2) without noticing the safety vehicle strip, while simultaneously observing the F100 become airborne.

- The controller had a single runway bay on the Tower console (Figure 2) where flight progress strips for aircraft using either of the two runways in use were placed. The runway assigned to the aircraft was written on the aircraft's strip.

- The vehicle strip (red with a white centre) was in the console runway bay at the time of the incident. There were two possible reasons the controller may have missed it: the process of placing the aircraft strip without reconciling with the vehicle strip already there was a muscle memory or automatic process rather than a conscious one; or, the combination of picking up the strip, talking and scanning all at once when issuing a landing clearance meant that the controller was looking outside at the runway, talking and moving the strip without looking at the bay to reconcile the strips.

An integrated tower automation suite (INTAS) will combine flight and operational data, surveillance and voice communications into a single integrated tower-specific layout and replace the existing manual air traffic control system. If INTAS had been available at the time of this incident, the controller would have been able to allocate the electronic flight strip assigned to the aircraft in the runway bay, but an alarm would have been triggered.

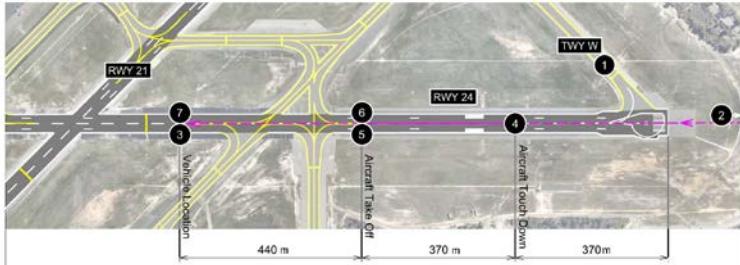
**Figure 3: Sequence of events**

At about 1204, as NXL touched down on runway 24 about 370 m from the threshold, the first officer saw the flashing lights of a vehicle ahead on the runway, immediately stated 'go-around, car on the runway' and the captain commenced a go-around. About 6 seconds later, the aircraft became airborne about 740 m from the threshold. At that time, the safety vehicle was stationary on the centreline of runway 24 about 1180 m from the threshold and facing away from the approaching aircraft. The SO did not see the aircraft, until it passed about 150 feet over the vehicle (Figure 3).

Point	Description
1	Safety vehicle held at W
2	NXL cleared to land on runway 24
3	Safety vehicle stopped short of runway 21
4	NXL touched down on runway 24
5	NXL reported going around due car on the runway
6	NXL became airborne
7	NXL passed over vehicle at a height of 150 ft

At the time of the incident, the safety vehicle was facing away from the landing aircraft, and stationary on the white runway 24 centreline markings. The first officer in NXL reported that it was very difficult to see the vehicle on the runway markings. He started looking when the aircraft was about 30 ft AGL and only saw the vehicle as the main landing gear touched down.

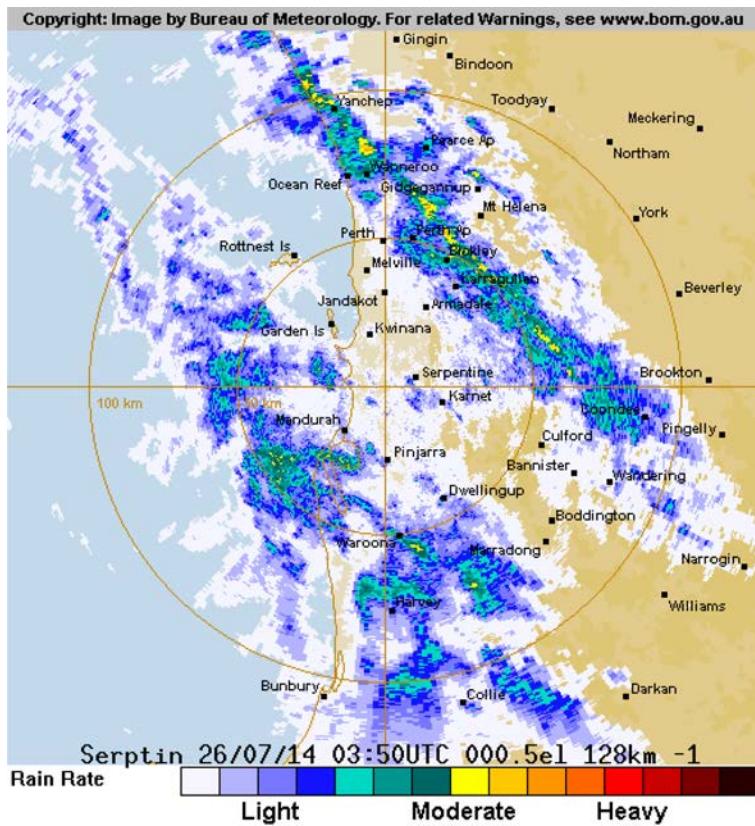
**Figure 4: Rain radar at 1150 WST**

The Bureau of Meteorology data indicated that about 10.2 mm of rain fell between 1150 and 1200 on the day of the occurrence. The weather radar showed a line of showers passed through the area about 10 minutes prior to the incident (Figure 4).

- A heavy shower had moved through from west to east and was about 3 NM on final approach to runway 24. A moderate shower was passing over the airport at the time of the incident.
