REPORT EXT IN-007/2012

Date and time	Sunday, 29 July 2012; at 13:10 local time
Site	Évora Aerodrome – Alentejo (Portugal)

Registration	EC-IBY
Type and model	PILATUS PC-6 B2-H4 Turbo Porter, S/N: 815
Operator	Skydive Lillo

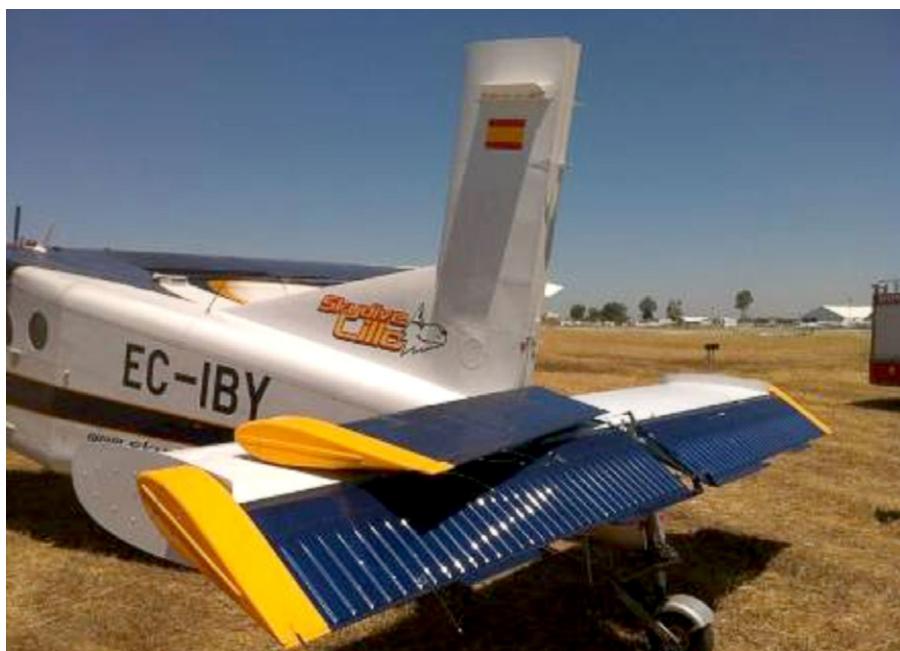
Figure 1. Condition of the tail section after landing

An examination of the aircraft revealed that the upper axle on the rudder and the point where it attached to the tailfin were missing. This caused the lower support to bend and partially break, along with the torsion tube and the rudder, which fell to the left on top of the left horizontal stabilizer and associated elevator, as shown in figures n.º 1 and n.º 2. The skin on the left elevator had been torn by the rudder trim tab lever, which limited the rearward motion of the rudder after it fell on the stabilizer.

As the investigation revealed, the loss of the hinge bolt in the top part of the rudder allowed the rudder to fall on top of the stabilizer and left elevator, causing the elevator to jam, thereby limiting the controllability of the airplane.

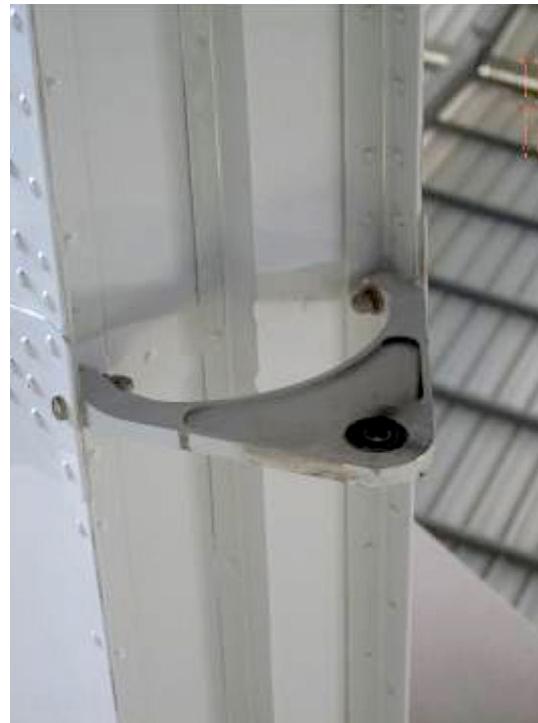
The design of the PC-6 is over 50 years old and thus follows the criteria used back then. For example, the direction of the hinge bolt on the rudder, from bottom to top, which from a modern perspective is not a recommended practice.

Close-up 1. Rudder support fitting in the tailfin

Based on this event findings happened in Evora, Pilatus reviewed the design of the rudder hinge bolt and have plans to modify it in a way that the bolt is now installed from the top. Pilatus informed that this modification is outlined in the recommended SB 55-003 which will be issued soon.

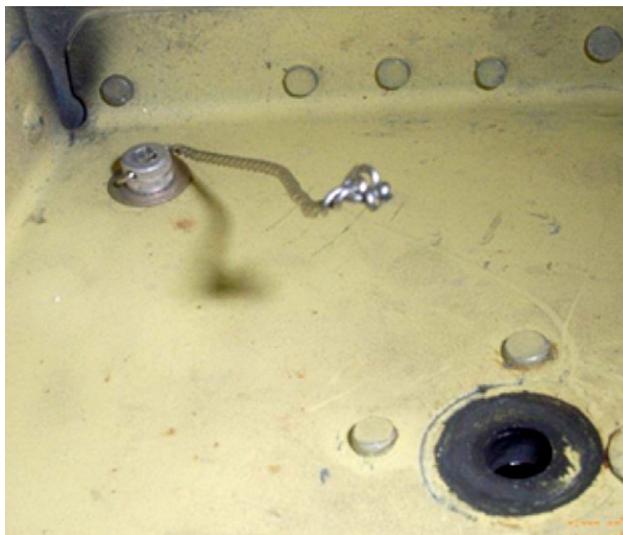
When the service cover for the removal/installation of the rudder was opened, the missing upper hinge bolt was not found within the rudder structure. It is presumed that the bolt was lost during the flight. Only the bolt's washer was found inside the rudder, along with the lockwire, which was attached to the locking screw. The lockwire itself was broken and twisted at the hinge bolt end (see figure n.º 2). The locknut on this screw was found riveted in place, on the top part of the tooling hole.

Figure 2. Lockwire on the rudder's hinge bolt

The rudder detached during the flight due to the loss of the hinge bolt on its upper fitting, which had become loose due to its lockwire being attached in the wrong direction.

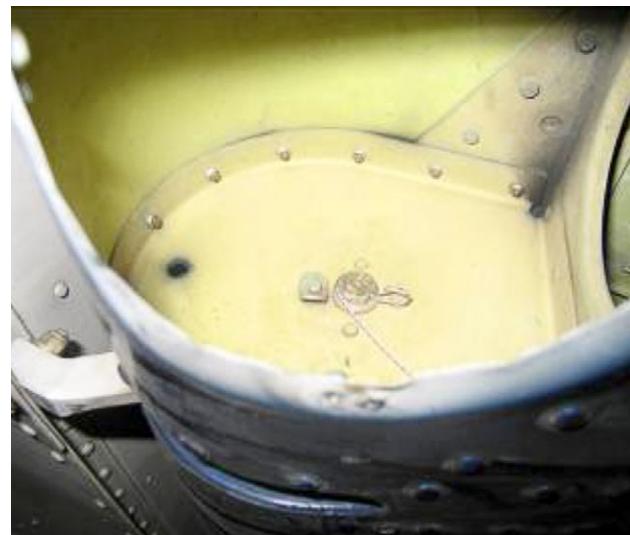
The outboard hinge bolts on both elevators were examined through the service covers. These were also modified by SB 55-001 Rev. 1, as noted in point 1.2.1. The lockwires on both were found to be installed in the counter clockwise, or loosening, direction (see Close-up 2).

Close-up 2. Lockwire on the left elevator hinge bolt, installed counterclockwise

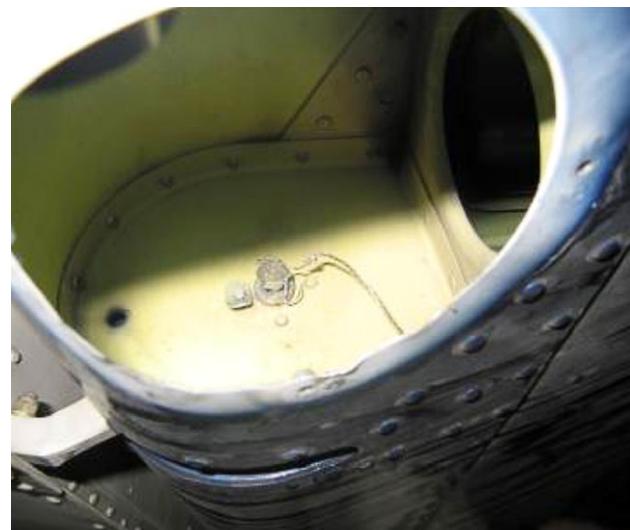
To check the behavior of one of these components in the as-found condition, the hinge bolt on the left elevator was loosened, with the following result: the torque needed to start it turning was 70 lb./in. (the tightening torque specified in the SB is 45 lb./in. plus the run-down torque). The lockwire allowed the bolt to be rotated 2/3 of a turn without offering any resistance. The wire remaining after this initial turn allowed the bolt to continue loosening. The force needed to loosen the bolt kept decreasing gradually after the initial turn. The lockwire broke before the hinge bolt was out of the hole, its final appearance being very similar to that of the lockwire on the rudder hinge bolt (see figure 3).

Figure 3. Lockwire on the left elevator hinge bolt, after being broken

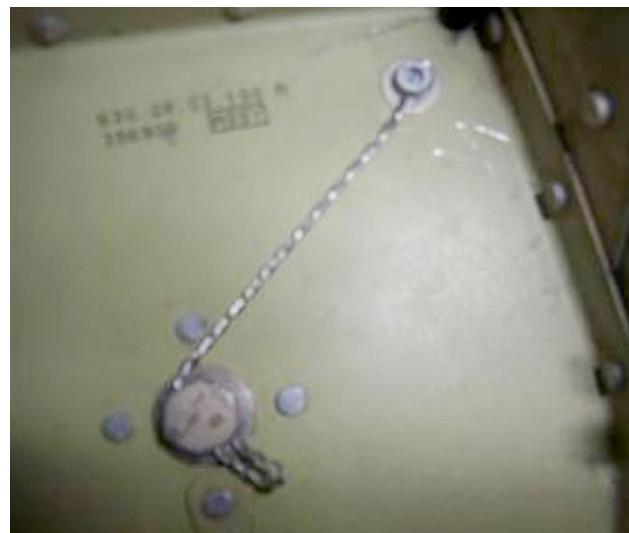
In both aircraft the directive and SB were verified to have been properly implemented with the correct installation of the lockwires on the hinge bolts, none of which showed signs of loosening.

Figure 4. Example of SB implementation on the right elevator of another aircraft
