FINAL  
KNKT.11.12.30.04

# NATIONAL TRANSPORTATION SAFETY COMMITTEE

Aircraft Accident Investigation Report  
**PT. Sriwijaya Air**  
**PK-CKM**  
**Boeing 737-300**  
**Adisutjipto International Airport, Yogyakarta**  
**Republic of Indonesia**

**20 December 2011**

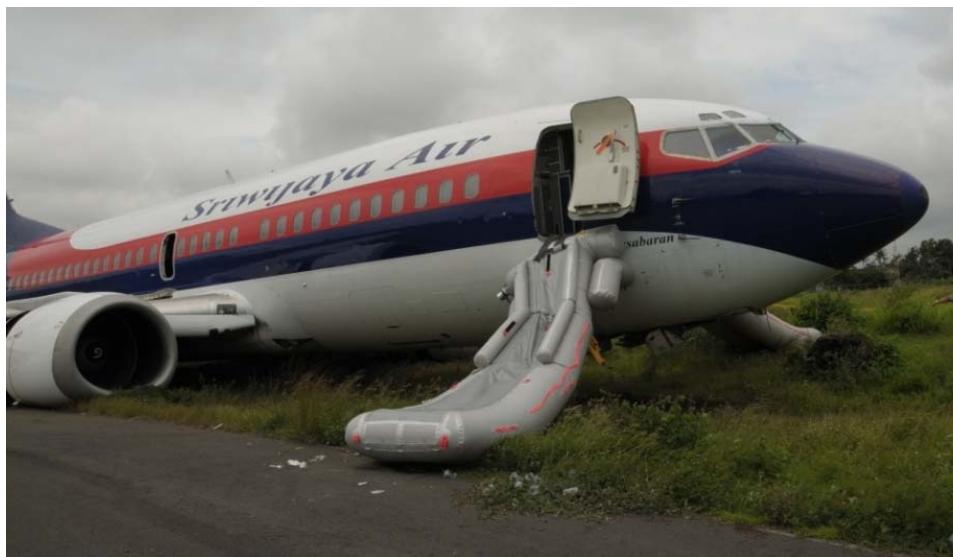
Figure 1: PK-CKM stopped at 75 meters from end of runway 09

The aircraft stopped at 75 meter from the end of runway 09 and 54 meter on the left side of the centre line.

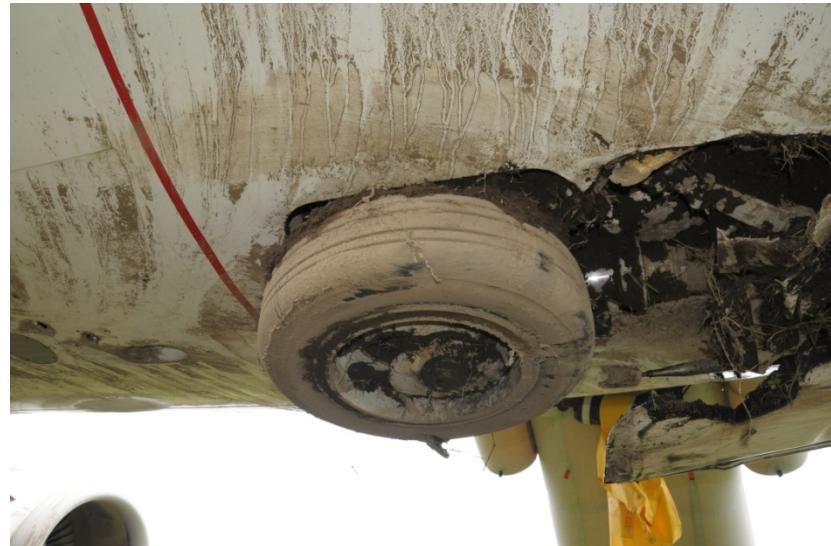
Figure 2: Nose wheel

The aircraft hit the ground with nose landing gear and right main landing gear collapsed, damaged the aircraft bottom structure.

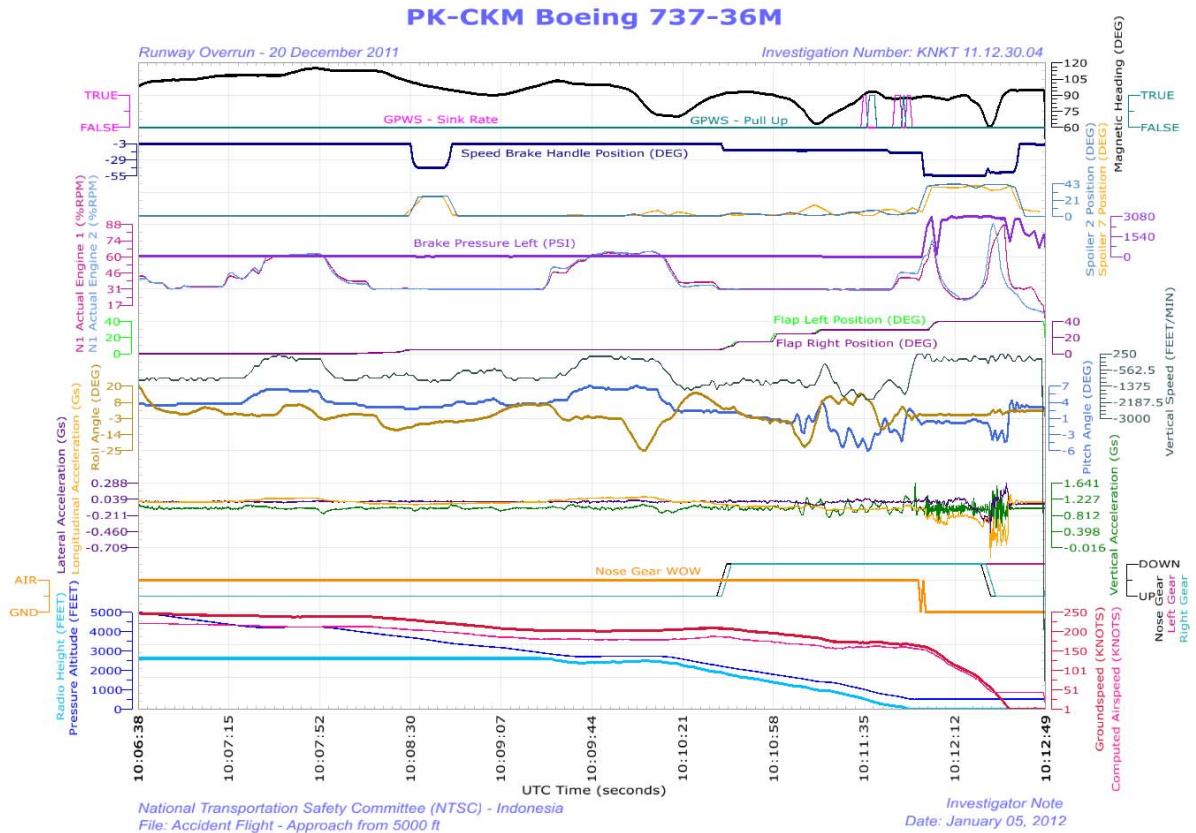
Figure 5: The FDR data plot on approach started from altitude 5000 ft.

- The aircraft was at heading greater than 090 after started to descend left 2500 ft;
- At below 1000 ft, the aircraft heading was relatively constant;
- The rate of descend recorded vary and up to 1920 ft per minute and below 500 ft AGL, the rate of descend recorded up to 2040 ft per minute.
- The aircraft touched down at 10.12 UTC at speed 156 Kt before it bounced.
- The left and right engines indications were relatively equal during the approach phase. After landing, the N1 value increased then decreased to idle value and increased until the aircraft about to stop.
- The ground spoilers were extended, immediately after landing.
- The flap extended to 40 after the aircraft touch down.
- The brake pressures were relatively at maximum pressure from few moments after touch down until the aircraft stop.

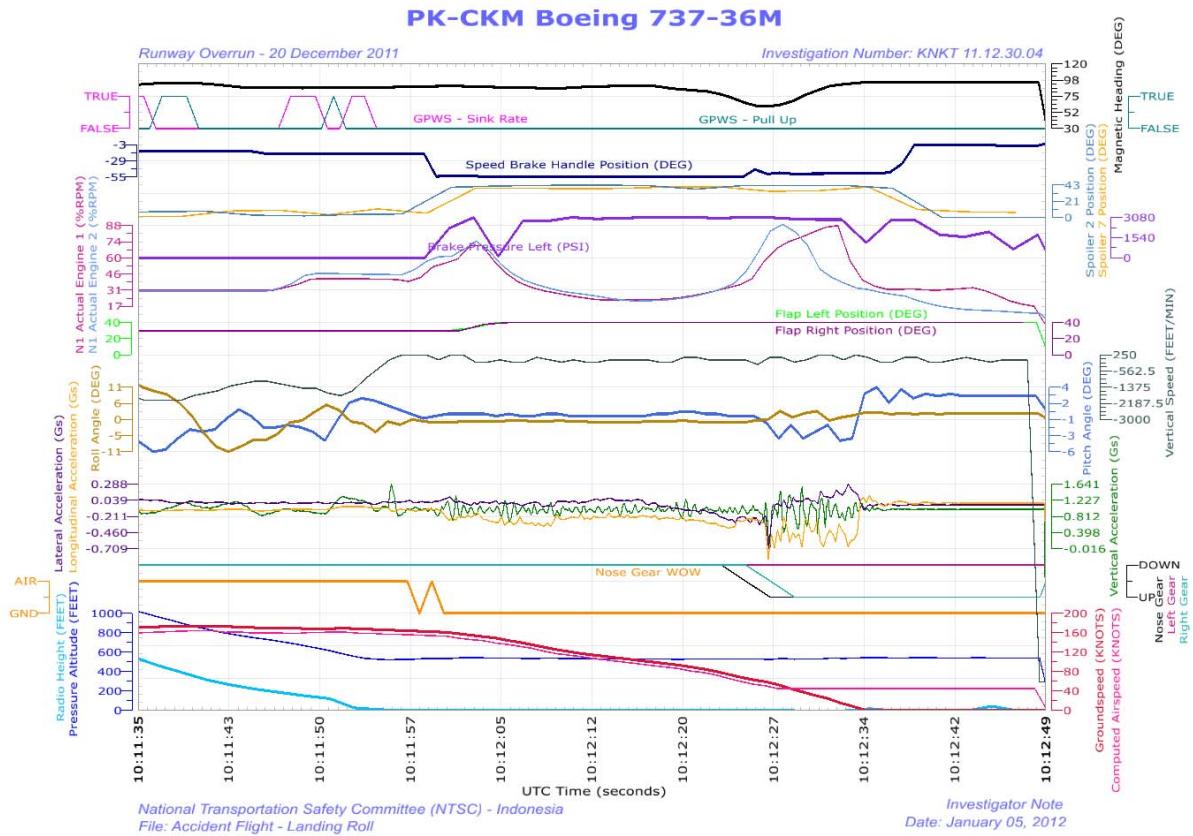
Figure 6: FDR data plot started from altitude 1000 feet.

These situation indicated that the approach was not meet the 9 criteria of stabilize approach according to the Flight Safety Foundation as stated in the Boeing Flight Crew Training Manual (FCTM). The aircraft speed was 20 Kt above the target. The aircraft path was deviate and higher from the published approach path. The pilot corrected the final track and approach path by lowering the aircraft nose down and rate of descend up to 2040 ft per minute. However, this action has resulted in high aircraft speed.

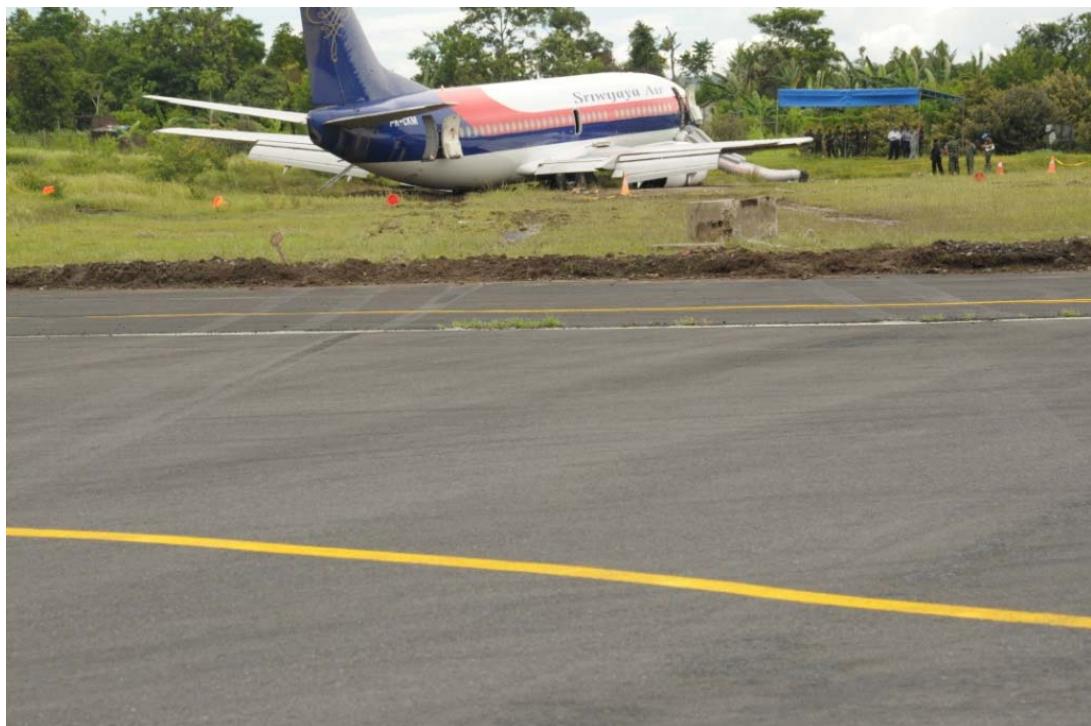
Figure 8: Aircraft final position

Aircraft tail position was 75 meters from the end of runway and 54 meters left side of runway centreline.

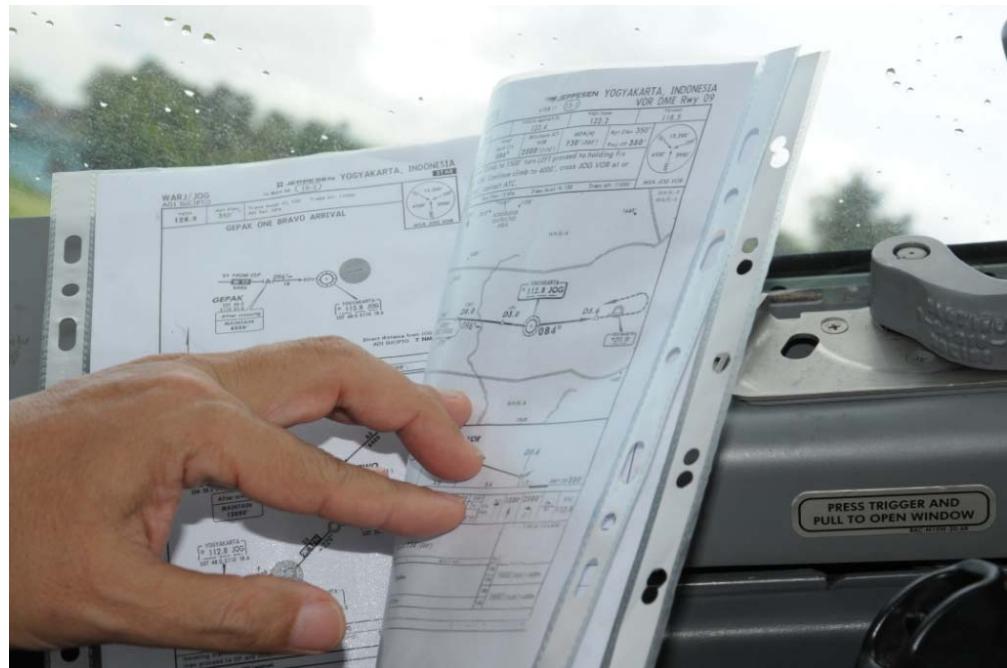
Figure 9: Approach charts on the PIC pad folder.

During the investigation it was found on the left writing pad holder found 3 pages of approach chart. The top page was ILS Approach runway 10 Surabaya, second page was ILS approach runway 09 Yogyakarta and the VOR/DME runway 09 on the other side of the page (face down) and the bottom page was Standard Arrival (STAR) runway 09 Yogyakarta.

The investigation found that the VOR/DME runway 09 was not ready to use on the PIC writing pad holder. The available approach chart was the ILS Approach runway 10 Surabaya. It also found that both pointers of the Radio Magnetic Indicator (RMI) on the left pilot were set to Automatic Direction Finding (ADF).

Missing the crew briefing and no approach chart available might have made the PF not familiar with the VOR/DME runway 09 approach path.
