# TAWS alert involving ATR-GIE Avions de Transport Regional ATR72-212A, VH-FVR

Moranbah Airport, Queensland | 15 May 2013

## ATSB Transport Safety Report

AO-2013-085

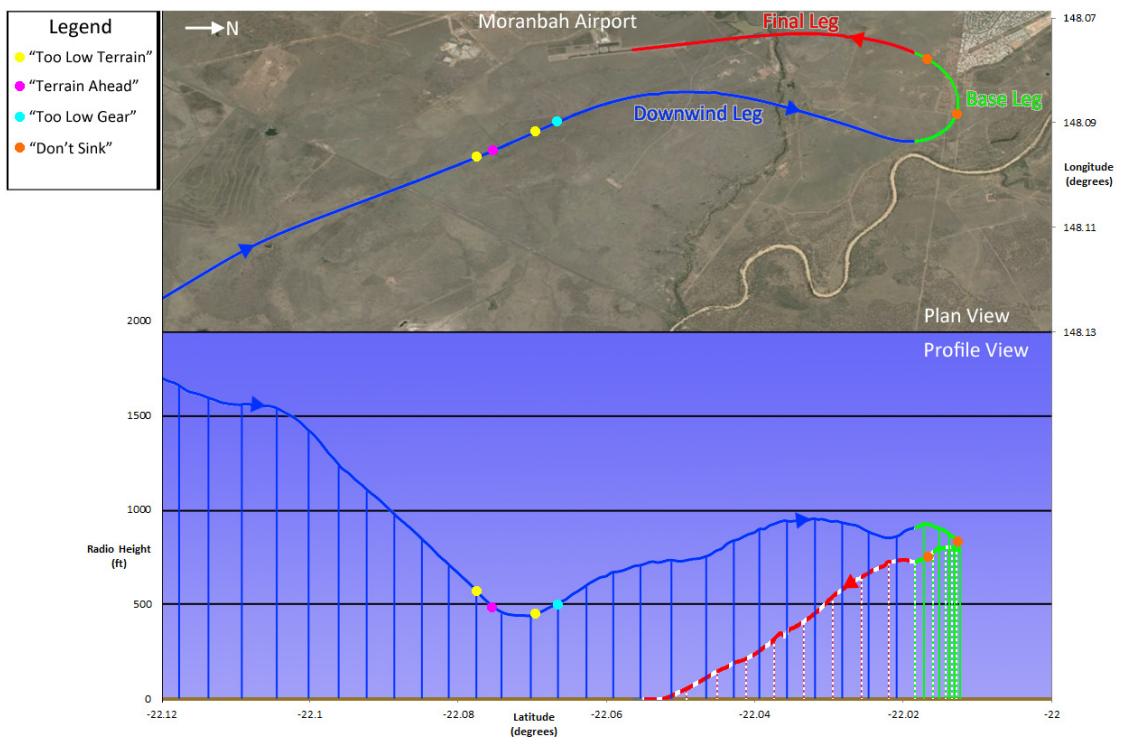
**Figure 1: Flight path and descent with TAWS alerts indicated (see legend)**

Concurrently the captain recognised that, if the current flight path was continued and the aircraft levelled at 1,500 ft AGL on downwind, they would enter cloud. Without discussing it with the FO, the captain decided and announced that they were disconnecting the autopilot and continuing the descent in an attempt to remain clear of the cloud. The captain reported that they believed the aircraft would only need to descend 200-400 ft to be clear of the cloud layer. The captain stated that during the approach and manoeuvring, they were in sight of the runway and ground; although visibility along the flight path was reduced because of the cloud.

Consistent with the recorded vertical speed, the FO indicated that, soon after descending from the intended circuit height, they observed the aircraft's vertical speed at about 700 ft/min in descent. About 30 seconds later, while passing 562 ft AGL, the aircraft's terrain awareness warning system (TAWS) ground proximity warning system activated (Figure 1), sounding an aural 'Too Low Terrain' alert together with a visual 'caution' annunciation on the glareshield. This alerted the crew of the aircraft's proximity to terrain and was followed shortly after by a 'Terrain Ahead' alert, another 'Too Low Terrain' alert and then a 'Too Low Gear' alert. All occurred within 12 seconds of the aircraft being levelled at about 440 ft AGL.

The recorded average vertical speed during the descent from circuit height to 440 ft AGL, the lowest recorded height before the crew initiated a climb, was 1,750 ft/min.

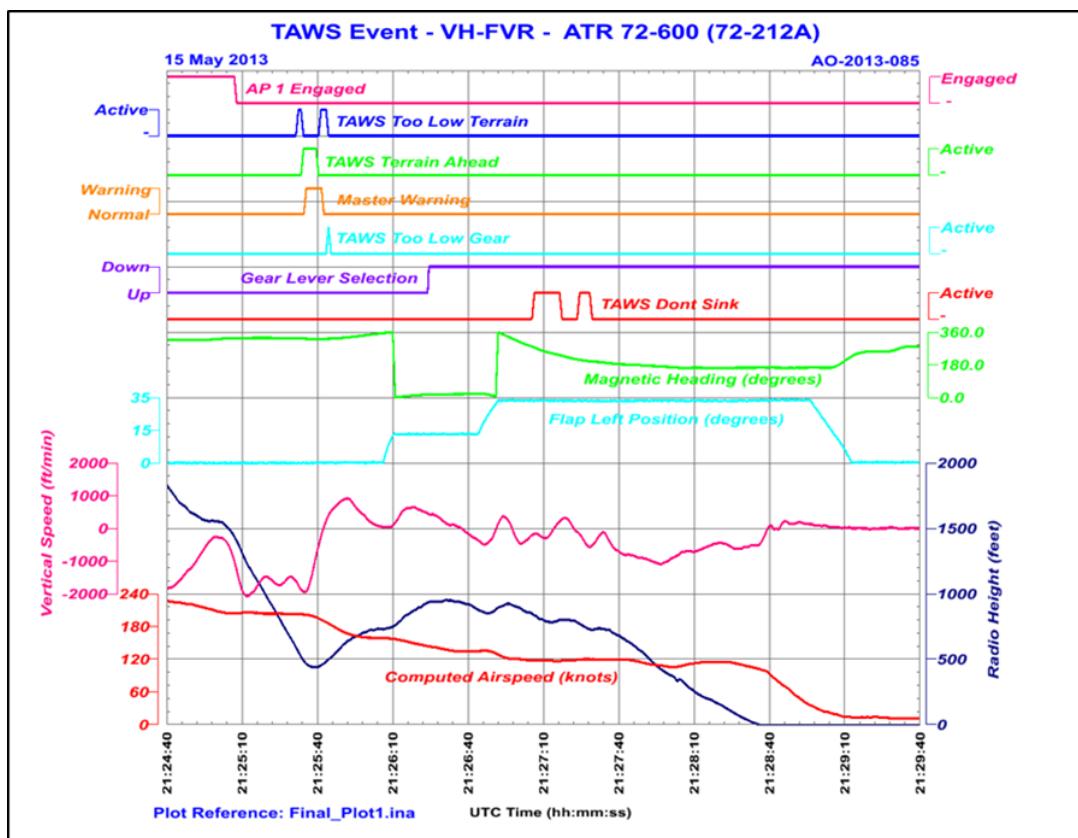
Figure 2: Recorded aircraft flight parameters with TAWS alerts indicated

The following TAWS alerts were activated after the crew descended from the intended circuit height of 1,500 ft AGL (Figure 2):

In this case, the TAWS Mode 3 functionality was armed when the crew initiated the climb from 440 ft AGL when in a clean configuration. The 'Don't Sink' alert activated when the crew commenced their descent for landing without first reaching 1,500 ft AGL (as measured by the radio altimeter).

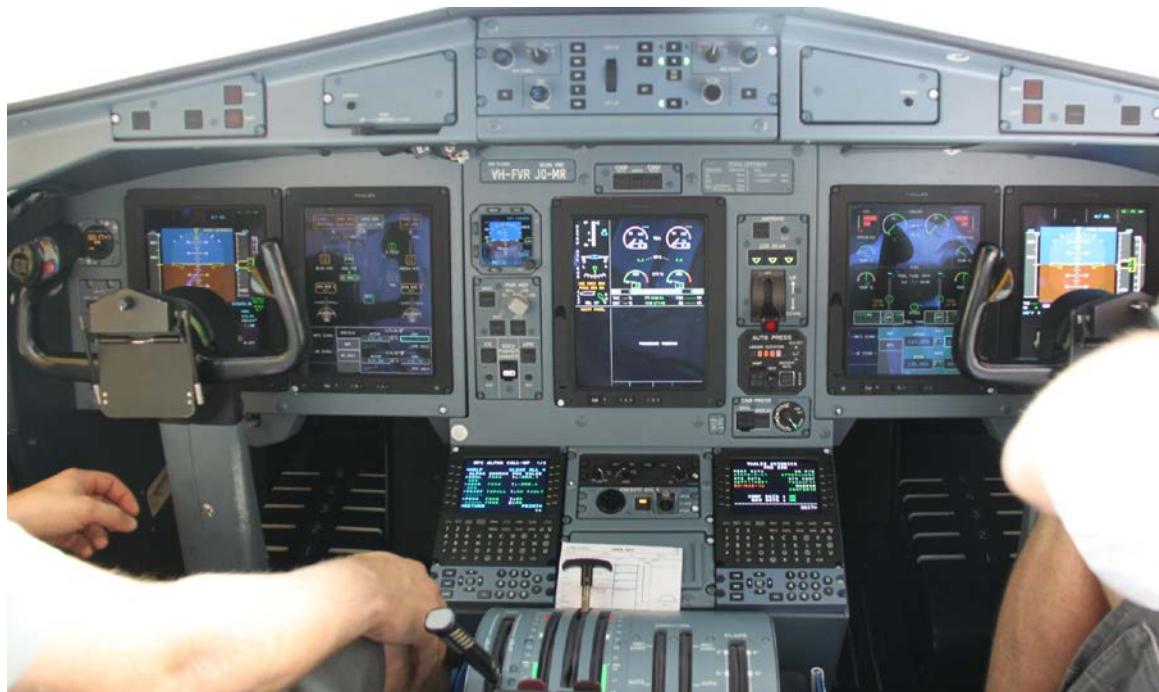
**Figure 3: VH-FVR flight information displays**

A number of cues were available to the crew to assist with monitoring the aircraft's performance and flight profile (Figure 3). The FO reported that during flight, attention was normally given to information presented on the primary flight display (Figure 4). This included monitoring the radio altitude when at lower altitudes, the speed indicator (or 'tape') to ensure the aircraft did not exceed

any limitations and the vertical speed indicator to ensure the aircraft's vertical speed was appropriate for the phase of flight.
