AIRCRAFT INCIDENT REPORT AND EXECUTIVE SUMMARY

Reference:	CA18/3/2/1067								
Aircraft Registration	ZS-NMF / ZS-SZZ	Date of Incident	10 July 2014		Time of Incident	1108Z							
Type of aircraft	Bombardier CL600 / Airbus A320			Type of operation	Part 121 - Commercial								
Pilot-in-command licence type		Airline Transport	Age	38	Licence valid	Yes							
Pilot-in-command flying experience		Total flying hours	8 724.1		Hours on type	1 657.5							
Last point of departure		King Shaka International aerodrome (FALE), Kwa-Zulu Natal province											
Next point of intended landing		Port Elizabeth aerodrome (FAPE), Eastern Cape province											
Location of the incident site with reference to easily defined geographical points (GPS readings if possible)													
Overhead Port Elizabeth (GPS position: 33°59'38.02" South 025°35'35.30" East)													
Meteorological information	Surface wind: 040/5 knots, Temperature: 18°C, Visibility: +10 km

AIRCRAFT INCIDENT REPORT

Name of Owner : SA Express / South African Airways (Pty) Ltd
Name of Operator : SA Express / South African Airways (Pty) Ltd
Manufacturer : Bombardier / Airbus
Model : CL600-2B19 / A320-232
Nationality : South Afri

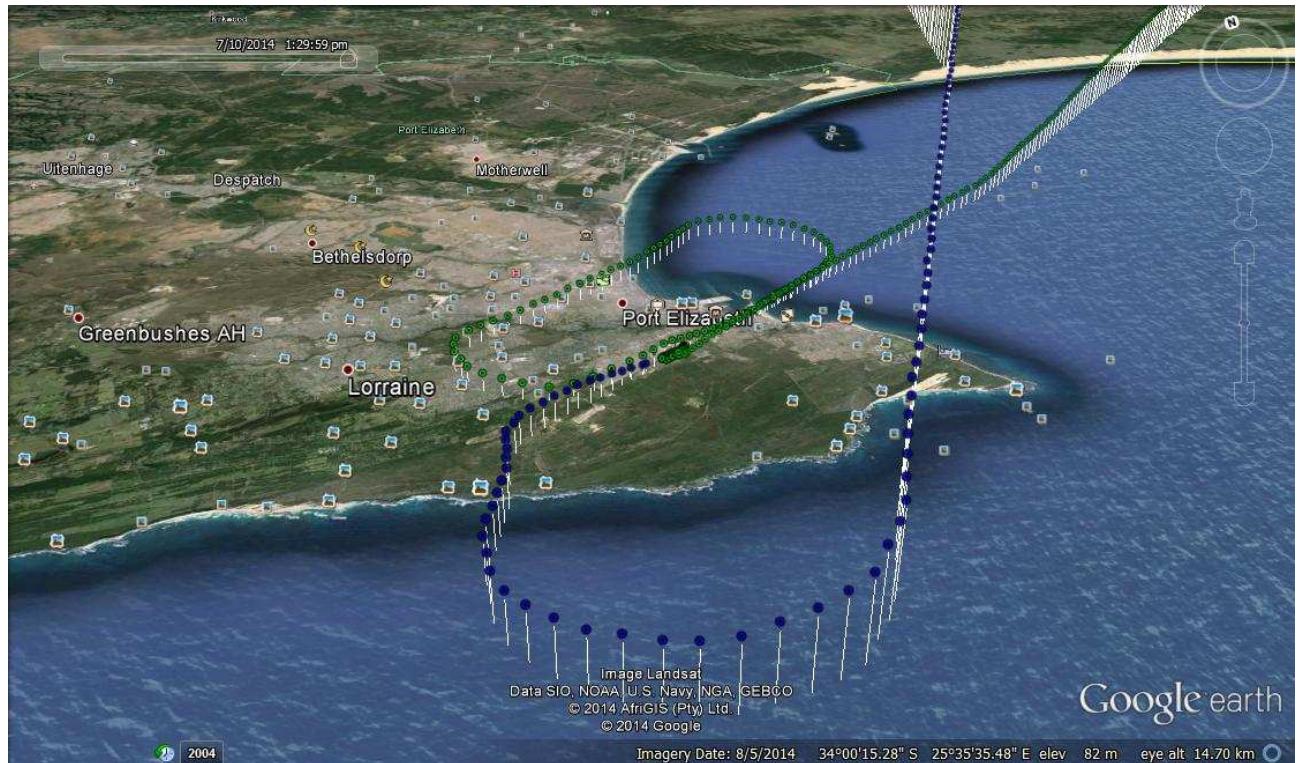
- 1.1.6 The radar data depicted in figure 1 indicates the flight path flown by EXY336 (green track), which approached FAPE over the sea from the northeast and following the go-around flew a right-hand circuit followed by a full stop landing on runway 26. The blue track indicates the flight path flown by SAA410, which was instructed to

Figure 1. The radar data display of the track flown by EXY336 (in green) and SAA410 (in blue)

1.1.7 According to radar data, the vertical separation between the two aircraft was 263 feet (80 m) and the horizontal separation was 0.2 nautical miles (370 m).

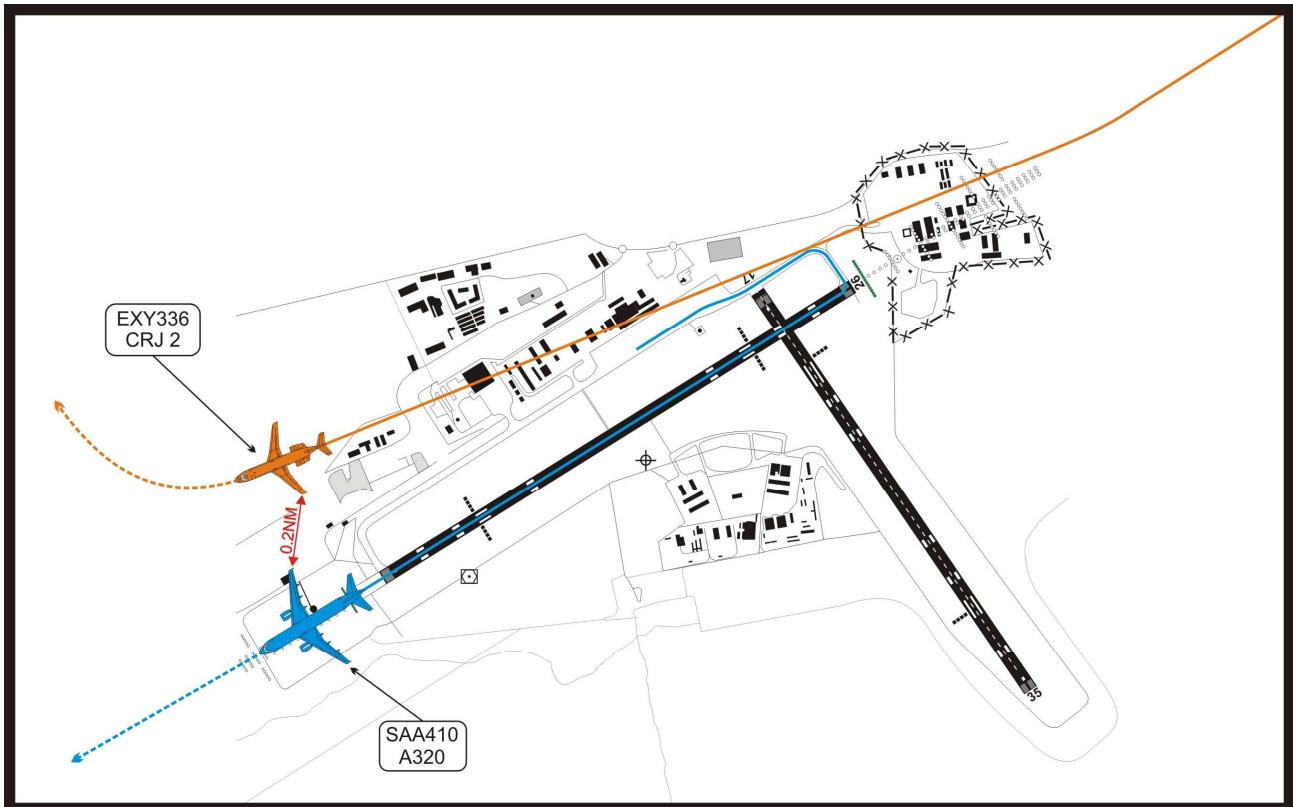
1.12.1 According to radar data obtained the vertical separation between the two aircraft deceased to 263 feet (80 m) and the horizontal distance to 0.2 nm (370 m), as illustrated in Figure 4.

Figure 4. Illustration of the separation between the two aircraft in the horizontal plane.

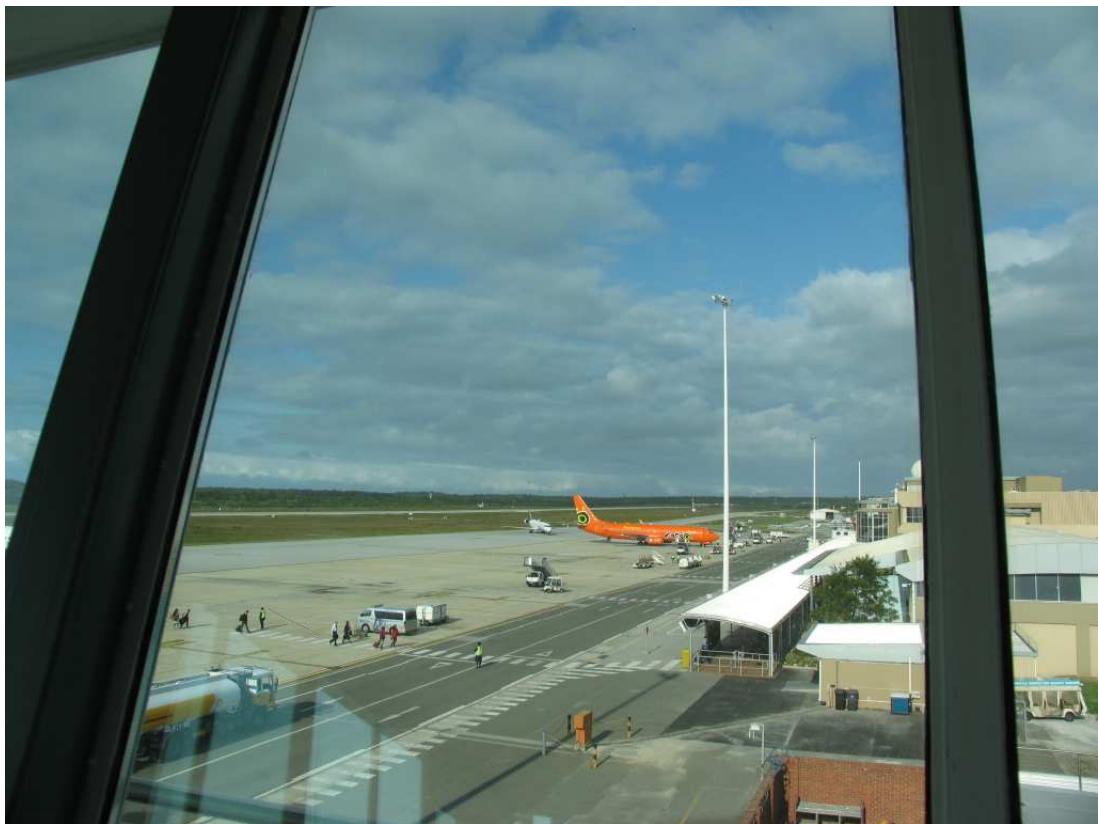
The control tower is located on the north-eastern side of the aerodrome and elevated above the administration building, which is a single-level building. The tower was found to be low if compared with several other control towers in the country and abroad, taking into consideration that the aerodrome held an international licence. For illustration purposes a photo (figure 6) was taken from inside the tower onto the apron area and in the direction of the threshold of runway 08.

Figure 6. View from the control tower onto the apron area and threshold of runway 08

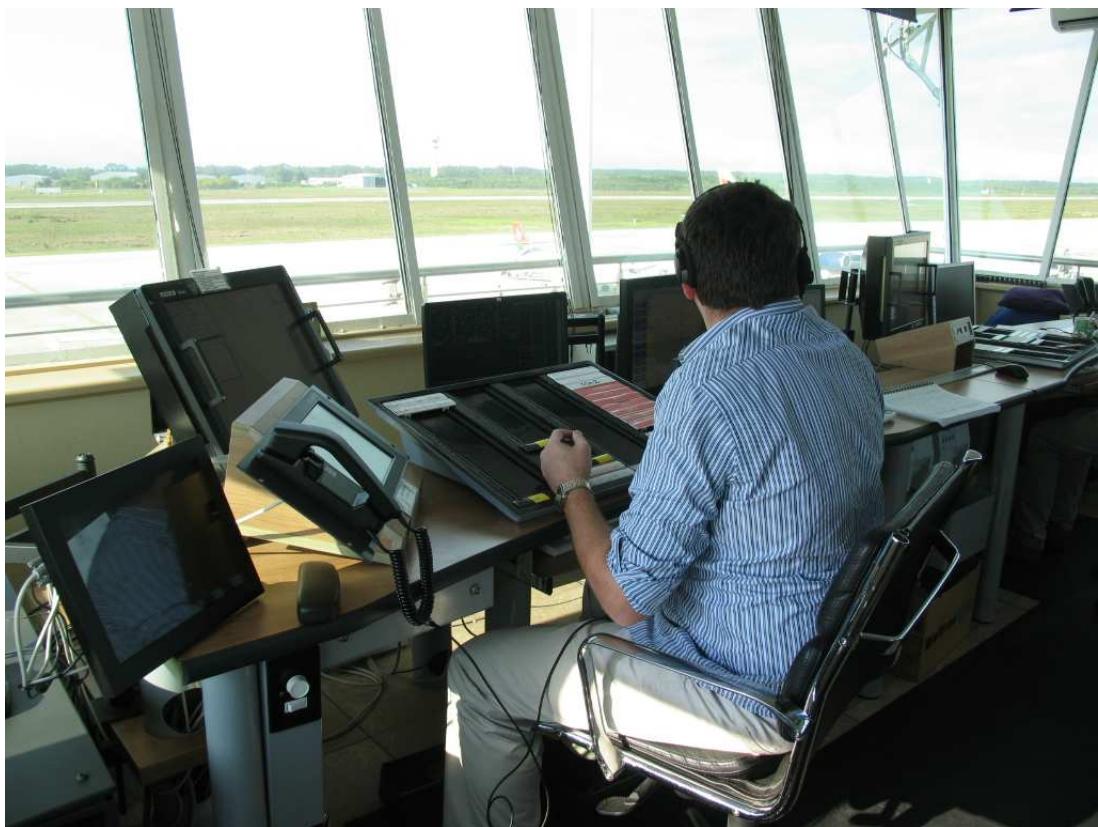
Figure 7. The aerodrome controller's work station in the tower

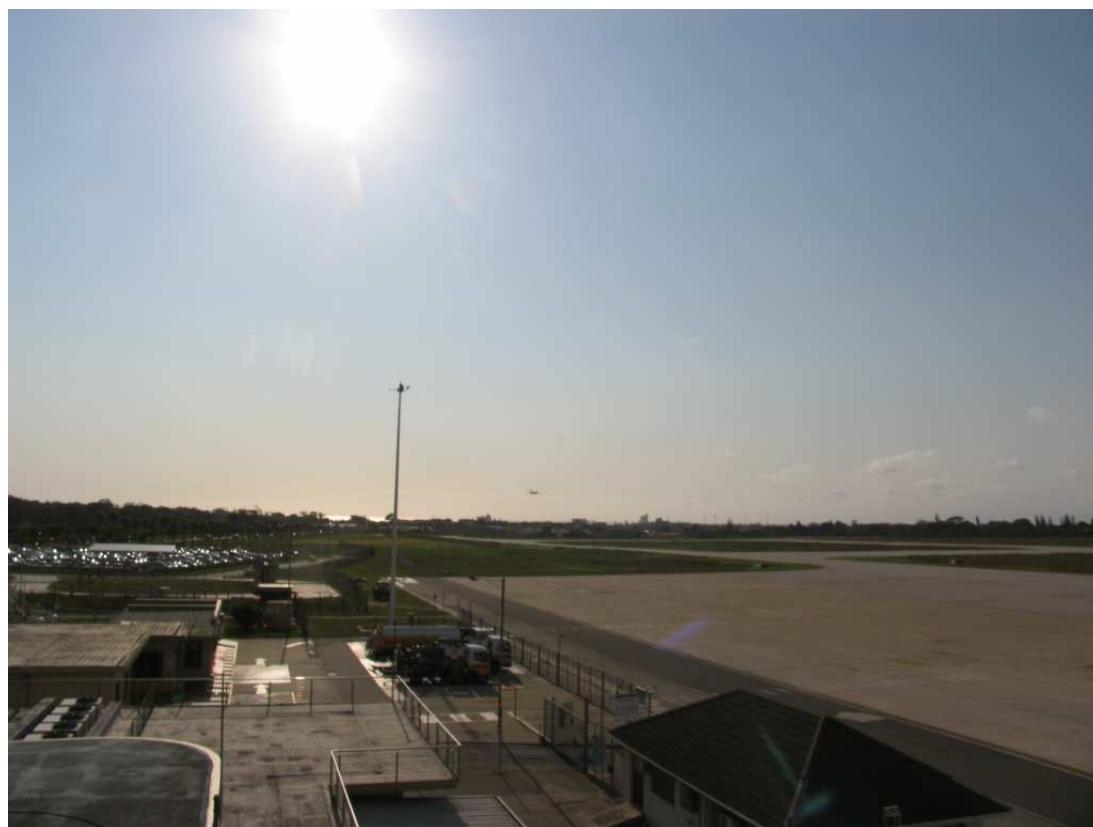
Figure 8 illustrates a view from the control tower looking towards final approach to runway 26. During daytime, in good weather conditions, the sun causes a substantial brightness/reflection/glare on the sea (photo tried to illustrate this

phenomenon) for a substantial period of the day, which makes it very difficult for the controller to visually observe aircraft on final approach, even if the aircraft are properly illuminated by external lights. Glare shields had been installed inside the tower, and the controller can move them up or down to try and alleviate the problem; however, if the controller took his eyes off the approaching aircraft and wanted to refocus, he or she might not be able to pick up the aircraft again. Estimating the distance to an aircraft on the approach by looking at it poses a challenge, and the radar display screen does provide such information; but with the aircraft on short final approach the controller does not look at the radar display. With Port Elizabeth being one of the windiest places in South Africa, wind can have a profound effect of the ground speed of the aircraft on the approach, as upper winds might vary substantial in speed, strength and direction relative to surface winds. Aircraft might therefore be flying much faster (greater ground speed) on the approach than the controller might anticipate.

Figure 8. A view from the control tower looking towards final approach of runway 26

The control tower at FAPE was found to be very low when compared with a number of other control towers in the country and abroad, taking into consideration that this is an aerodrome with international status. It was observed that the reflection of the sun on the sea during a certain time of the day can cause the controller(s) to have some difficulty following an aircraft visually on the approach for runway 26, something that could not be ruled out as a contributory factor to this incident. The tower was found to be equipped with glare shields to limit this phenomenon; however, there might be instances where the glare shield might not be properly adjusted for a certain controller at a certain time and the aircraft might not be immediately visible to the controller.
