BULLETIN

Serious incident

BOEING MD-82

SE-DIK

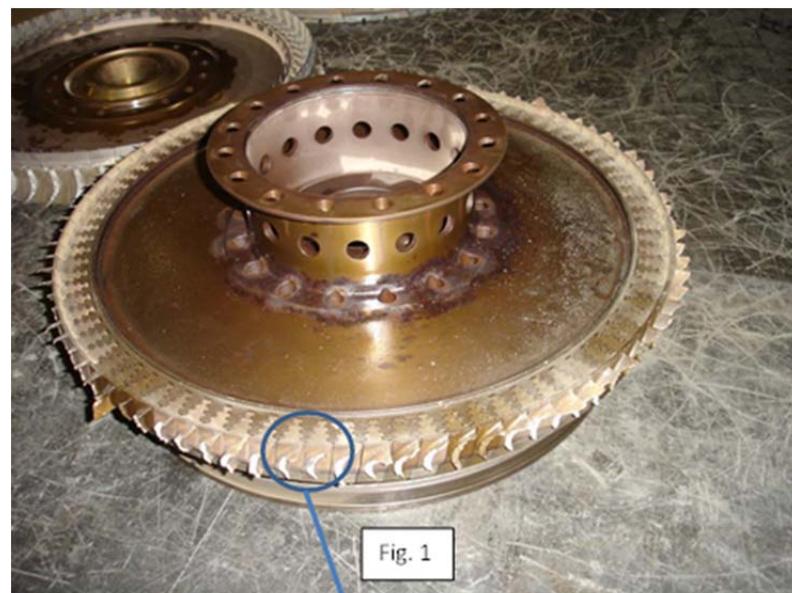
Fig. 1

The visual examination of the engine revealed that all 3rd stage low pressure turbine (LPT) 88 blades were fractured at or near the airfoil root above the flowpath platform. See figure 1.

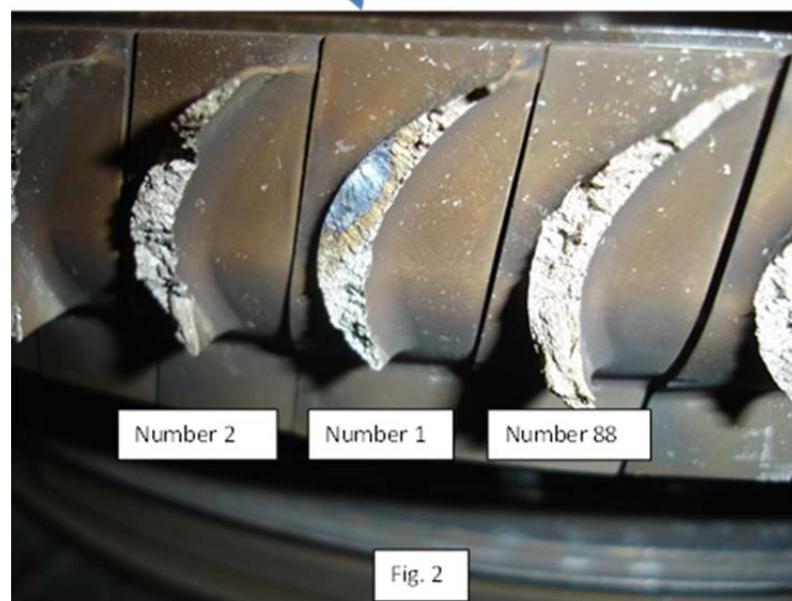
Fig. 2

The examination revealed that one of the 3rd stage LPT blades (blade number one) had signs of heat and fatigue in the fractured area, see figure 2.

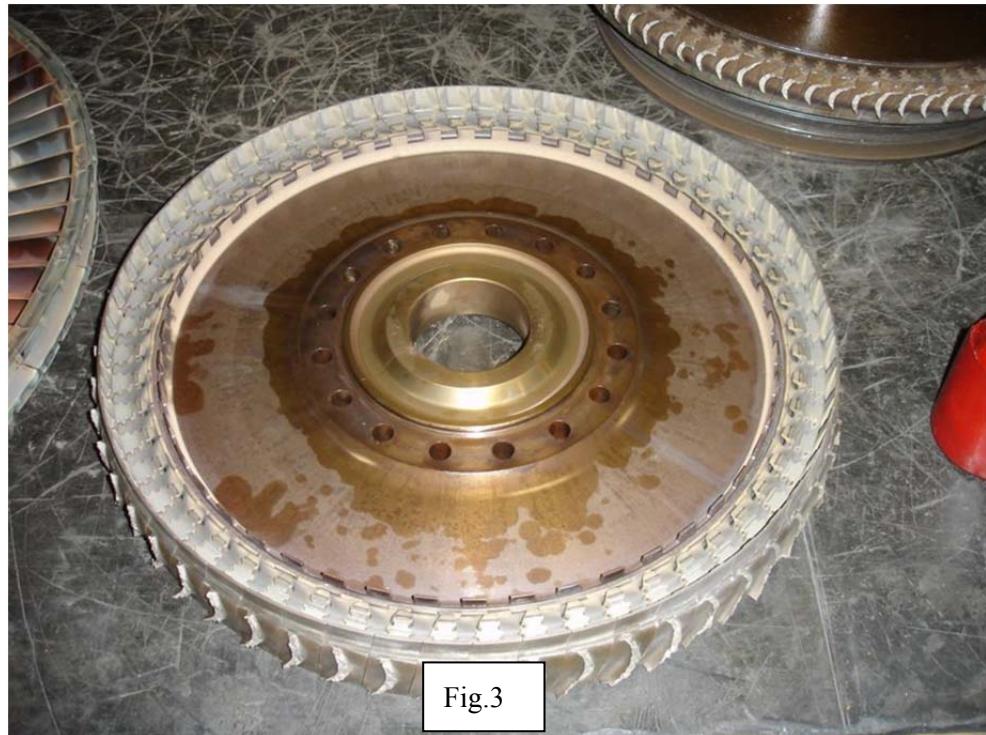
All 4th stage LPT blades were fractured at the blade airfoil roots. See figure 3.

The remaining parts of the 4th stage LPT disk blades did not reveal any evidence of fatigue.

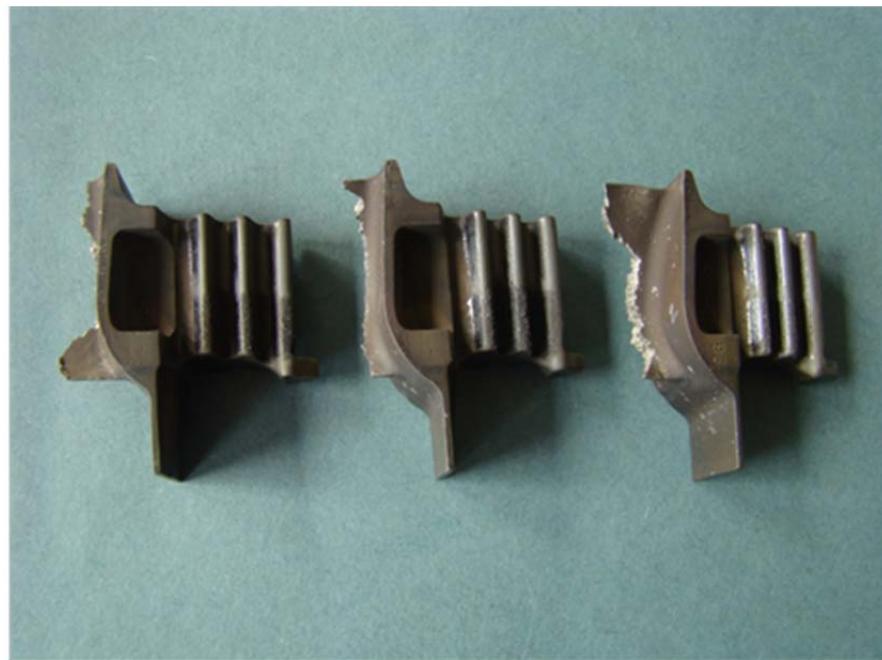
Fig. 4

The suspected blade (number one) and the blades next to (number 88 and number two) were removed from the disk and examined. The three blades are shown in figure 4.

LPT 3rd stage blades. From left: Blade 2, 1 and 88.

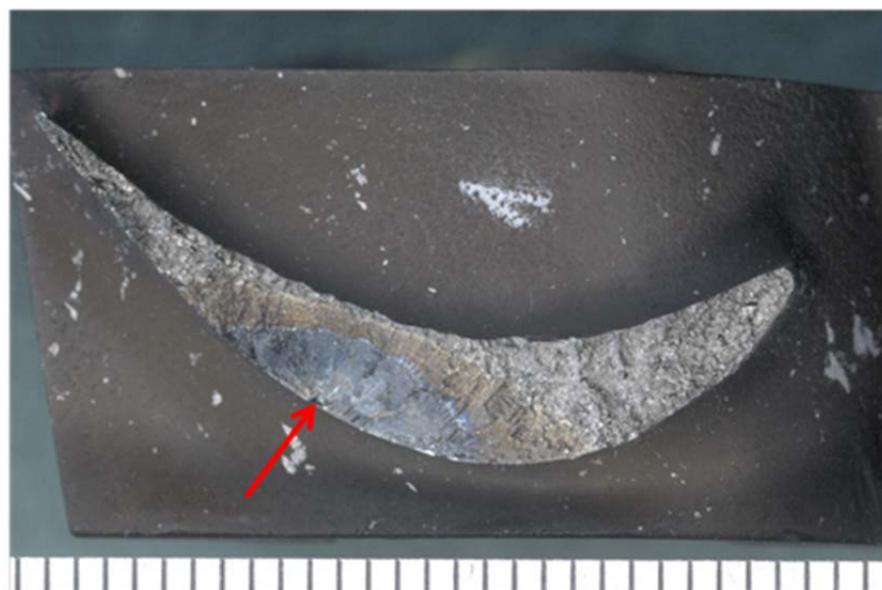
Fig. 5

Clear signs of fatigue were observed on blade number one. The fracture surface was oxidized to various degrees and beach marks were visible.

The fatigue crack initiation point is marked with an arrow in figure 5. The fatigue part of the fracture was relatively plane and smooth, whereas the final fracture was rough and serrated. Fatigue crack showed in figures 6 and 7 with various magnifications.

Blade 1.

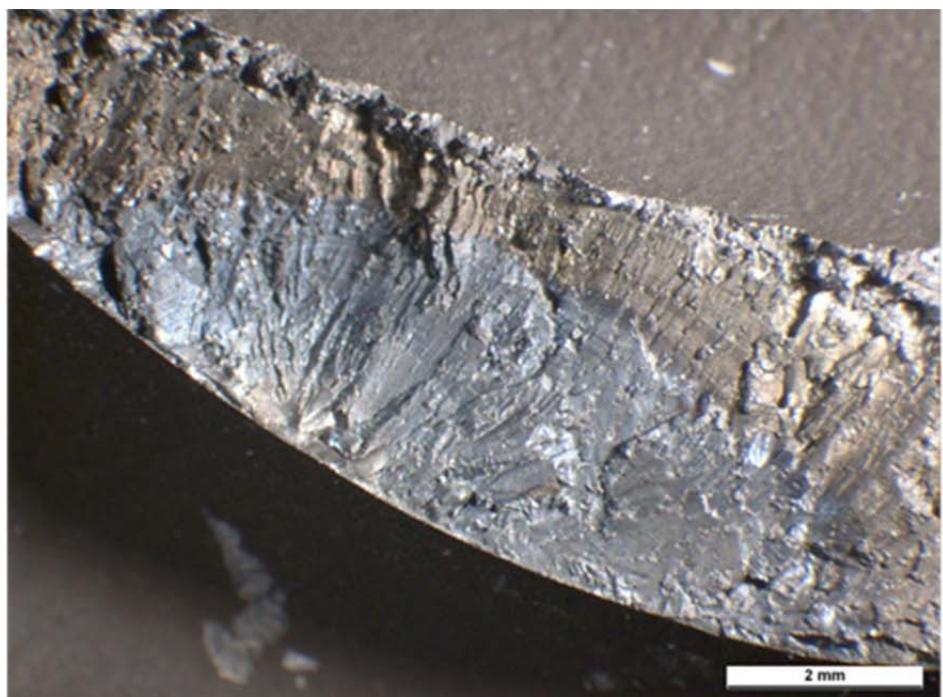
Fig. 6

Blade 1. Enlarged section of figure 5.

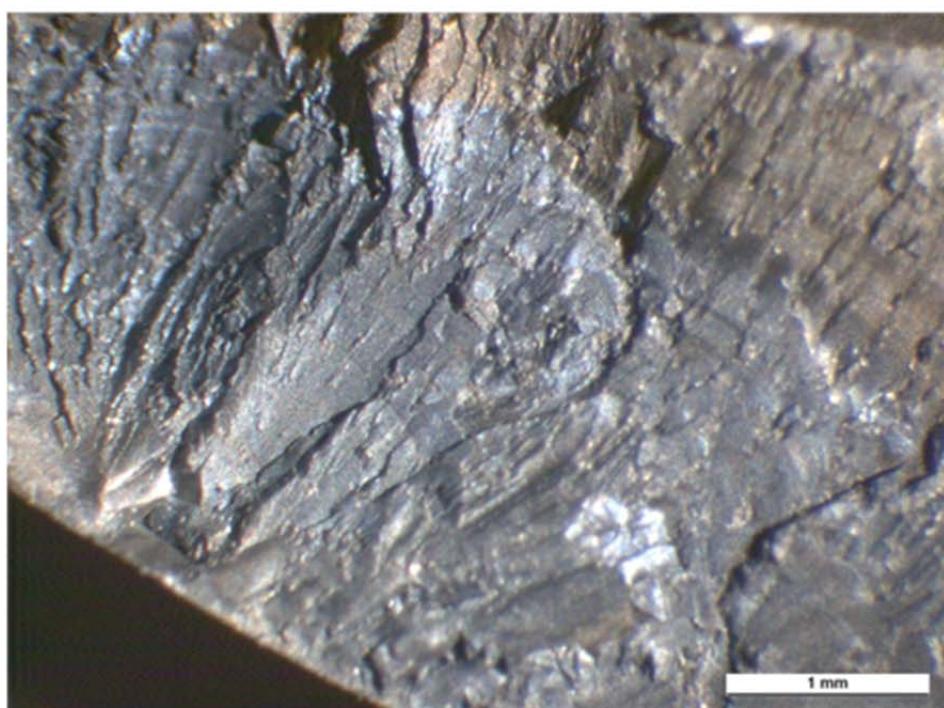
Fig. 7

Blade 1. Enlarged section of figure 6

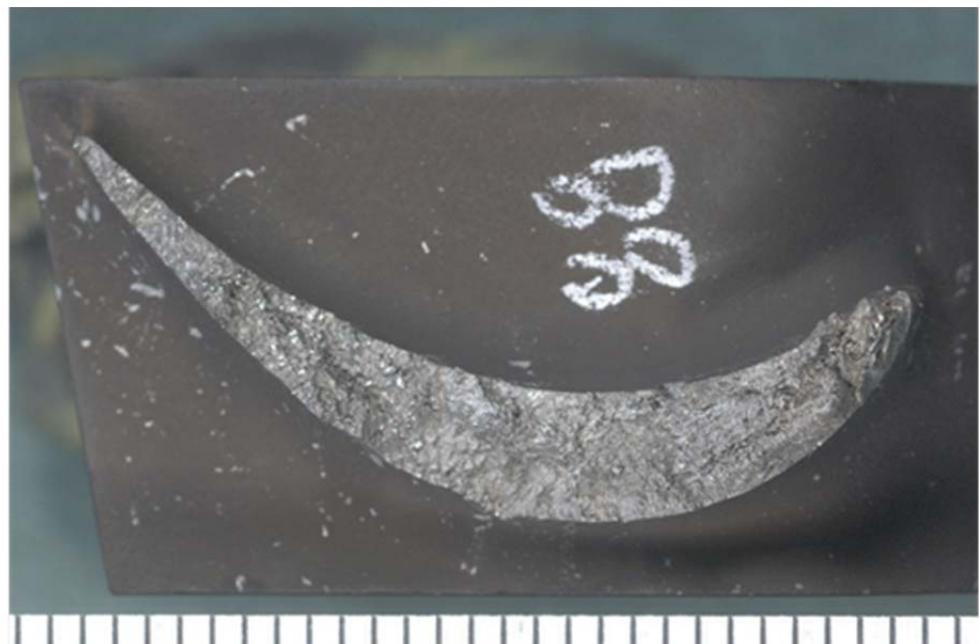
Fig. 8

Blades number 88 and number two are shown in figures 8, 9 and 10. There were no signs of fatigue. In the stereo microscope in some parts of the fracture surfaces dendrite-like appearances were observed as illustrated in figure 9.

Blade 88.

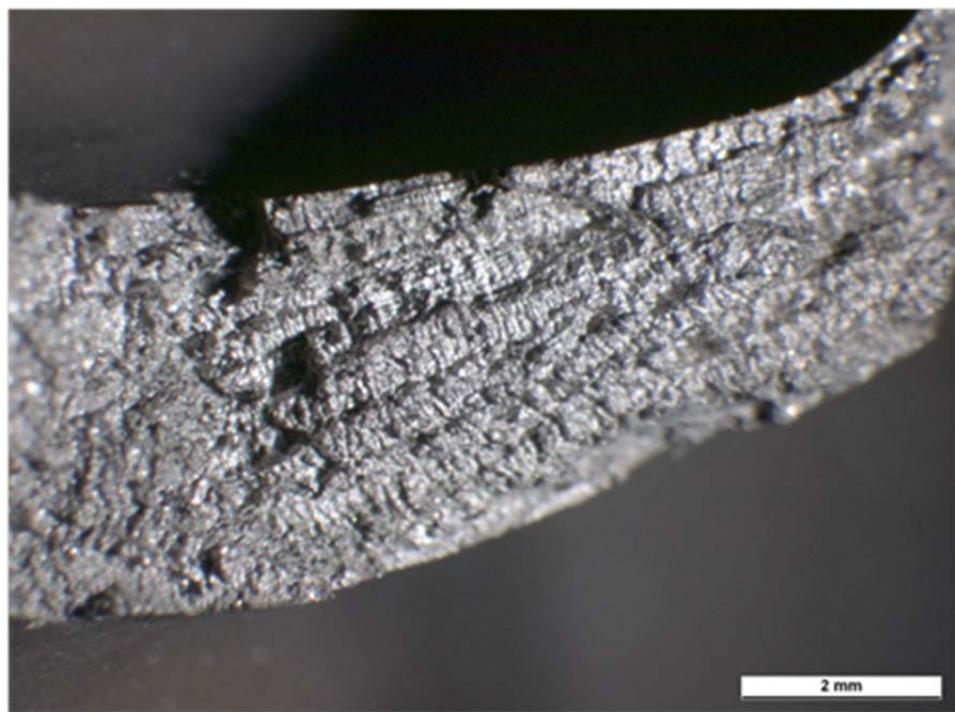
Fig. 9

Blade 88. Enlarged section of figure 8

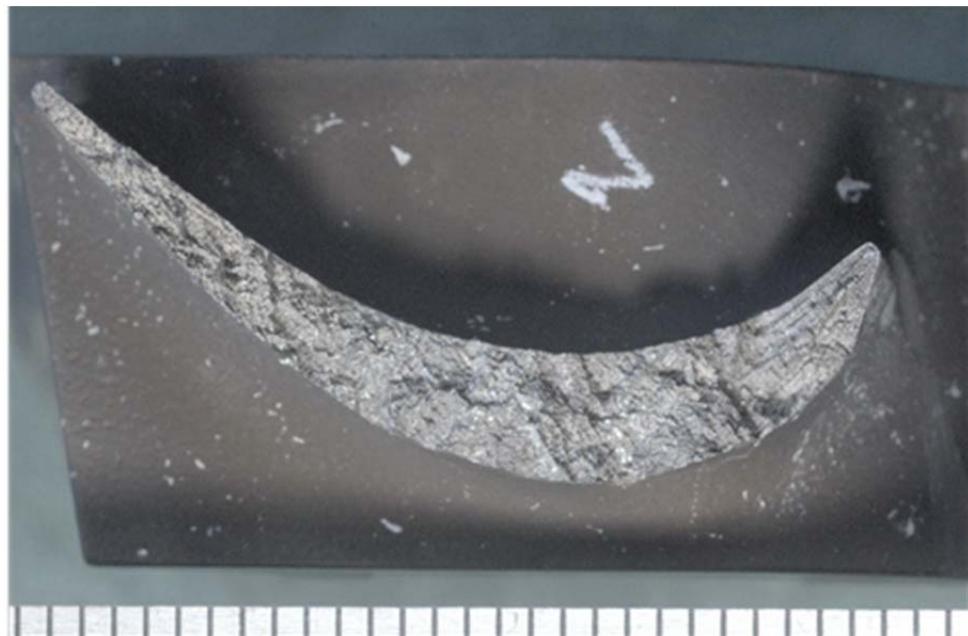
Fig. 10

Blade 2.

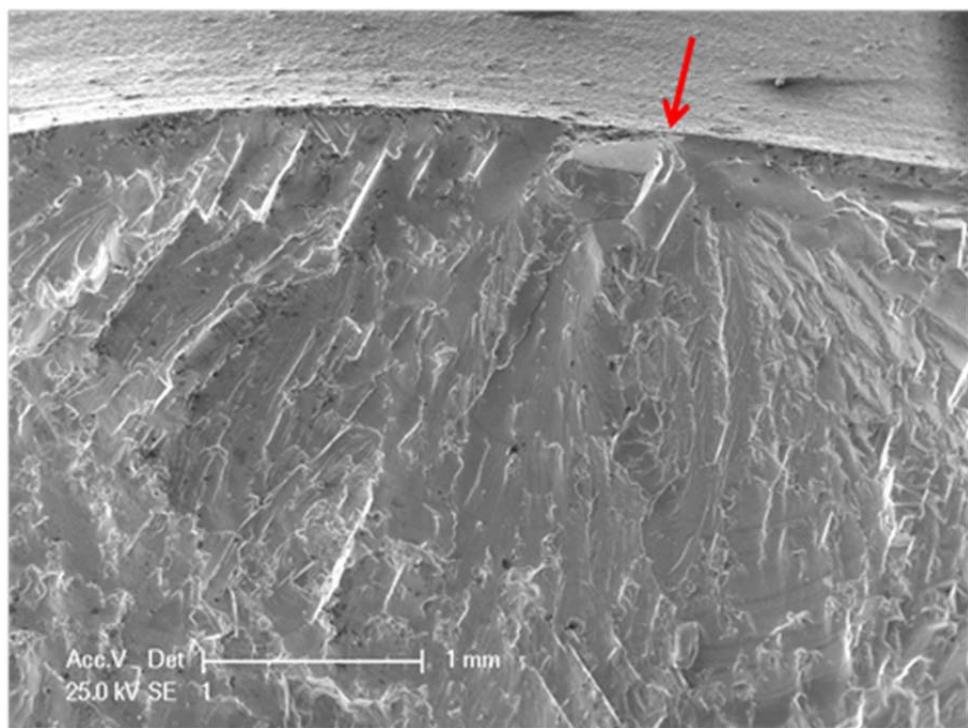
Fig. 11

The SEM revealed a crack initiation area in blade number one (is shown in figure 11). No material defects - which could have caused the crack initiation - were observed.

Blade 1. Fatigue initiation point is marked by arrow.

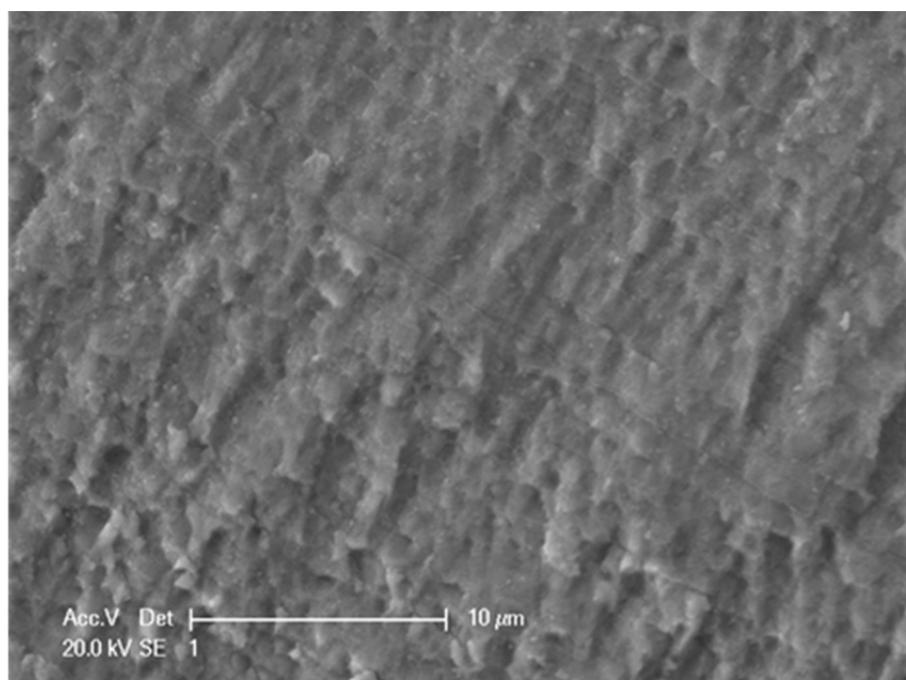
Fig. 12

In the yellow tinted part of the fracture surface (figures 5, 6 and 7) faint signs of fatigue striation were observed. An example is shown in figure 12.

Blade 1. Fatigue striations.

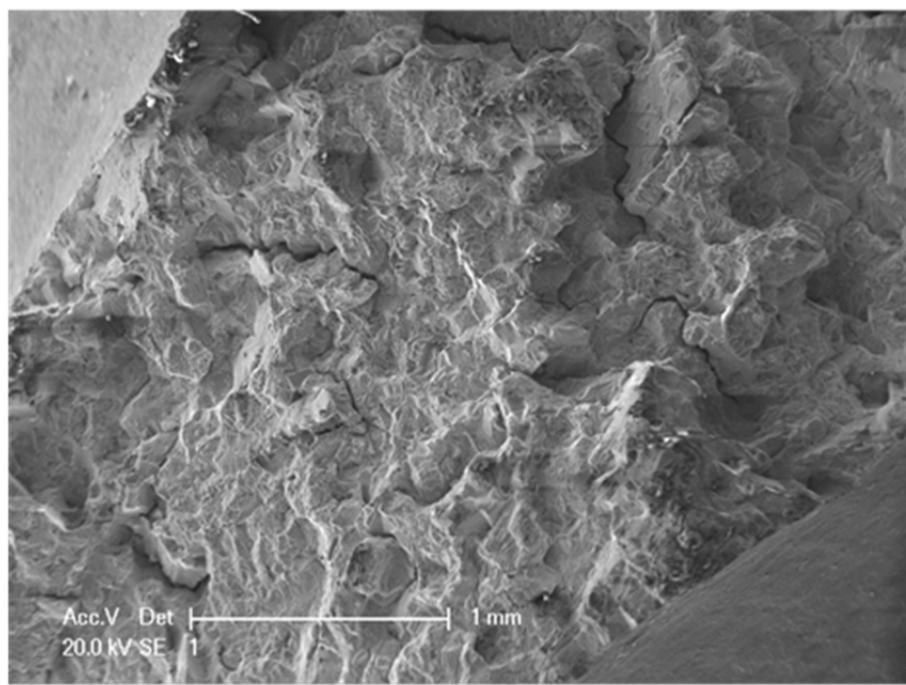
Fig. 13

A part of the final fracture close to the leading edge is shown in figure 13. The rough nature of the fracture surface from this part of the fracture was evident. In higher magnification, dimples, characteristic of ductile overload were observed. Figure 14 shows an example.

Blade 1. Part of the final fracture close to the leading edge.

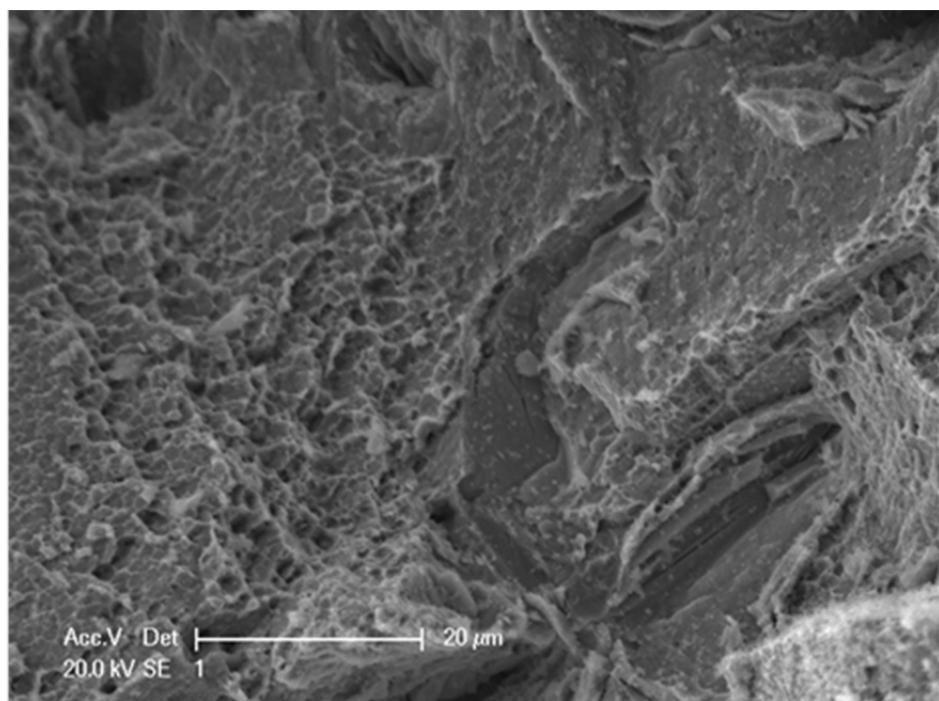
Fig. 14 Blade 1. Enlarged section of figure 13.

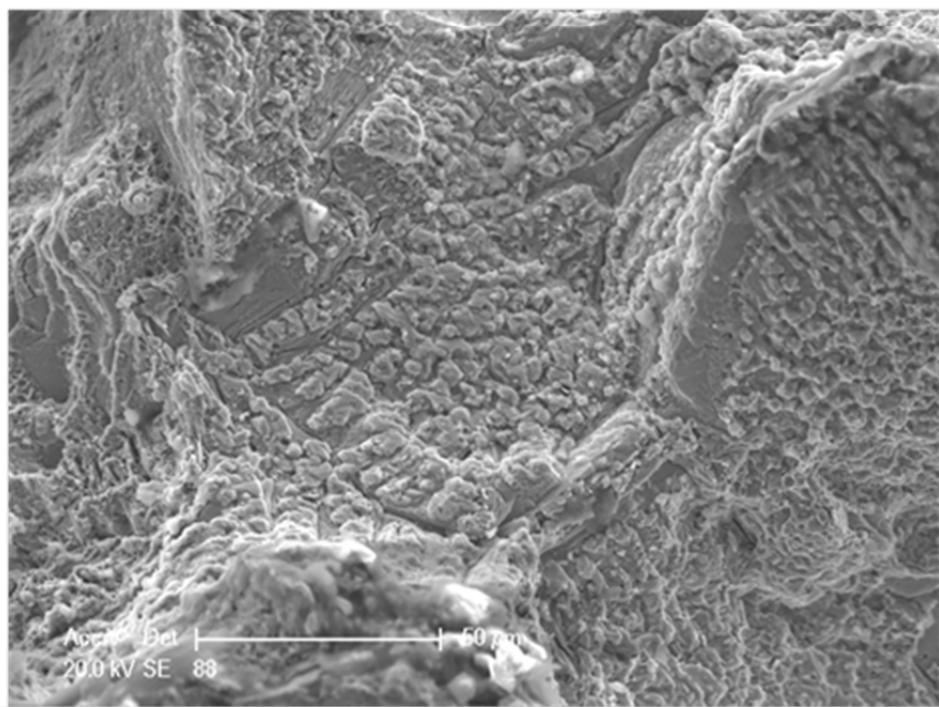
Part of the fracture surface, which in stereo microscope displayed a dendrite like appearance (figure 9), was further examined in SEM. A section of the fracture surface is shown in figure 15.

Dimples, characteristic of ductile overload were observed but no inter dendritic shrinkage cavities were found.

Fig. 15 Blade 88. Section of the fracture surface displaying a dendrite-like appearance. Dimples, characteristic of ductile overload are also seen.

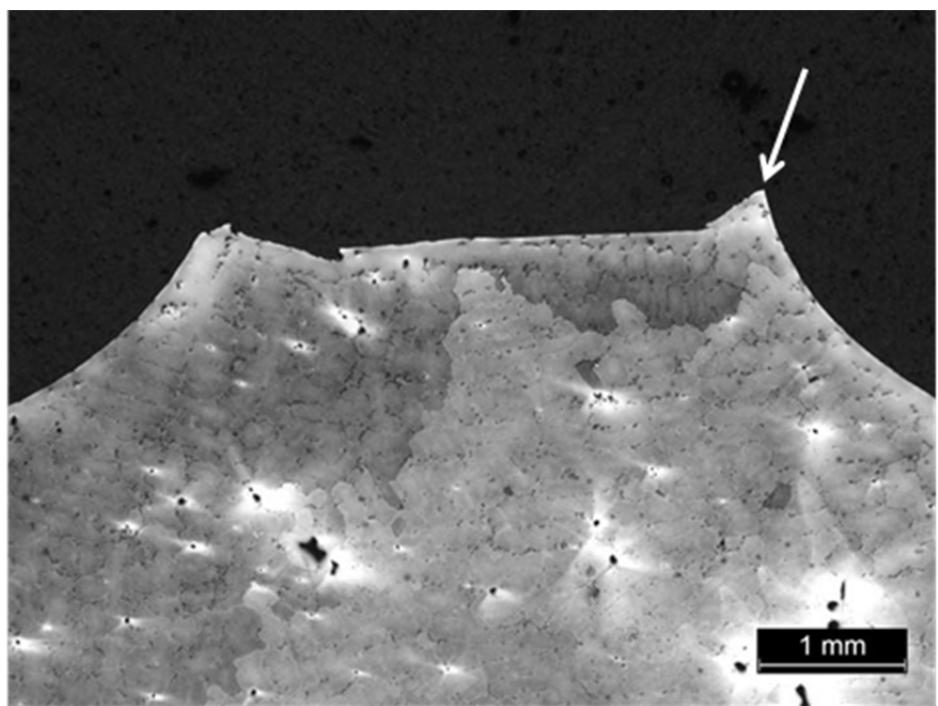
Fig. 16

Figures 16, 17 and 18 show the section perpendicular to the fracture surface in increasing magnification. No material defects or structural abnormalities were observed at the crack initiation shown in figure 18.

Blade 1. Section through the fracture surface in blade 1.
Crack initiation at arrow.

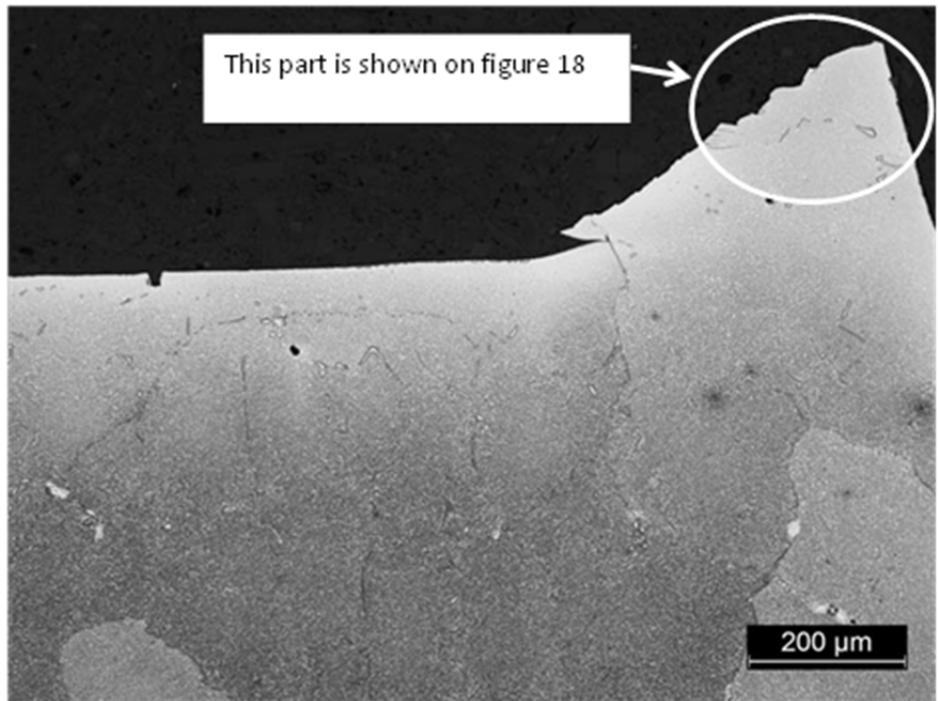
Fig. 17

Blade 1. Enlarged section of figure 16

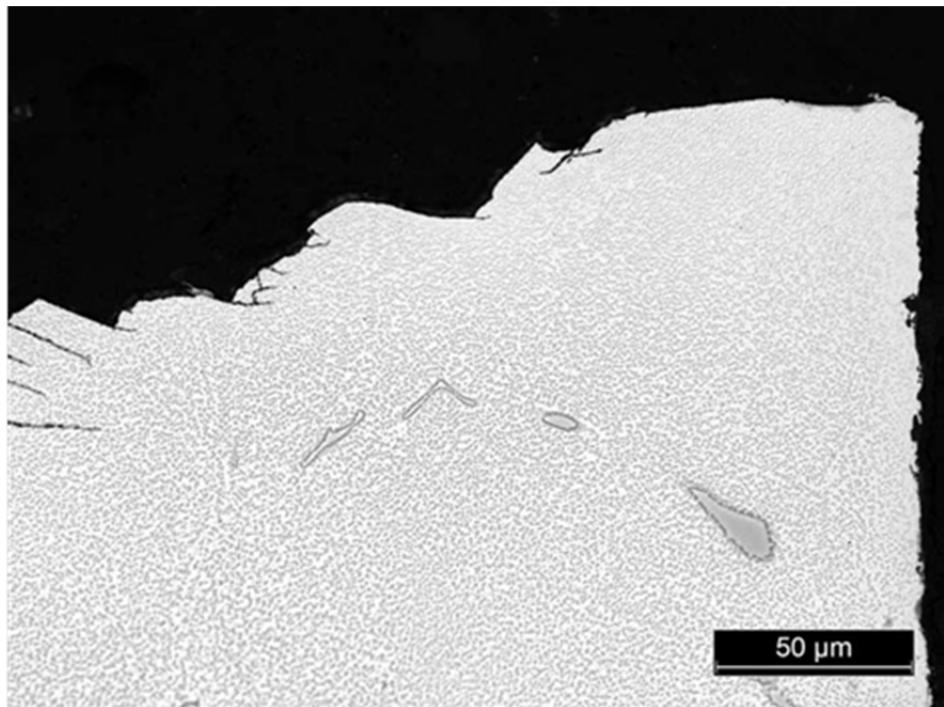
Fig. 18 Blade 1. Enlarged section of figure 17.

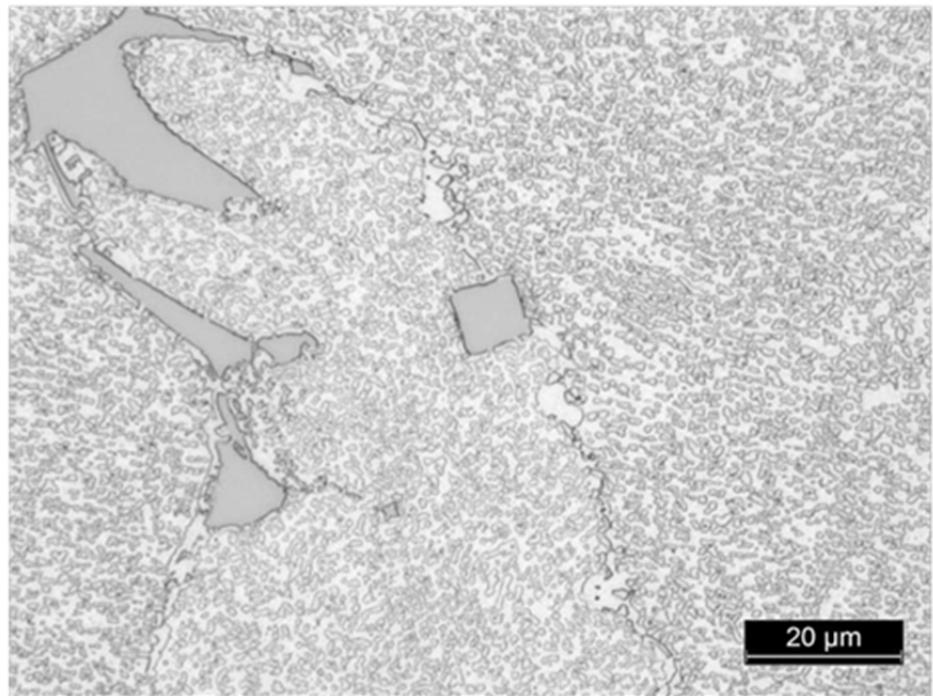
The structure displays primarily carbides in a γ - γ' (gamma – gamma prime) matrix. The structure is shown in higher magnification in figure 19.

Fig. 19 Blade 1. The structure of the blade.

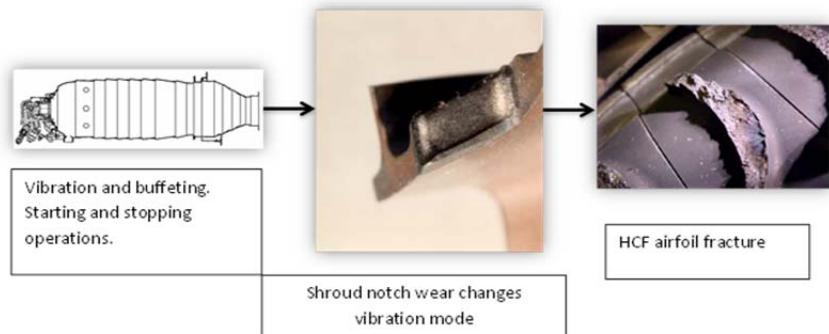
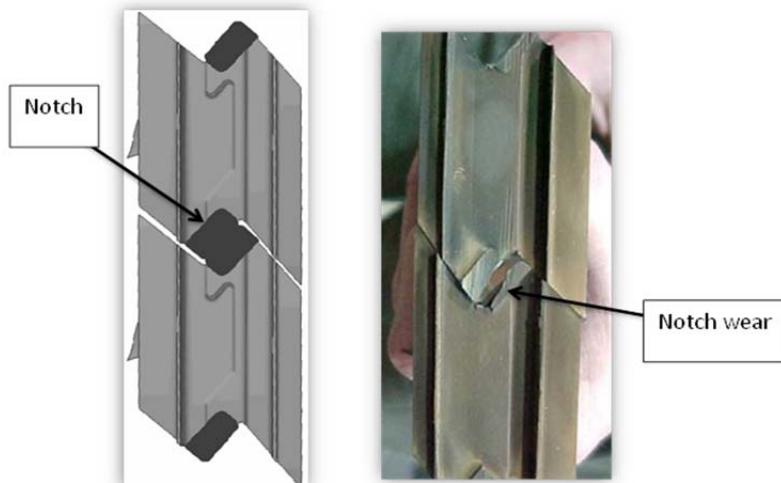
Fig.23

Figure 23 shows in general the above description in sequence.

Shroud wear = Loss of damping = Fatigue fracture

However, a possible scenario, which might have led to fatigue, might be a result of wear in the mechanical blade interlocking feature during normal operation. This might have led to worn 3rd stage LPT blade notches and loss of vibration damping.

However, since a number of JT8D-217C/-219 engines are still in service, the AIB encourages the type certification holder (TCH) of the involved engine type (PW JT8D-217C) that they should evaluate the need for mandating shroud notch wear inspections on stage 3 LPT blades. Currently these inspections are mandatory only at stage 4 LPT blades.
