# Investigation Report

Type of Occurrence:	Serious incident
Date:	4 April 2012
Location:	Near Lugano, Switzerland
Aircraft:	Airplane
Manufacturer / Model:	Boeing / 737-800
Injuries to Persons:	13 persons suffered minor injuries
Damage:	None
Other Damage:	None
Information Source:	Investigation by BFU
State File Number:	BFU FX003-12

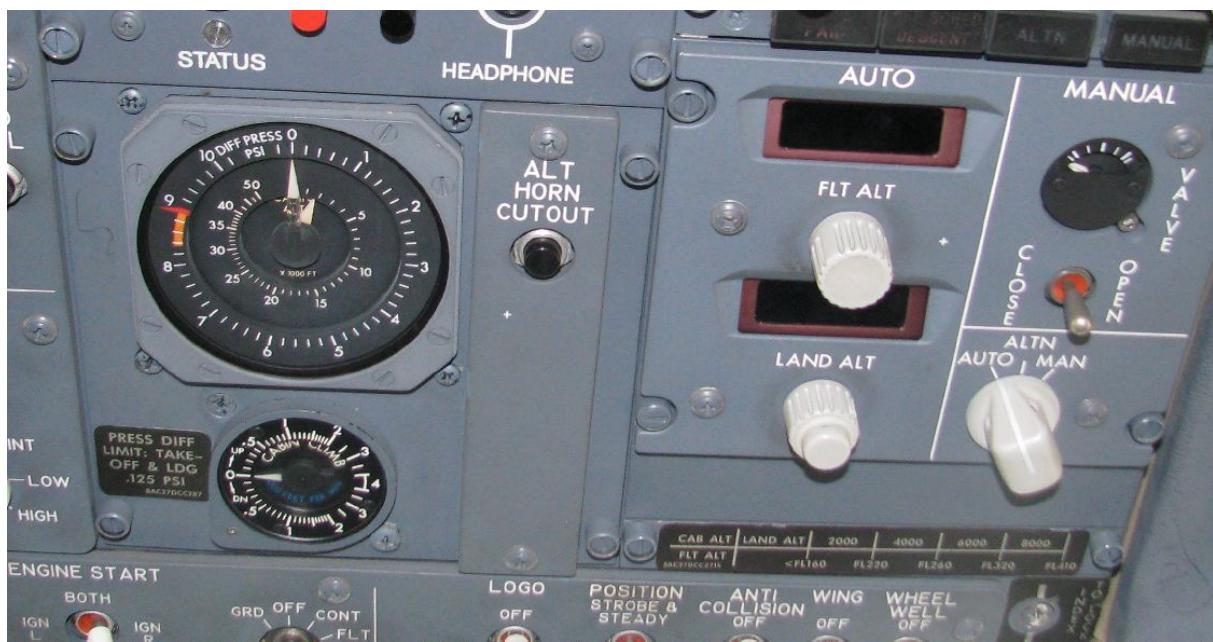
The operating and indication panel of the digital cabin pressure control system was part of the overhead panel in the cockpit. Indications for the cabin altitude and the differential pressure, the cabin rate of climb indicator (maximum 4,000 ft/min) and the outflow valve position indicator were installed.

Digital Cabin Pressure Control System

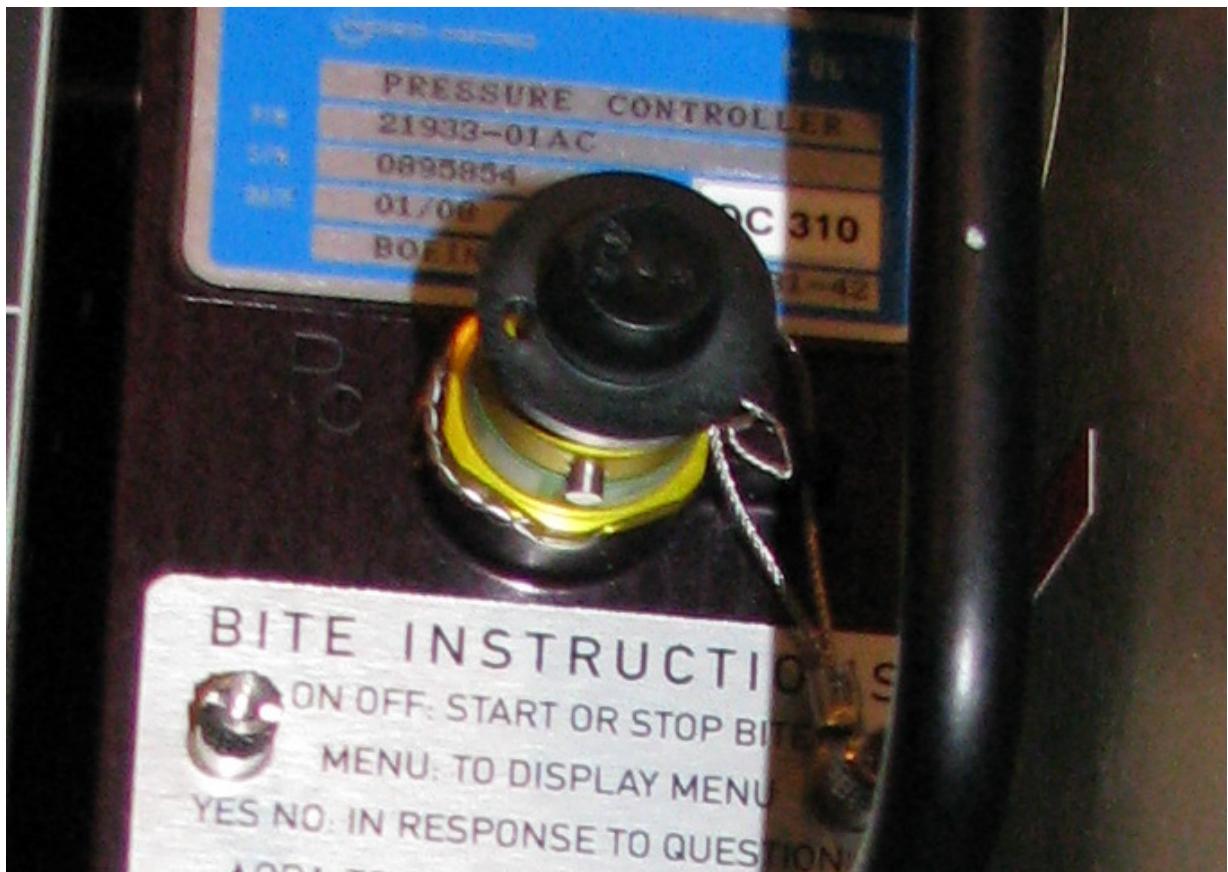
The two CPCs were located in the electronic equipment compartment behind the nose landing gear. The static port sensor on the CPC#1 was covered with a black shipping plug.

Cabin Pressure Controller #1 Static Port

The black shipping plug did not stand out from the black surface of the CPC housing. Colour and shape of the shipping plug were very similar to the thumbscrew holdown

used to hold the avionic equipment in place. Nord Micro stated the drill hole in the shipping plug's side was meant to hold a tag. It is likely that the tag had fallen off. It could not be determined as to when the tag had fallen off. Such a tag can be viewed as a defence much as a shipping plug which is easily recognisable. In the case at hand it was not present and was insufficient, respectively.

- Due to an omission during the installation of the cabin pressure controller the shipping plug was not removed from the static port as required by written procedure.
- During the flight a pressure difference was measured and the OFV opened which resulted in rapid decompression.

- The shipping plug was not clearly noticeable and did not carry a tag.
- The pressurisation system ground test after installation was not suitable to detect the error.

The BFU is of the opinion that the shipping plug should be designed in a way that it stands out from its surroundings. This could be ensured by shape and colour. However, the BFU is of the opinion that it would be best if the shipping plug had a tag which is noticeable and long enough to cover the keys of the CPC which the maintenance personnel needs to use for the pressurisation system ground test. Mistakes would be easier recognised and eliminated and resulting consequences could be avoided.

The Federal Aviation Administration (FAA) should require Boeing to re-design the shipping plugs in a way which makes them more recognisable. The shipping plugs should also be coupled with an eye-catching tag.

Maintenance and Repair Organisations should only cover the static ports of a cabin pressure controller with a shipping plug which is clearly visible coupled with a tag.

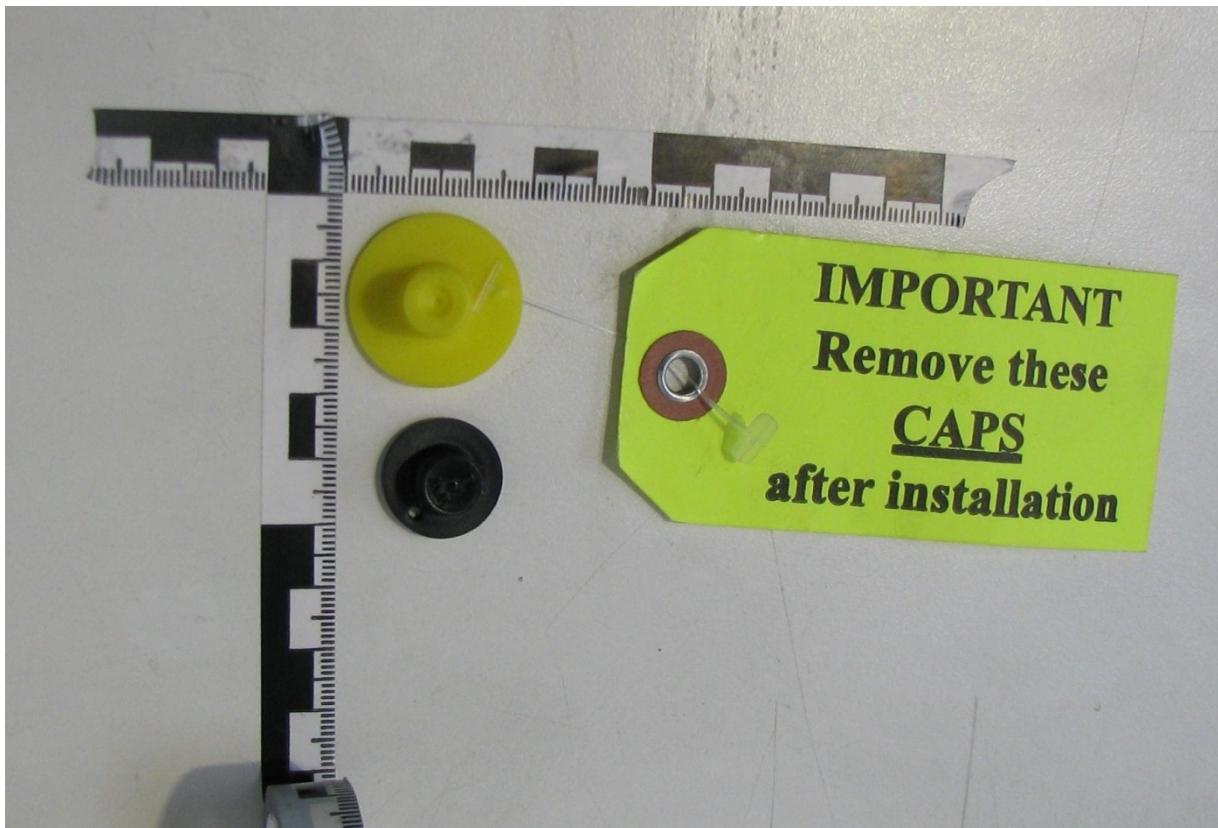
During the BFU investigation of the serious incident the maintenance organisation at Frankfurt Hahn Airport changed the two CPCs after the data had been downloaded. The replaced CPCs were equipped with shipping plugs which were yellow and larger than the ones found on the removed CPCs. They also carried a yellow tag with the sign: **IMPORTANT – Remove these CAPS after installation.**

Different shipping plugs of the component manufacturer

Shortly after the event on July 2, 2012, Boeing began working with the supplier (Nord-Micro) to evaluate and address the cap color issue. As a result of these discussions, Nord-Micro implemented a process change to exclusively use yellow shipping plugs and orange shipping tags on cabin pressure controllers. The Boeing Certificate Management Office is ensuring the process change remains in place.

Boeing defines the design requirements for the pressure controller on a Specification Control Drawing. There is a section of this drawing which outlines shipping requirements for the controller. Boeing has incorporated additional language requiring that shipping caps be yellow in color and have orange or yellow colored tags stating that the cap must be removed after installation of the controller.

We also understand that the current vendor of the pressure controller, Nord-Micro has purged their supply of any black caps and has revised their internal drawings and maintenance manual material to require only yellow caps with yellow or orange tags.

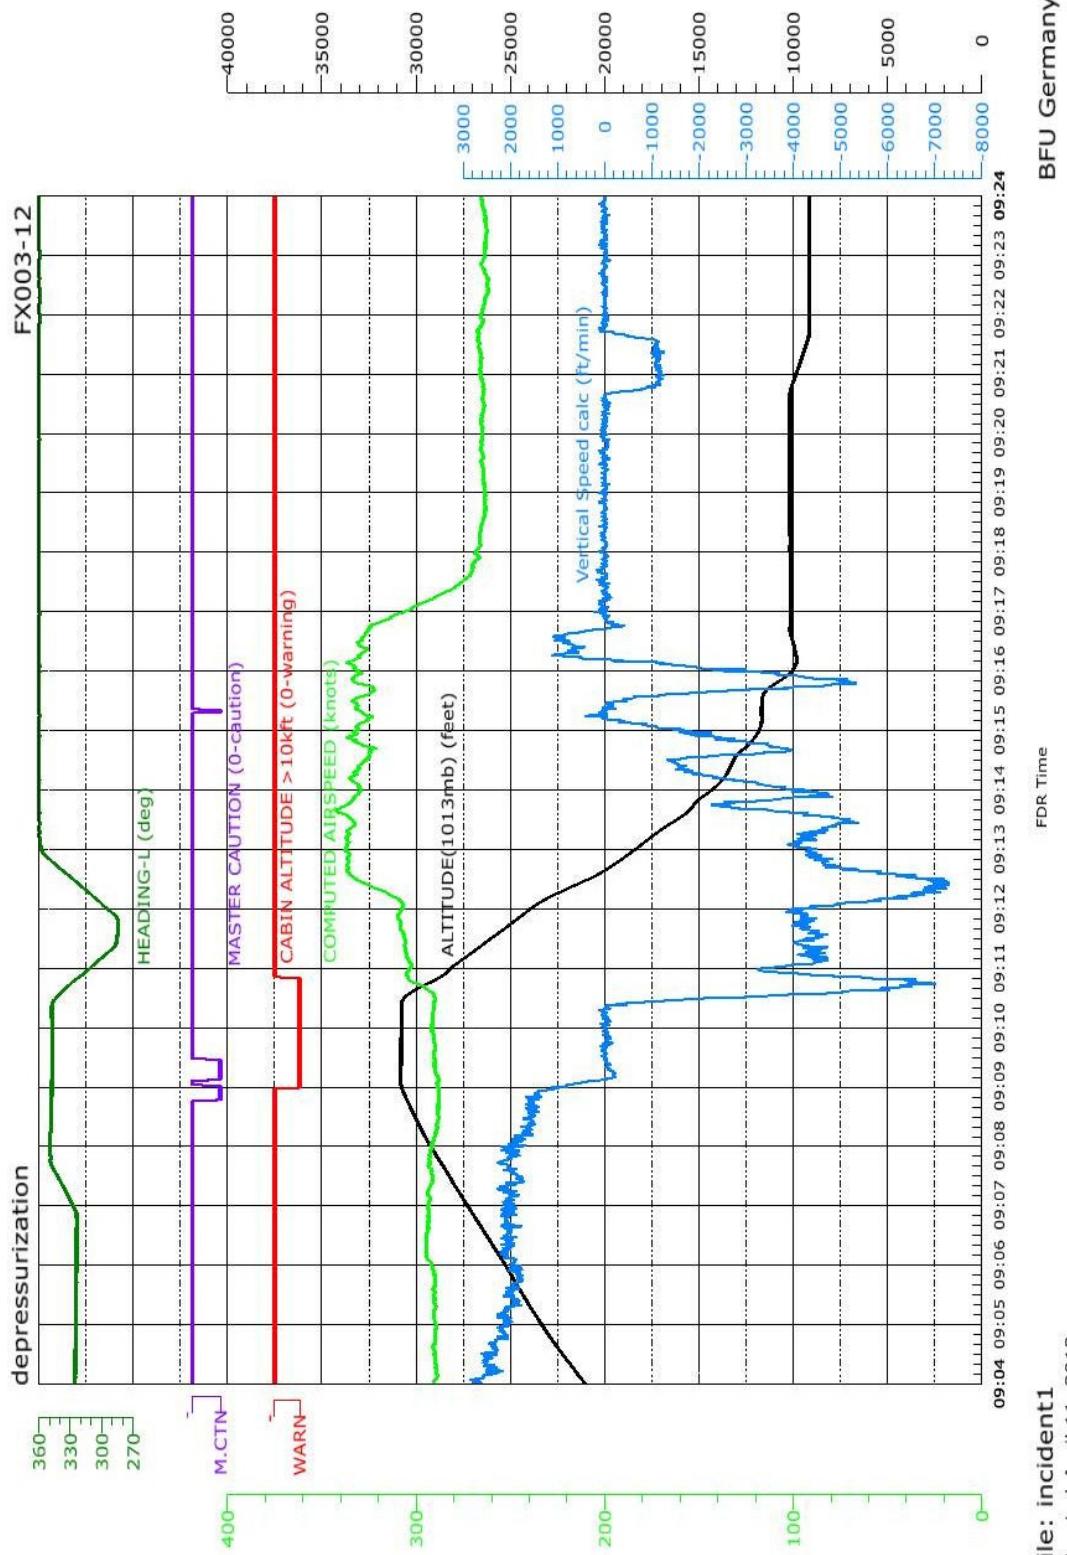
Excerpt FDR data

The data of the Flight Data Recorder (FDR) showed that at 1108:40 hrs the Master Caution and about 20 seconds later the cabin altitude warning (cabin altitude > 10,000 ft) was triggered. The warning ceased about two minutes later.

The data of the flight data recorder showed that at 1108:40 hrs the master caution and about 20 seconds later the cabin altitude warning (cabin altitude > 10,000 ft) was triggered. Further six seconds later the CPC recorded a cabin altitude of 13,500 ft at a rate of climb of 7,656.5 ft/min.
