Flight path management and ground proximity warning involving Airbus A330-202 VH-EBV

15 km NNE of Melbourne Airport, Victoria, | 8 March 2013

ATSB Transport Safety Report

AO-2013-047

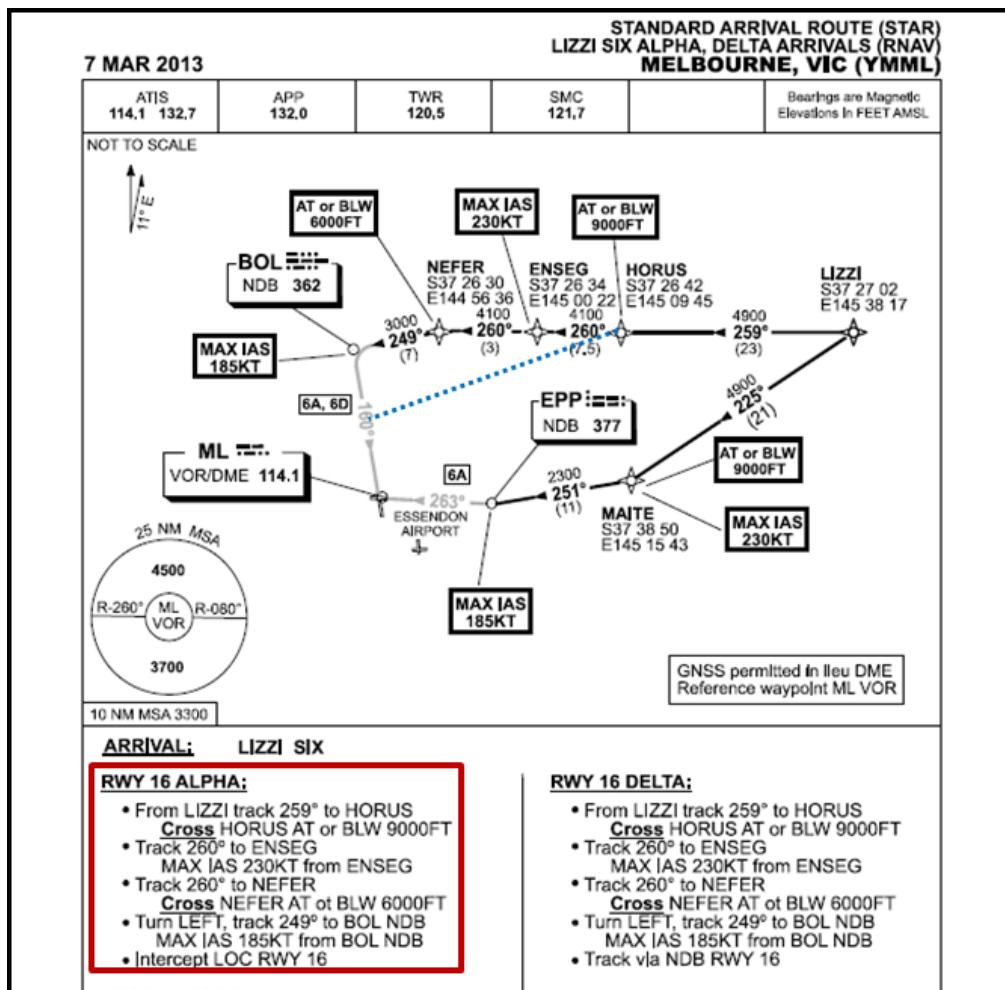
Figure 1: LIZZI SIX STAR chart with anticipated track shortening (blue dotted line)

At 1844, with the aircraft approaching 9,000 ft, ATC cleared the crew to descend to 5,000 ft and offered track shortening from HORUS (Figure 1). The crew accepted an amended track from HORUS to the FAF and activated the secondary flight plan.

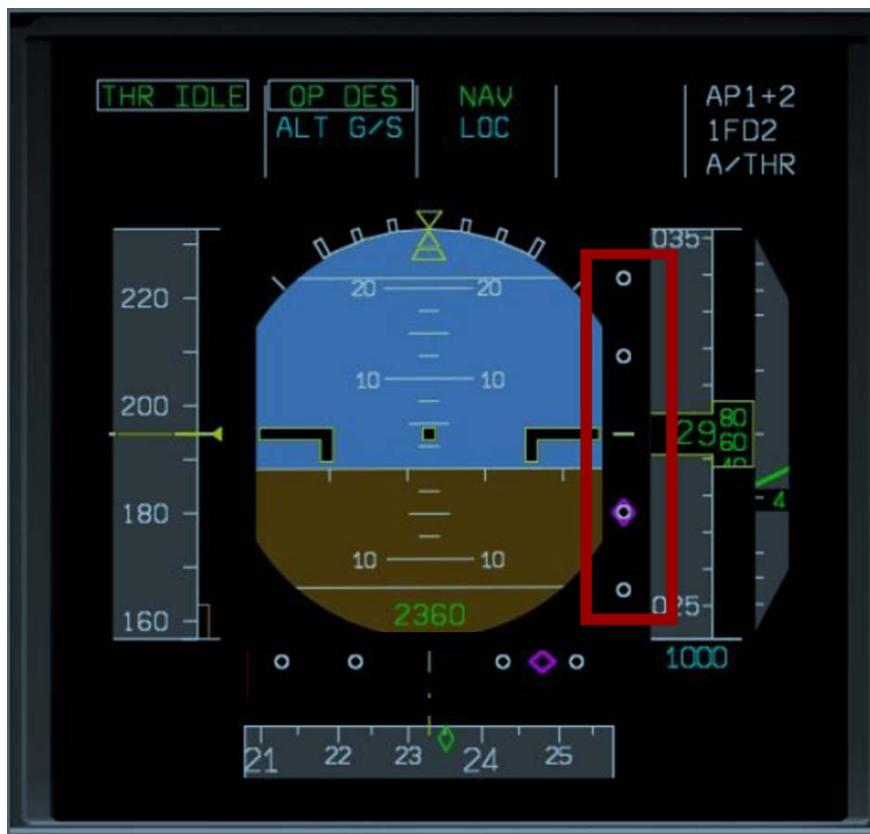
Figure 3: A330 primary flight display with the glide slope indication scale highlighted in red

The captain reported observing the aircraft's instrument landing system (ILS)⁶ glide slope deviation indicator on the primary flight display and that it was indicating the aircraft was above the glide slope. This appeared valid to the captain and was consistent with his earlier assessment of the aircraft being high relative to the track-shortened computed profile. Although other information about the aircraft's flight path was available and the aircraft was not established on the ILS localiser, the captain used the glide slope deviation indicator as the primary vertical flight path guidance.

The captain observed that the ILS glide slope indications were active and indicating that the aircraft was above the glide slope, which was consistent with his expectation. As a result, the captain considered the glide slope indications to be valid and useful for flight path guidance. Subsequently, the captain focussed on the glide slope without any apparent reference to the other available flight path or profile information.

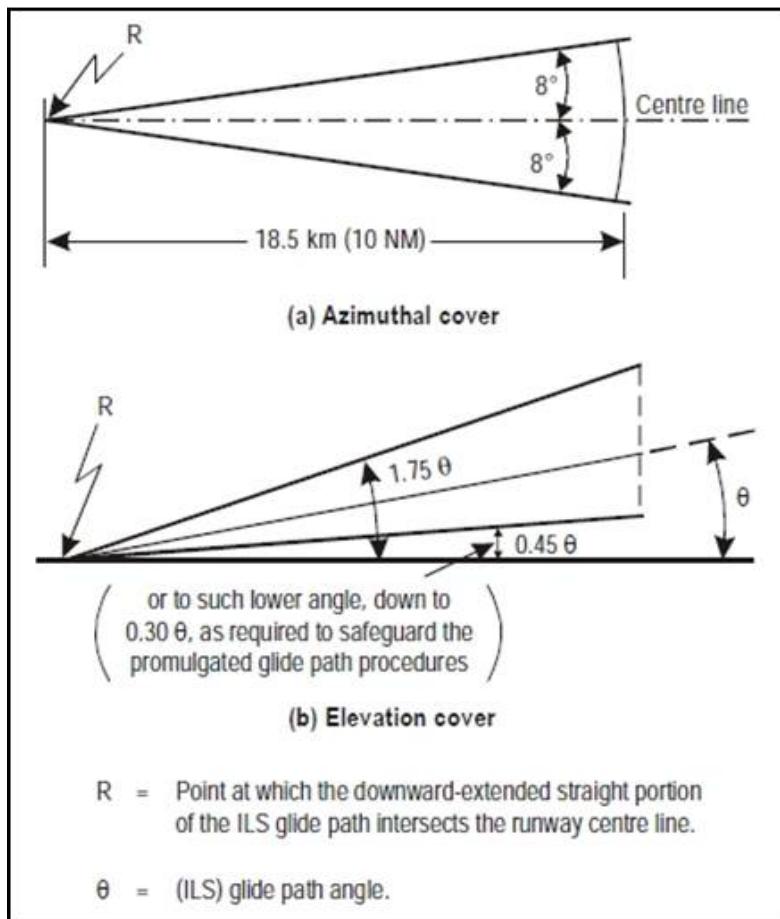
Figure 4: ILS glide slope coverage

The use of ILS glide slope indications when an aircraft was displaced from the approach centre-line was not specifically addressed in the Qantas procedures. However, a note in the standard operating procedures for conducting an ILS approach highlighted the International Civil Aviation Organization (ICAO)-defined envelope where the quality of the glide slope signal ensured a normal capture. This envelope was within 10 NM (18.5 km) and 8° either side of the glide path centre-line, and within a small range of elevation (Figure 4 – diagram not included in the Qantas procedures). The note indicated that when arming the approach well outside of the normal glide slope capture envelope, a spurious glide slope engagement may occur due to a wrong glide slope deviation signal. Whenever a pilot noticed any spurious indications, it was stipulated that the auto-flight system and approach mode be disengaged and recommended that any subsequent rearming of the approach mode occur within the normal capture zone.

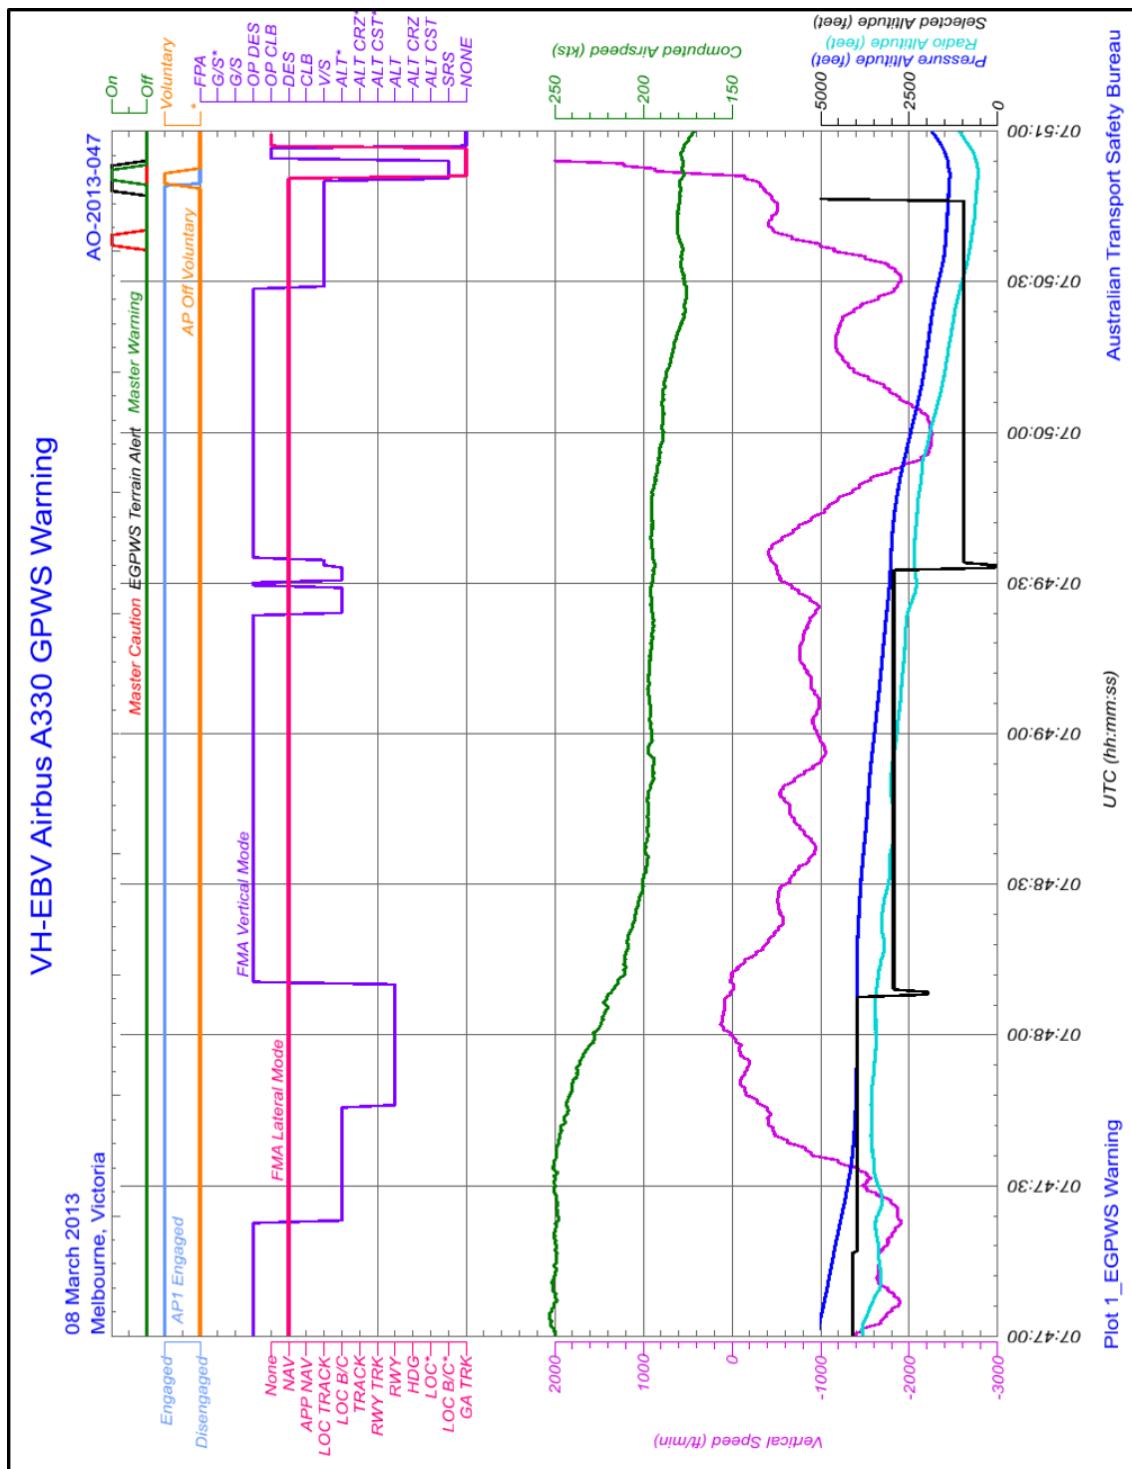
Appendix A – VH-EBV flight data recorder and enhanced ground proximity cautions, alerts and warnings

At the time of the EGPWS alert the aircraft had descended to 1,400 ft, which in that area was 600 ft above ground level, with 9 NM (17 km) to run to touchdown. This was 100 ft below the control area lower limit and 1,900 ft below a normal 3° descent profile.

600 ft above ground level (AGL), followed by a second terrain alert. The aircraft was 9 NM (17 km) from touchdown, on a bearing displaced 30° from the runway centre-line and at an altitude of 1,400 ft at that time. This was 1,900 ft below the nominal 3° descent profile and 100 ft below the lower limit of controlled airspace.
