**Report on the accident to
Eurocopter (Deutschland) EC135 T2+, G-SPAO
Glasgow City Centre, Scotland
on 29 November 2013**

Air Accidents Investigation Branch

October 2015

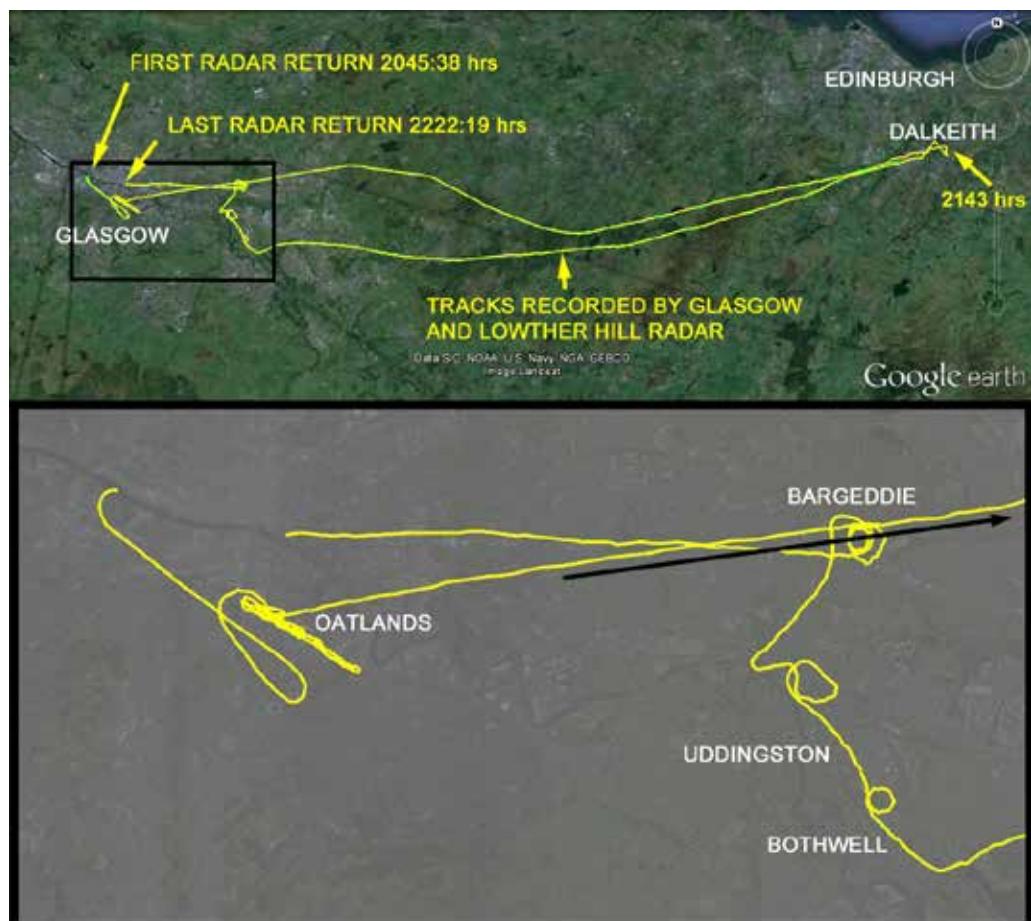
The helicopter tracked towards GCH at an altitude of about 1,000 ft amsl, with a ground speed of approximately 100 kt. Between 2221:35 hrs and 2221:45 hrs, when the helicopter was about 2.7 nm east of GCH, the right engine flamed out, leaving the pilot with one engine inoperative (OEI). Approximately 32 seconds later, about 1.8 nm east of GCH, the left engine flamed out.

Figure 1
Overview of the helicopter's flight path

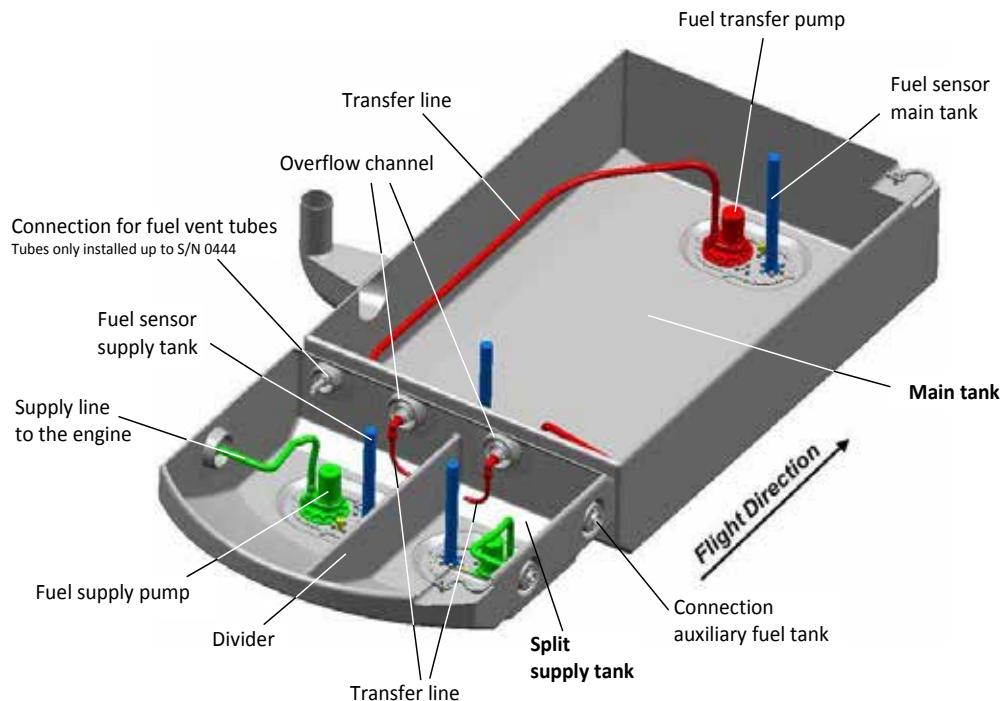
Two overflow channels connect the main tank to the supply tank. So, with the system fully replenished, or almost so, fuel can flow freely between the two tanks. The overflow channels are positioned with their lower edges close to the level of the top of the supply tank divider. See Figure 3.

Figure 3
EC135 fuel tank arrangement

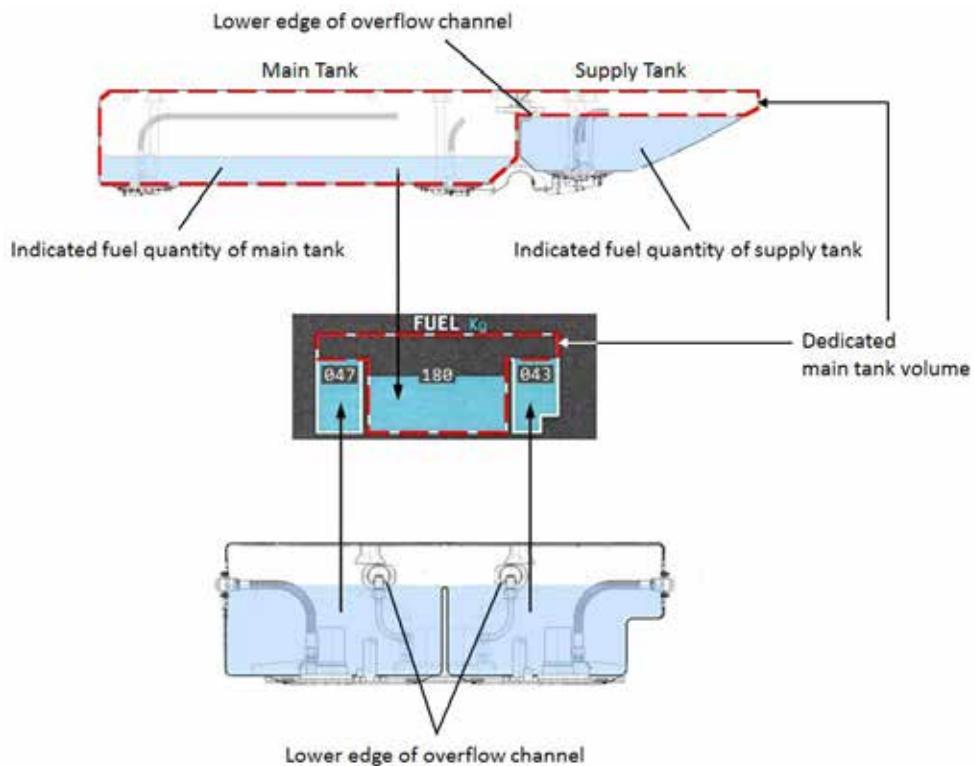
to the amount in the main tank, to produce a total which is displayed as main tank contents. Thus, the fuel in the supply tank above the level of the divider is treated as part of the main tank contents. See Figure 4.

Figure 4
Fuel tank contents indication schematic

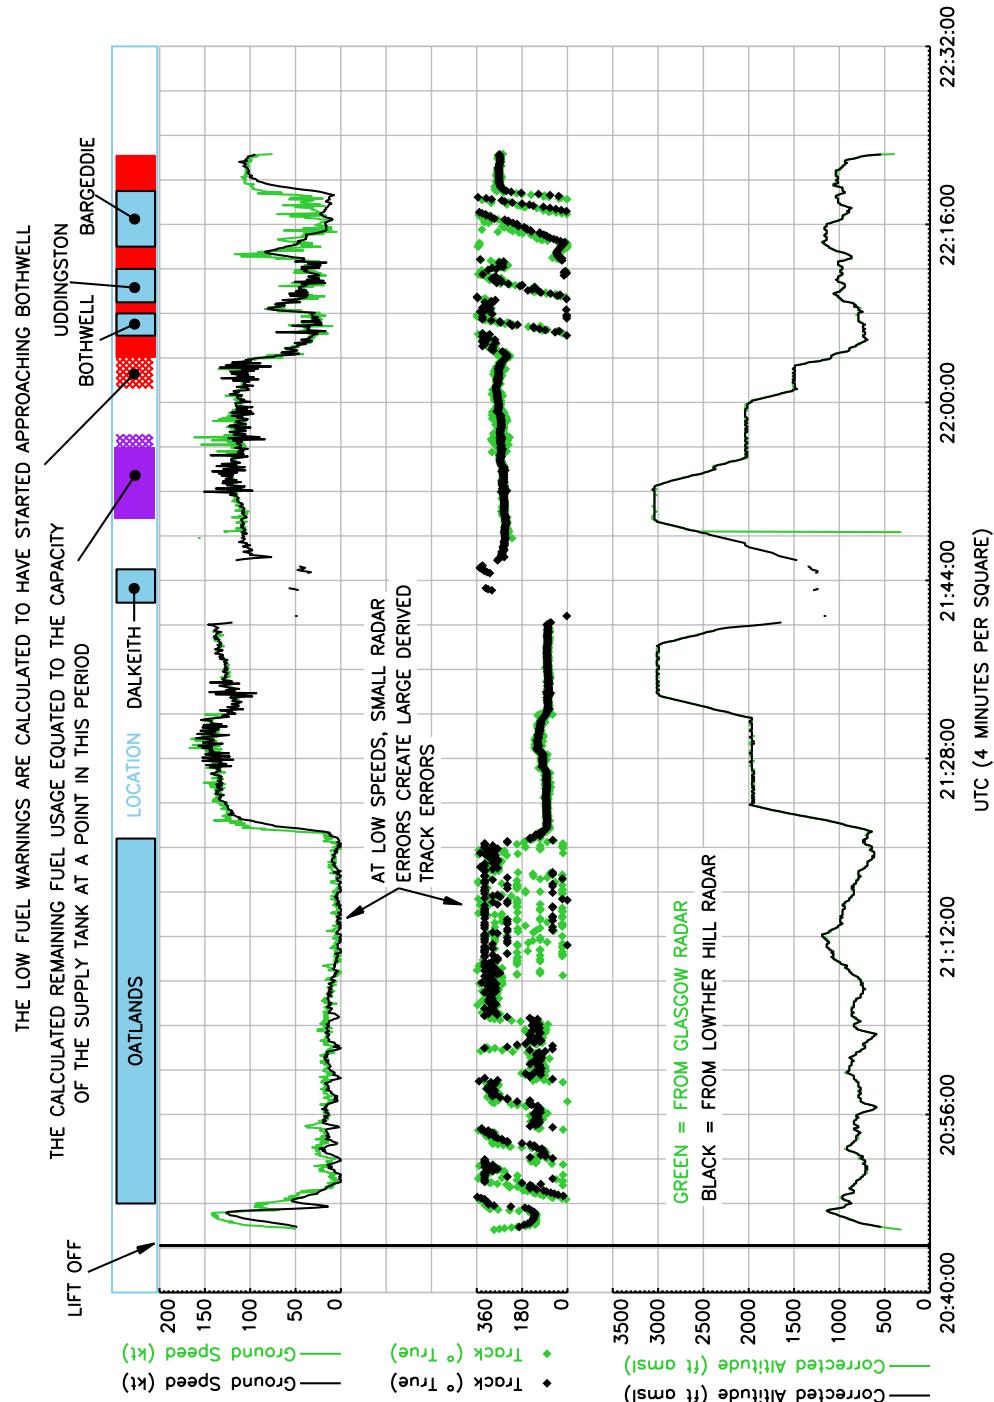
Figure 7

Derived speed and track information, with calculated fuel contents

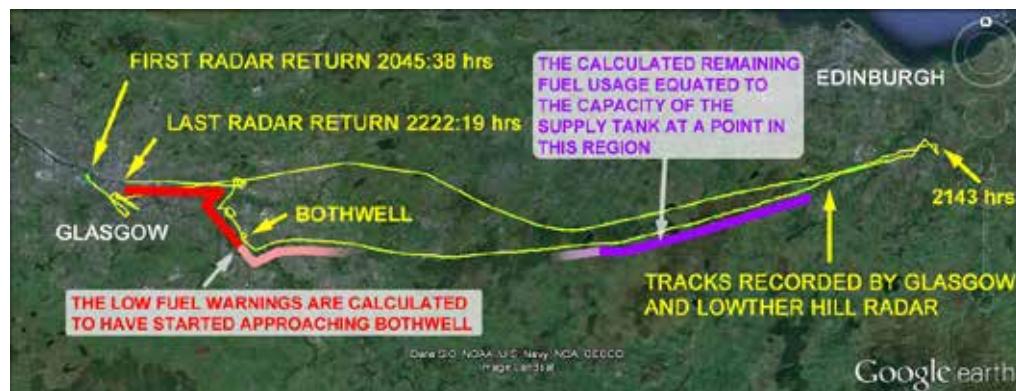
Figure 8

Helicopter's track, with calculated fuel contents

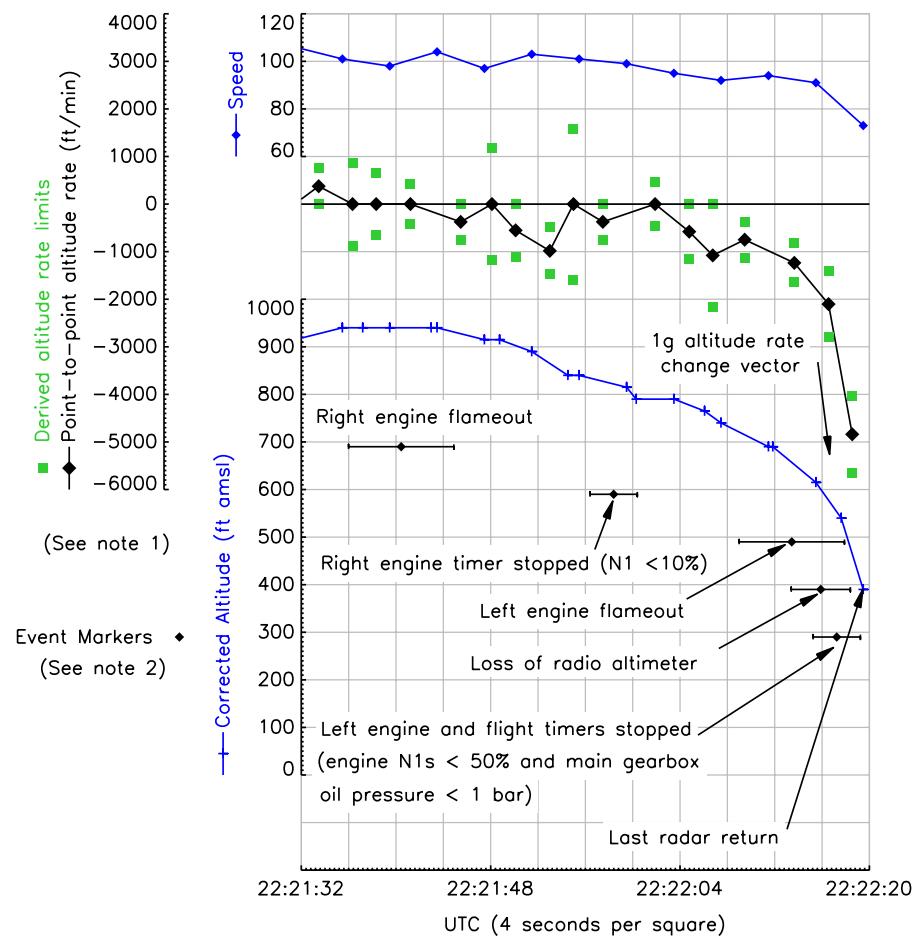
Figure 9
Radar data and related events at the end of the flight

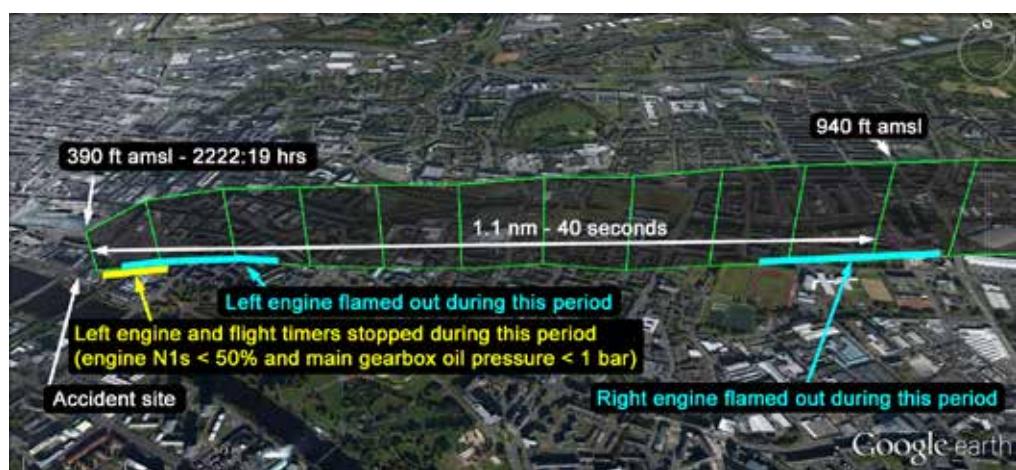
Figure 10
Flight path at the end of the flight

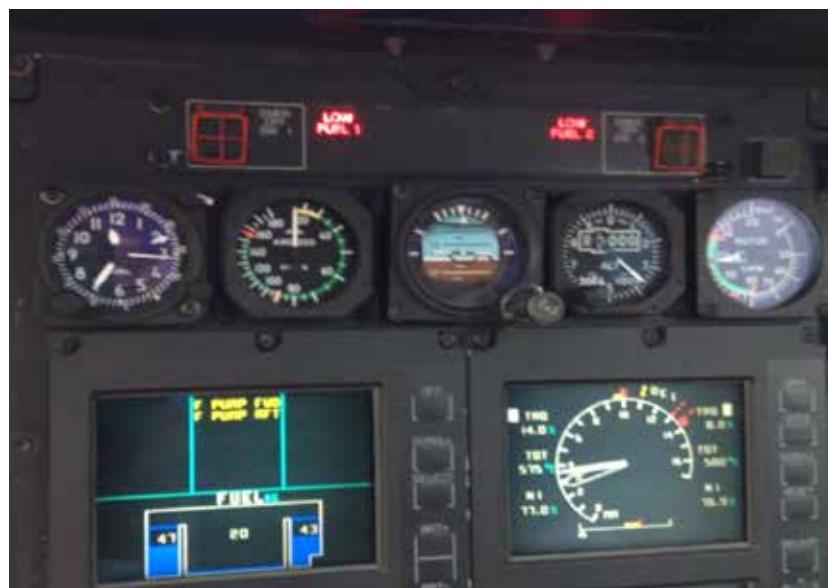
A ground run was carried out, starting with the fuel system indicating 47 kg and 43 kg of fuel in the left and right supply tank cells, respectively, and 41 kg in the main tank. During the ground run the main fuel tank contents were seen (by reference to the fuel gauge on the CAD) to deplete, with the forward and aft fuel transfer pumps OFF. When the main tank contents had depleted to approximately 20 kg, the LOW FUEL 1 and then the LOW FUEL 2 warnings illuminated on the Warning Unit, with an indicated 47 kg and 43 kg still in the supply tank cells. At no stage did the FUEL caution illuminate. See Figure 11.

Figure 11
G-NWEM fuel indications during ground run

The manufacturer removed and tested the fuel sensor units under the supervision of the AAIB. The test results indicated abnormalities within the sensor unit outputs, which appeared to be the cause of the false tank contents indication.

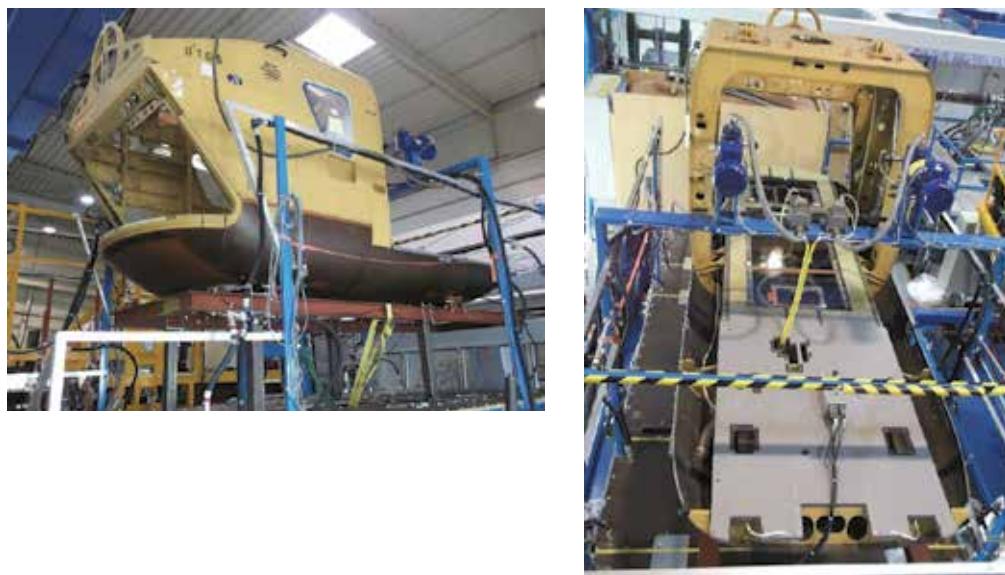
Figure 12
EC135 Articulated Fuel System Test Rig
