# Interim Report

Type of Occurrence:	Serious incident
Date:	5 November 2014
Location:	12 NM north-west of Pamplona, Spain
Aircraft:	Airplane
Manufacturer / Model:	Airbus Industrie / A321-231
Injuries to Persons:	None
Damage:	None
Other Damage:	None
Information Source:	Investigation by BFU
State File Number:	BFU 6X014-14
Published:	17 March 2015

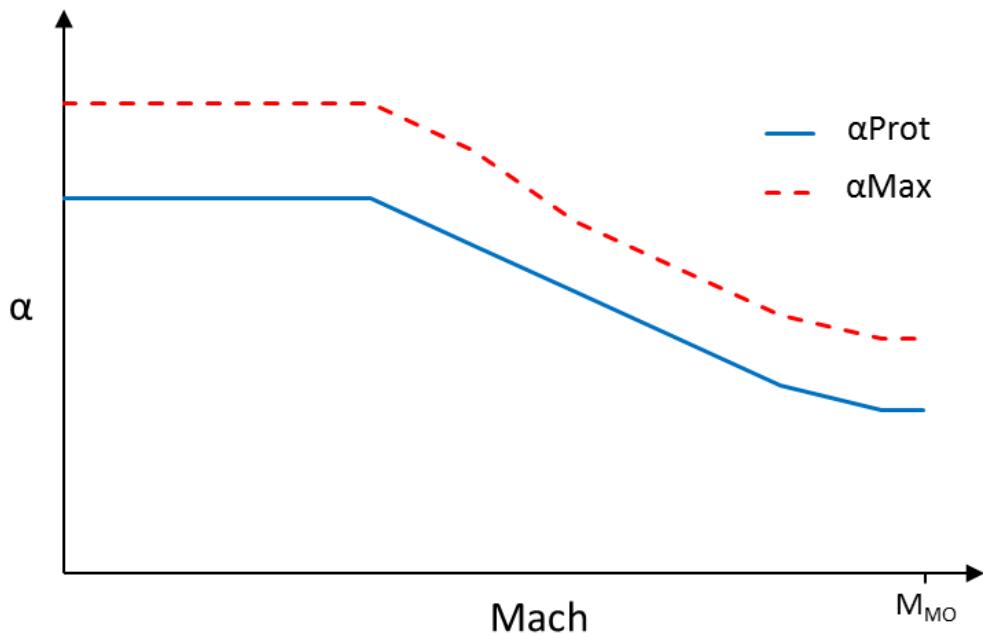
AlphaProt and AlphaMax depend on the Mach number of the aircraft, among other factors. When the Mach number increases AlphaProt and AlphaMax decrease.

Dependence of AlphaMax and AlphaProt from the Mach number

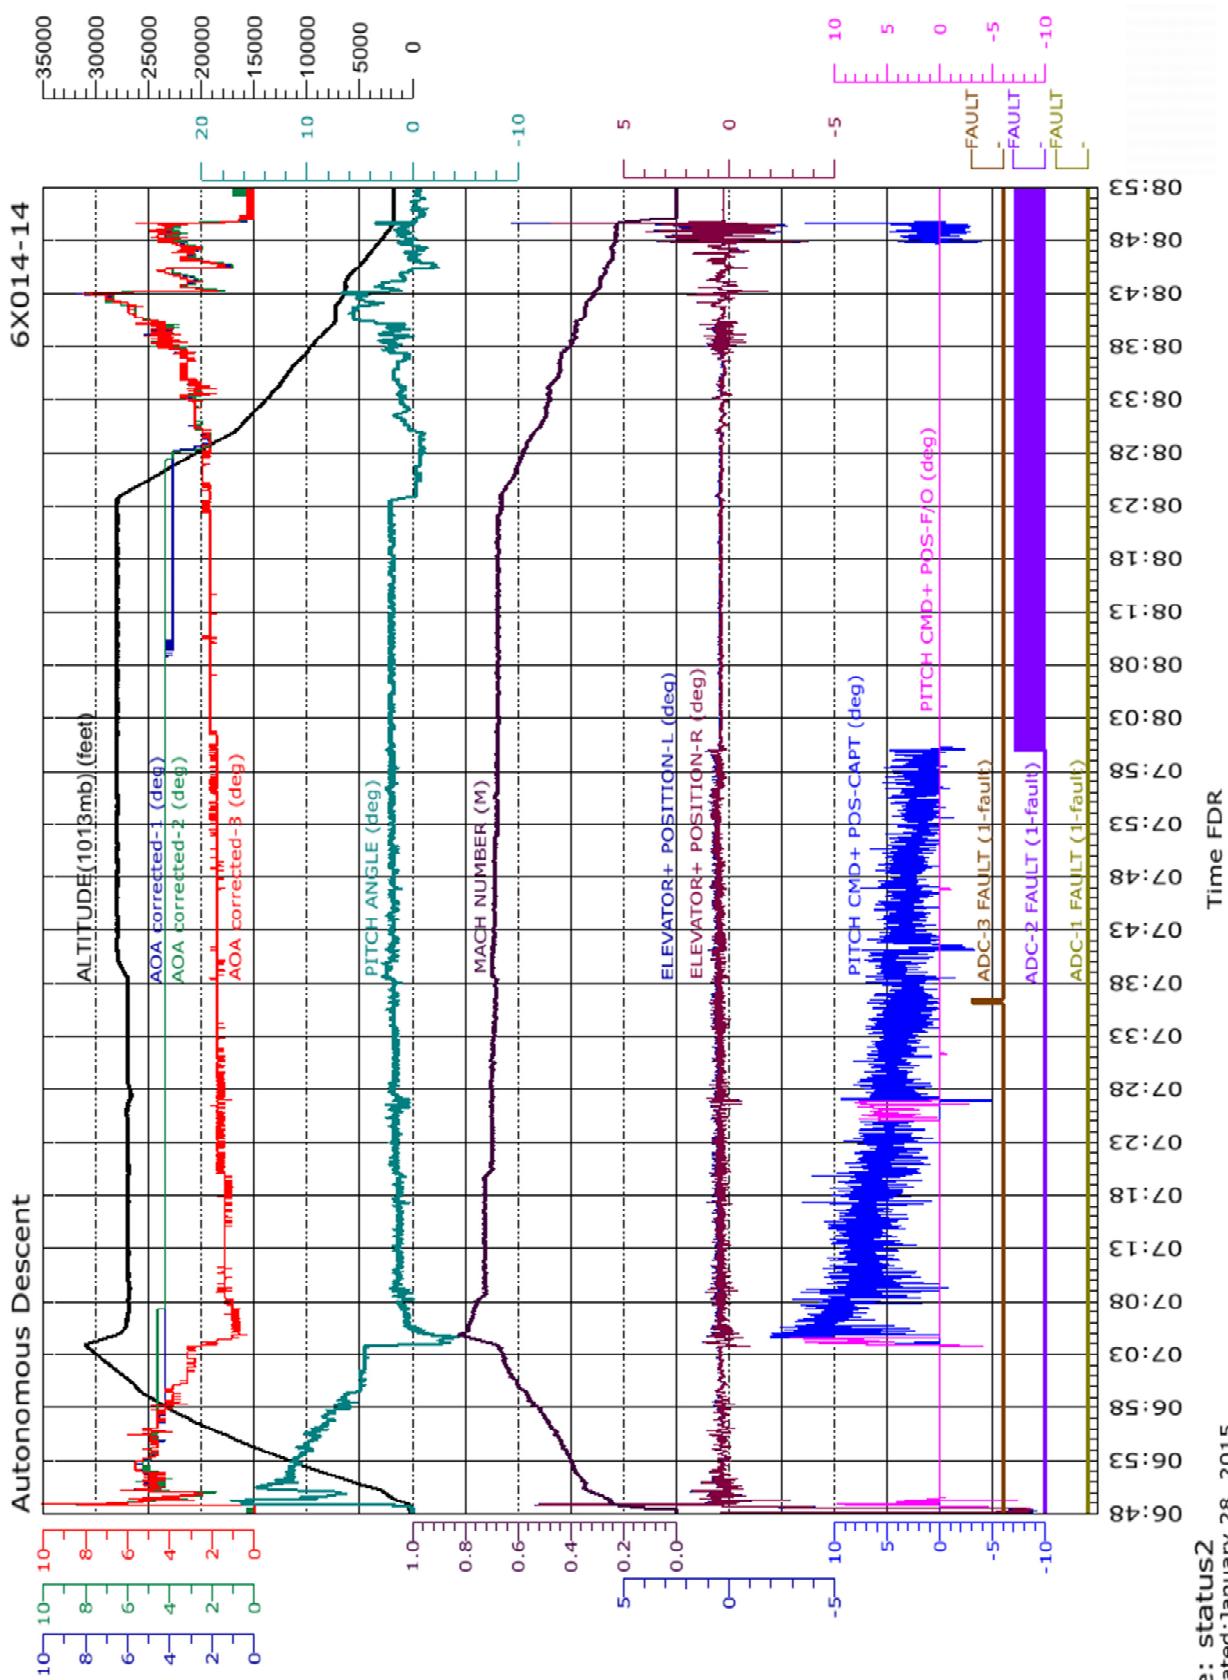
### FDR Excerpt

All three AOA sensors functioned normally at take-off of the airplane. Eight minutes after take-off, while reaching FL 195, at an outside air temperature of -35°C (SAT), freezing of the AOA sensors 1 and 2 led to AOAcor recorded at 4.5°. This value remained unchanged for the next approximately 1 hour and 32 minutes until the descent.

At 0803:19 hrs a left-hand turn with a bank angle of 15° was initiated. At 0803:52 hrs the crew disengaged the autopilot. At that time the Mach number was at 0.675, the corresponding value of the AlphaProt was at 4.2° and the one for the AlphaMax at 5.8°. Since the angle of attack the system had calculated was 0.3° higher than AlphaProt the high angle-of-attack protection was active as soon as the autopilot was disengaged and the system ordered a nose down movement. Progressively and for 15 seconds the co-pilot gave backward sidestick inputs up to 3/4 of the way to coun-

teract this movement. The pitch changed from 4.5° to -3.5 and the rate of descent increased to 4,000 ft/min. At 0804:54 hrs the ELAC rejected ADR 3 as the AOA 3 value deviated from the other two by more than the monitoring threshold. From 0805:20 hrs on the airplane once again flew stabilised with Mach 0.79 in FL 270 with 2/3 continuous backward sidestick input (pull).
