ACAS II Bulletin – Near collision over Yaizu

January 2022 | № 25

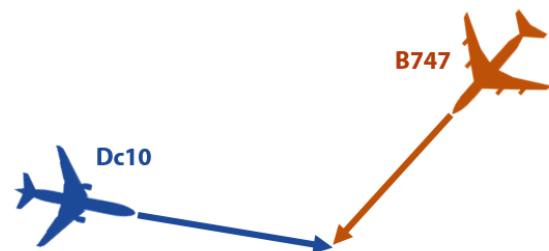
Simultaneously with the controller instruction, coordinated TCAS RAs were issued to both aircraft: the DC-10 received a Descend RA while the B747 a Climb RA. Both RAs required the vertical rate of 1500 ft/min. (in the opposite vertical sense).

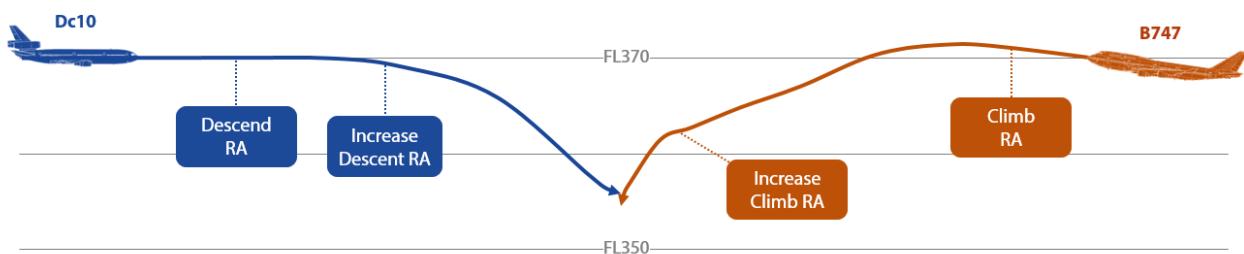
In the meantime, on the receipt of the Descend RA the DC-10 pilot disengaged the autopilot, set power to idle and started a descent. Fifteen seconds after the initial RA, the RA on the DC-10 strengthened to Increase Descent (requiring the descent rate of 2500 ft/min.) and the crew deployed speed brakes in order to achieve a higher descent rate and turned the fasten seat belts signs on.

The B747 RA strengthened to Increase Climb 31 seconds after the initial RA. Although the strengthening RA required the climb with the rate of 2500 ft/min., the B747 crew continued their descent. The visibility was excellent and each crew had the other aircraft in sight. Both aircraft continued to descend towards each other at similar vertical rates.

At the last moment, the DC-10 pilot pulled up and the B747 crew increased their rate of descent to avoid an imminent collision. The B747 passed below the DC-10 at FL357, some 36 seconds after the initial RAs.

At the closest point of approach, the estimated **vertical separation was 130 feet**. To put this number into perspective: that's about twice the height of the B747.
