SL Report 2007/23

**REPORT ON THE AIRCRAFT ACCIDENT AT BODØ AIRPORT ON 4
DECEMBER 2003 INVOLVING DORNIER DO 228-202 LN-HTA, OPERATED
BY KATO AIRLINE AS**

June 2007

Type of aircraft: Dornier DO 228-202

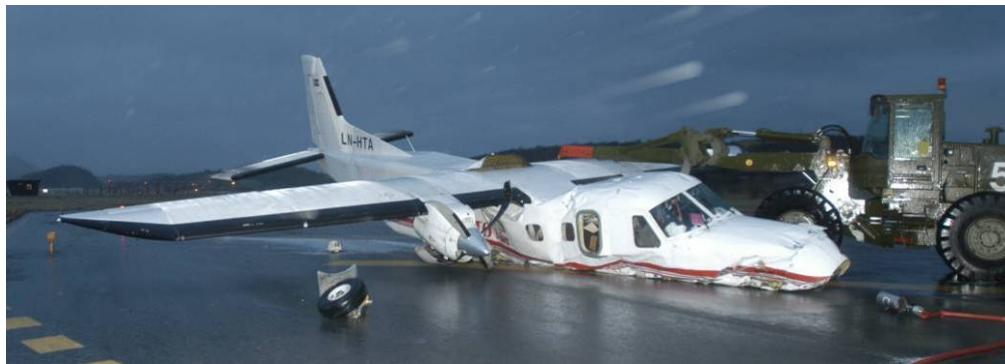
Figure 4: The wreckage (photo taken by armed forces)

- 1.12.2.1 The aircraft's flight data recorder registered up to 8.4 G on impact. The landing was so forceful that the aircraft's nose wheel leg broke off and both main landing gears were pushed in, then twisted back and came loose. The force of impact pushed the aircraft's wing so far down into the cabin that the propellers on both engines were badly bent after contact with the ground. In addition, the whole of the aircraft's underside was compressed, particularly at the front. (See figures 4 and 5). This forced up the floor of the cockpit by about 20 cm, resulting in somewhat restricted legroom. Powerful vertical forces were transferred to the pilots and passengers via all the seats. These forces were most powerful in the front part of the aircraft, resulting in injuries to the pilots' back, buttocks area and neck.

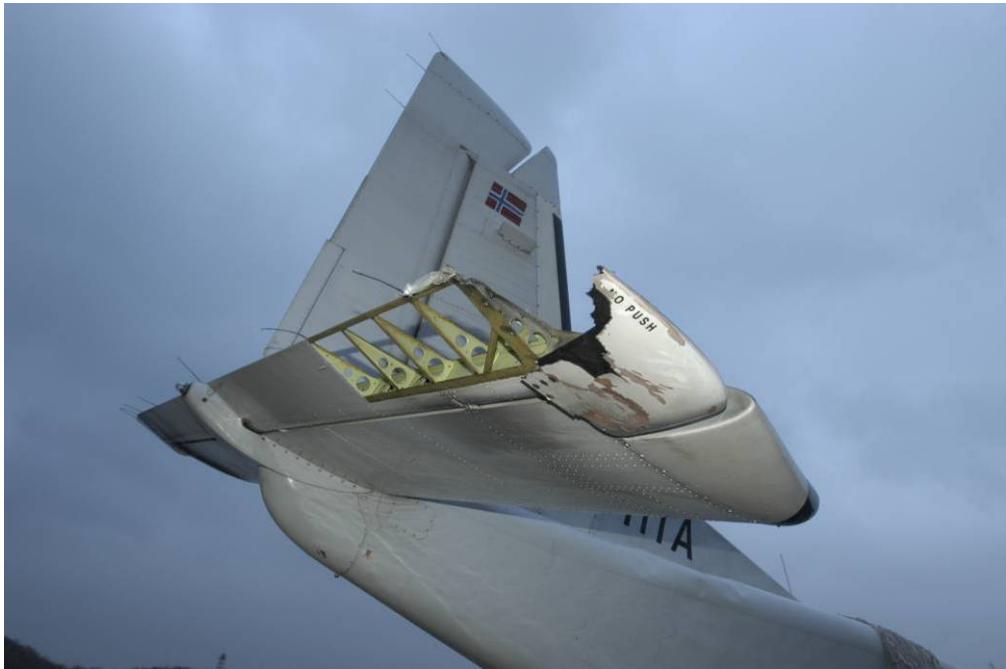
Figure 6: Damage to the right elevator (photo taken by armed forces)

1.12.2.4 It was decided to remove the right elevator, the broken rod and the bondings between the fuselage and the horizontal tail surface for closer examination. During the dismantling of the elevator, damage to one of the four bolts holding the two halves of the right elevator together was also discovered. The bolt which also holds the corner where the elevator rod was fixed had gradually melted.

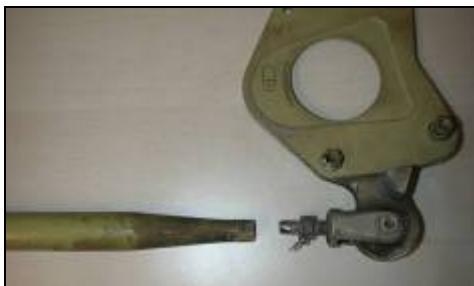
Figure 7: Broken elevator transfer rod

- 1.12.2.3 On the morning of 5 December, the aircraft was moved to one of the Norwegian Armed Forces' shelters for closer examination. It was then discovered that there was a break in the elevator control rod in the end that was connected to the elevator. The right elevator was missing approximately half of its fabric covering. About half of the carbon fibre cover on the end was also missing, including the elevator's outer static discharger (see figure 6). The outer right corner of the elevator's aluminium structure was also burnt off. With the help of an ohmmeter, a break in the electric connection between the elevator and the fuselage was discovered. Closer examination revealed several breaks in the bonding connections between the elevator and the fuselage (see figures 8 and 10). Almost the entire bonding on the outer bonding connection to the right elevator was missing. In addition, both nails holding the bracket to the bonding had melted leaving the bracket loose in the space between the elevator and the horizontal tail surface (see page 2 of Report by Norwegian Armed Forces, appendix B). It was also discovered that there was no electric connection between the horizontal tail surface and the fuselage. The reason for this was found to be that the tail surface was fixed by means of bearings with Teflon

The strength of the current which passed through the aluminium elevator rod melted one end of the thread part in the actual rod. The end parts, which are coated with high alloy steel, withstood the loads. In order to calculate the strength of the current which passed through the rod, it was decided to measure the electrical resistance in the intact end. However, the first measurements also revealed that the apparently undamaged end had suffered damage to the thread part and the counter nut had loosened. After the thread part was cleaned and the counter nut retightened, the electrical resistance was measured at $0.7 - 1 \text{ m}\Omega$ (milliohm). Aerotech Telub's calculations showed that the thread part in question could have melted during loads from an A pulse (see figure 3).

1. Ensure that the attachment of the bonding jumpers as described above are clean and without grease and/or dirt and control that the bonding jumpers are intact (not splintery) and correctly attached ref. MM chapter 23-61-00.
2. If the bonding jumpers are splintery or in other ways are incorrect they should be replaced by new approved bonding jumpers.

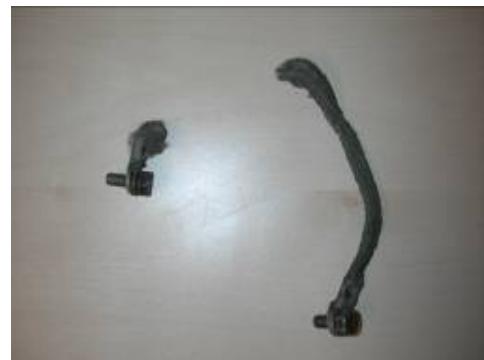
Figure 8: Burnt bonding

- 1.16.3.1 Both bondings between the horizontal tail surfaces and the fuselage were found to be broken in two. To ascertain the condition of the bondings before the aircraft was hit by lightning, parts of the two bondings were sent to the Armed Forces' laboratory services at Kjeller for analysis. A bracket from the outer bonding connection from the right elevator was also analysed with the bondings. The results were documented in "Technical Report no. 04012.03" (see appendix B). The report's conclusion was as follows:

The bondings we received had reduced conductivity as a result of mechanical wear (worn conducting wires) and considerable corrosion.

It is highly likely that the bondings burned off due to an electrical overload resulting from the lightning strike. The observed damage is consistent with observations made during experiments conducted by FOLAT/EMC and the Kraftforsyning laboratory.”

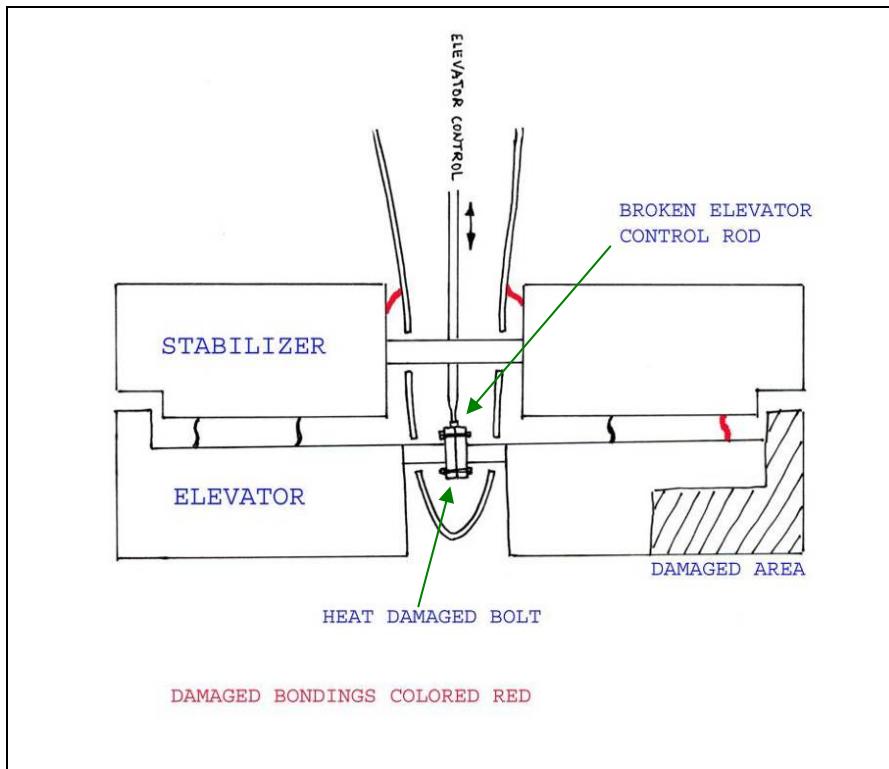
Figure 10: Diagram showing damaged bondings

coating. Consequently, the horizontal tail surfaces became electrically isolated from the fuselage when the bonding connections broke.

1. Annual/1,200-hour inspection of the general condition of all bonding connections.
2. Measure the resistance of all connections to the nearest part.
3. Measure the resistance of all static wicks to the nearest bonding connection.
4. Ensure a double ground plane between stabilizer and fuselage.

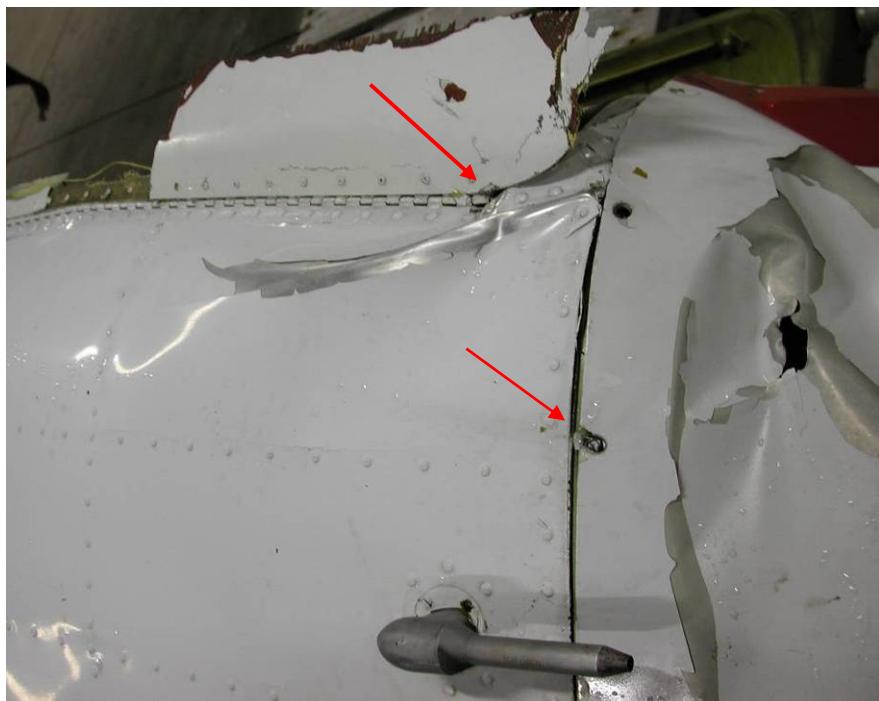
1.12.2.5 The aircraft was examined in order to identify the site of the lightning strike if possible. The only sign was two small marks high on the nose on the left (see figure 11). A small area (2 x 6 mm) in the left baggage door had melted in front of the handle. A nail head in the left pitot tube had melted in a similar way.

Figure 11: Photo of the aircraft's nose. Front of the aircraft is to the right. The red arrows show the impact points.

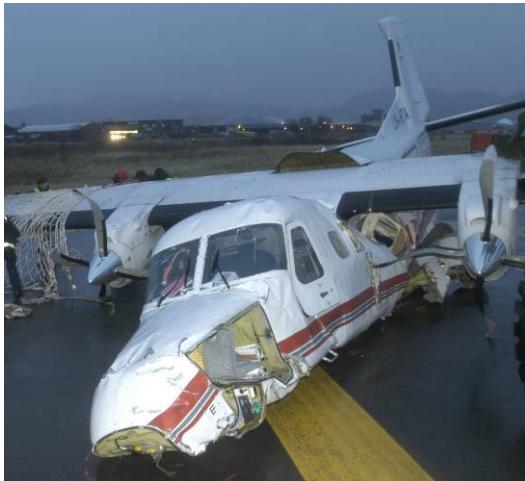
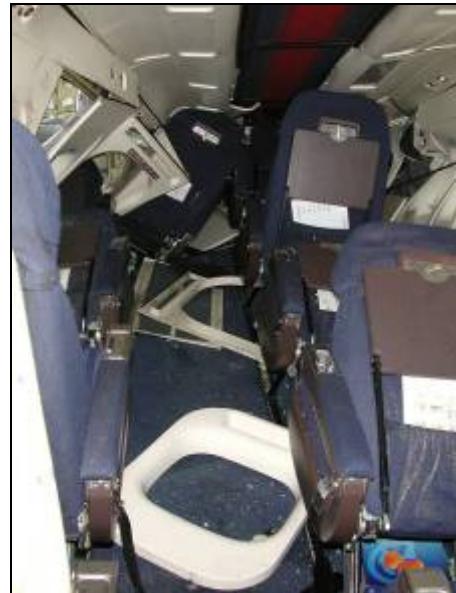
1.15.8 The front of the cabin had been forced up towards the ceiling and the two passengers had to crawl to the nearest emergency exit. There was torn metal in several places, which could have caused injuries to those onboard.

Figure 12: Compressed cabin (photo taken by armed forces) Figure 13: Front of the cabin.

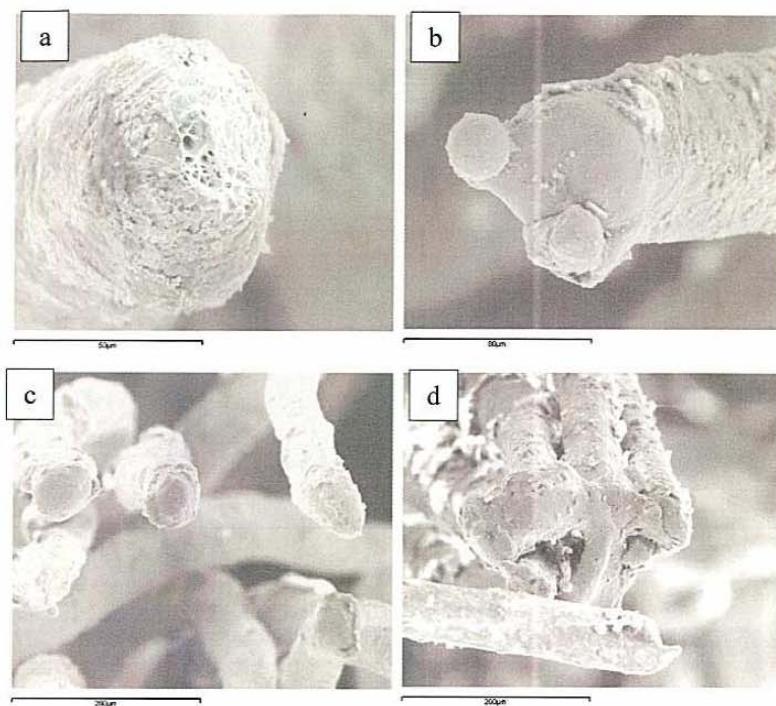
Figur 3 a: Tråd med dimpler i bruddflaten, b: Tråd med smelteperler, c: Oversiktsbilde av tråder med glatt overflate, d: Sammensmeltede tråder. (Leder i Figur 2A).

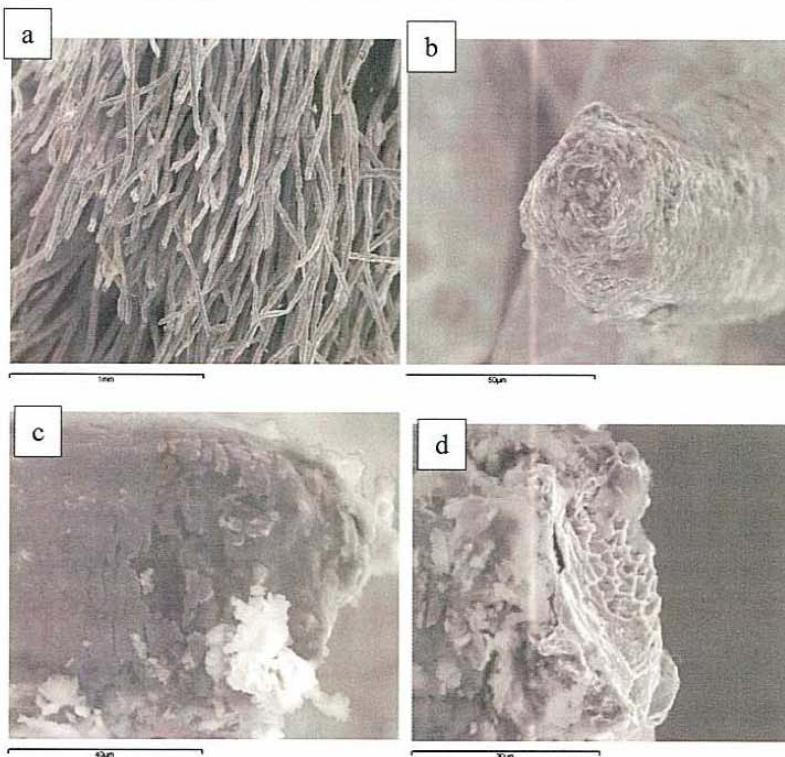
Figur 4 a: Oversiktsbilde av tråder, b: Tråd med innsnevring ut mot bruddflaten uten dimpler, b: tråd med glatt og oksidert bruddflate, d: tråd med dimpler i bruddflaten. (Leder i Figur 2B).

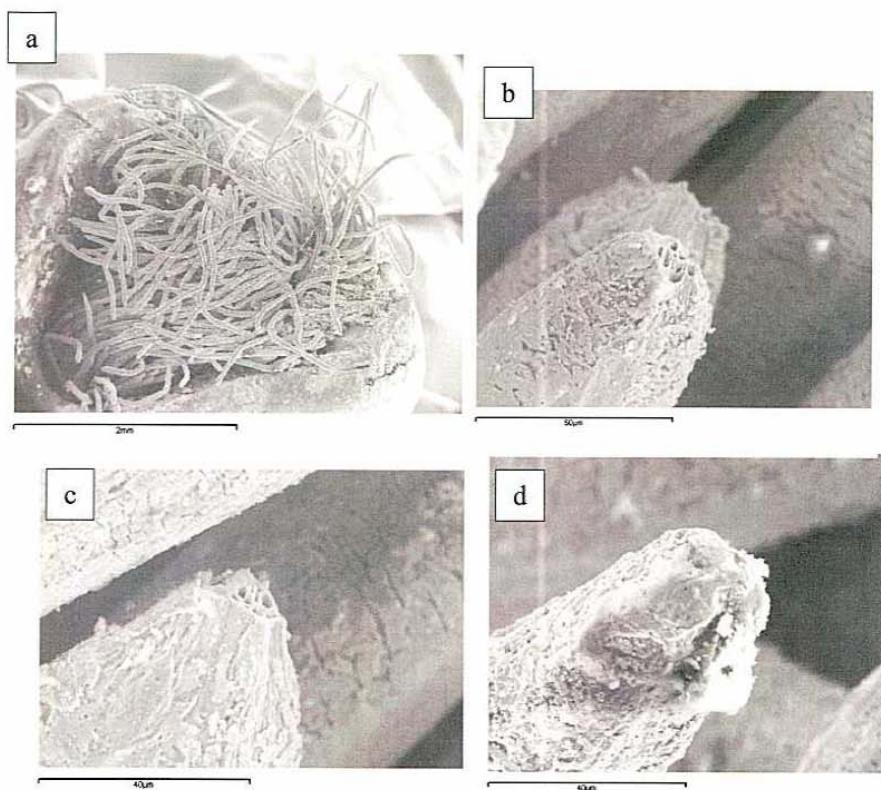
Figur 5 a: Oversiktsbilde av tråder, b: Tråd med dimpler i bruddflaten, c: Tråd med dimpler i bruddflaten, d: tråd med innsnevring ut mot bruddflaten uten dimpler. (Leder i Figur 2C).

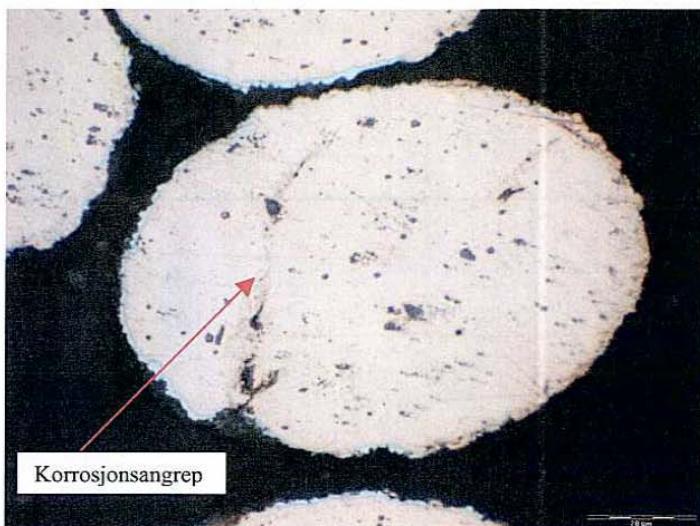
Figur 8 viser et bilde tatt i lysmikroskop gjennom et tverrsnitt av en tråd, bildet er representativt for lederne, og viser tydelig korrosjonsangrep. En tilsvarende tråd med tydelig pitting ble undersøkt med EDS i SEM, se hhv Figur 9 og Figur 10. Det fremgår av bildene at tråden består av rent kobber med et tynt tinnbelegg, spekteret fra rotten av korrosjonsangrepet påviser klor.

Figur 8 Bilde av tverrslip gjennom en leder tråd med tydelig korrosjonsangrep.

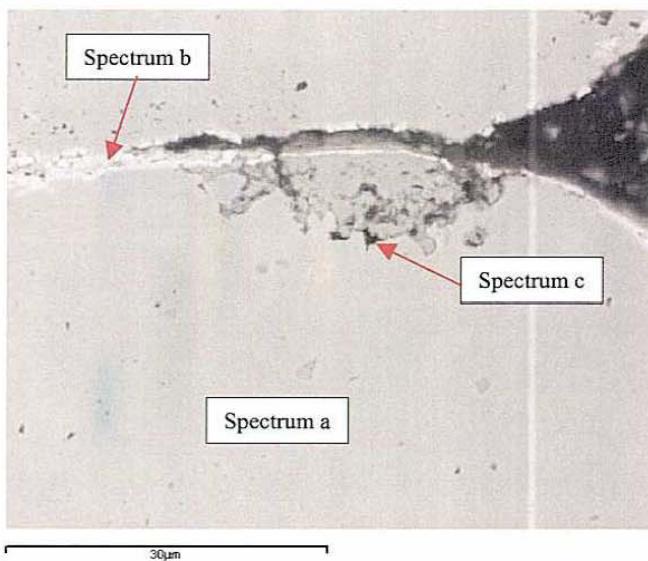
Figur 9 Bilde av tverrslip gjennom tråd med korrosjonsangrep. Bildet er merket med områdene for EDS spektrene vist i Figur 10.

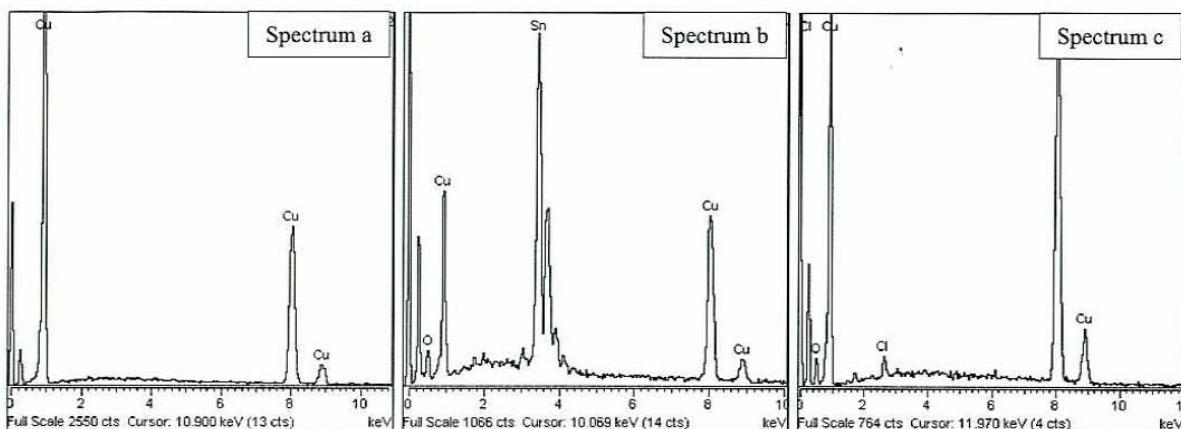
Figur 10 EDS spektere fra områdene avmerket i Figur 9. Spectrum a viser grunnmaterialet i tråden; kobber. Spectrum b viser belegg på tråden; tinn, Spectrum c viser forekomst av klor i korrosjonsgropen.
