# Report

Accident on **13 July 2012**  
at **Le Castellet aerodrome (83)**  
to the **Gulfstream G-IV** aeroplane  
registered **N823GA**  
operated by **Universal Jet Aviation (UJT)**

Bureau d'Enquêtes et d'Analyses  
pour la sécurité de l'aviation civile

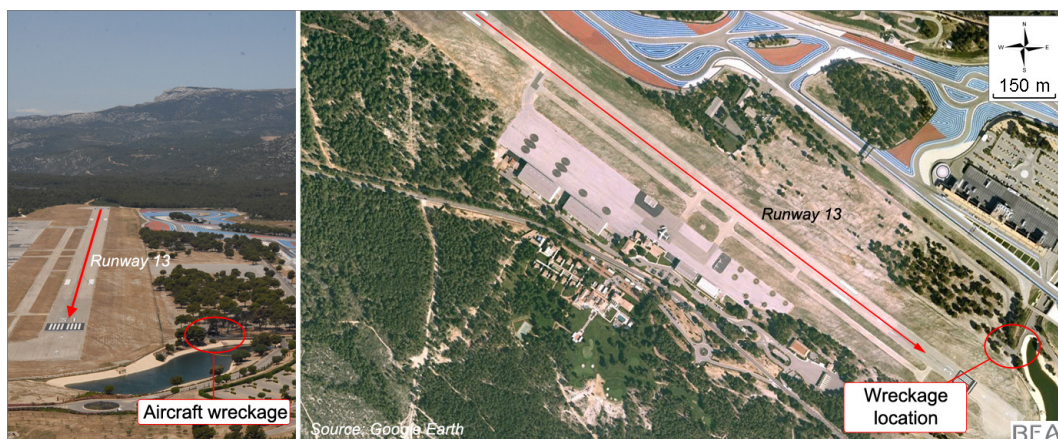
Figure 10: location of the wreckage

The wreckage was located outside the aerodrome perimeter fence.

No debris from the aeroplane was found within the aerodrome perimeter. The first part (piece of the nose gear) was located just behind the fence that the aeroplane went through.

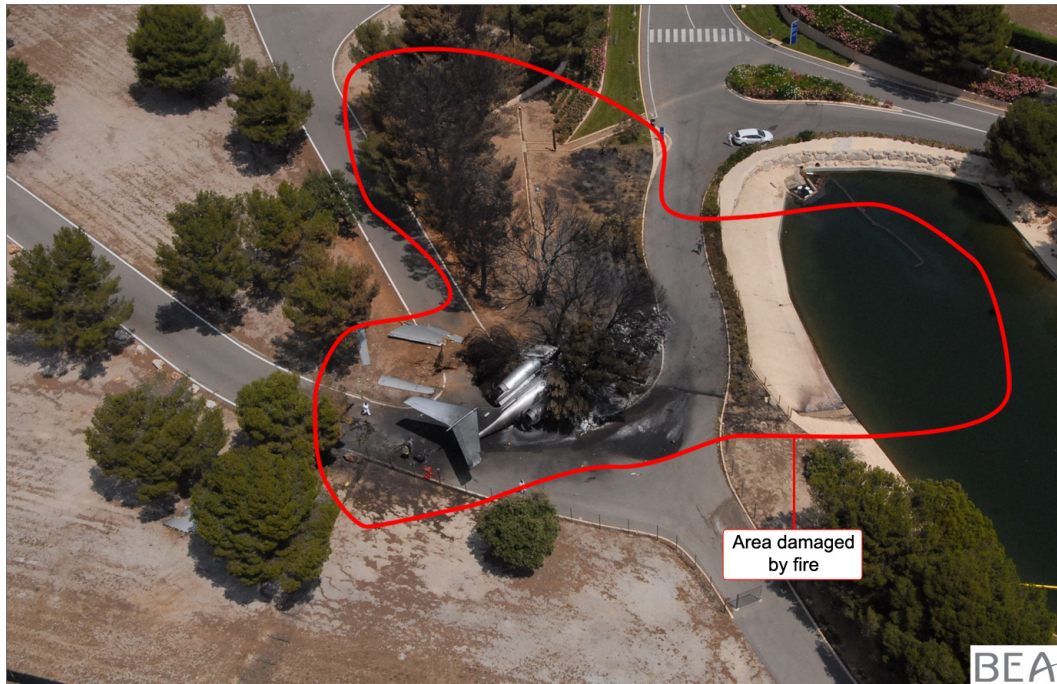
Figure 11: area affected by the fire

A large amount of debris from the aeroplane was found near the wreckage. This resulted from the contact between the aircraft and the fence demarcating the enclosure of the aerodrome, as well as the rocks and trees. Most of the aeroplane was destroyed by fire (figure 11).

A fire started after the impact of the structure with the rocks and trees. The wing tanks ruptured and the fuel immediately ignited. The fire spread to a few surrounding trees.

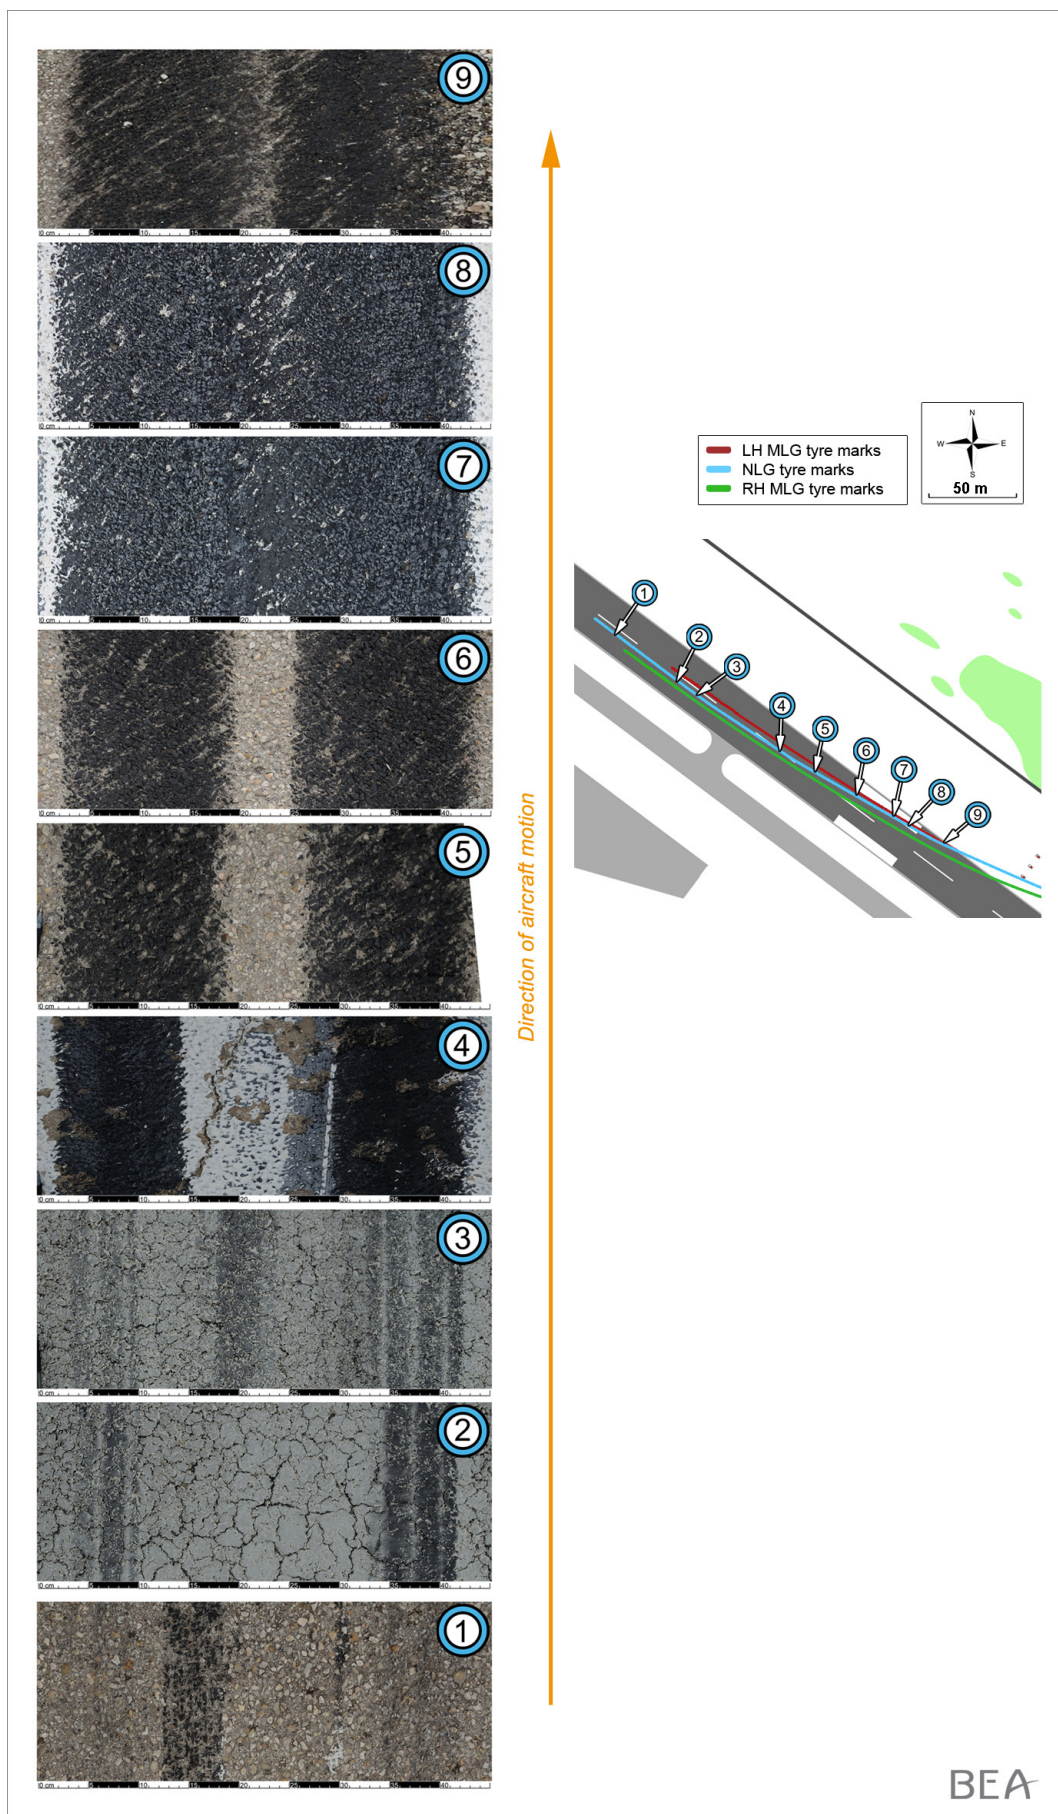
Figure 12: photos of the nose gear tyre marks

The first tyre marks observed on the runway attributed to N823GA were left by the nose gear<sup>(19)</sup>. They were continuous to the runway edge over a longitudinal distance (in relation to the runway centre line) of 270 metres. The marks from the right main landing gear start 30 metres after those of the nose gear, those of the left main landing gear started 25 metres after those of the right main landing gear (*see the diagram and photographs below*).

Shortly before the runway centre line (between points 3 and 4 of the diagram above) and until the runway edge these marks had striations trending towards the right in the direction of travel of the aeroplane. Their angle, measured between the edge of the mark and the striation, changed along the marks (see the measurements below).

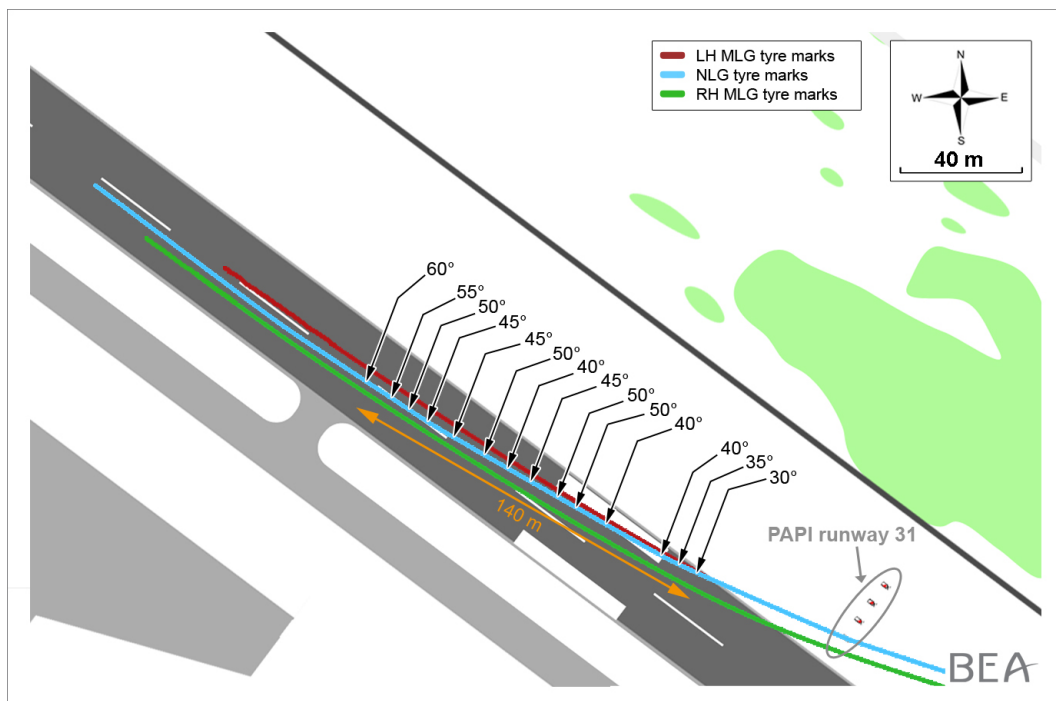
Figure 14: striation angle values along the nose gear marks

The interpretation of these striations was the subject of a study that is presented in 1.16.7.

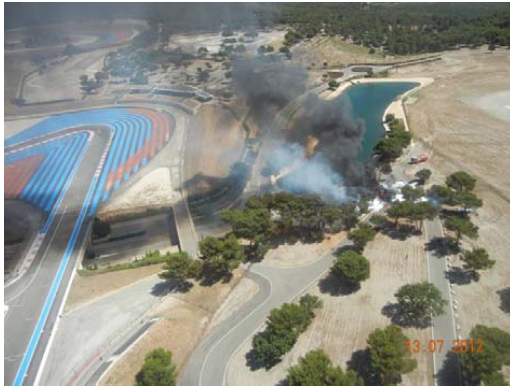
Photo 2

On photo 2, (taken by the helicopter that had just taken off), the foam response vehicle (VIM) is in front of a gate not referenced, inside the racing circuit. It has not yet carried out its second intervention.

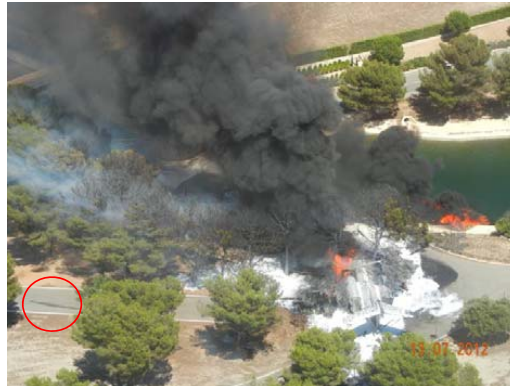
Photo 3

On photo 3, two outbreaks of fires are visible (wreckage and the slick of kerosene in the pond). The mark of water on the "east" road (red circle) shows the location of the first intervention (puddle caused by the drainage of the system).
