# Investigation Report

Type of Occurrence:	Accident
Date:	27 September 2012
Location:	Warbelow near Gnoien
Aircraft:	Airplane
Manufacturer / Model:	Pilatus / PC-9/B
Injuries to Persons:	Both pilots fatally injured
Damage:	Aircraft destroyed
Other Damage:	None
Information Source:	Investigation by BFU
State File Number:	BFU 3X146-12

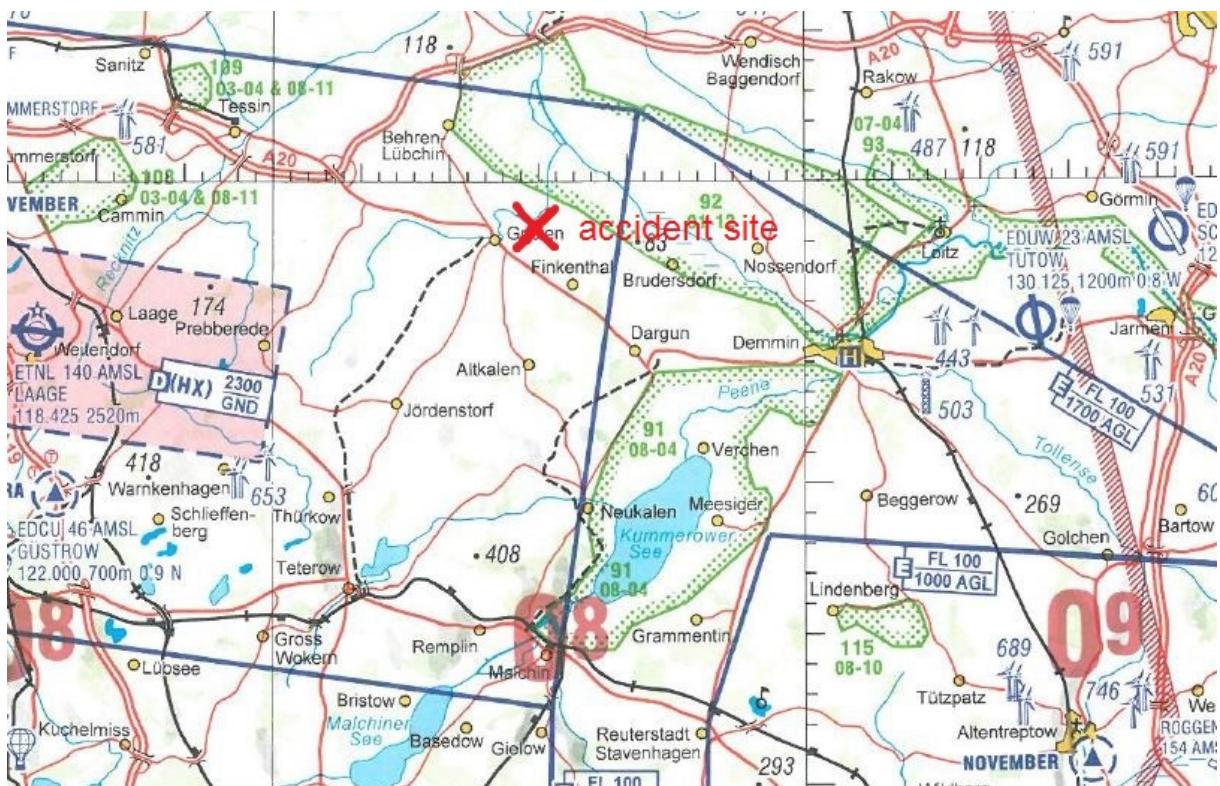
The ICAO Aeronautical Chart 1:500 000 showed Aircraft Relevant Bird Areas (ARA). Directly to the north-east of the accident site the ARA Trebeltaal (ID92) (active all year round) was located. The ARA Kumerower See (ID 91) (active August to April) was located south-east of the accident site.

Excerpt ICAO chart with Aircraft Relevant Bird Areas 91 and 92

The accident site was located close to an Aircraft Relevant Bird Area (ARA) depicted in the ICAO Aeronautical Chart 1:500,000.

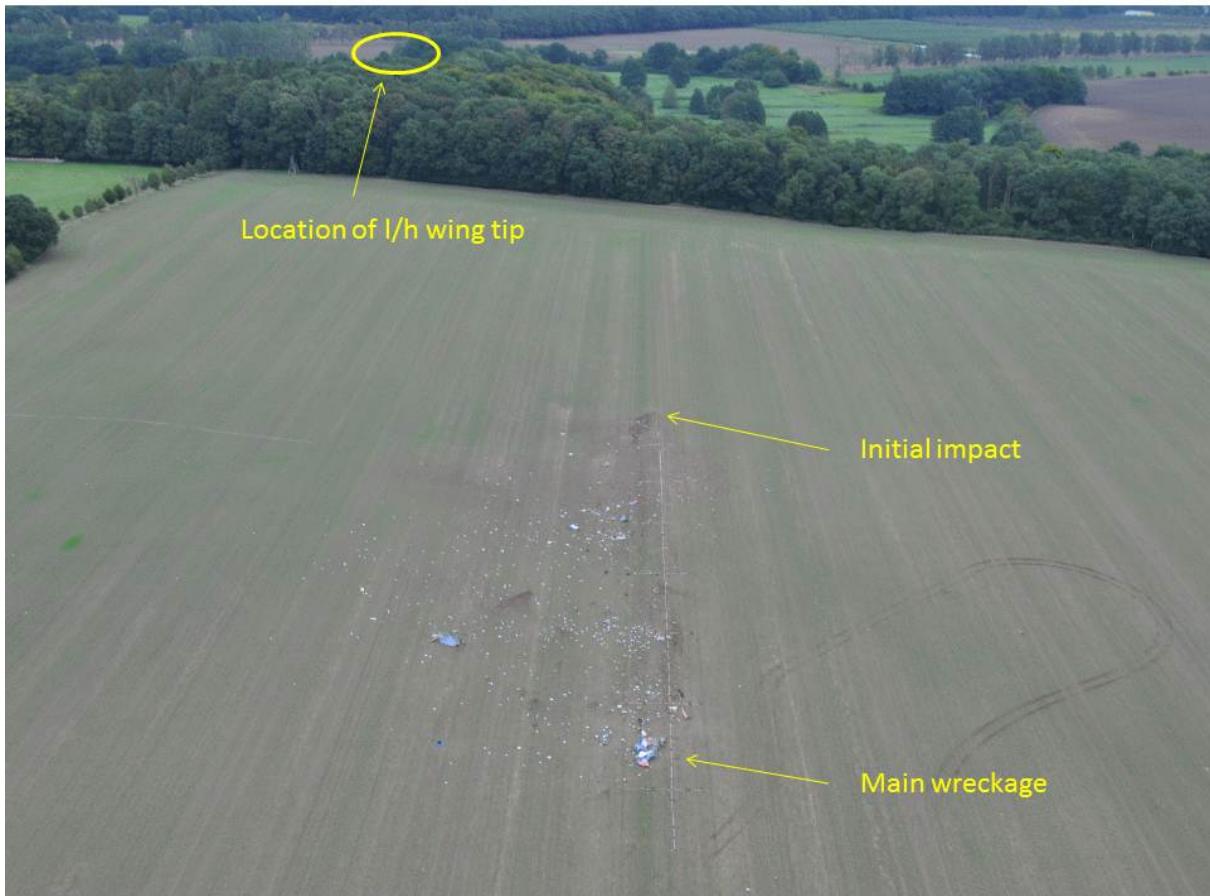
With a heading of about  $290^\circ$  the airplane impacted a tilled field about 225 m northwest of a mixed forest. The initial ground contact occurred with the left wing.

Accident site viewed against the approach direction

The very distinct traces of the initial point of impact at the accident site and the fan-shaped wreckage distribution are typical for an impact with great horizontal velocity and low impact angle.

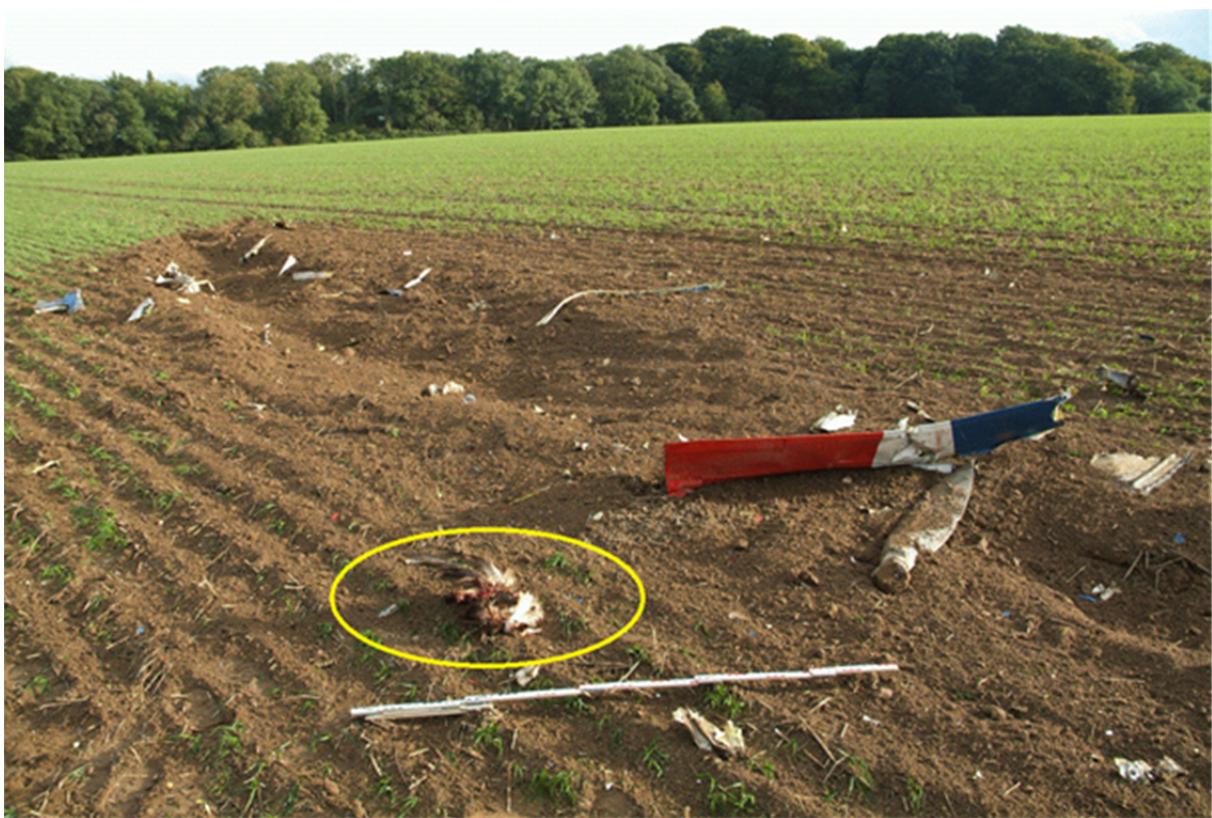
In this area the left aileron, parts of the left horizontal tail and one propeller blade were found, among others. The cadaver of a bird of prey measuring  $56 \times 20 \times 10$  cm and weighing 1.26 kg was found next to the left aileron. The bird of prey was identified as an osprey.

Accident site, view to the south-east, bird cadaver, left aileron and propeller blade

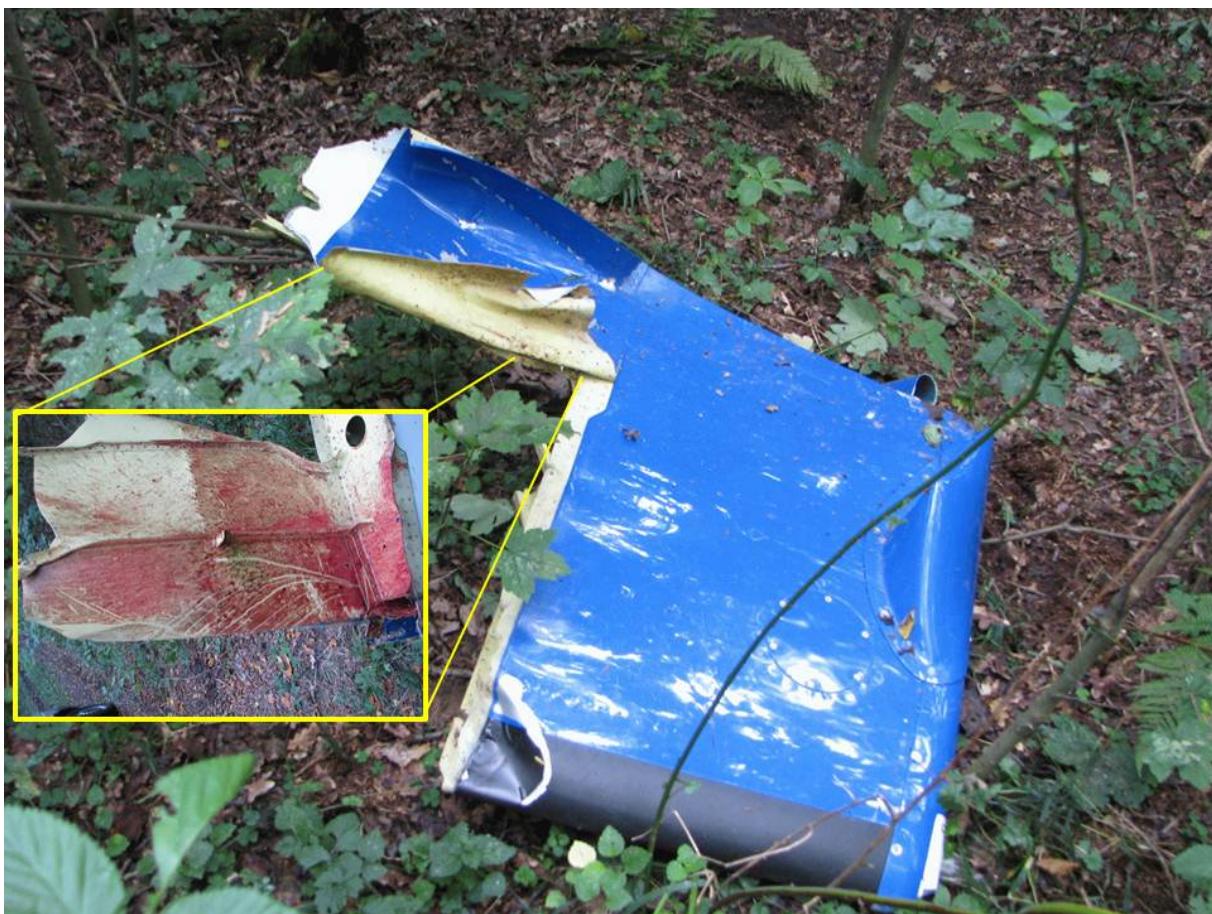
Part of the wing with traces of blood on the inner surface

Part of the left wing was found in a mixed forest about 500 m east of the initial point of impact of the main wreckage. It was the wing tip which had been torn off along a row of rivets about 0.70 m from the tip. The upper surface of the wing leading edge showed a dent of about 15 x 15 cm with a depth of approximately 5 cm. The wing covering was severed along a row of rivets which ran along a rib. The main spar was fractured. The inside of the wing upper surface showed traces of blood. The aileron hinge mounted to the aft beam had been severed.

Since the outer part of the left wing had been found in great distance to the main wreckage it is clear that it had already been severed in flight. That a bird strike had occurred at the left wing is shown unambiguously by: the damages from the wing leading edge backwards, the traces of blood on the inside of the wing structure, and the remains of a bird of prey found at the accident site.

The bird strike occurred at the rivetting of the wing. Subsequently the outer wing part and the aileron hinge were severed. The loss of the wing part resulted in a change in lift behaviour in combination with a rapid roll movement and the severely damaged aileron affected the controls.
