Civil Aviation Accident
Investigation Board (JIAAC)

Technical Report 096/2011

Accident that occurred on 18 May 2011

**Aircraft Saab 340 A, LV-CEJ. Location: Caltrauna,
between Los Menucos and Prahuanieu, province of Río
Negro**

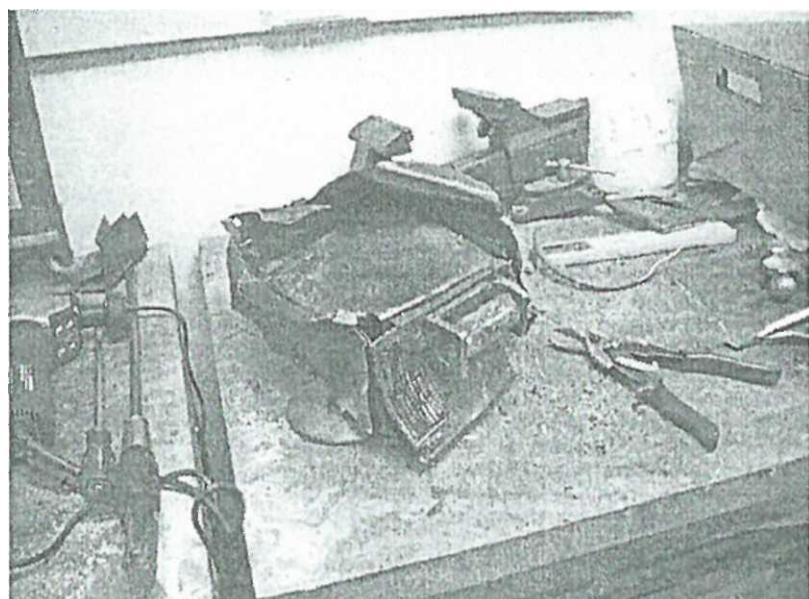
1.11.4.1.1 The CVR showed signs of severe impact shock and impact penetration, with the destruction of the external structure (impact and penetration) and the internal protection (resistant structure and thermal protection). There was evidence that the equipment had been on fire for a considerable period of time. The Underwater Locator Beacon (ULB) was found to be damaged; however, it withstood the impact and was still attached to the equipment.

1.11.4.1.2 The protective structure, along with the recording medium, were extracted with the use of manual tools, while the rest of the equipment was removed and preserved. Upon removing the subset and opening it up, the internal thermal protection was found to be damaged. When the last layer of mechanical protection was extracted, the recording medium was found to be fractured and damaged, as were the recording heads and other internal components.

The state of the CVR equipment at the time of the retrieval.

1.11.4.1.3 Upon the removal of the magnetic tape, it was found to be torn; one part was detached from the rest, but recovered. The damages to the tape ("Mylar®" polymer tape coated with ferromagnetic material)

were found close to the recording heads, and the impact had left the tape entangled.

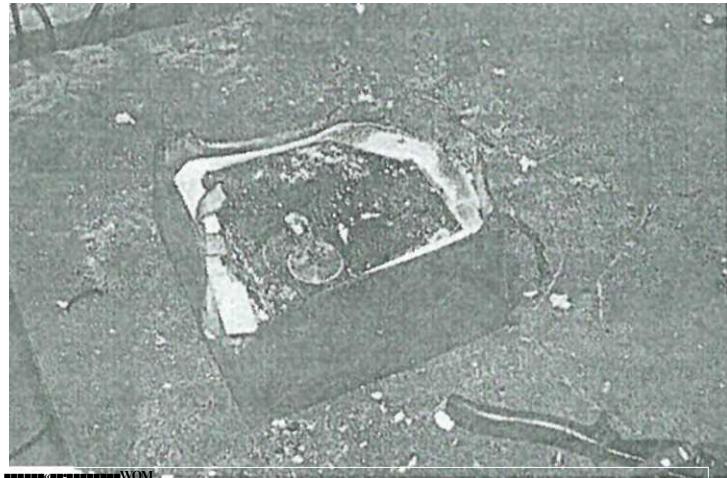
1.11.5.1.1 The FDR equipment was damaged by the impact and the fire; however, it was in better condition than the CVR. During the impact, the protective internal module - in which the tape was located - became detached. Despite becoming detached, the recording medium was protected.

1.11.5.1.2 When opening up the equipment, it was revealed that the tape around the recording heads was damaged and torn. This occurred due to the violence of the impact. It resulted in the tape tearing and stopping in the final recording position.

The state of the FDR equipment at the time of the

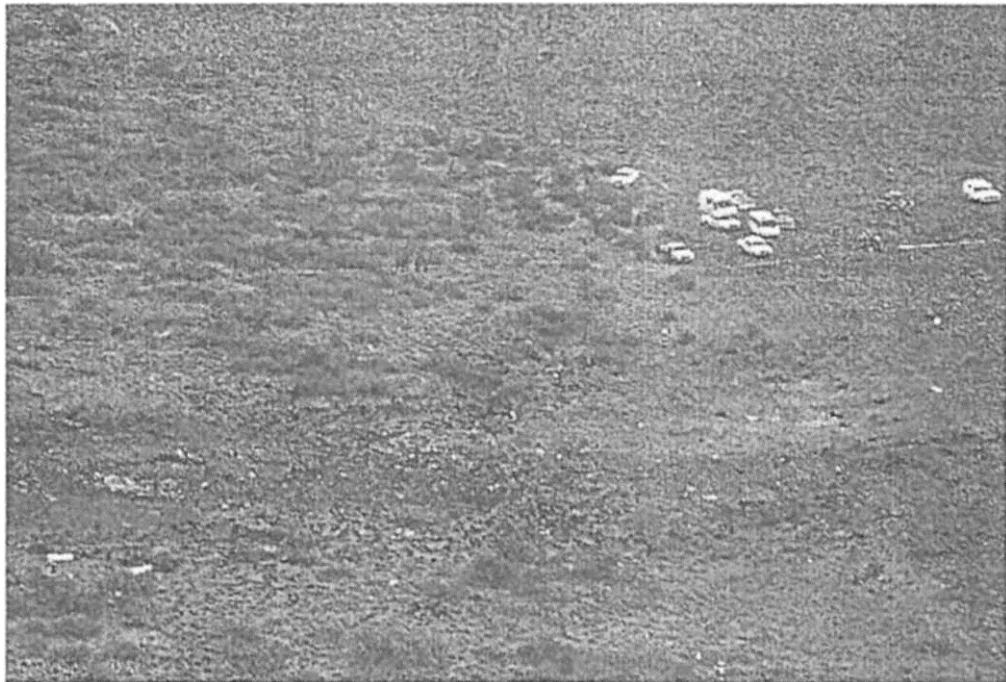
1.12.2 Most of the wreckage was spread out, starting at the site of the first impact, with a heading that formed a scattering angle, ranging from 300° to 350° with a minor amount of wreckage spread out in a radius of about 200 m around the main point of impact. There was no evidence of the aircraft components detaching before impact.

1.12.3 The components of the right engine and the propeller blades were scattered about 130 m from the main impact point with the same heading. The components of the left engine and propeller blades were 90 m from the impact and with a recovery degree (R°) of 350. The remaining propeller blades were found 70 m from the main impact and with $R^\circ 350$.

Aerial view of the impacted area.
