Investigation Report

Identification

Type of Occurrence:	Incident
Date:	13 March 2013
Location:	Nuremberg
Aircraft:	Transport aircraft
Manufacturer / Model:	Embraer / ERJ 170-100 LR
Injuries to Persons:	None
Damage:	Minor damage to aircraft
Other Damage:	None
Information Source:	Investigation by BFU
State File Number:	BFU TX001-13

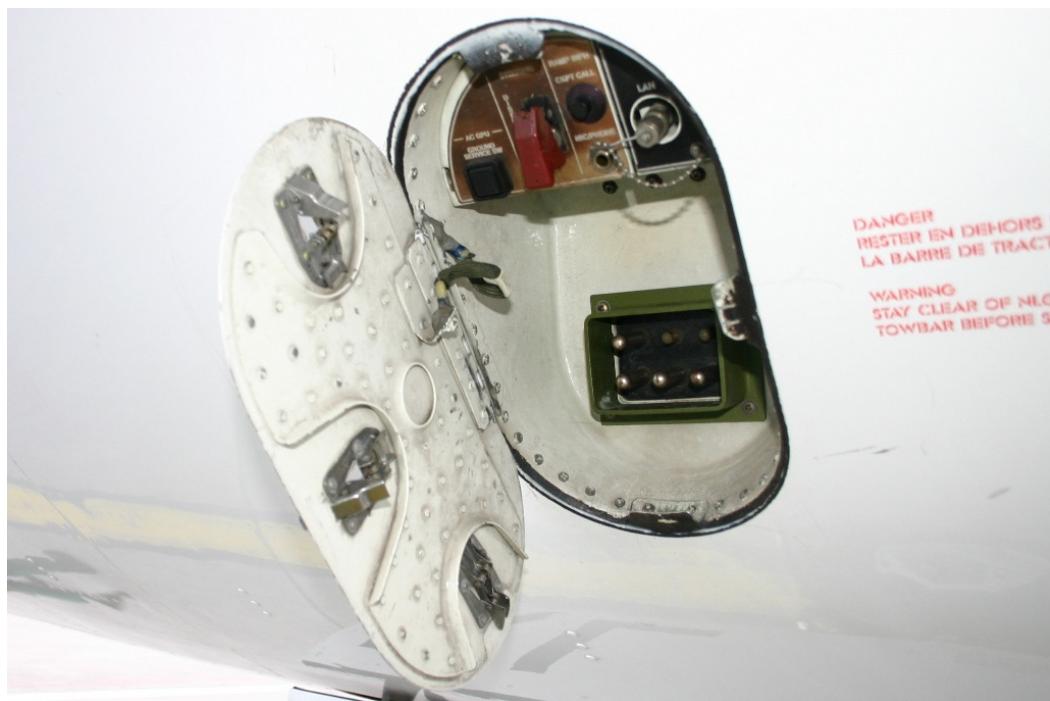
The outer area of the aircraft around the external power receptacle did not show any damage. The inside was covered by molten material, the connected cables and the circuit breakers located above were covered by soot. The wire bundles above the receptacle were covered by soot and the insulation of the pipes showed heat damage.

The outside of the external power receptacle

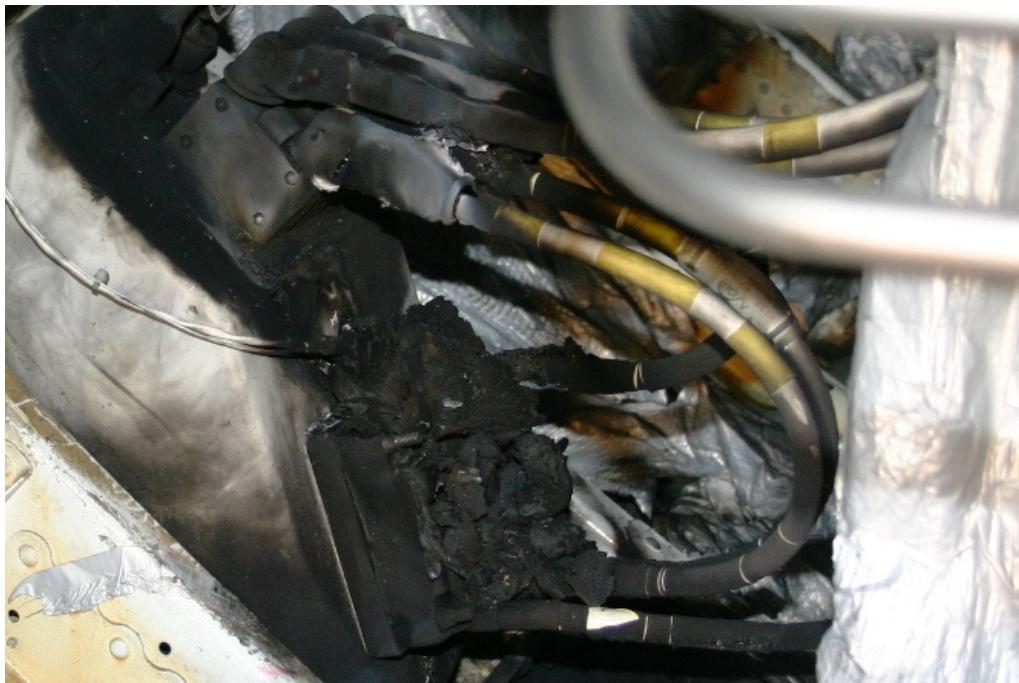
The inside of the external power receptacle

On 30 September 2015, the aircraft manufacturer issued the Service Bulletin SB170-24-0057 which describes how the openings on the upper side of the external power receptacle covers can be closed to prevent short circuits by foreign objects.

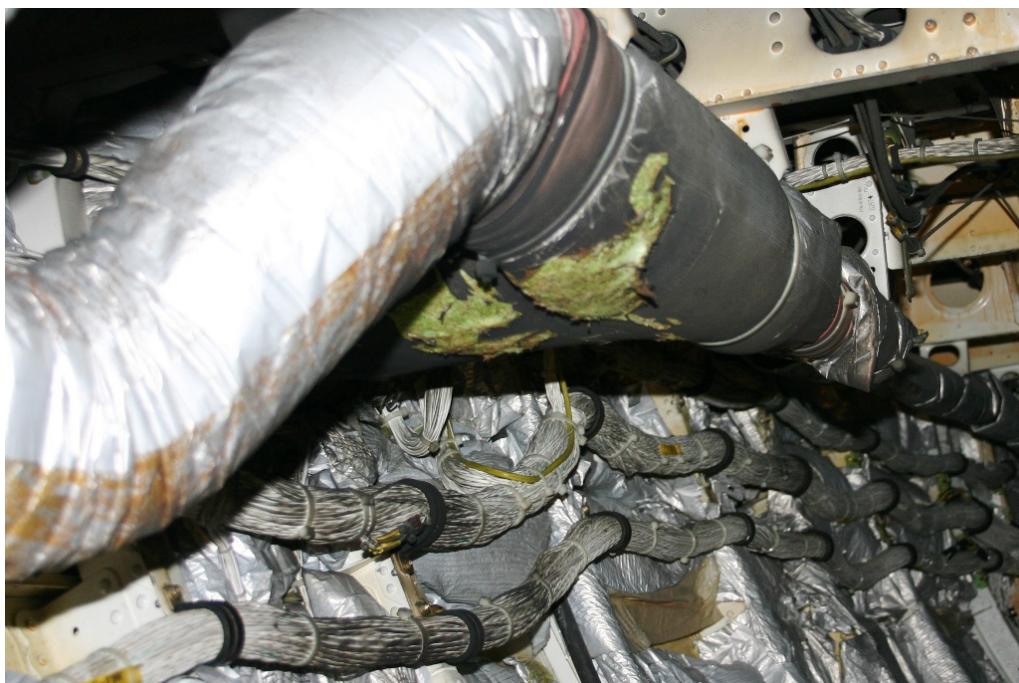
Area above the external power receptacle

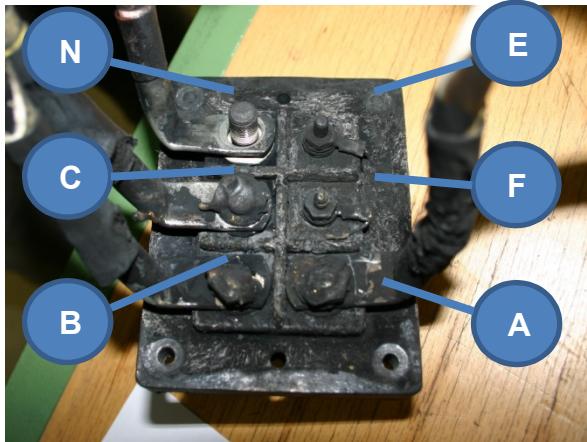
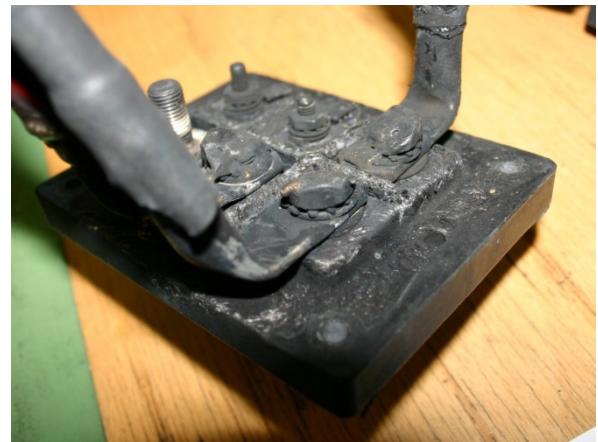
The individual parts of the external power receptacle (P/N MS90362-3) were removed and examined in more detail. It was determined that the pins, the cable clips and the screw nuts of the receptacle A, B and C for the alternating current phases were molten on the sides facing each other.

Inside of the receptacle

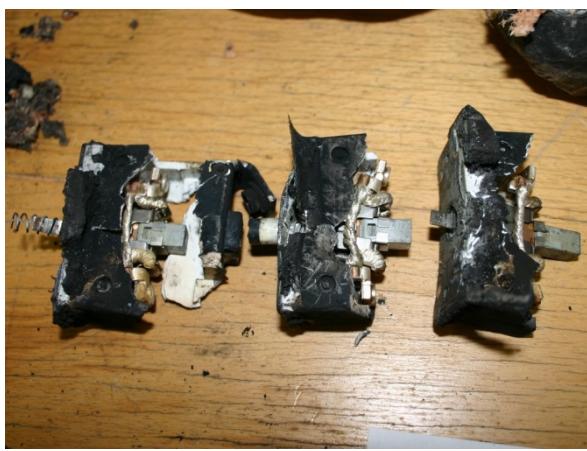
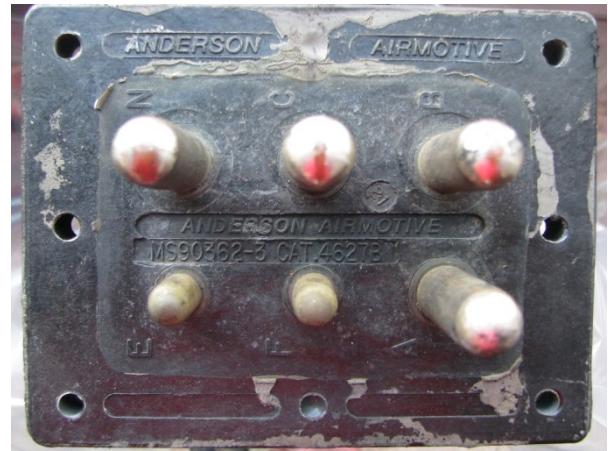
The three circuit breakers showed heat damage. The housing was fractured. The insides of the housings did not show any traces of heat or high current. The insulation panels of the fuselage above the receptacle showed heat damages. The pins of the receptacle did not show any visible damages.

Automatic circuit breakers (overview) and the outside of the receptacle
