AIRWORTHINESS BULLETIN

AWB 02-052 Issue : 2
Date : 23 March 2016

Wasp Nest Infestation - Alert

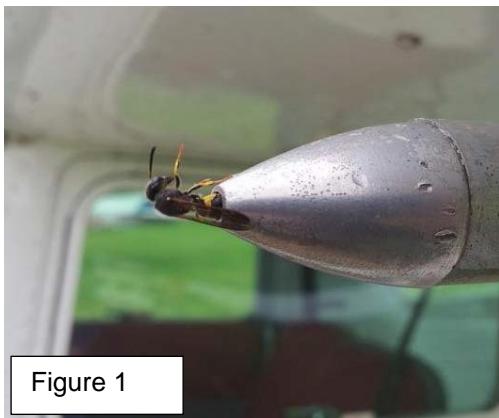
Figure 1

Figure 1. Mud dauber wasp emerging from an uncovered pitot tube.
(Source:backcountrypilot.org)

1. Install pitot / static and vent covers any time the aircraft is parked.
2. Consider installing approved fuel vent screens or removable drain/vent covers and engine compartment blanks, as well as installing tight fitting pitot / static vent covers.
3. In instances where the aircraft has been stored long term in the open air, remove inspection panels before flight as required to inspect unsealed wing and fuselage cavities etc.
4. Continually monitor and remove any wasp nesting sites in the general area where the aircraft is stored or maintained in accordance with appropriate insect control procedures.
5. Be aware that on-ground pre-flight air data module BITE tests and/or computer checks will usually not test pitot probes or static vents for blockages.

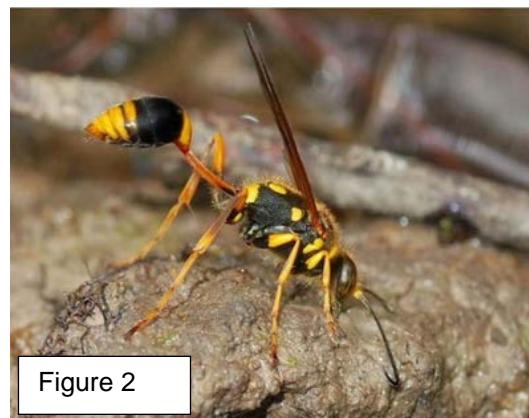
Figure 2

Figure 2. Australian Mud Dauber Wasp
(Source: BrisbanelInsects.com)

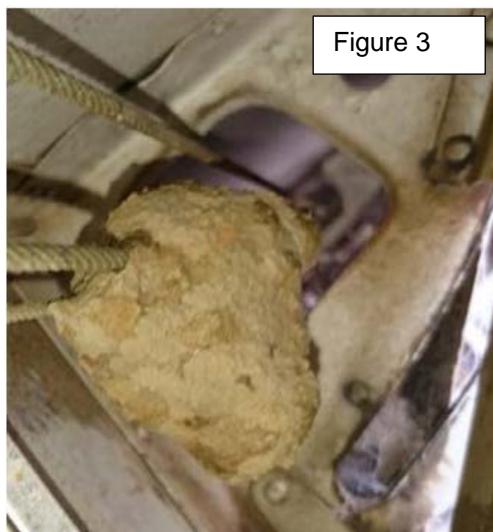
Figure 3

A recent SDR investigation found a number of wasp nests inside the wing of a Cessna 182, in the cavity formed between the rear spar and the flap fairing, (Figure 3).

There was also one large wasp nest entirely suspended on the flight control cables in the rear fuselage.

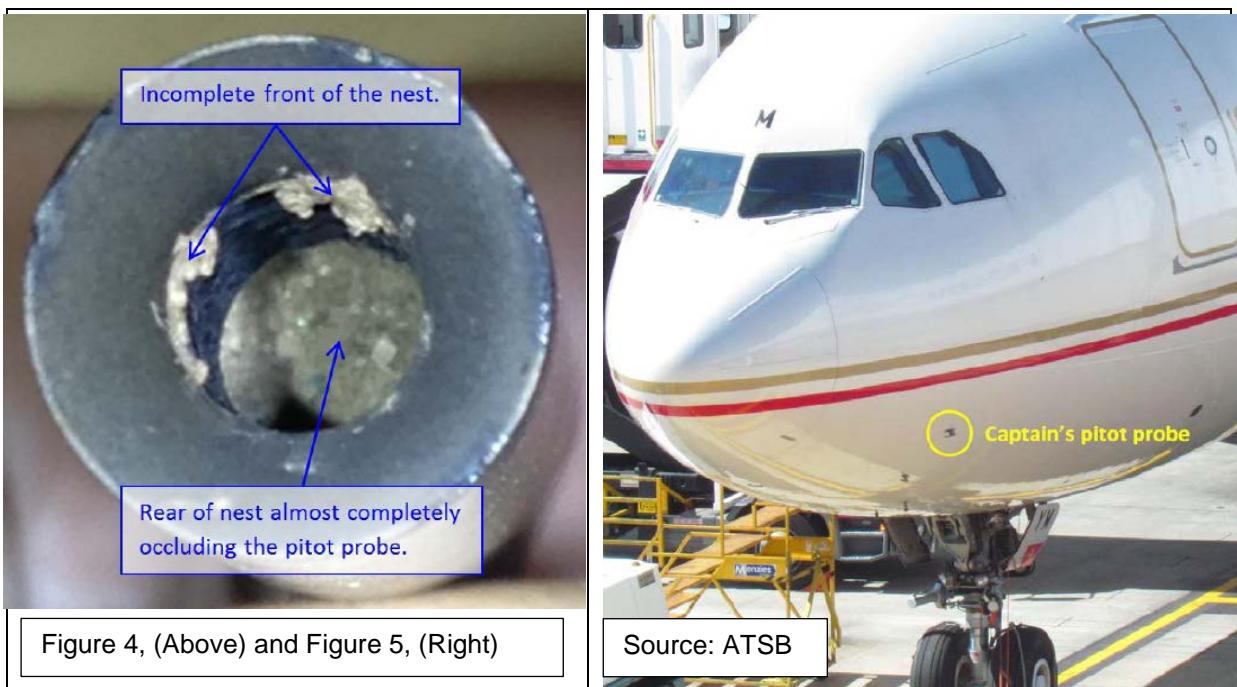
A typical example occurred in 2013 when an Airbus A330 suffered a rejected take-off in Brisbane, Australia, due to an airspeed indication failure which was only detected during the take-off roll. During the subsequent inspection it was found that the Captain's pitot probe (Figure 5) was almost totally obstructed by an insect nest, consistent with mud-dauber wasp nest residue. (Figure 4)

The residue was built up while the aircraft was on the ground over a two hour period, while the aircraft was parked at the loading gate. The pitot probe covers were not installed by maintenance staff during this time.
