Air Accident Investigation Sector

Accident - Final Report -

AAIS Case N° AIFN/0018/2014

Cabin Crewmember Injured During Taxi

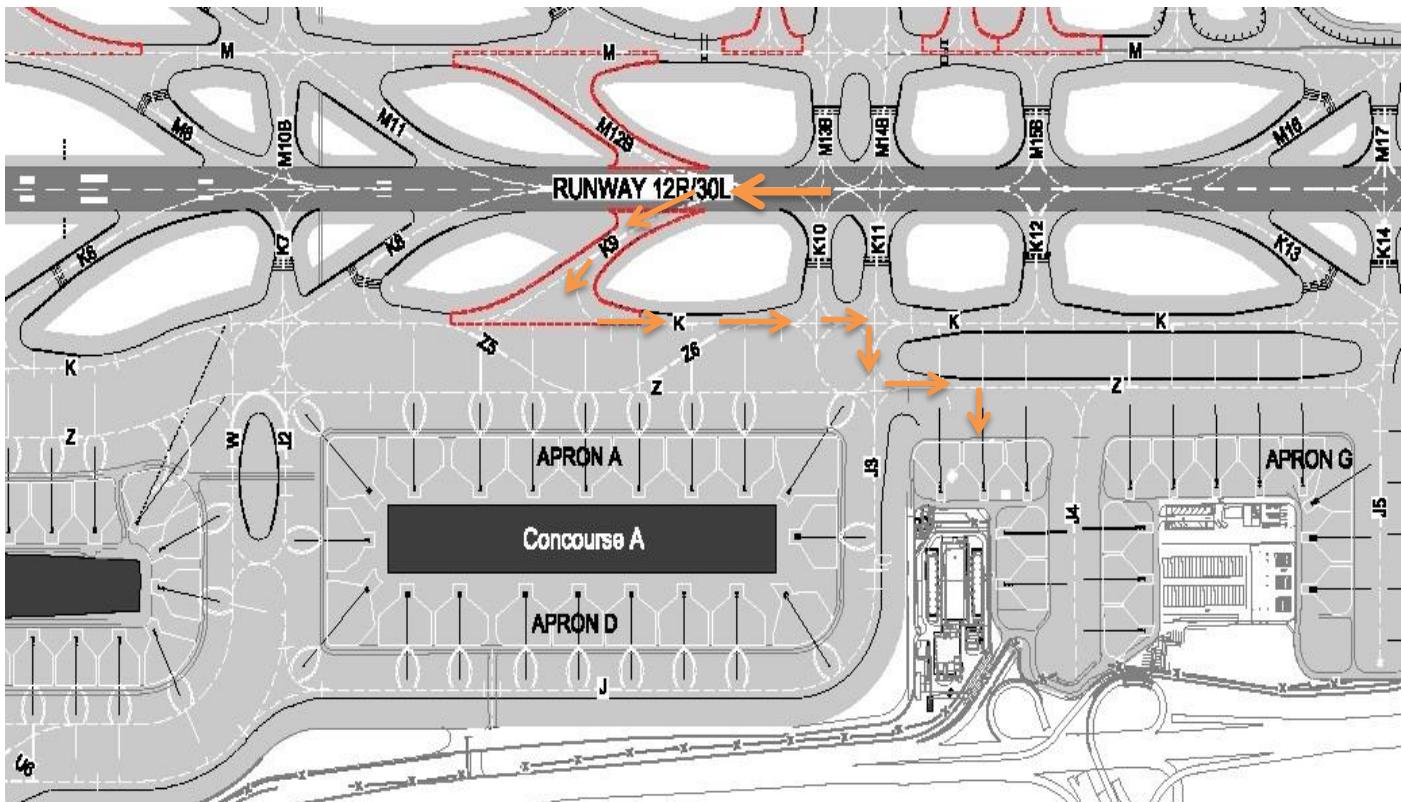
Figure 2. Taxi route of the Aircraft

After landing, the Aircraft vacated runway 30L via taxiway Kilo 9 and then turned left onto taxiway Kilo. While the Aircraft was taxiing on taxiway Kilo, ATC instructed the crew to turn onto taxiway Juliet 3, then to turn left onto taxiway Zulu and park on parking bay Golf 2 (Figure 1).

After vacated the runway, both engines were running, while the Aircraft was taxiing until it reached taxiway Zulu, (Figure 1). The Aircraft made a series of sharp turns, including several 90° turns, before finally turning onto the parking bay,

During the time taken by the SCCM to reach the forward cabin, the Aircraft had reached taxiway Zulu, (Figure 1).

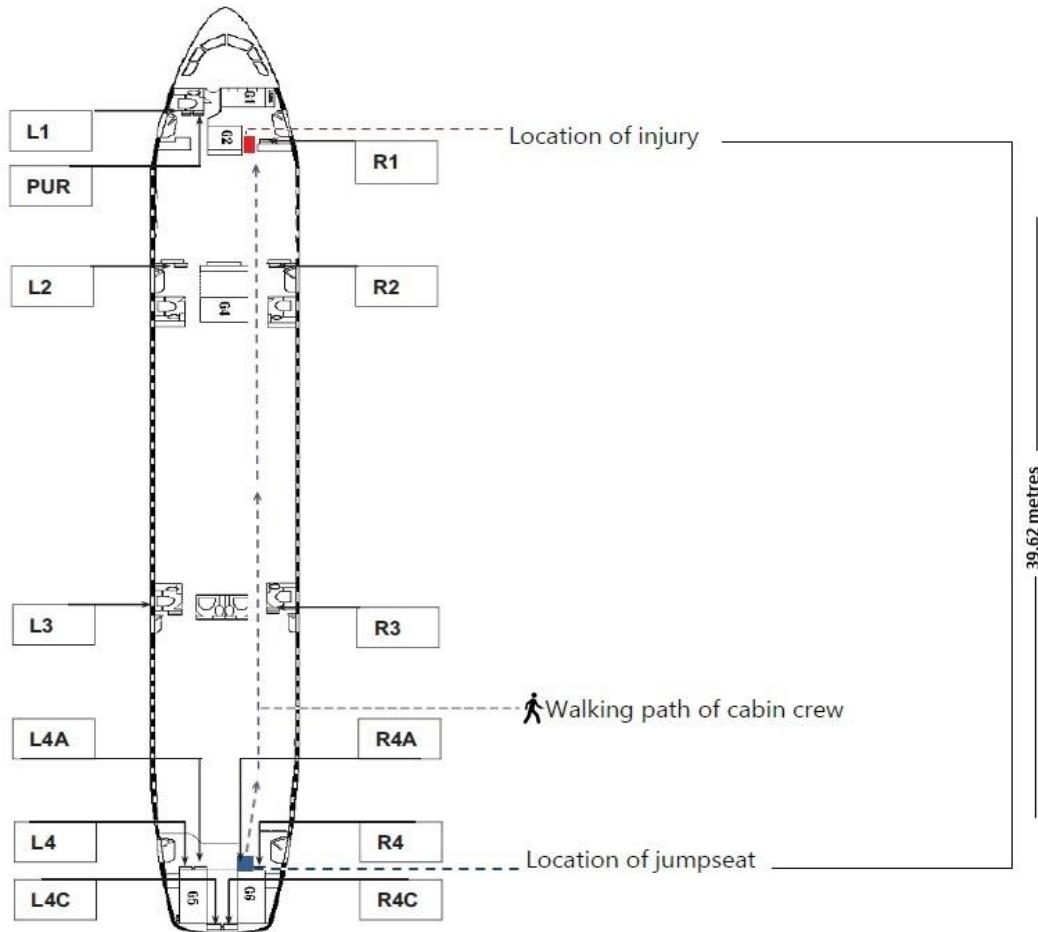
Figure 2. Aircraft configuration/injured cabin crewmember seat/workstations

As the Aircraft taxied on taxiway Kilo, the Senior Cabin Crewmember (SCCM), left her designated jump seat (R4A), which was located next to the R4 door main jump seat (refer to figure 2), and moved towards the forward economy galley to perform her nominated duty as the L2 door checker. However, prior to approaching the L2 door, the SCCM walked directly to the business class galley to retrieve her uniform hat, which was located in the coat closet stowage behind the R1 jump seat.

The distance that the cabin crewmember had walked from her jump seat to the location where she had lost her balance before falling was 39.62 meters (figure 2).

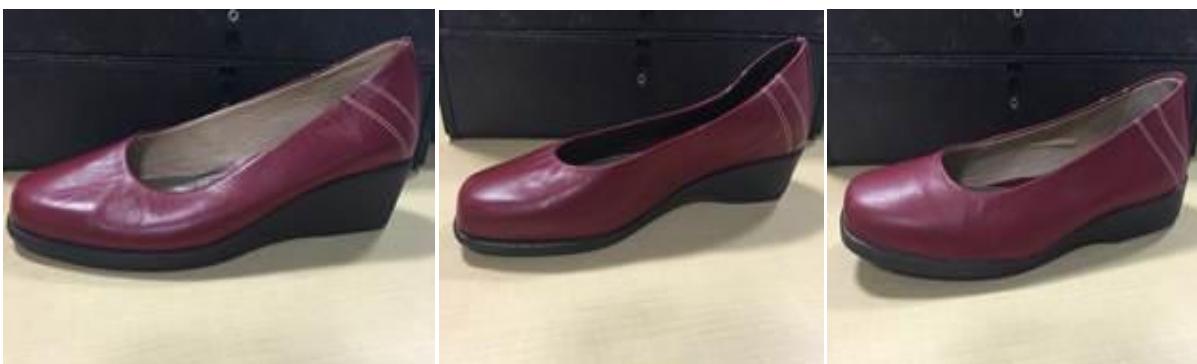
Figure 3. Flatter heeled shoes

There are three different types (figure 3), Wedge style – 1.7 inches (4.5cm), Flat style 1 – 1.5 inches (3.5cm), flat style 2 – 1 inch (2.5cm) for the inflight service.

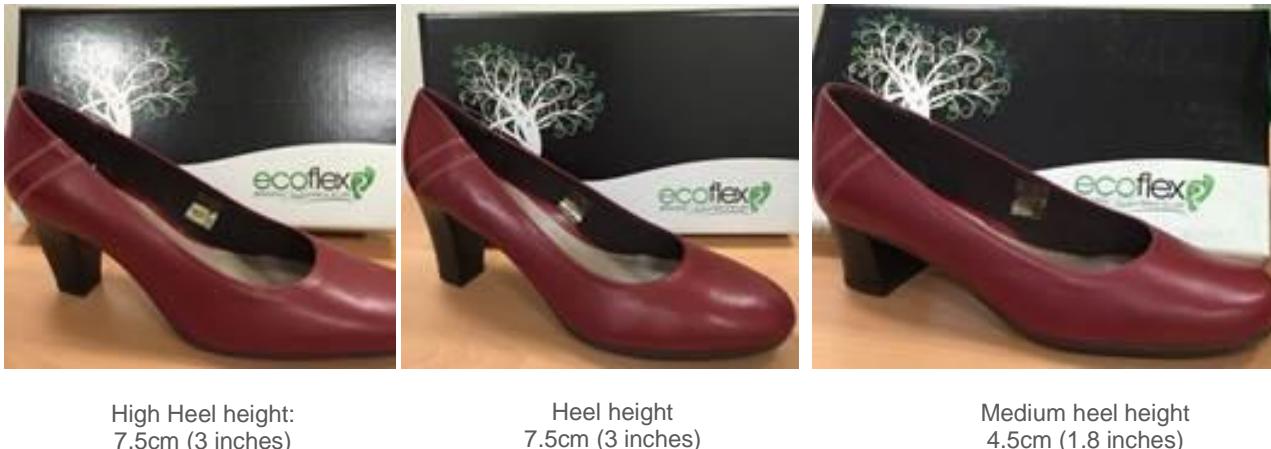
Figure 4. Cabin crew shoes style

At the time of the event the cabin crewmember was wearing the medium heeled shoes (figure 4).

There are three different heights of female high heeled (court) shoes. The injured crewmember was wearing the medium heeled height, which is 1.8 inches.

With this accepted practice of shoe changing, the operator did not risk assess and provide mitigating advisory actions concerning CCMs walking through the aircraft cabin during taxi, while wearing high heeled/medium shoes.

Assess the risk to female cabin crewmembers of wearing high/medium heeled shoes during the critical phases of the flight (taxi, take-off, climb, descent and landing).

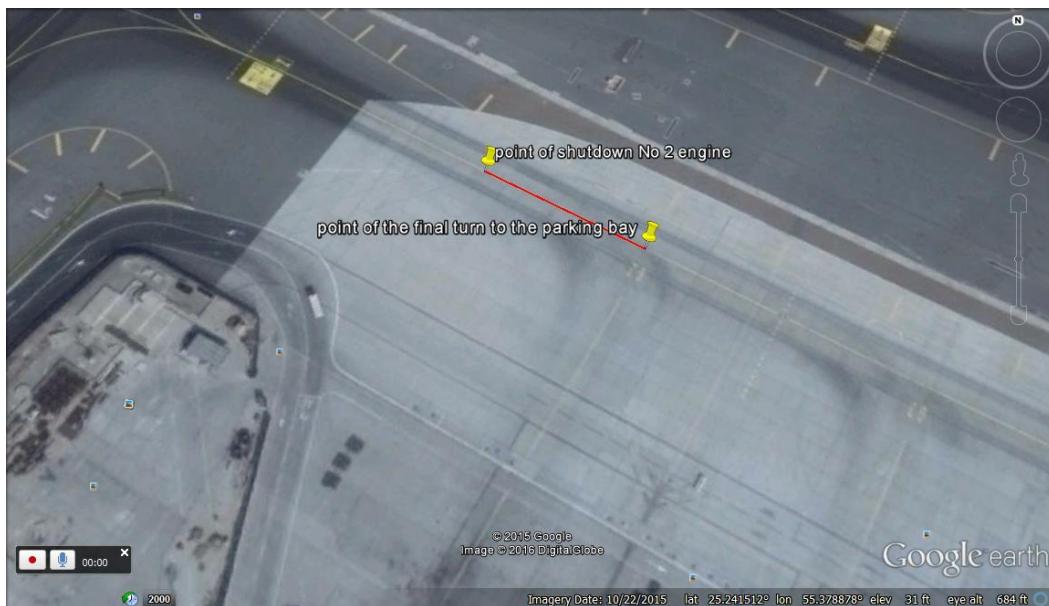
Figure 5. Dubai International Airport [Source: Google earth]

Using the google map, the distance from the point where No. 2 engine was shut down, and the point where the final turn onto the parking bay (Golf 2) begins is also approximately the same distance, from calculation.

The time taken by the aircraft to travel this distance was sufficient to complete the engine shutdown procedure. However, the transition from completing the checklist and commencing to turn the aircraft turn was short and this required the captain to apply firm braking to make the final turn. The flight crew's situational awareness of the turn onto the Golf 2 bay may have been compromised by the time constraint imposed by the short taxi distance, the speed of the aircraft and carrying out the engine shutdown procedure.

Although, the application of the braking caused the SCCM to lose her balance and fall, the investigation believes that, the firm braking may be considered as a contributing factor, and not the direct cause of this event, and the Accident most likely would not have happened had the SCCM stayed seated until the aircraft completed the final turned onto the parking bay.
