DUTCH
SAFETY BOARD

Hard landing after automatic approach

at Amsterdam Airport Schiphol

The Hague, May 2016

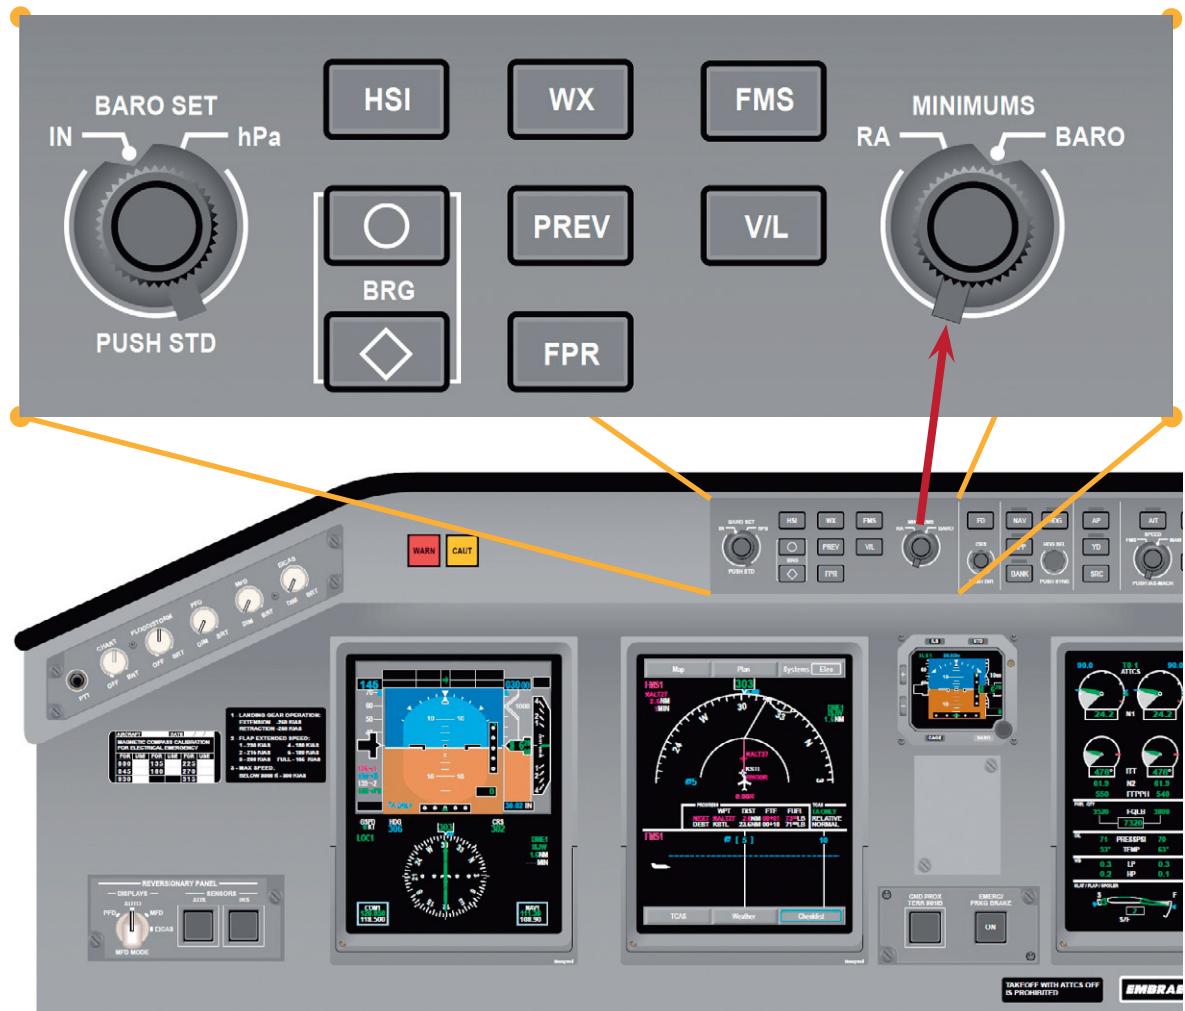
Figure 1: Location of the BARO/RA selection knob on the instrument panel (see red arrow). (Photo: Embraer)

To perform an automatic landing, the reference must be set to radio altitude (RA) and the flaps to position 5 before the start of the automatic ILS approach. Only after the AUTOLAND function has been activated (when the aeroplane is at an altitude of between 1,500 and 800 feet on the ILS glide slope) the pilot should set the BARO/RA selection knob to BARO in order to make the correct 'minimums' call.

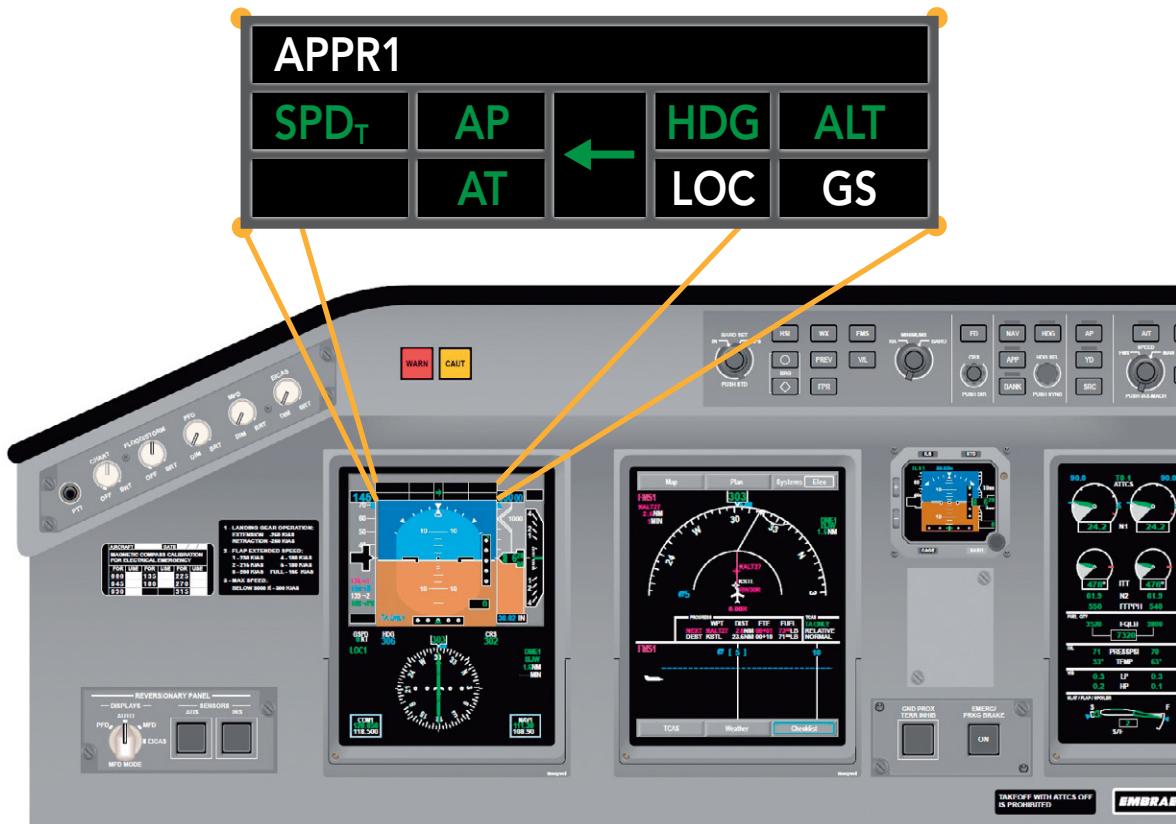
Figure 2: Location of and indications on the Flight Mode Annunciator (FMA) on the instrument panel. (Photo: Embraer)

Because the FMA indications the crew members saw during the approach were the same as what they were used to seeing, the indications from the automatic pilot did not cause them to notice that the aircraft was configured for an ILS Category I approach followed by a manual landing. Moreover, the aircraft was in a valid configuration, which meant no error messages were generated. As a result, both pilots had no reason to think that the aircraft was not flying in the correct mode for an ILS Category I approach followed by an automatic landing.

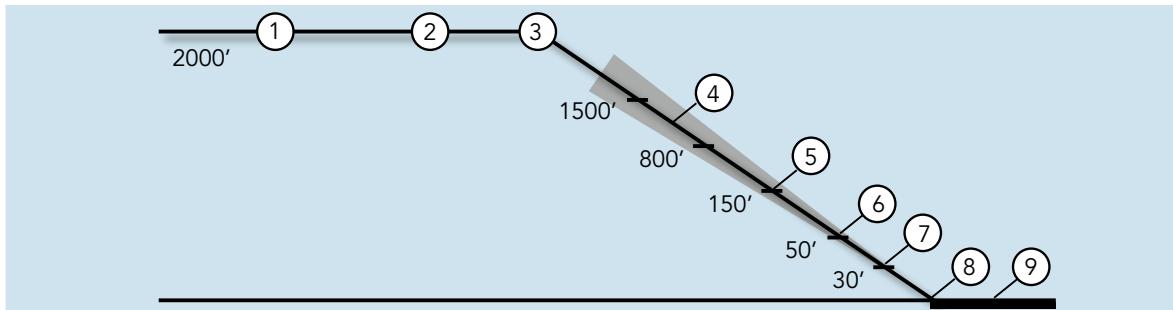
Location 2: Interception of the final approach path

On intercepting the final approach path the FMA indicates that the heading to the final approach (HDG) is no longer being followed but that the signal from the localizer antenna (LOC) will be followed. Activation of the LOC mode is first displayed on the FMA against a green background, after which the FMA field turns black and LOC appears in green letters.
