Air data system failure involving Airbus A330-243 A6-EYJ

near Brisbane Airport, Queensland | 21 November 2013

ATSB Transport Safety Report
Aviation Occurrence Investigation
AO-2013-212
Final – 6 May 2016

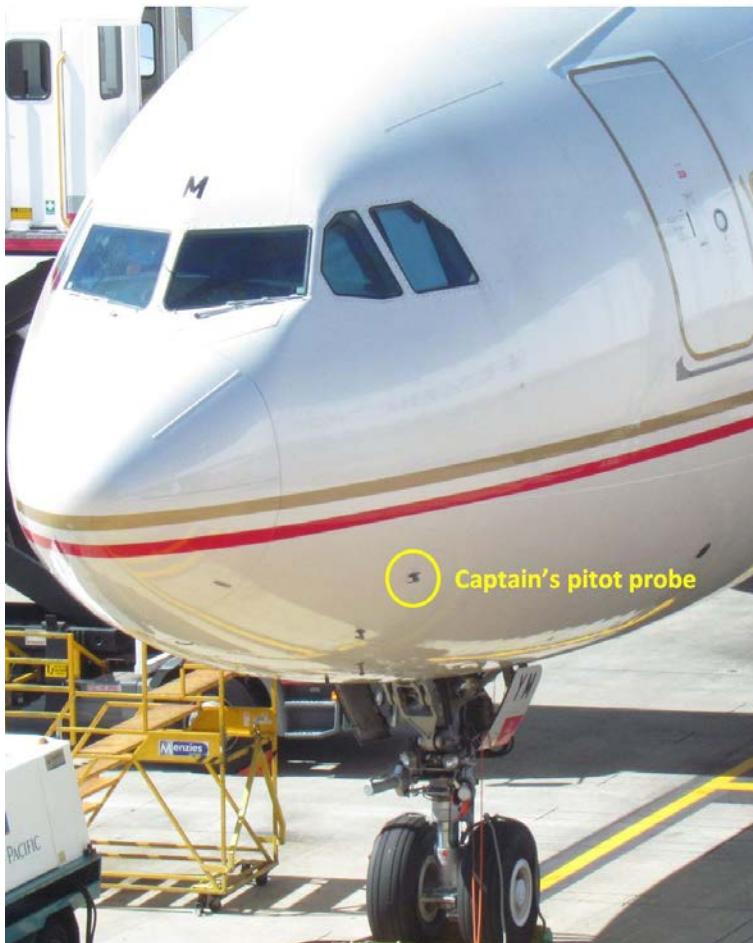
Figure 1: Location of the captain's pitot probe

Engineering inspection after the overweight landing found that the Captain's pitot probe was almost totally obstructed by an insect nest, consistent with mud-dauber wasp residue. The pitot obstruction had occurred during the 2 hour period that the aircraft was on the ground at Brisbane and was not detected during troubleshooting after the initial rejected take-off.

Subsequent visual inspection of the pitot probes found that there was an internal obstruction of the captain's probe (Figure 1), while the FO and standby probes were clear.

The aircraft operator has changed its policy on the use of pitot covers. They are now required to be used on all transits at Brisbane Airport, regardless of ground time.

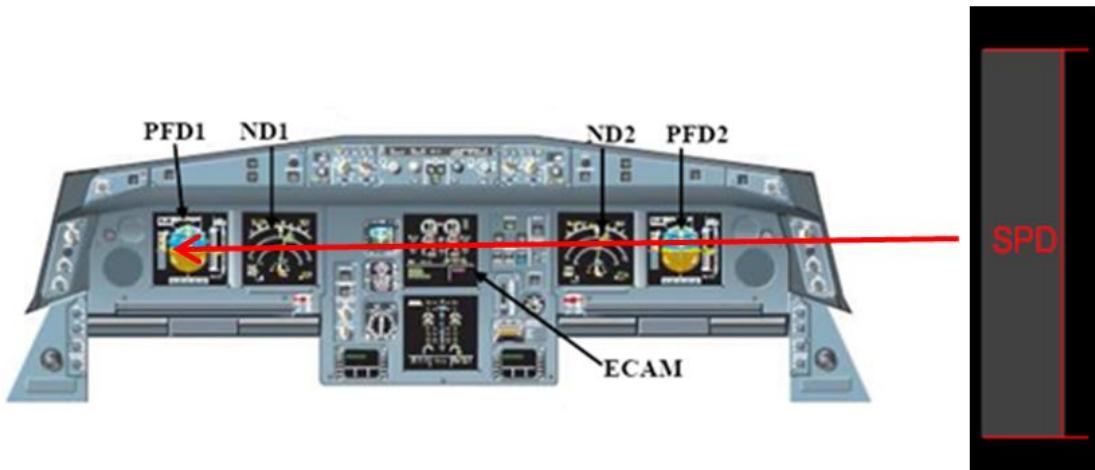
Figure 5: Location of the 'Red speed flag'

During the RTO the crew reported that a red speed (SPD) flag appeared on the captain's PFD (Figure 5). One of the conditions for displaying this flag is that no valid¹² airspeed data was available from ADR 1 at the same time as ground speed data was valid and greater than 50 kt. The flight data (Figure 6) showed that CAS sourced from ADR1 (i.e. the CAS that was displayed on the captain's PFD) was zero when ground speed increased through 50 kt and this is consistent with the crew report.

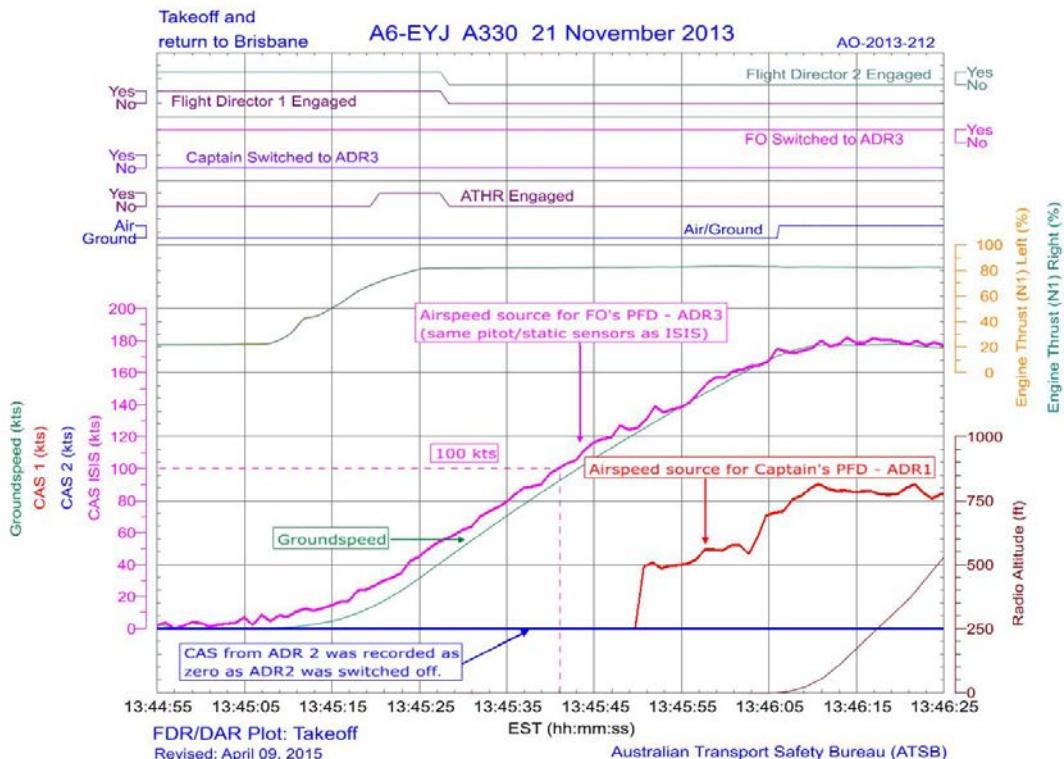
Figure 7: Flight data for the take-off and return to Brisbane

During the second take-off at 1345, the crew reported that the airspeed flag appeared after V_1 . However, the flight data again showed that CAS sourced from ADR1 (i.e. the CAS that was displayed on the captain's PFD) was zero when ground speed increased through 50 kt (Figure 7).

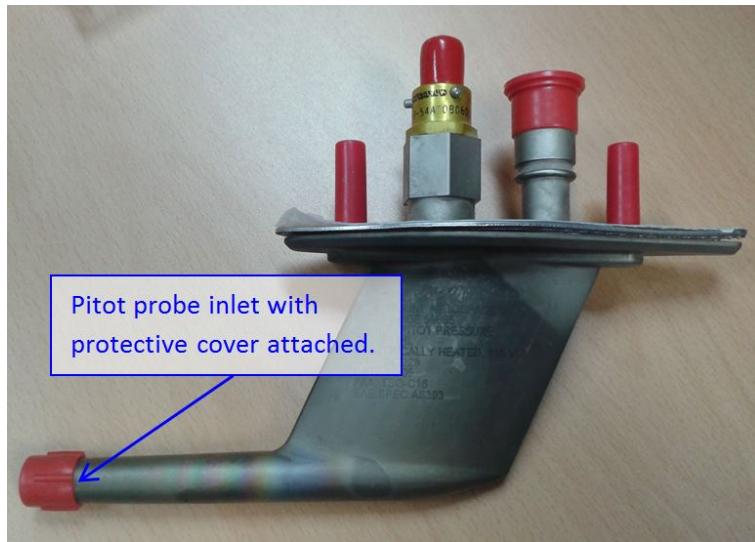
Figure 8: Pitot probe

The captain's probe (model 0851HL and serial number 242228) was removed from the aircraft and sent to the probe manufacturer in the USA (Figure 8). In consultation with the participants in the investigation, a test plan was developed prior to examination and testing of the probe.

The probe had been continuously fitted to A6-EYJ since its first flight and had been in service for approximately 7 ½ years. Its condition was consistent with its time-in-service with the probe inlet showing wear, but within component maintenance manual (CMM) limits. Visual inspection showed that there was no evidence of obstruction of the drain holes. A borescope examination was performed through the pitot inlet and also through the pneumatic port. The examination showed that the interior of the probe was occluded by an incomplete insect's nest and the nest material was consistent with that of the mud-dauber wasp (Figure 9). Compressed air was applied to the probe and none of the material was dislodged. The base of the nest was broken away with a sharp instrument and was fully removed by flushing with hot water. After removal of the obstruction, the probe was tested and, according to the CMM, it could be re-certified and returned to service.

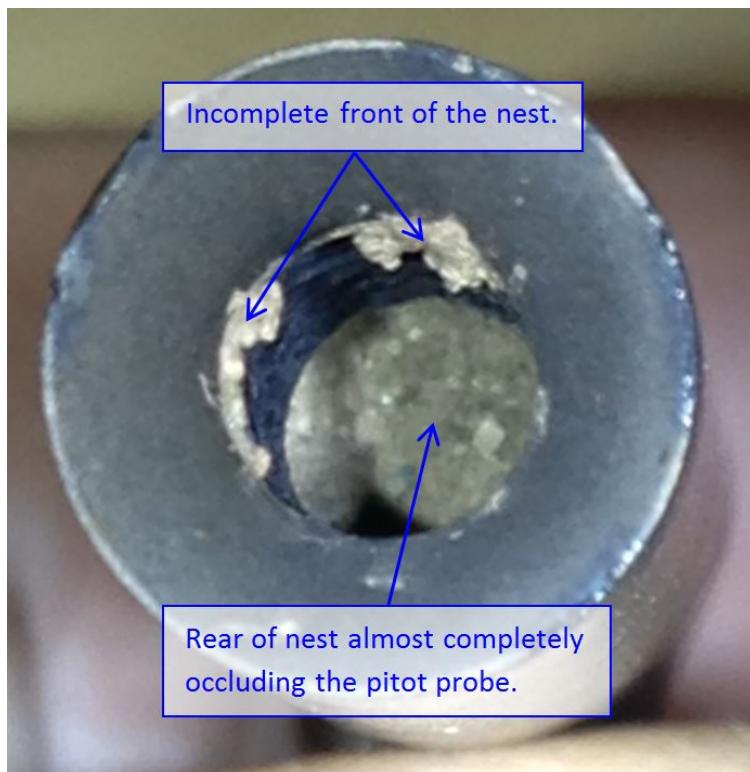
Figure 9: View looking into the pitot probe inlet

The captain's probe was removed from the aircraft and sent to the probe manufacturer in the US for examination. The examination showed that the interior of the probe was occluded by an incomplete insect's nest. The aircraft was on the ground at Brisbane for a period of 2 hours and 3 minutes. Despite this relatively short period, the nature of the material recovered from the captain's pitot probe makes it highly likely that the obstruction was due to mud-dauber wasp activity after the aircraft had landed.
