Air Accident Investigation Unit Ireland

SYNOPTIC REPORT

SERIOUS INCIDENT
Boeing 757-224, N41140
80 NM Southwest of Dublin, Ireland
20 October 2013

AAIU Report No: 2016-007

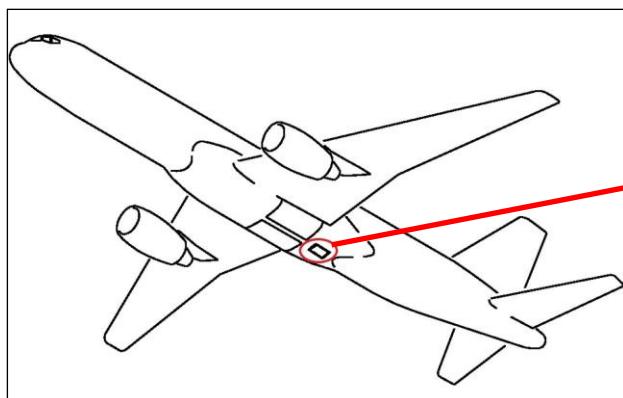
- The door frame of the centre hydraulic system servicing bay and adjacent structure (**Figures No. 1 and No. 2**).
- The centre hydraulic system servicing bay door and hold-open rod.
- The electrical connector on the filter module pressure transmitter.
- The reservoir drain valve, quantity transmitter and associated electrical connector.
- The hydraulic service panel light.
- The wiring loom P-Clip at the rear of the hydraulic service bay.
- Some wing to body fairings had popped open.

Figure No. 1: Location of the centre hydraulic system servicing bay

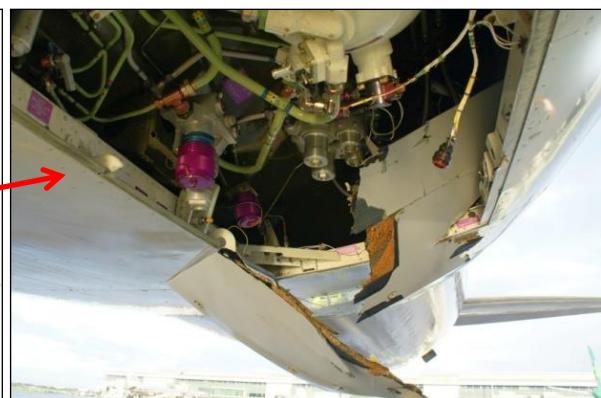
Figure No. 2: Photograph of Damage to Service Bay and Associated Structure

FDR data shows that the hydraulic quantity decreased sometime after 19,685 seconds. At this time the aircraft was undergoing the second pitch down manoeuvre, after which the aircraft underwent a rapid change in normal load factor from -0.22 g to + 1.62 g, as the airspeed increased through the Vmo of 350 kts. The computed airspeed remained above 350 kts for the next 50 seconds, peaking at 380 kts. It was likely that the centre hydraulic access panel became detached during this period, causing the damage that resulted in loss of centre hydraulic system fluid and pressure.

Following the occurrence, maintenance personnel performed a functional test of the Air Data System and no defects were found. The aircraft's pitot-static system was tested and no leaks or heating systems faults were identified. The damaged centre hydraulic system components and servicing bay door were replaced and a temporary repair was carried out to the wing to body fairings. The aircraft then operated on a ferry flight to KEWR, USA, where permanent repairs were carried out.

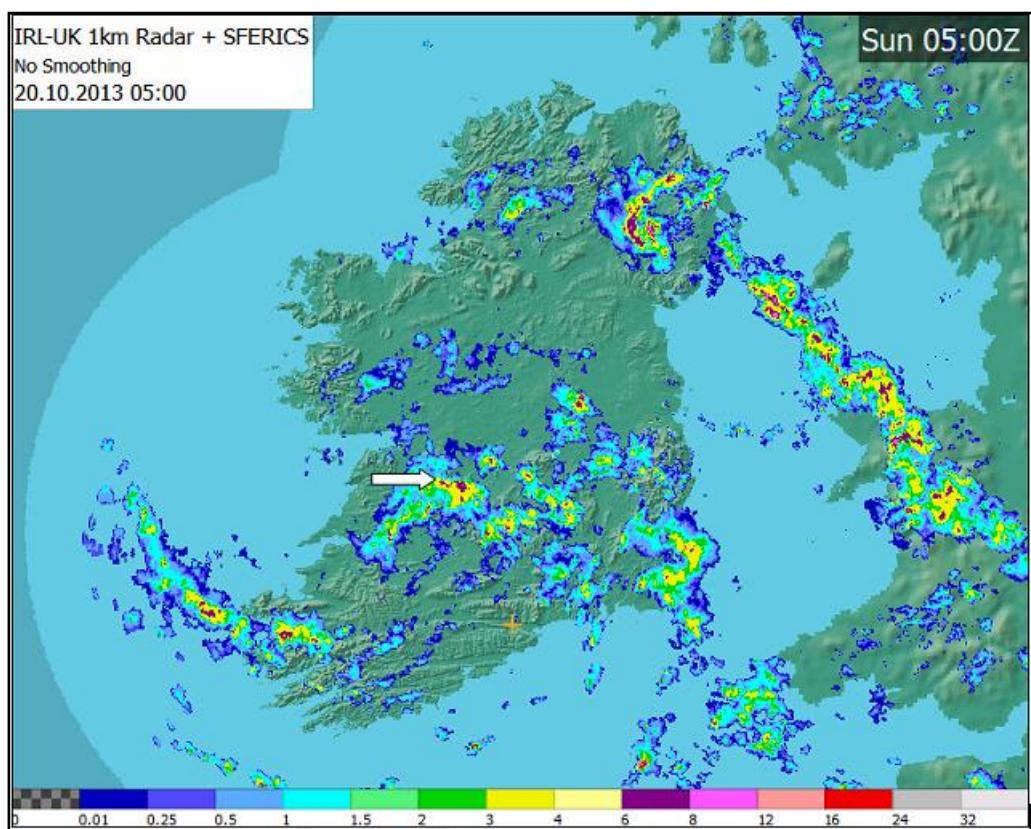
The Investigation requested Met Éireann¹⁷ to provide details of the weather conditions present in the area at the time of the event. They stated that: *"Low pressure with a centre of 988 hPa¹⁸ at the mouth of the Shannon estuary maintained an unstable south easterly flow across the country. A well-defined showery trough was moving through the region at the time of the incident with embedded cumulonimbus cloud present. Archived radar echoes indicate some heavier embedded showers were also present".* It was also stated that: *"The radar and satellite evidence clearly shows that there was a high possibility of significant (moderate to severe) turbulence associated with cumulonimbus cloud that was present in the area at the time the incident occurred" (Figure No. 4).*

Figure No. 4: Radar image for 0500UTC 20/10/2013. The white arrow shows approximate position of occurrence (Met Éireann)

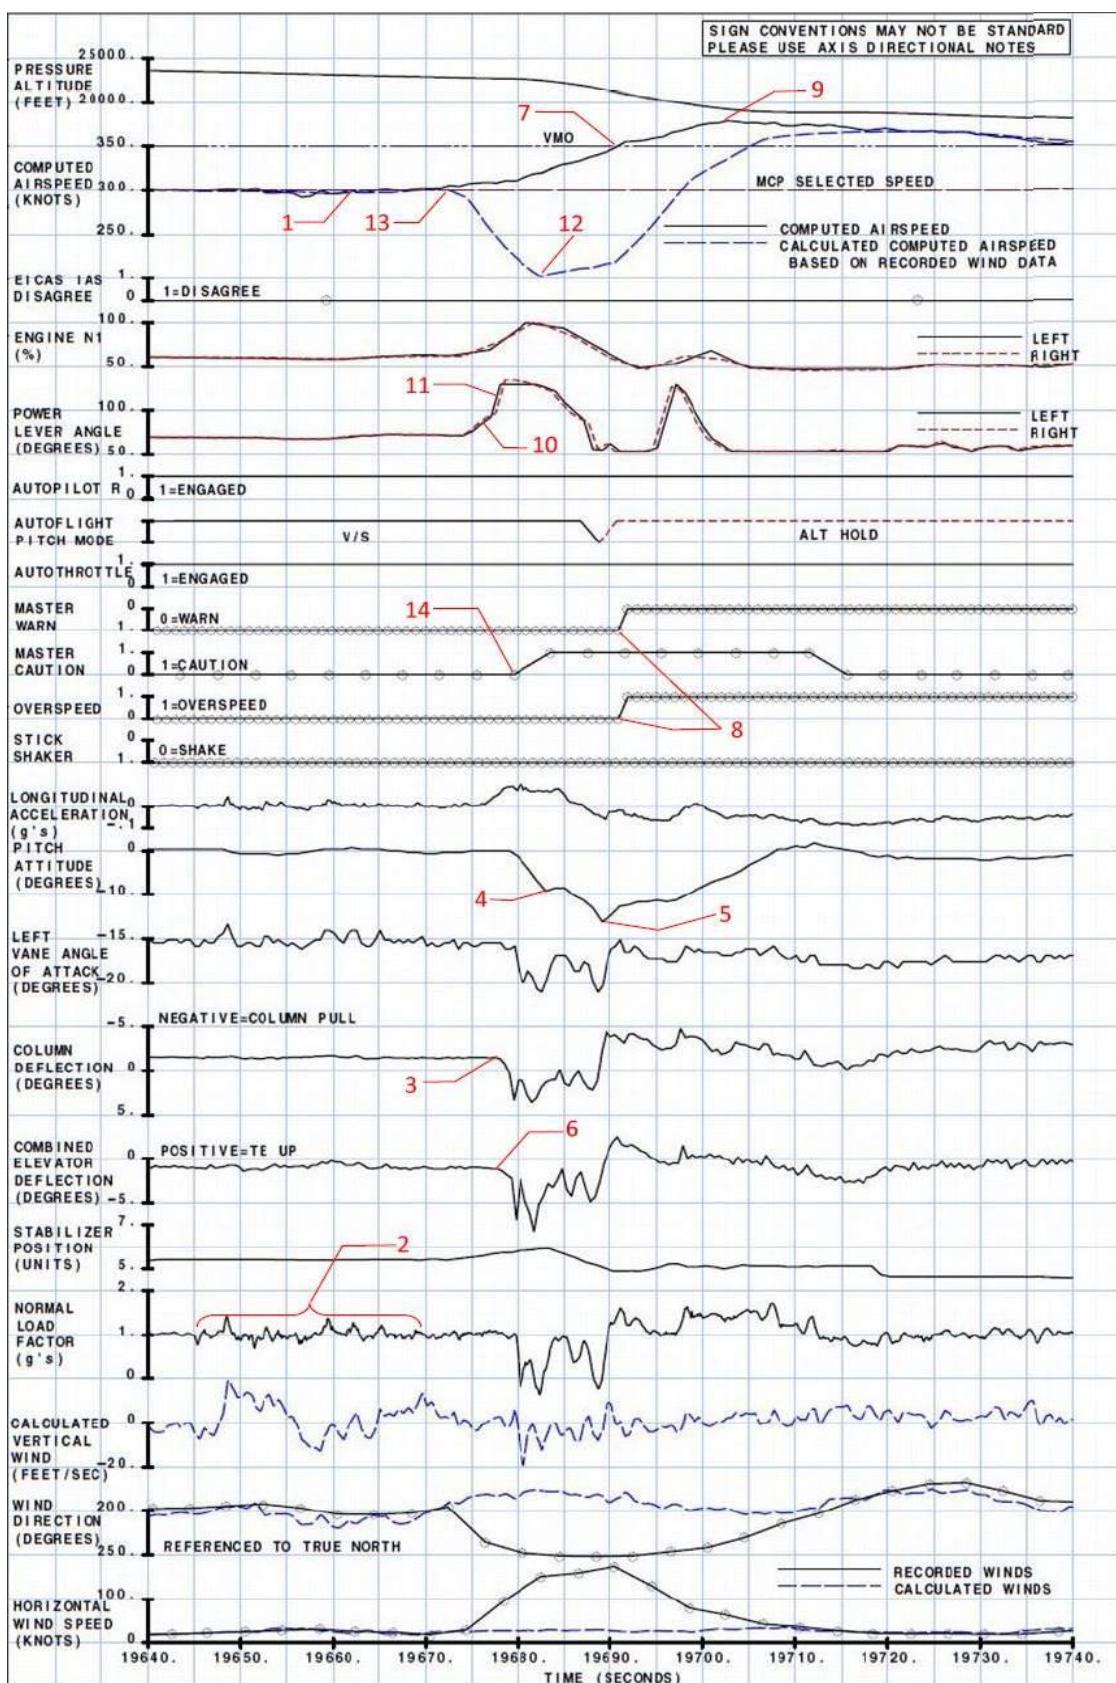
At 19,560 seconds, descending through approximately 25,500 ft, the atmospheric conditions became turbulent, as indicated by the fluctuations in certain parameters including computed airspeed, acceleration and control wheel deflection. The level of turbulence increased at 19,645 seconds (**Figure No. 6, Point 2**) and beginning at approximately 19,678 seconds, a series of control column commands were recorded with corresponding elevator deflections (**Figure No. 6, Point 6**).

The first control column command, at 19,678 seconds (**Figure No. 6, Point 3**, and **Figure No. 7 Point 1**) was a nose-down command that caused the airplane to pitch down to -9.1 degrees at 19,683 seconds (**Figure No. 6, Point 4**). This was accompanied by an increase in engine thrust (100% N1). As a result, airspeed started to increase. When aircraft pitch reached -9.1 degrees, the control column was pulled back and thrust was reduced towards idle. This resulted in a reduction in nose-down pitch from -9.1 degrees to -8.2 degrees. Consequently, airspeed continued to increase. At 19,684 seconds there was another control column nose-down command, which resulted in aircraft nose-down pitch increasing to -16.2 degrees at 19,689 seconds (**Figure No. 6, Point 5**). Airspeed continued to increase with a computed airspeed of 340 kts being recorded at 19,689 seconds.

Prior to the first column push, the FDR data shows two separate thrust (or power) lever movements, described in terms of Power Lever Angle (PLA), and measured in degrees. The first is a small movement from approximately 70^0 to 73^0 , which corresponds to a slight decay in computed airspeed at approximate 19,655 seconds. There is a second, faster, thrust lever movement from 72^0 to 95^0 , which occurs between 19,674 and 19,678 seconds (i.e. prior to the first column push) (**Figure No. 6, Point 10**).

Figure No. 6: FDR data from 19,640 seconds to 19,740 seconds
 Numbered labels refer to text in 1.9.3.2 (Courtesy of Boeing Aircraft Co.)

The Aircraft Manufacturer also noted that the 'Master Warn' discrete indicated 'Warn' around 19,690 seconds which lasted for 55 seconds followed by a second momentary 'Warn' shortly afterwards and that these warnings corresponded to an 'Overspeed' warning, (**Figure No. 6, Point 8** and **Figure No. 7, Point 4**).

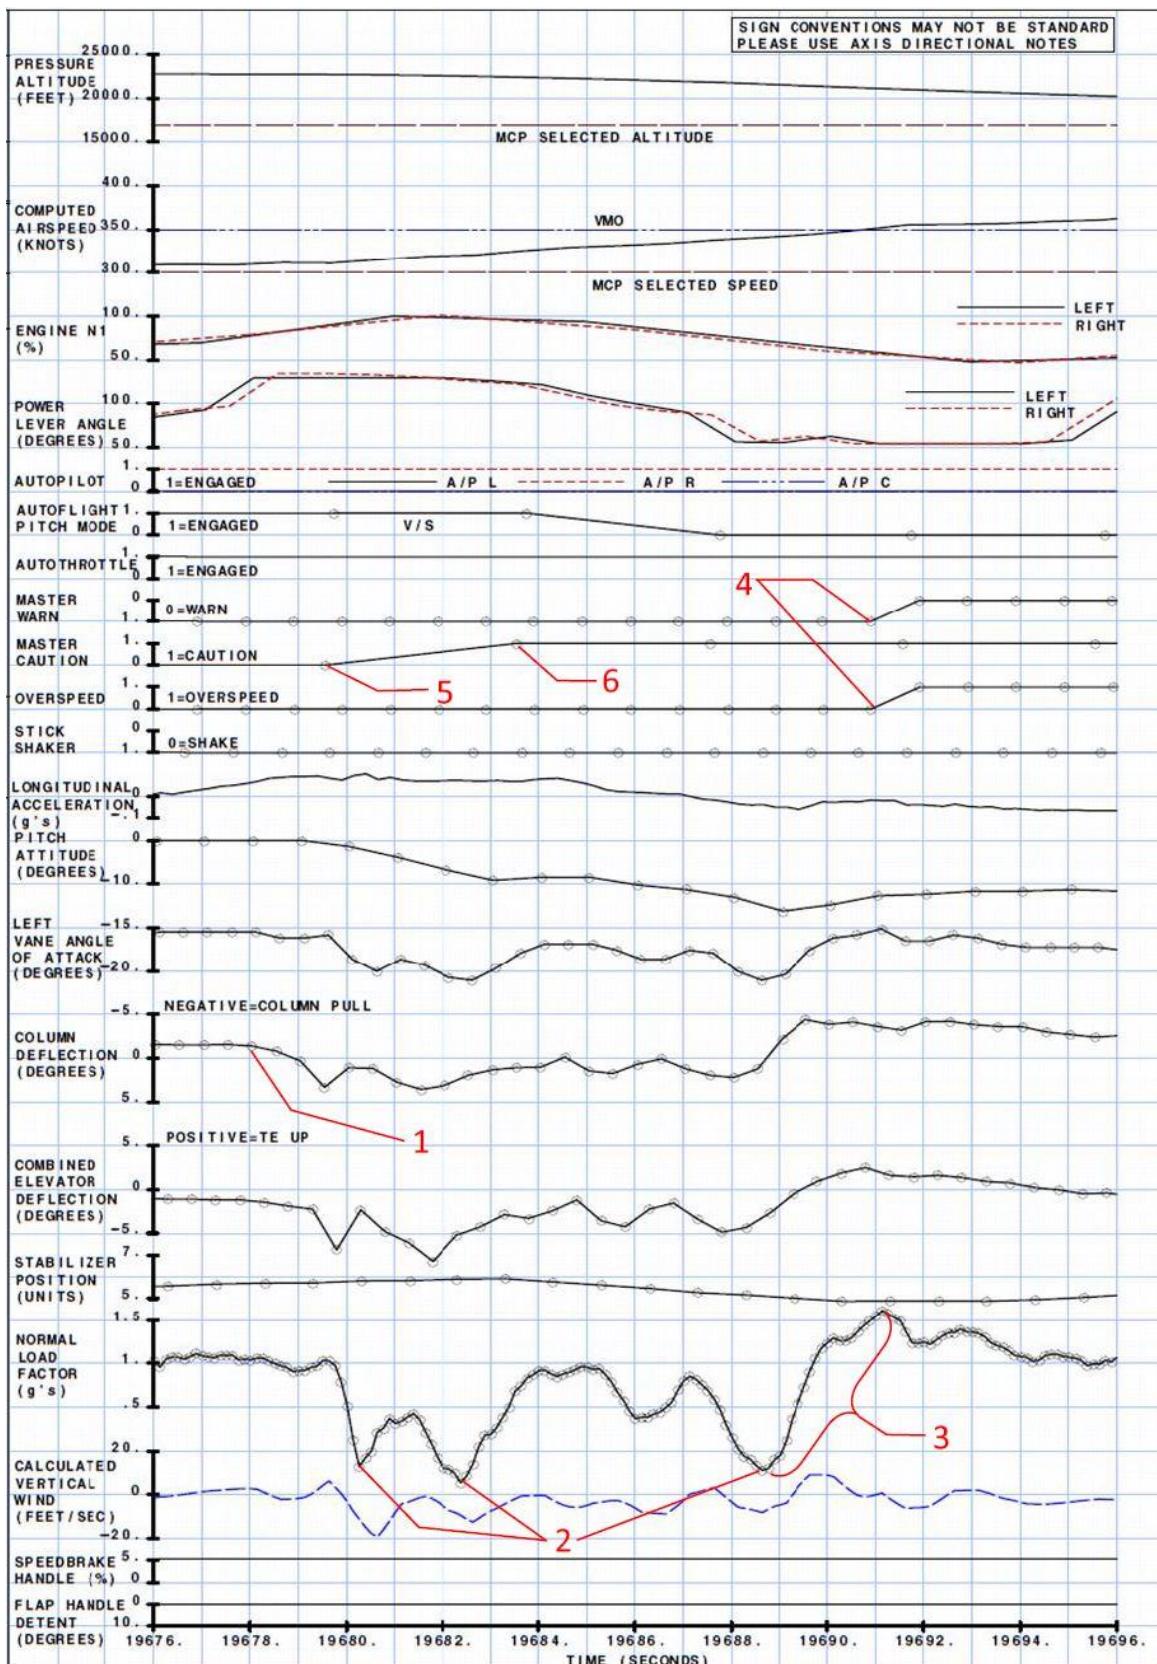
Figure No. 7: Close-up of FDR data from 19,676 seconds to 19,696 seconds
 Numbered labels refer to text in 1.9.3.2 (Courtesy of Boeing Aircraft Co.)

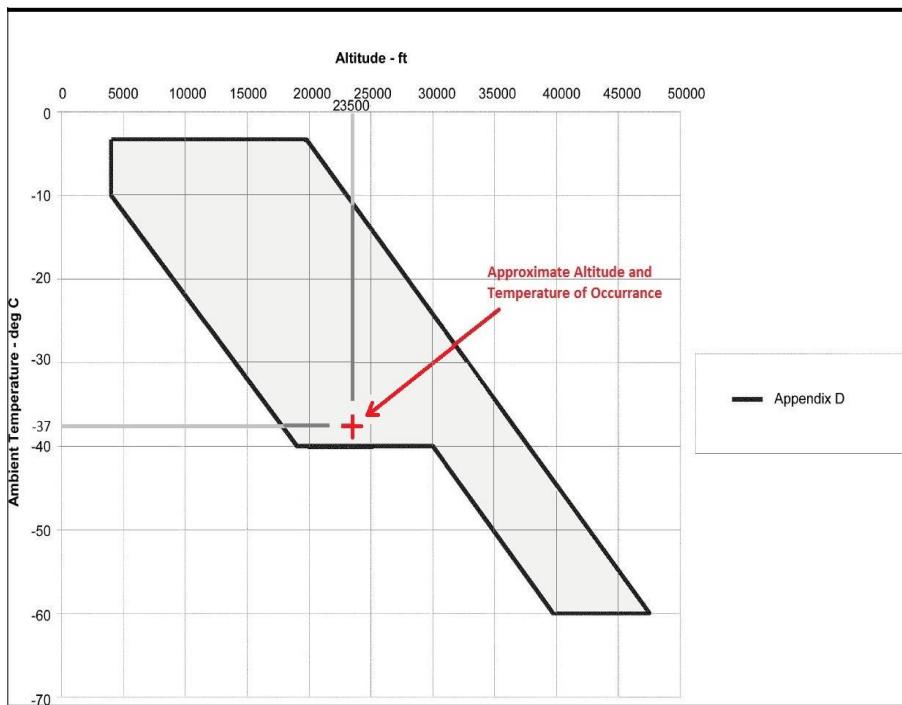
Following the event, the Operator performed a check on the Pitot-Static, Air Data, and Probe Heat Systems. No faults were found. The Investigation is therefore of the opinion that the most likely cause of the temporary blockage of the Co-Pilot's Pitot probe was ice crystal icing.

The altitude and temperature at which the event took place were plotted on the Convective Cloud Ice Crystal Envelope chart, from the latest certification standards contained in CFR Part 25.1323 (amendment level 33-34, effective from 5 January 2015). The graph shows that the event occurred within the envelope now specified (**Figure No. 8**).

Figure No. 8: FAR Part 33, Appendix D, ice crystal icing envelope with event plotted.
