9 \sqrt{P} AND ALL THAT

by Ian Wigmore

9 \sqrt{P} - what is that all about? Well, you shall see. This is a story about a Boeing 747 that overran the runway in Bangkok in 1999 - and 9 \sqrt{P} was very much a factor in that accident.

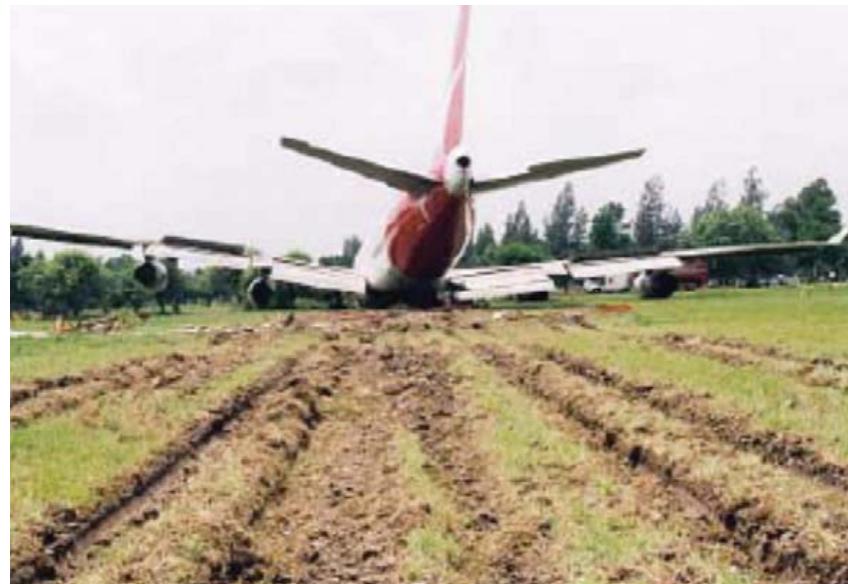
The aircraft overran the runway end at 96kts and entered the stop-way. At 79kts it collided with the ILS localiser antenna about 100 m beyond the end of the stop-way. It continued for a further 100 m through very wet boggy soil before coming to a stop.

The aircraft sustained substantial damage during the overrun. The collision with the ILS localiser antenna initiated the collapse of the nose and the right wing landing gear. Loss of the right wing landing gear caused the aircraft to adopt a slight right wing low attitude, allowing the right inboard engine nacelle, and then the right outboard engine nacelle, to contact the ground as the aircraft slowed. No significant injuries occurred during the

The investigation established that, during the landing roll, the aircraft tyres aquaplaned on the water-affected runway. This limited the effectiveness of the wheel brakes to about one third of that for a dry runway. In such conditions and without reverse thrust, there was no prospect of the crew stopping the aircraft in the runway distance remaining after touchdown.
