PRELIMINARY
KNKT.16.04.07.04

Aircraft Accident Investigation Report

**Batik Air Indonesia and TransNusa Aviation
Boeing 737-800 (PK-LBS) and ATR 42-600 (PK-TNJ)
Halim Perdanakusuma International Airport, Jakarta
Republic of Indonesia**

4 April 2016

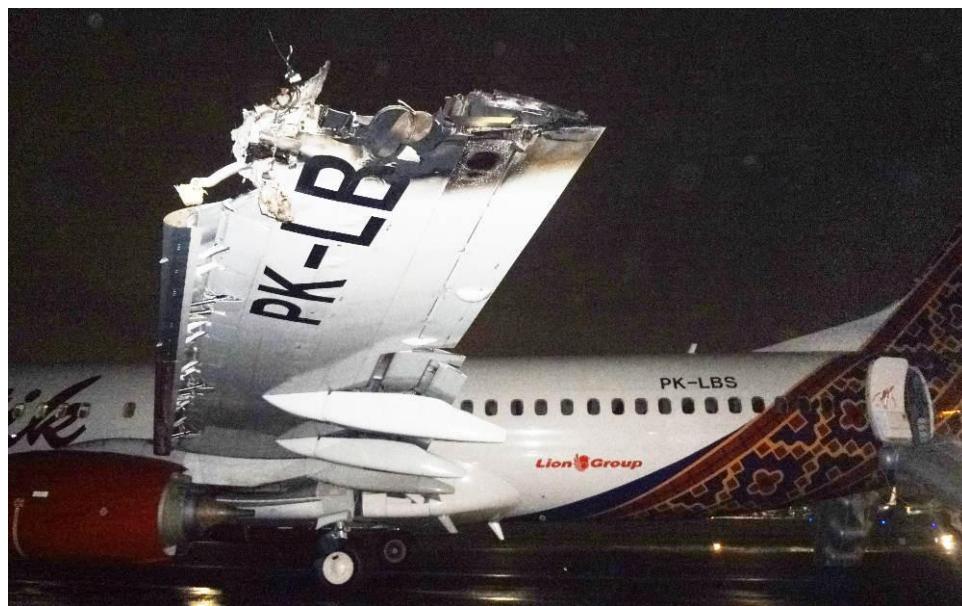
- The left wing damaged approximately 575 centimeters from the wingtip.
- The wingtip damaged in two parts.

Figure 3: The damaged left wing

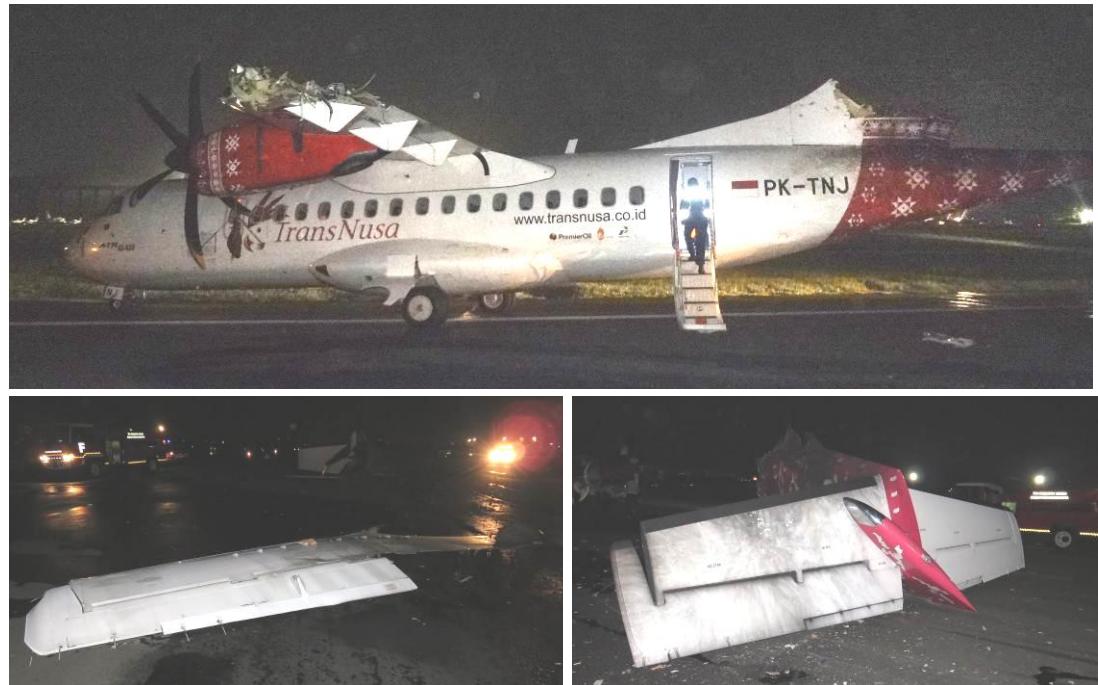
- The left wing damaged approximately 260 centimeters from the wingtip.
- The vertical stabilizer damaged including the horizontal stabilizer.

Figure 4: The detached part of wing and horizontal stabilizer

The detached left wing was found approximately 17 meters behind the towed aircraft.

The horizontal stabilizer is connected to the vertical stabilizer which damaged. The stabilizers were found approximately 30 meters behind the towed aircraft.

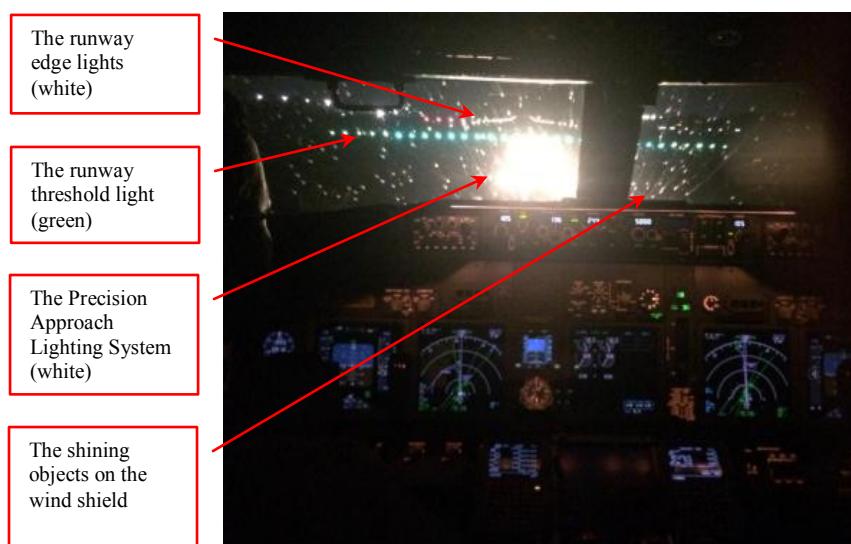
The pilot stated that during line up, the lights surround the turn pad were very bright and affected his forward vision for a short time. It was common practice in Halim to lineup at the turn pad beyond the threshold runway 24.

The pilots stated that the lightings on the turn pad were bright. The investigation received a photo showing the lightings condition taken on 20 November 2015 on turn pad by a flight crew, when aircraft was lining up on runway 24.

Figure 6: View from Cockpit on Line up position runway 24

In regard the condition of night take off on runway 24 and to avoid black out in vision caused by high intensity of approach light in dark environment during turning in to position on runway 24 Halim Perdanakusuma, pilot required to delay the take off until the eyes back to normal adaptive environment before call ready for departure.

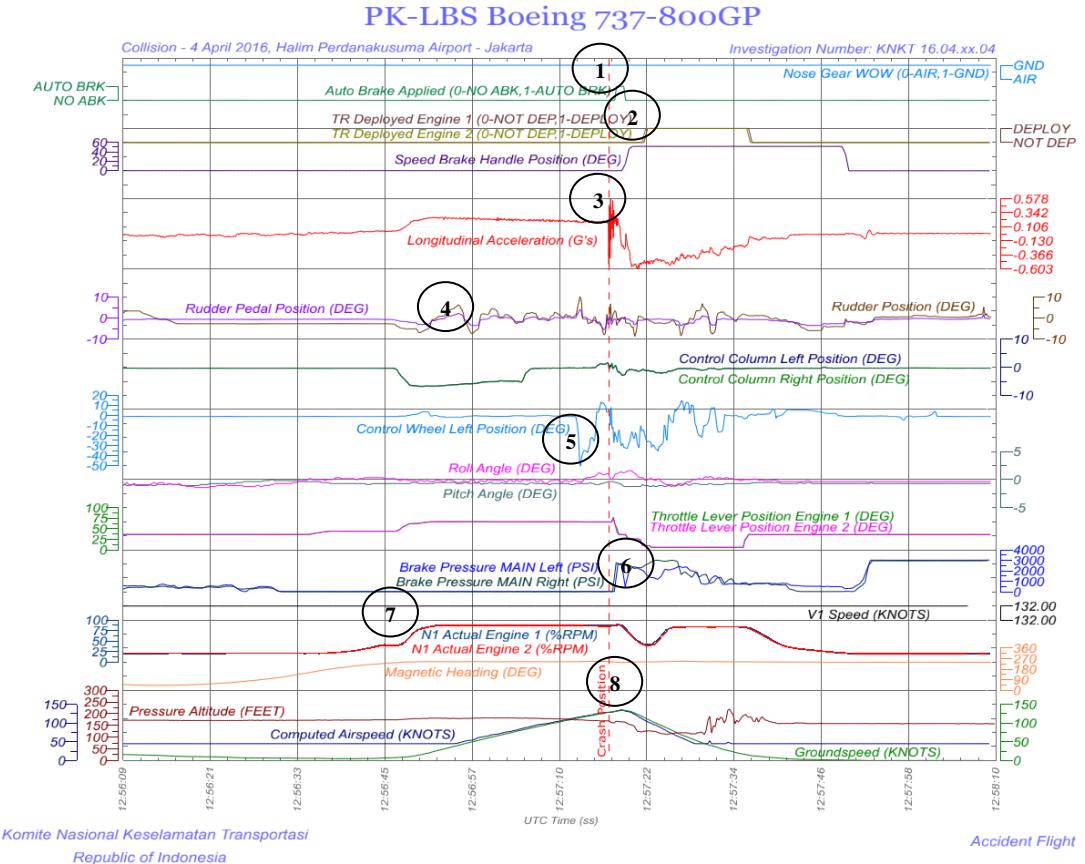
The FDR was successfully downloaded at KNKT facility. The downloaded data was between 1256 UTC until the aircraft stopped at 1258 UTC.

Figure 7: The significant parameter recorded by the FDR

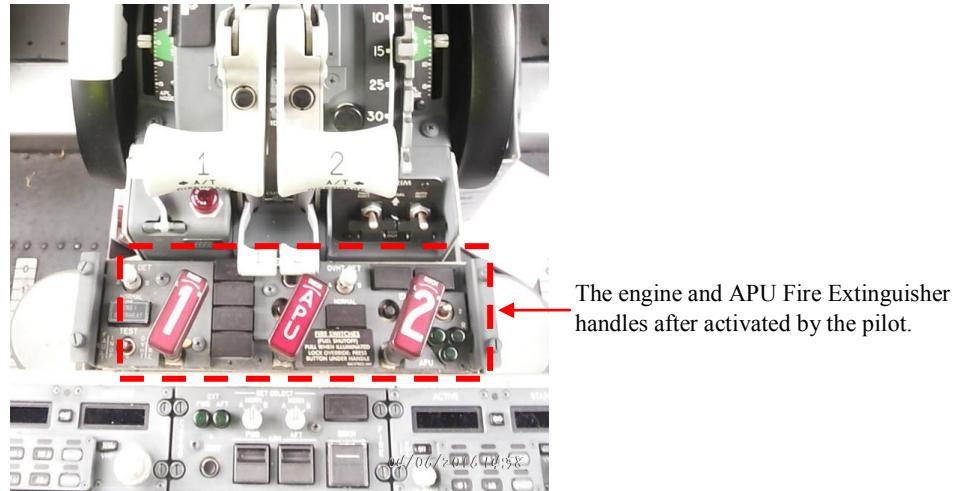
Both engines and Auxiliary Power Unit (APU) fire extinguishers were activated by the pilot.

Figure 8: The ID 7703 fire extinguishers activated

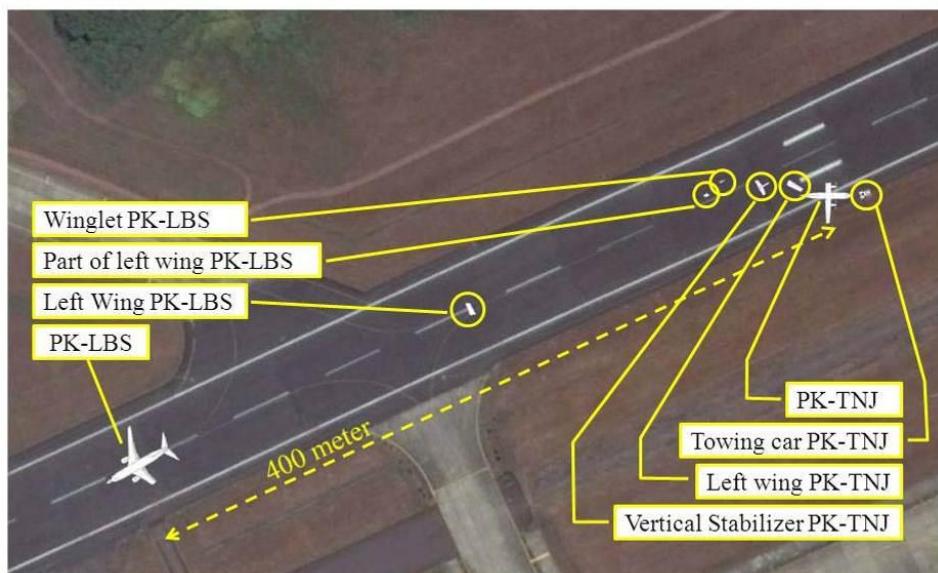
The left wingtip was found at approximately 200 meter behind the ID 7703 near the taxiway "H" while another part (winglet) was found approximately 300 meters behind the ID 7703.

Figure 9: The wreckage distribution superimposed in Google earth

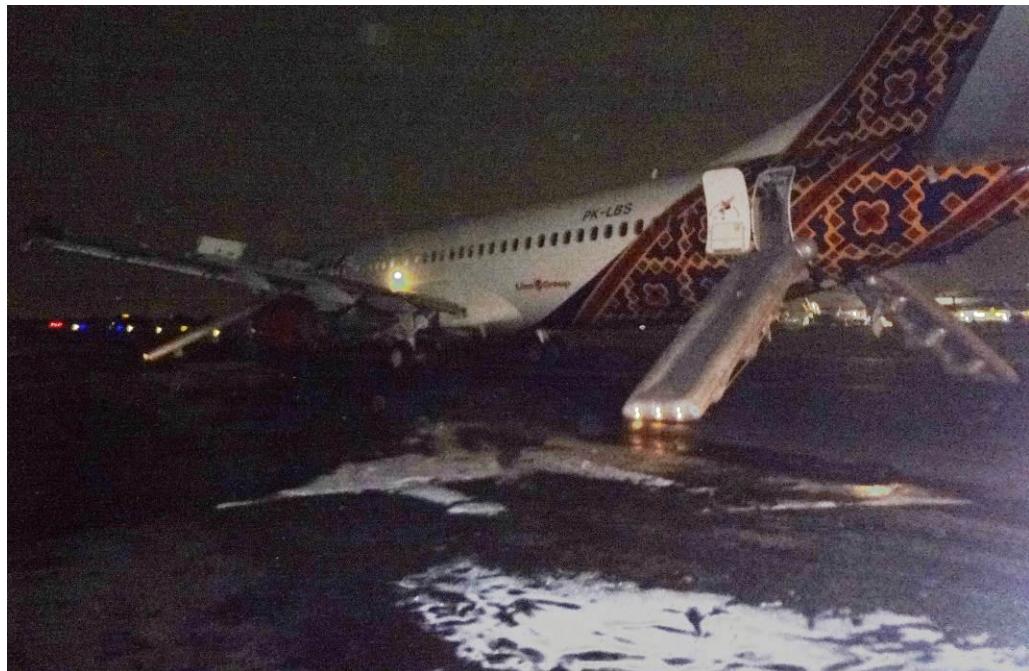
All ID 7703 escape slides were deployed by the flight attendants and the passengers were evacuated through the escape slides safely. The passengers and the crew then transported to the main terminal by bus.

Figure 10: The ID 7703 deployed escape slides
