Investigation Report

Type of Occurrence: Accident
Date: 5 March 2013
Location: Chicago, USA
Aircraft: Transport aircraft
Manufacturer / Model: Airbus / A 330-300
Injuries to Persons: None
Damage: Aircraft severely damaged
Other Damage: None
State File Number: BFU 2X001-13

As the aircraft was rotating during take-off for a flight from Chicago, USA, to Munich, Germany, the aft fuselage section touched the ground. The National Transportation Safety Board (NTSB) delegated the investigation into the occurrence to the BFU.

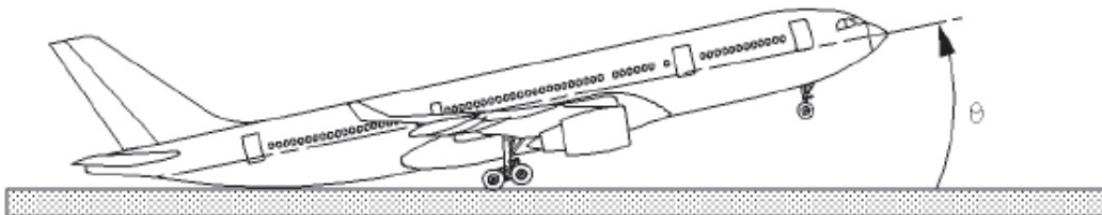
Prior to take-off the airplane rotates around the main landing gear, see image. There are two limitations between which the tail section has ground contact with the runway. In one case the main landing gear is fully rebound and the pitch angle is 14.4°. In the other case the landing gear shock strut compression is complete and the pitch angle is 10.1°.

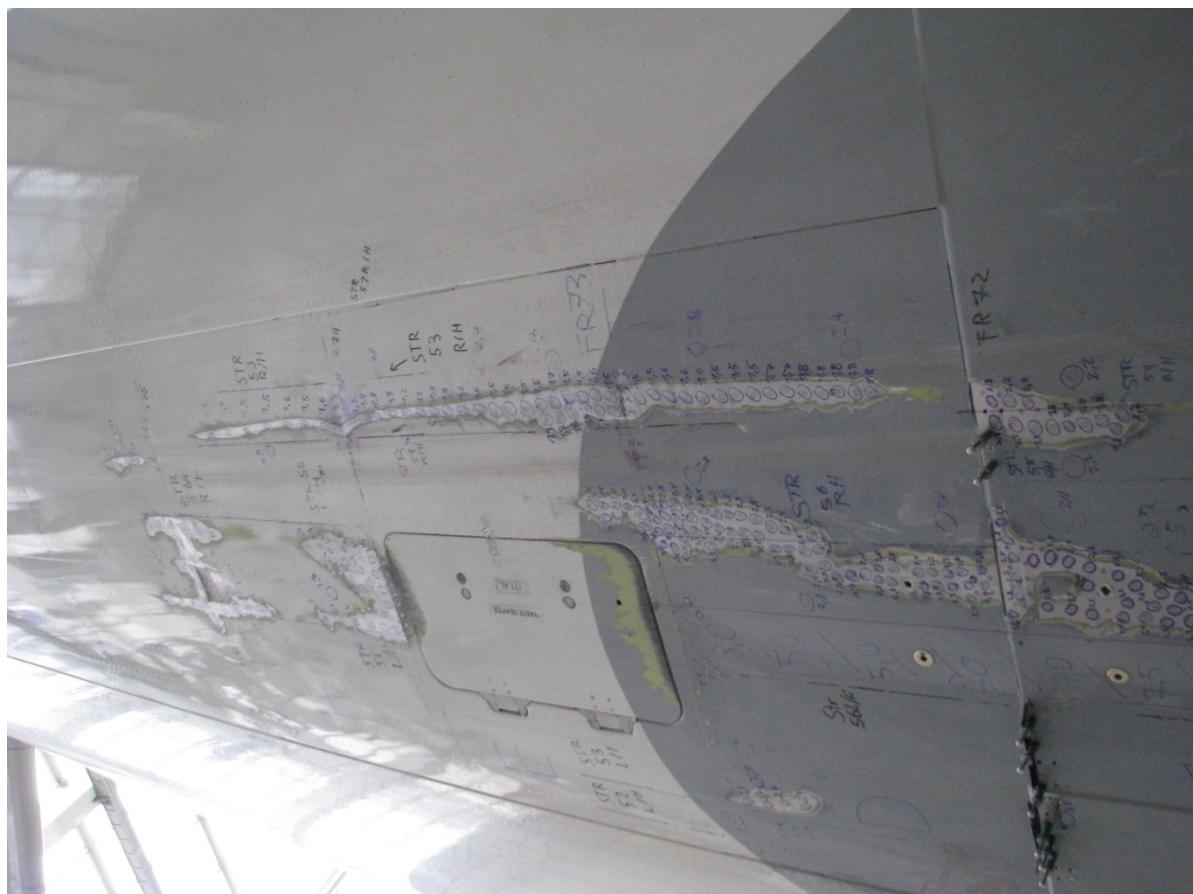
The lower surface of the tail section showed damages. Affected were frames 69 to 76 with a length of about 4.5 m. Laterally the damage affected stringer 53 left up to stringer 53 right. The stringer at the lowest part of the fuselage is stringer 57. The area showed rub marks, scratches, paint abrasions, and dents (Appendix). Several rivet heads were either partially or entirely abraded.

Damages on the lower surface of the tail section (flight direction right)

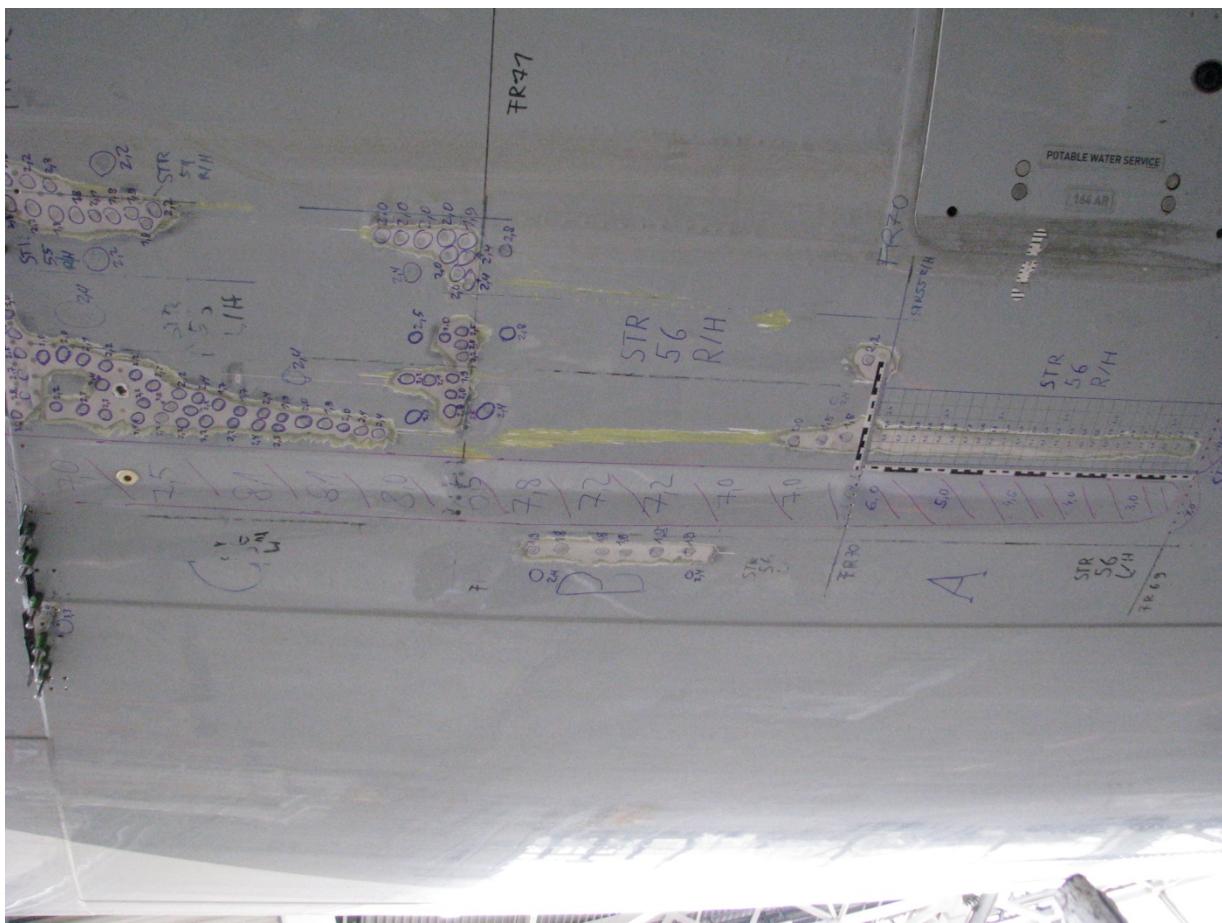
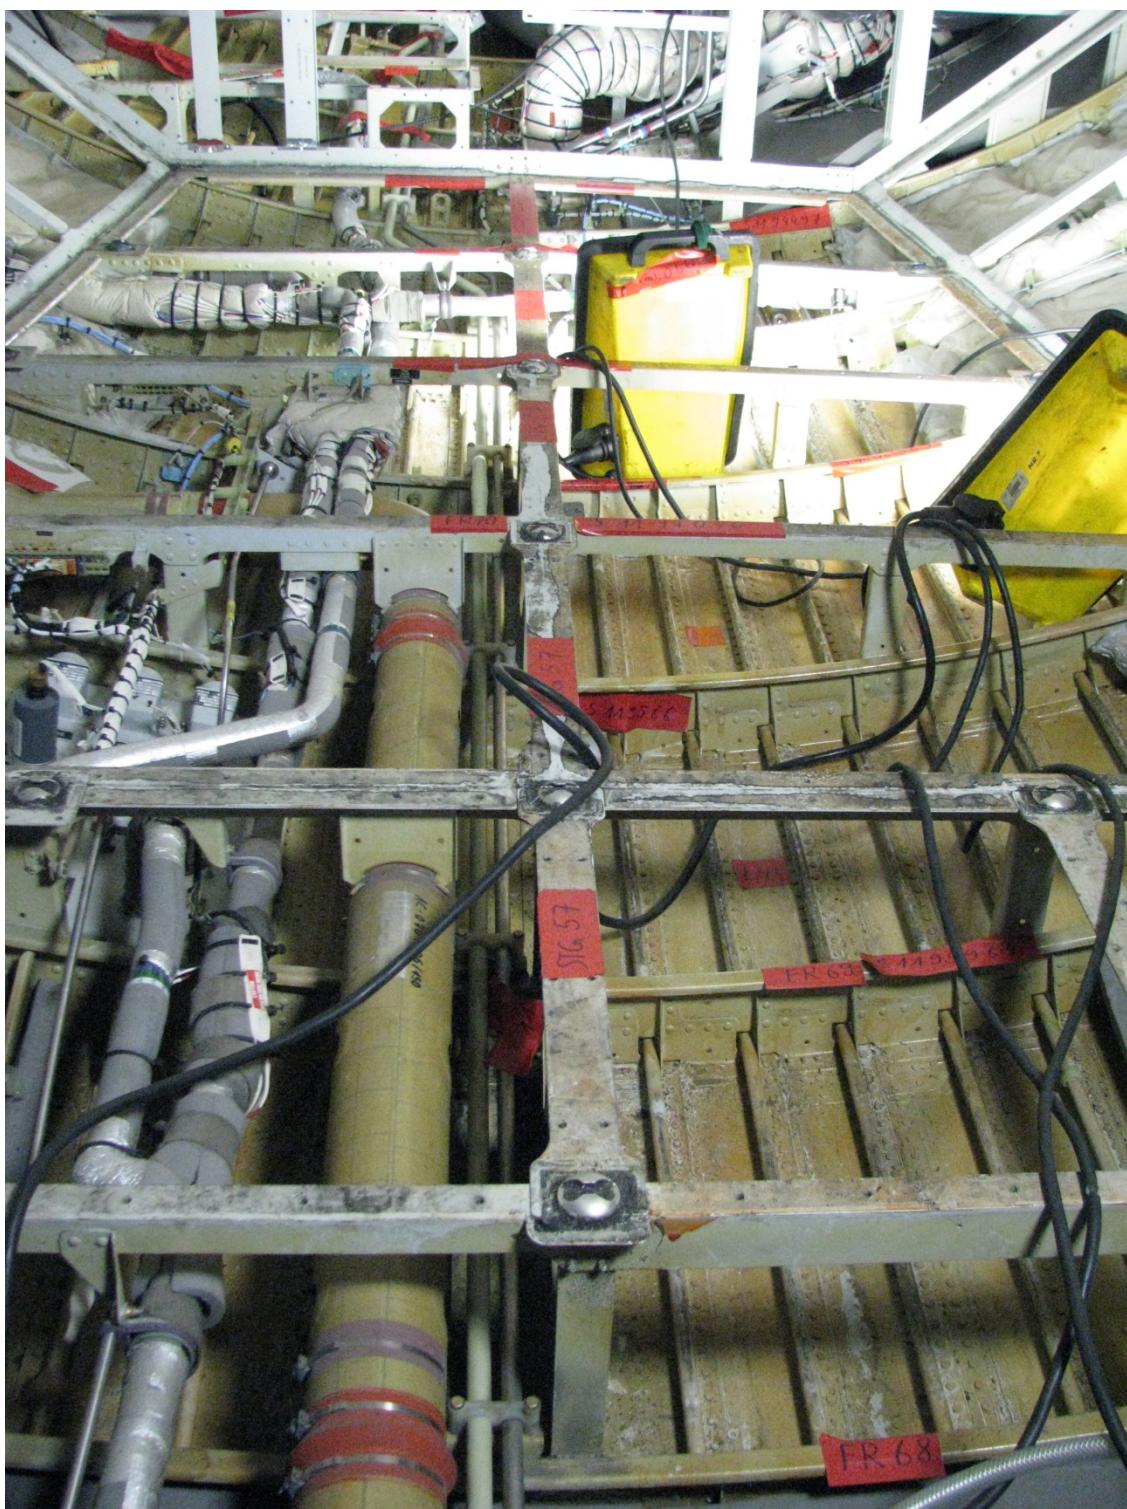
On the inside of the fuselage the web plates of stringer 57 between frame 69 and frame 73 were deformed (Appendix). The cross beams of frames 70 to 73, onto which the floor of the aft cargo compartment was mounted, were also deformed. Parts of the mounting elements between the inner structure and the outer skin were either damaged or severed.

Damaged area inside the fuselage, in the foreground frame 68 (FR 68)
stringer 57 is in the centre of the photo

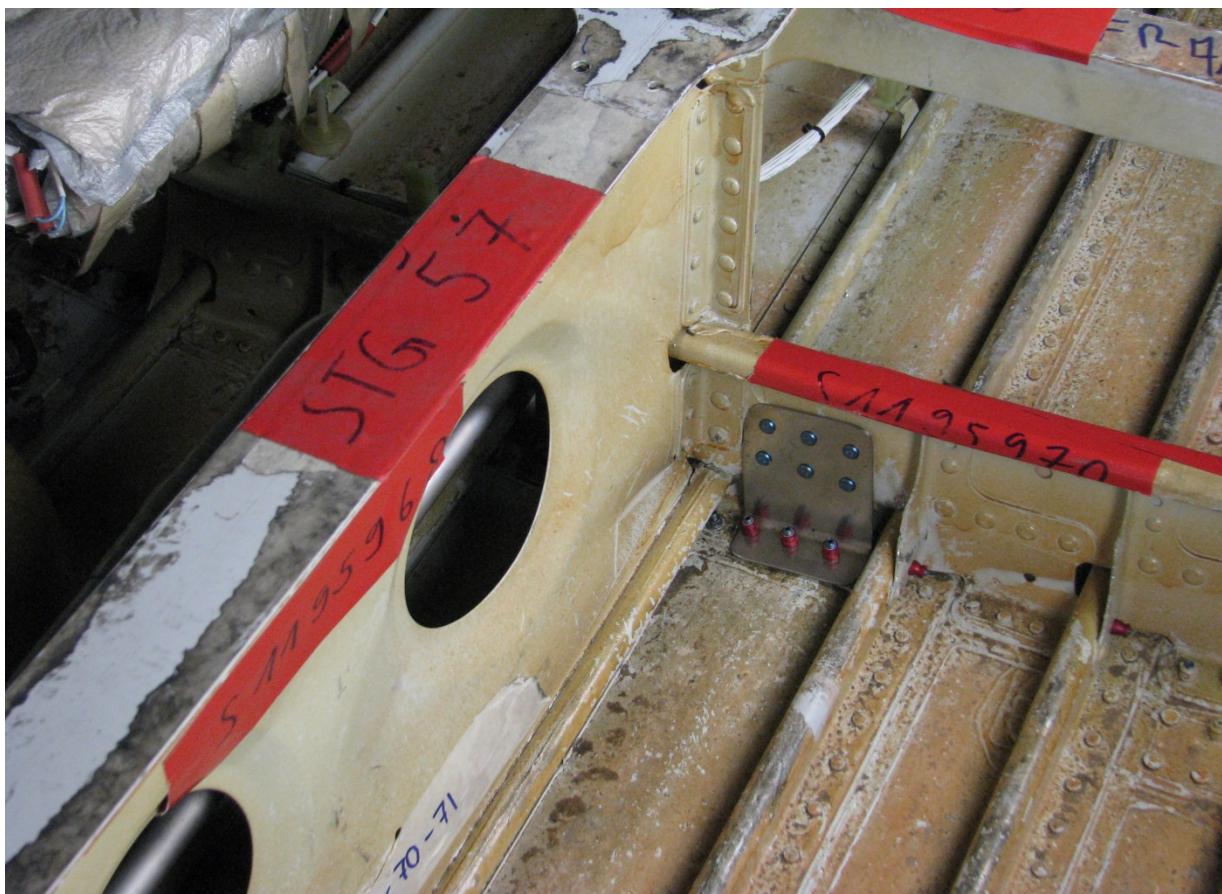
Deformed web plate of stringer 57 between frames 70/71, temporary connecting element right of stringer 57

The manufacturer stated the ferry flight to the maintenance organisation was conducted after makeshift repair work on the fuselage and with unpressurised cabin and a minimum crew.

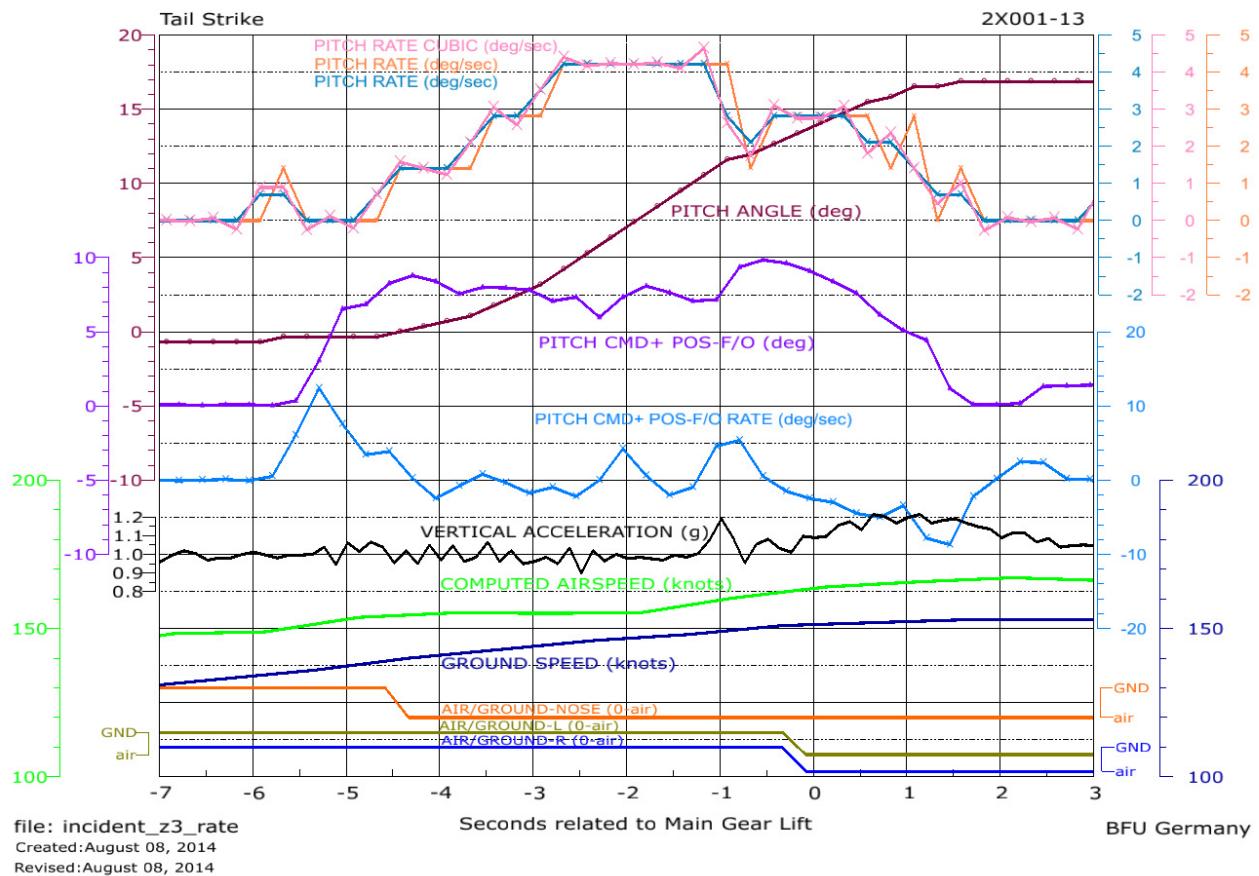
FDR Diagram

The Appendix shows the FDR diagram of the rotation. Parameters were chosen which show the pilot's control inputs and the airplane's reaction. Zero point is the time of rotation of the main landing gears (air-ground sensors).

At a computed airspeed of 150 kt, as calculated by the flight performance software, rotation was initiated. The pilot pulled the sidestick back with a rate of up to 12.5°/sec. After about half a second the airplane rotated and after 2.5 seconds had a constant rotation rate of a maximum of 4.2°. The rotation rate was determined with the help of three different calculation methods. The results are depicted in the diagram. The results were all very similar. The calculated maximum value was significantly higher than the rotation rate of 2 - 3°/sec the manufacturer had recommended. The rotation rate had been calculated using the FDR data. The on-board systems of the airplane do not determine or provide these values directly. The pitch angle had had a linear trend up until 4 to 1 second prior to rotation. About one second prior to rotation the straight line bends and the rotation rate decreases and stabilises at approximately 2.8°/sec. At this time vertical acceleration shows a significant peak of 1.18 g. According to the data this is the moment the airplane's tail section hit the runway.
