Air Accidents Investigation Branch

**Report on the accident to  
Boeing 737-236 series 1, G-BGJL  
at Manchester International Airport  
on 22 August 1985**

15 December 1988

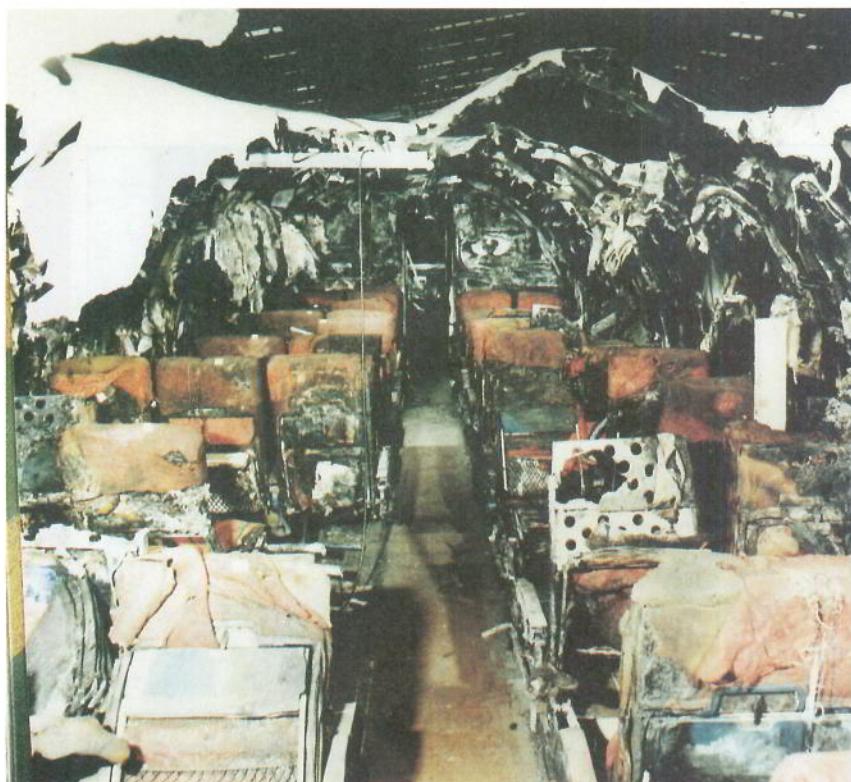
Appendix 3 e-f

Parts of the rear fuselage left sidewall together with most of the cabin roof were burnt away, and the rear fuselage and tail section had collapsed to the ground. Most of the cabin interior was extensively burnt and the floor in the rear of the passenger cabin had collapsed down into the rear cargo hold. Those areas of the cabin interior which had escaped direct damage by the fire were covered with a thick coating of viscous soot. (Appendix 3 photos e-f)

View Looking Forwards

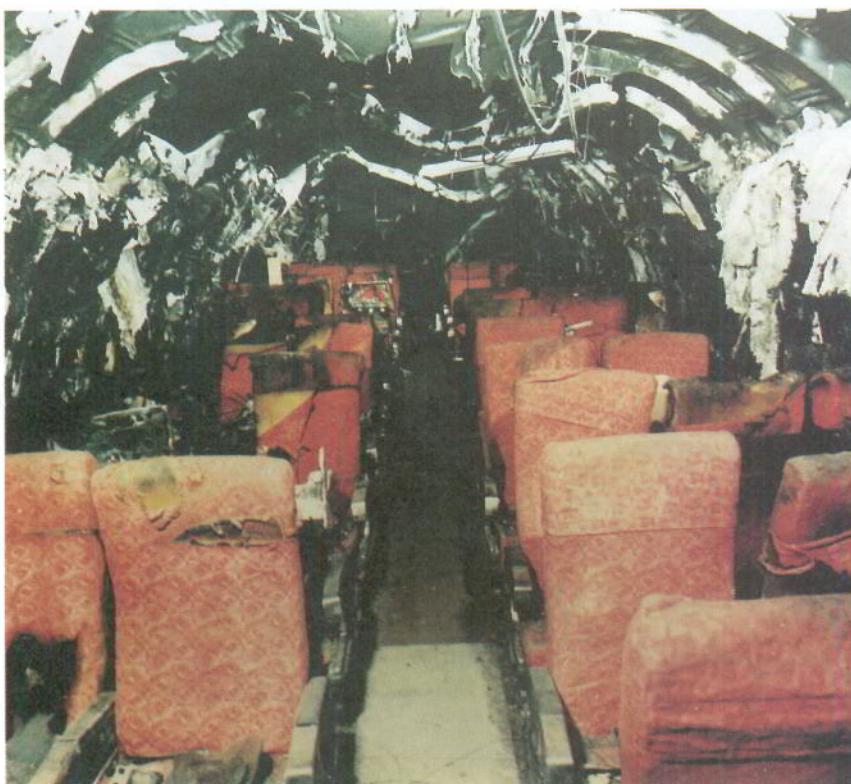
View Looking Aft

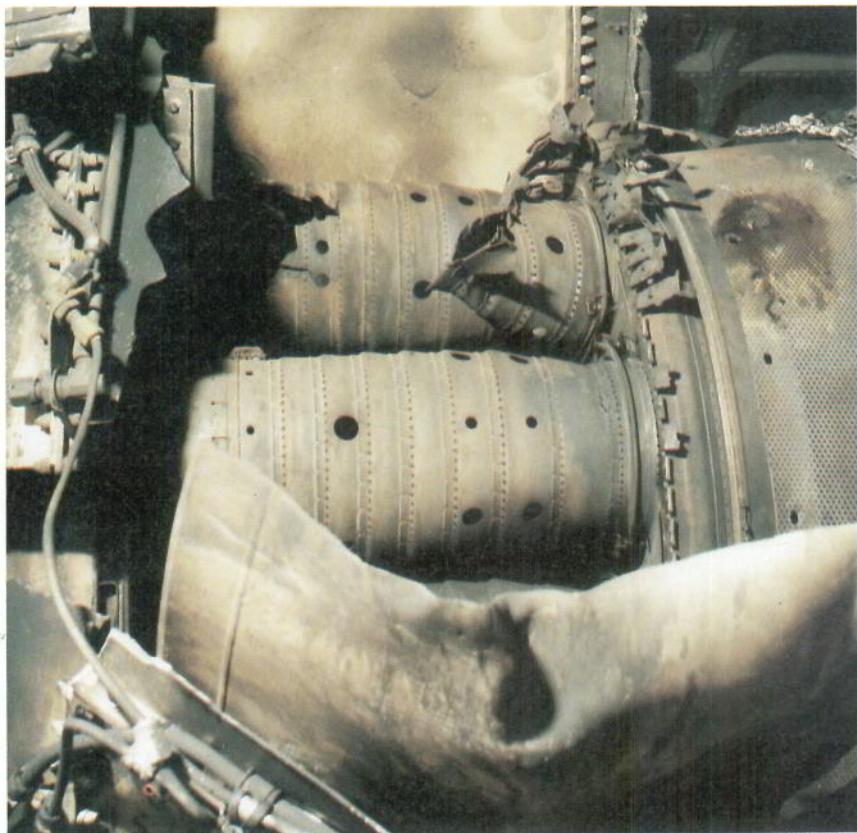
outboard door had blown off in a large, single piece, indicating that overpressure, rather than contact with other debris, was responsible for its detachment. In-fill panels on the engine pylon also showed evidence of overpressure damage. The remainder of the engine, its cowlings and thrust reverser, (which remained deployed) had suffered severe fire damage, particularly on the outboard face. Through the ruptured CCOC, it could be seen that only some 50% of the No 9 combustor can remained in the combustion section.

The aft portion of the can remained in the transition duct bulkhead in a crushed and burnt condition, and had rotated about 90° from its normal orientation. Hastelloy X metal spatter deposits could be seen on the adjacent cans 1 and 8, and more spatter was later found behind the can in the transition duct and on the first stage nozzle guide vanes. The dome recovered from the runway showed that separation had occurred around the 3rd/4th liner joint area - the aft portion of the can had then burnt and buckled in an irregular manner (Appendix 5 Fig f). A sizeable portion had broken off into the can and was found lodged against the nozzle guide vanes.

Remains of combustor can No 9 viewed through the CCOC rupture

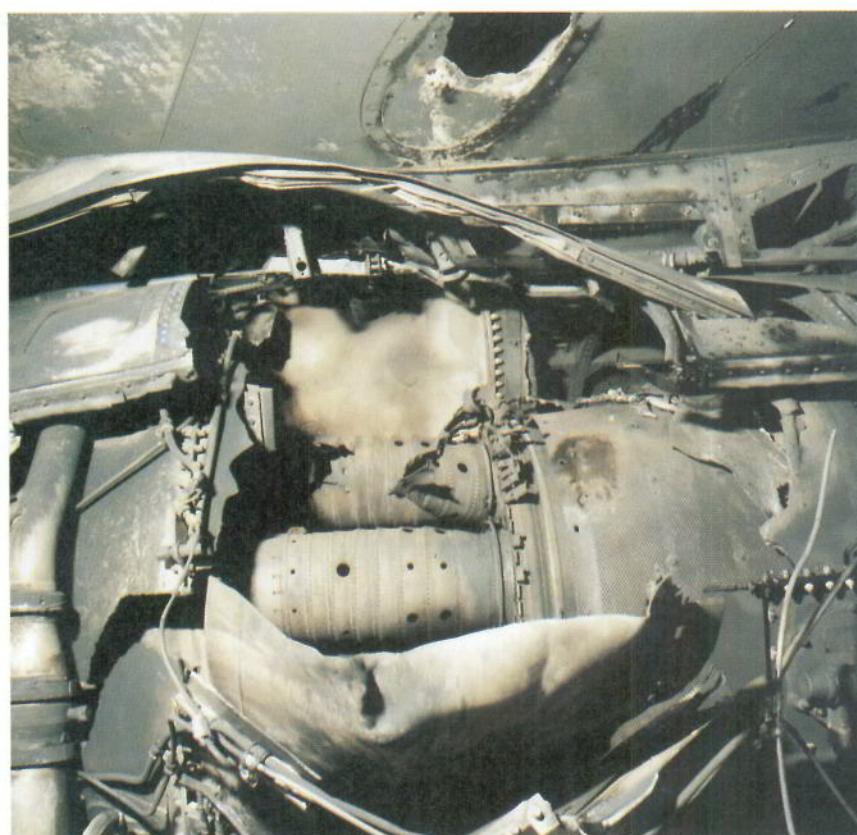
The left hand engine, Serial No P702868, had suffered an explosive rupture of the CCOC. The case had split along an axial line adjacent to No 9 combustor can and had then 'petalled' apart from approximately the 11 o'clock to 5 o'clock position (viewed from the front), failing the attachment bolts on the front flange and the flange itself on the rear face. The upper section of the CCOC had blown upwards onto the underside of the engine pylon, striking the fire/overheat detection system electrical loom. The lower section had blown downwards and outwards. Witness marks on the exterior surface of the CCOC adjacent to the rupture showed that it had struck the inner surface of the fan case as the rupture occurred. (Appendix 5 Fig e)

The centre of a fuel tank access panel on the lower surface of the wing immediately outboard of the left engine was broken-out, producing an approximately elliptic hole, 8" by 7", directly into the central region of the main

Engine rupture and holed fuel tank access panel

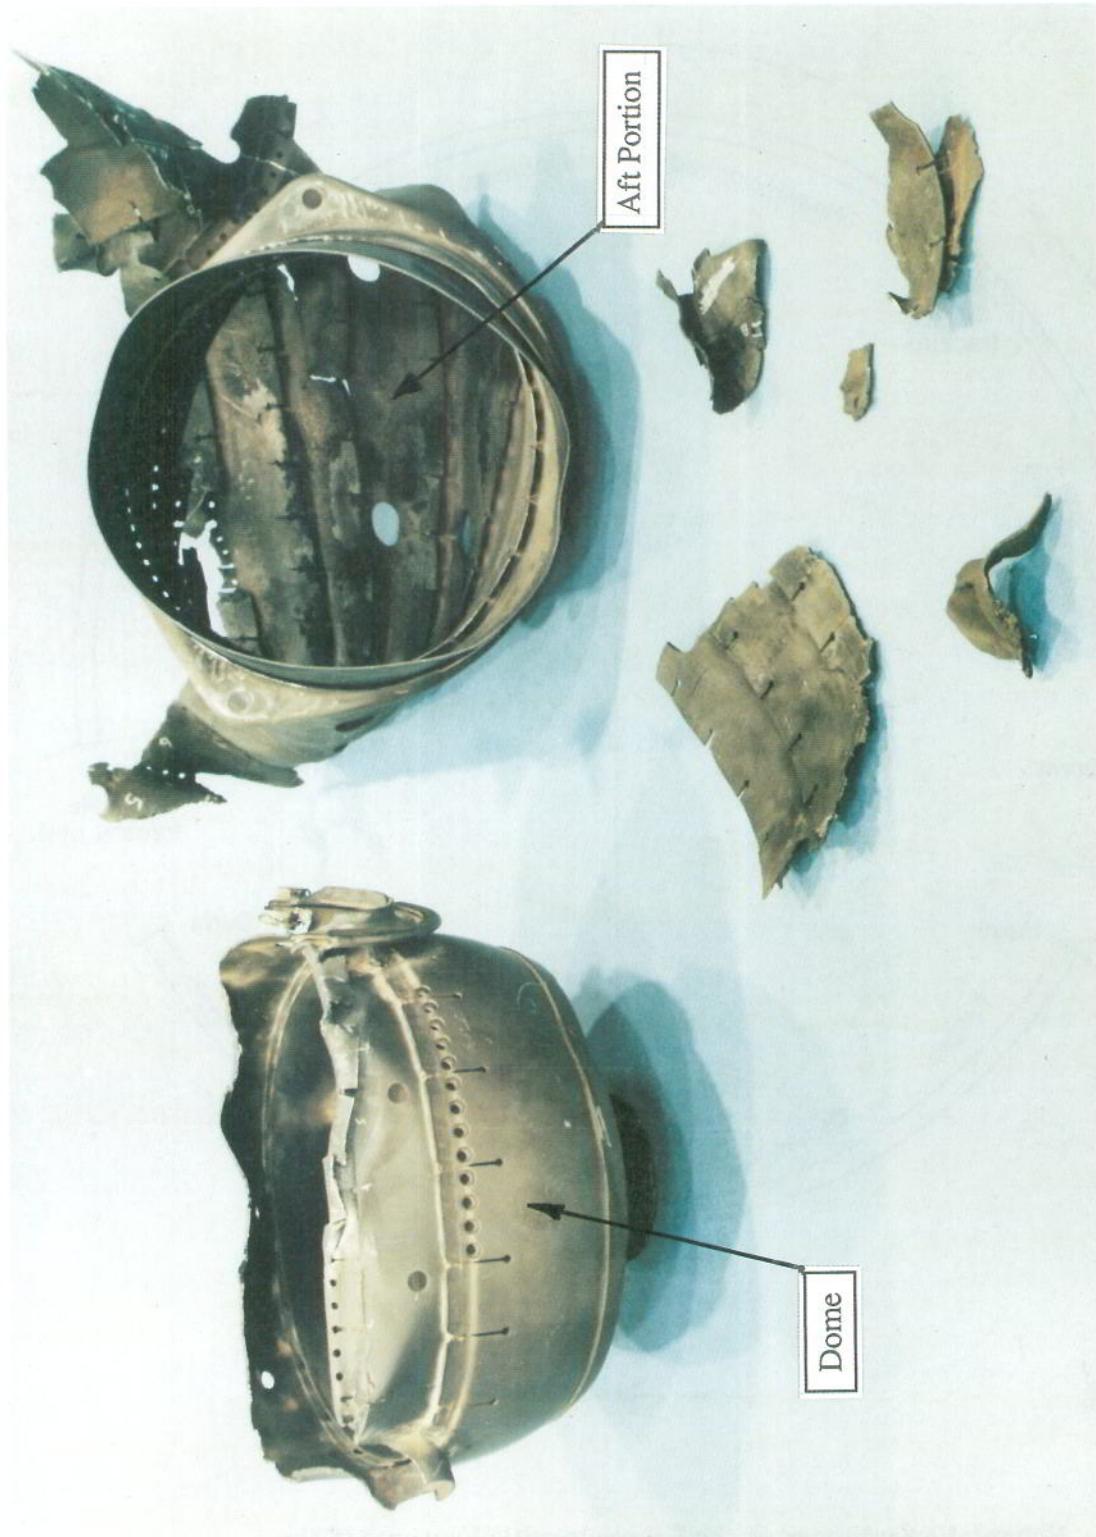
Appendix 5 fig f

The dome portion, which embodied the majority of liner 3, had suffered comparatively little damage. Witness marks were found which matched those on the holed underwing fuel tank access panel, and a sizeable metal scrape deposit on the air scoop was later analysed and found to be of the same material as the access panel, proving conclusively that the dome had struck the panel. Two small indentation marks in the air scoop also showed that the can location pin retention bolts had contacted the scoop as the dome assembly was forced outwards, fracturing the pin with a single overload bending force. Some galling of the fuel nozzle shroud, associated with similar marks in the mating hole in the dome was also found, indicating movement of the dome relative to the nozzle. The dome itself, particularly the exposed fracture surface of liner 3, was noticeably free of burning or overheat damage although there had been some mechanical damage to the fracture surfaces. In addition to extensive cracking in the 3/4 liner joint area cans numbered 1 and 8 had clearly suffered extensive damage due to their proximity to the badly disrupted No 9 can, with material missing. The other six cans showed varying degrees of circumferential cracking in this area.

The Recovered Remains of Combustion Can No 9 from the Left Engine

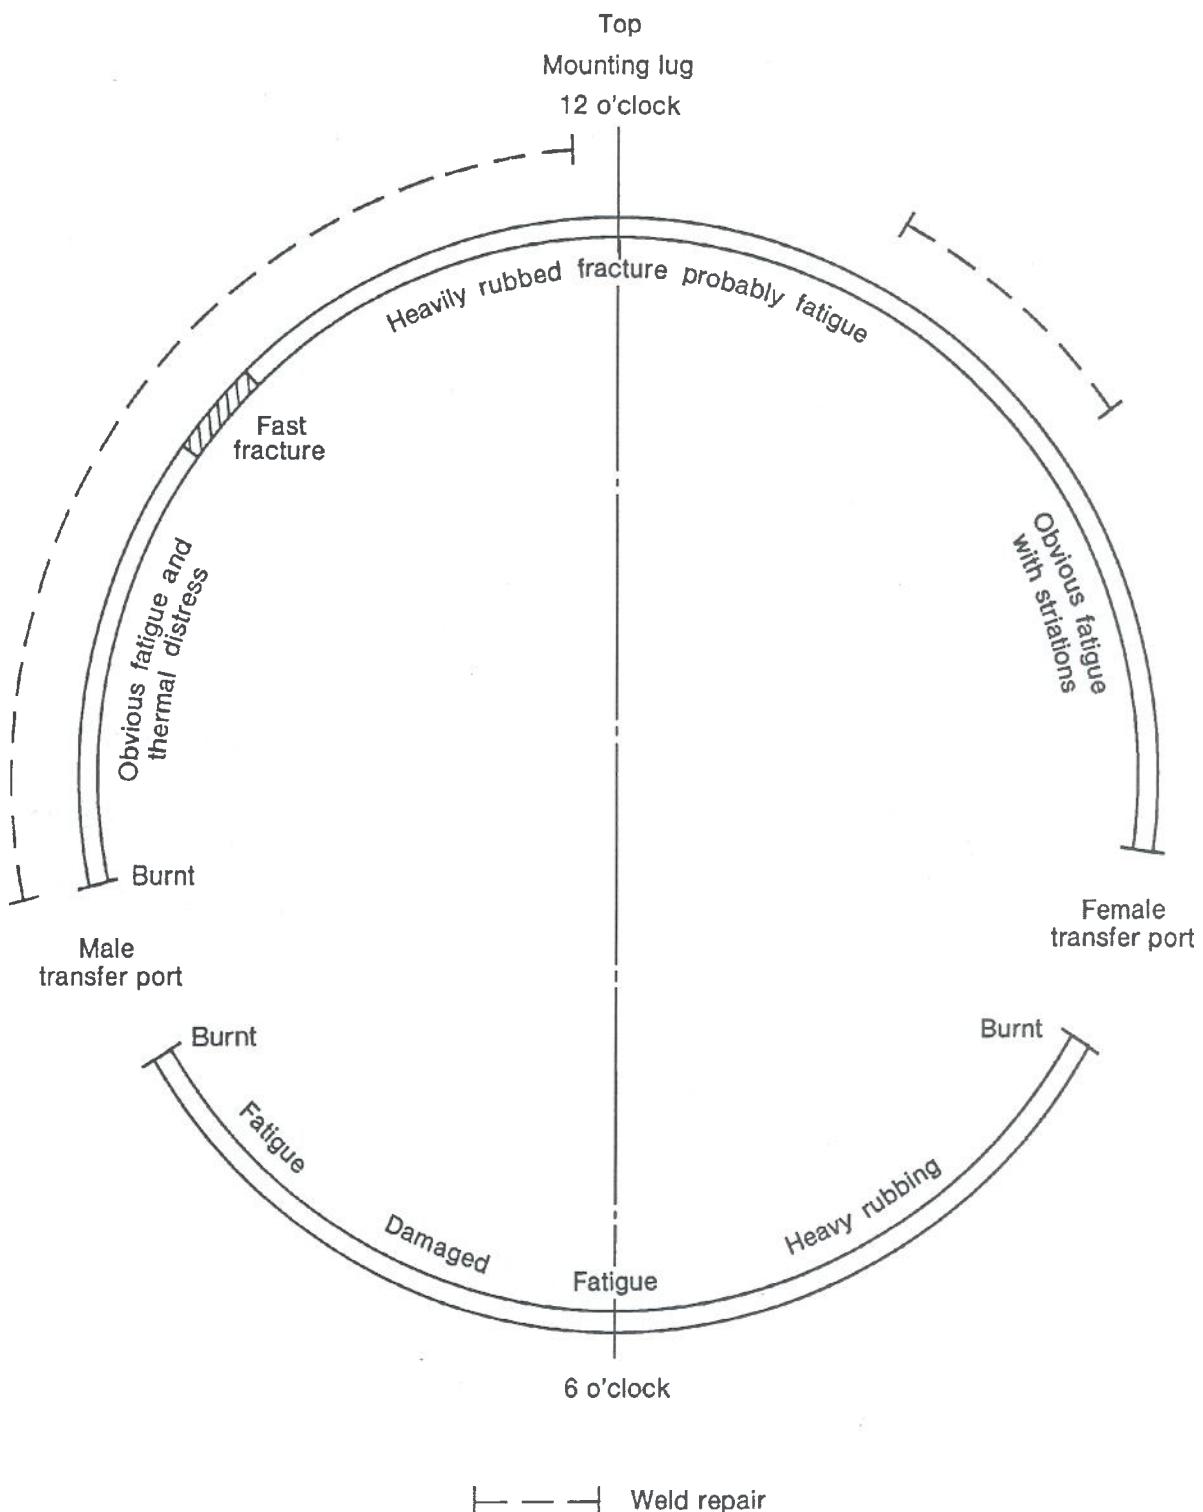
Examination of the radiographs showed that the can exhibiting the most cracking in the 3/4 liner joint was can No 9, serial number TS351 (installation position was the same on both engines). A circumferential crack 160 mm in length extended in the third liner from the male flame transfer tube around the outboard face of the can, in the area of the seam weld to the fourth liner. A second crack 25 mm in length, barely discernible from the radiograph, was seen about 50 mm further round from the main crack (Appendix 5 Fig d).

Schematic Summary of the Fractographic Features of the Circumferential Cracking in the 3rd Liner of Can No 9

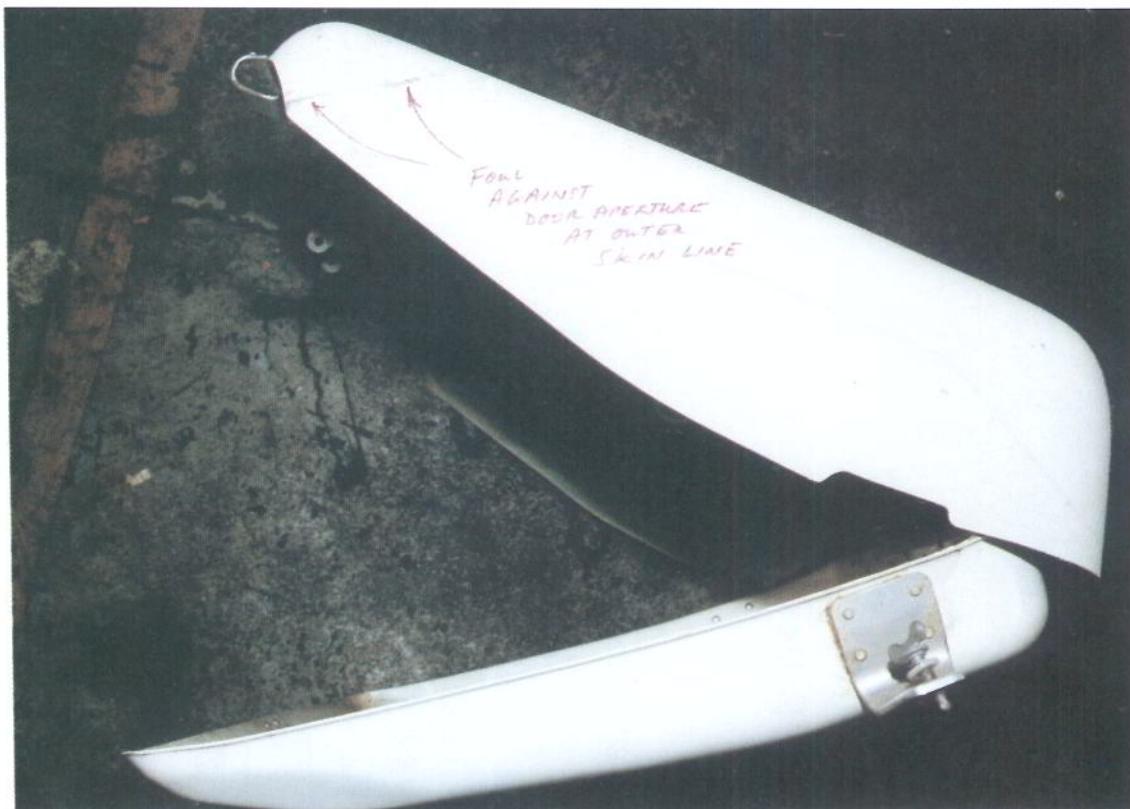
Appendix 10 Photos. a-b

After the purser had confirmed the evacuation with the commander he repeated the evacuation call a number of times over the PA system. Then, as the aircraft was coming to a halt, he went to the right front (R1) door to open it and release the inflatable escape slide. The door unlocked normally but as it was moving out through the aperture the slide container lid jammed on the doorframe preventing further movement of the door. After spending a short time trying to clear the restriction he postponed further effort and crossed to the L1 door. He cracked it open, ascertained that the forward spread of the fire was slow enough to allow evacuation from that door, opened it fully and confirmed the inflation of the slide manually. This was achieved about 25 seconds after the aircraft had stopped and coincident with the initiation of foam discharge from the first fire vehicle to arrive. Evacuation began on the left side under the supervision of the No 4 stewardess, who had to pull free some passengers who had become jammed together between the forward galley bulkheads in order to start the flow.

a - Witness Mark on Slide Box Lid

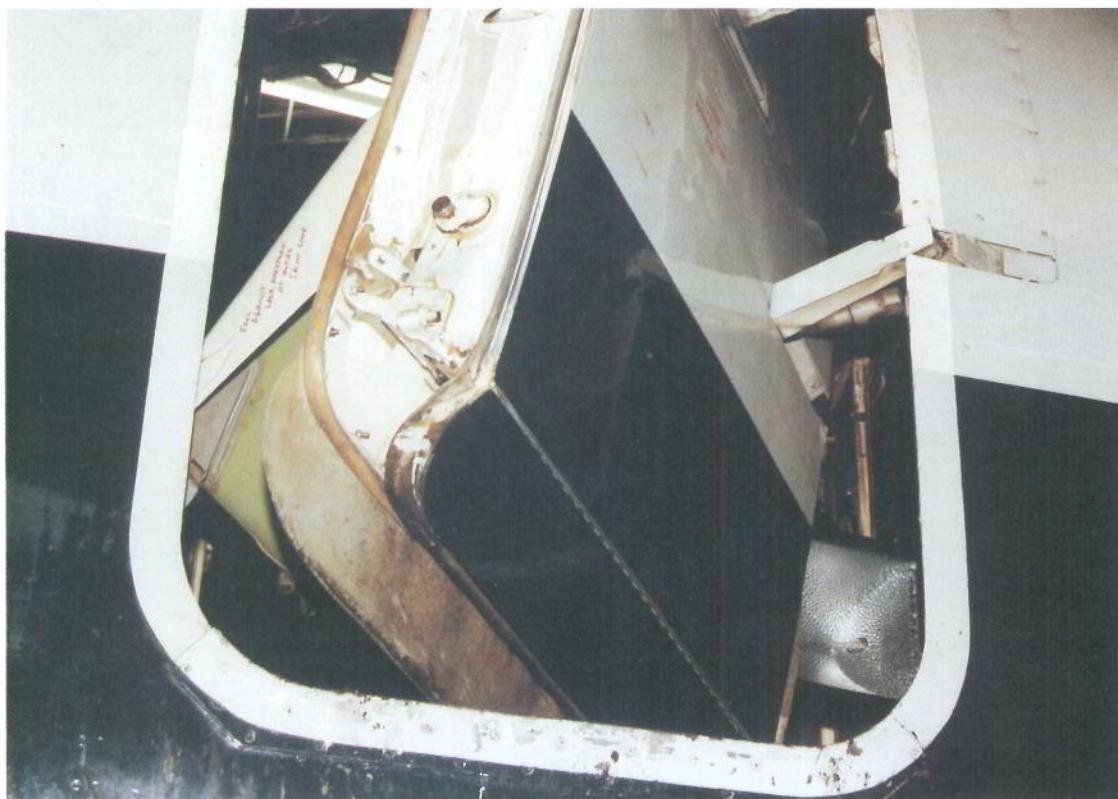
b - Door Position With Witness Marks Aligned-External

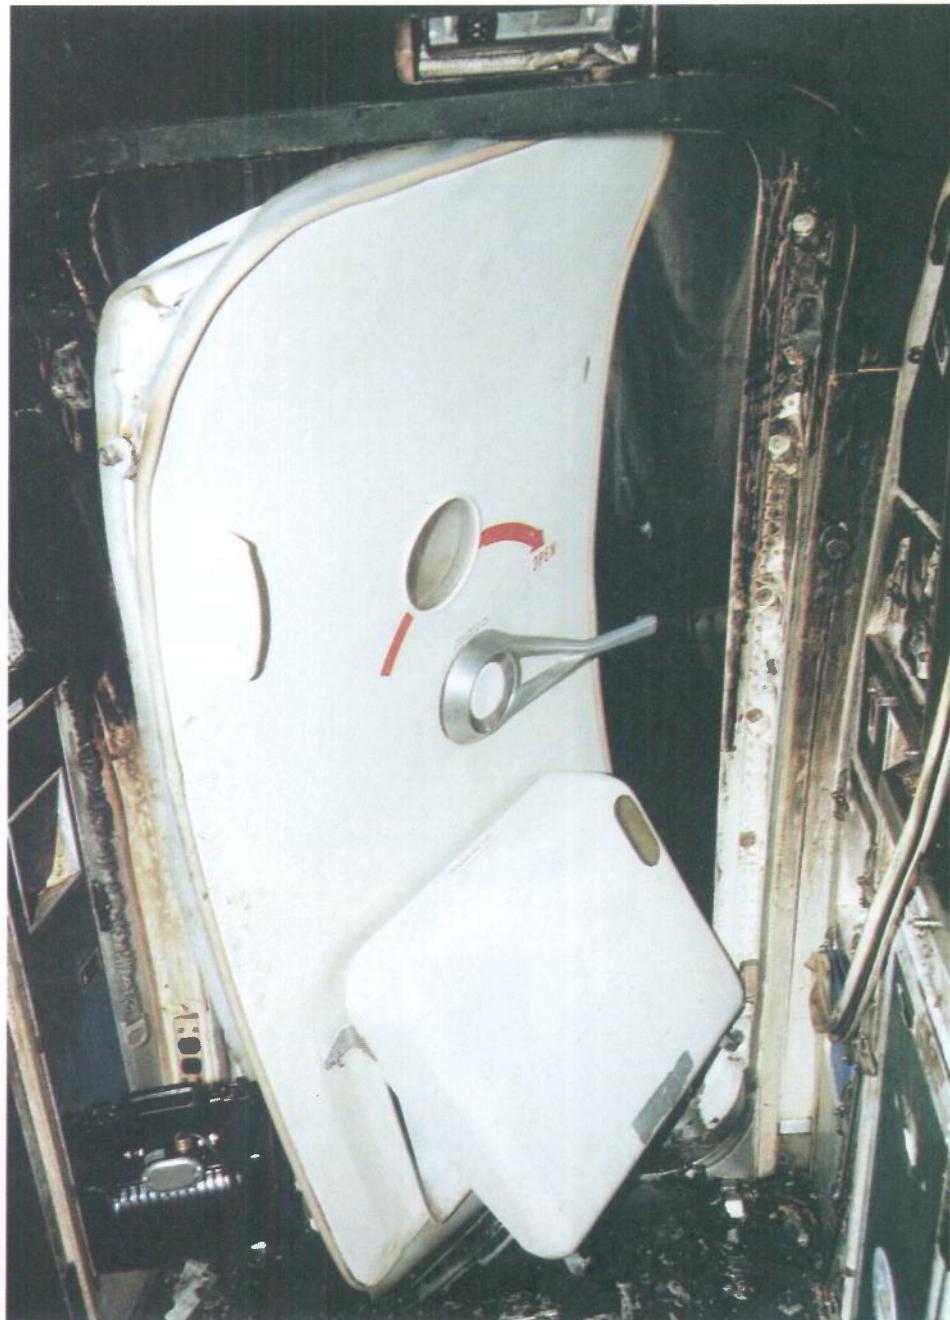
Appendix 10 Photo c

c-Door Position Witness Mark Aligned - Internal
