Air Accident Investigation Unit Ireland

SYNOPTIC REPORT

INCIDENT Boeing 737-8AS, EI-FIH Porto, Portugal

AAIU Report No: 2016-018

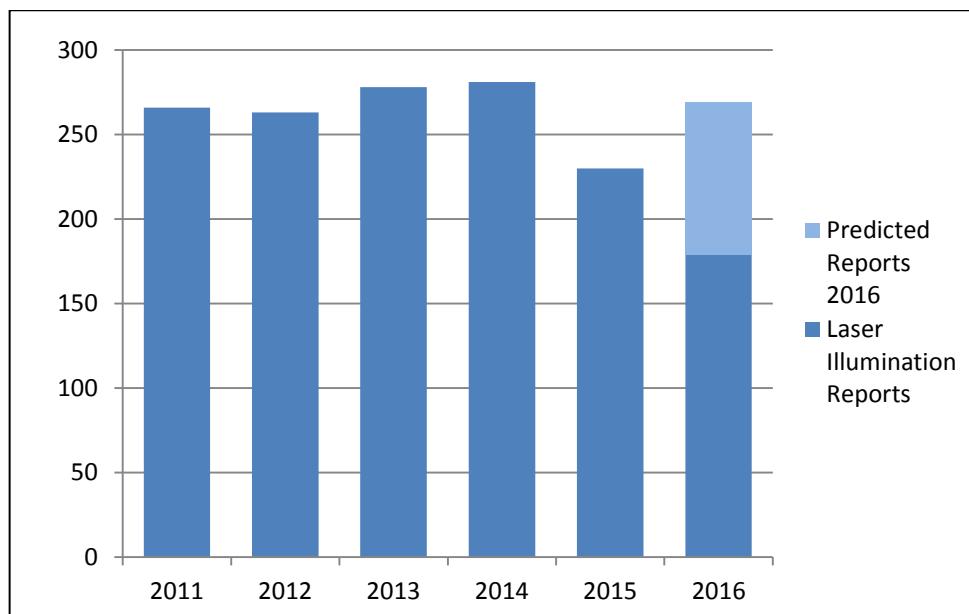
Graph No. 2: Reported Laser Illuminations

Statistical data for laser attacks on Irish registered aircraft are gathered by the IAA through Mandatory Occurrence Reports via the Safety Occurrence Tracking System. **Graph No. 2** shows data for reported laser illuminations to Irish registered aircraft operated by the seven largest Air Operator Certificate (AOC) holders in the State, from 2011 to 2016¹⁵.

¹⁵ Data up to and including 31 August 2016 is shown in dark blue. Projected numbers (based on average of previous years) for remainder of 2016 are shown in light blue.
