# AIRCRAFT ACCIDENT REPORT 1/2017

Report on the accident to  
**Hawker Hunter T7, G-BXFI**  
near Shoreham Airport  
on 22 August 2015

### Air Accidents Investigation Branch

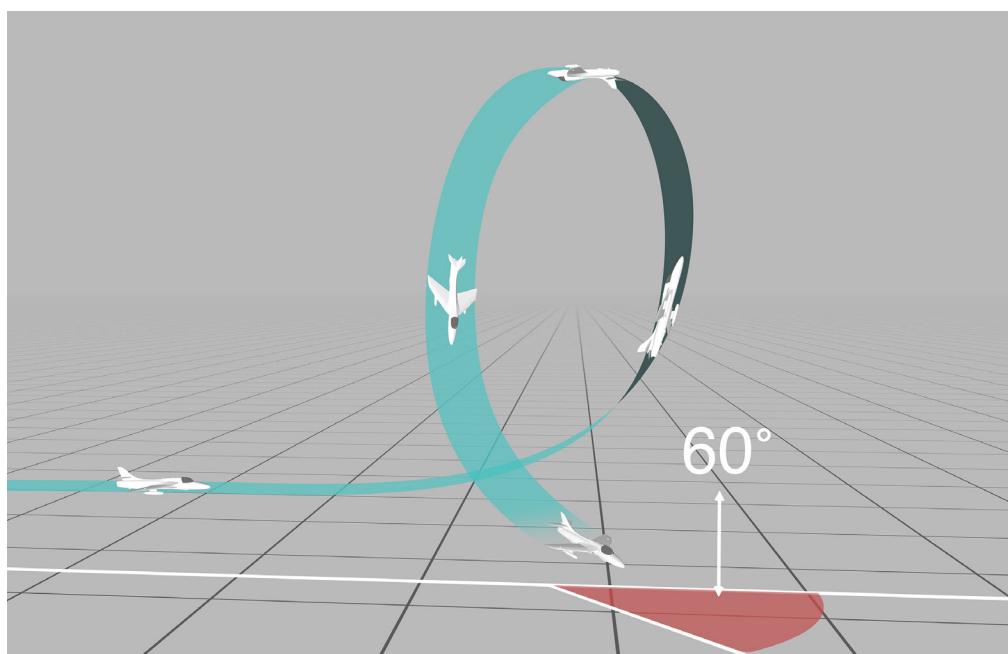
**Figure 2**

The aircraft then pitched up into the accident manoeuvre at an indicated airspeed of approximately 310 KIAS and with an engine speed of approximately 7,500 rpm<sup>2</sup>. As it approached the vertical, the pilot initiated a roll to the left. In the climb the engine speed first reduced, then increased to about 7,200 rpm, then reduced again nearing the apex. The aircraft was almost inverted with its wings level at the apex, at a height of approximately 2,700 ft. During the subsequent descent, its ground track was aligned to the west along the A27, Shoreham Bypass. As it descended it accelerated and the nose was raised but insufficient height was available to recover to level flight before it contacted the westbound carriageway of the A27.

Illustration of the accident manoeuvre  
(This is not a precise depiction of the aircraft's behaviour or flightpath)

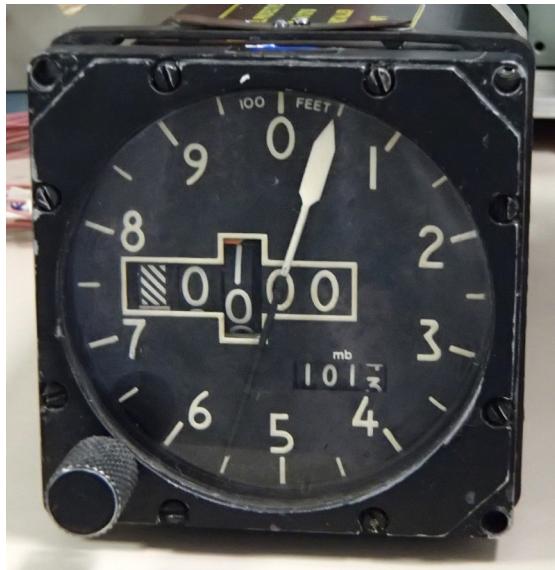
**Figure 5**

Mk 30B altimeter (barometric pressure setting not as found)

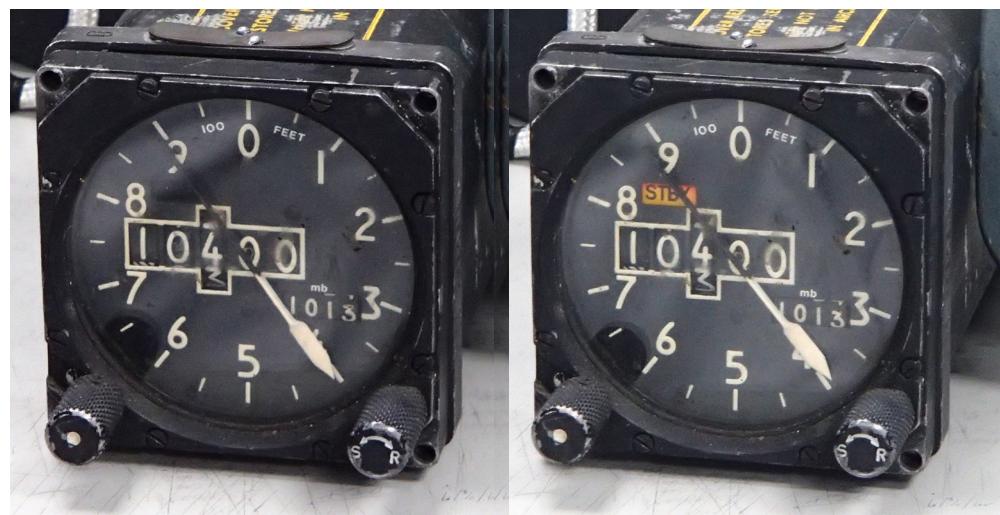
**Figure 6**

Mk 29B altimeter in servo mode (left image) and standby mode (right image). Reference barometric pressure setting not as found

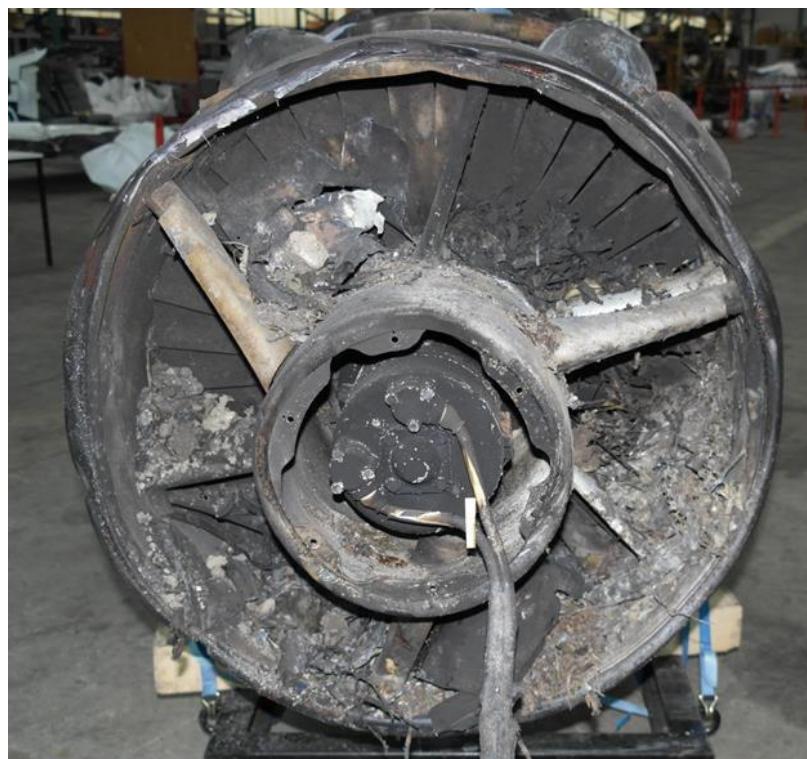
Figure 4: A view looking at the front of the engine. The level of ingested post-accident debris is clearly visible.

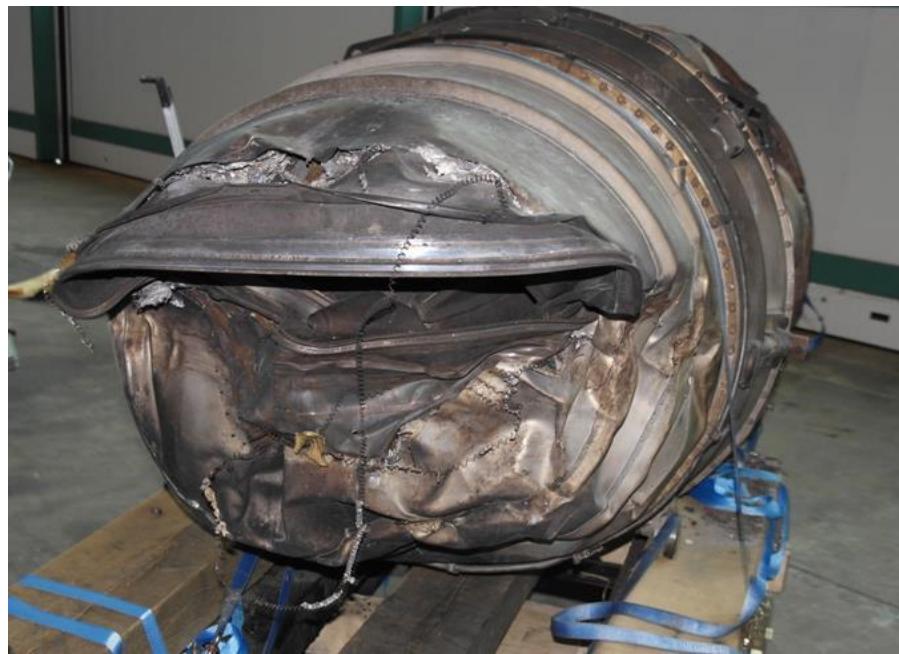
Figure 5: This is a view of the rear of the engine showing the distorted exhaust unit.

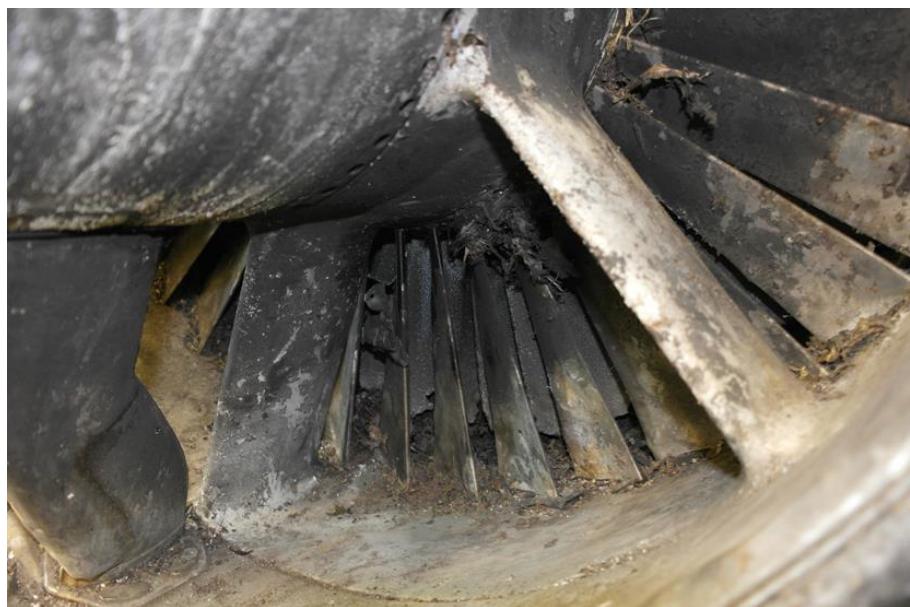
Figure 6: A closer view of the variable inlet guide vanes. The majority of debris has been removed at this stage.

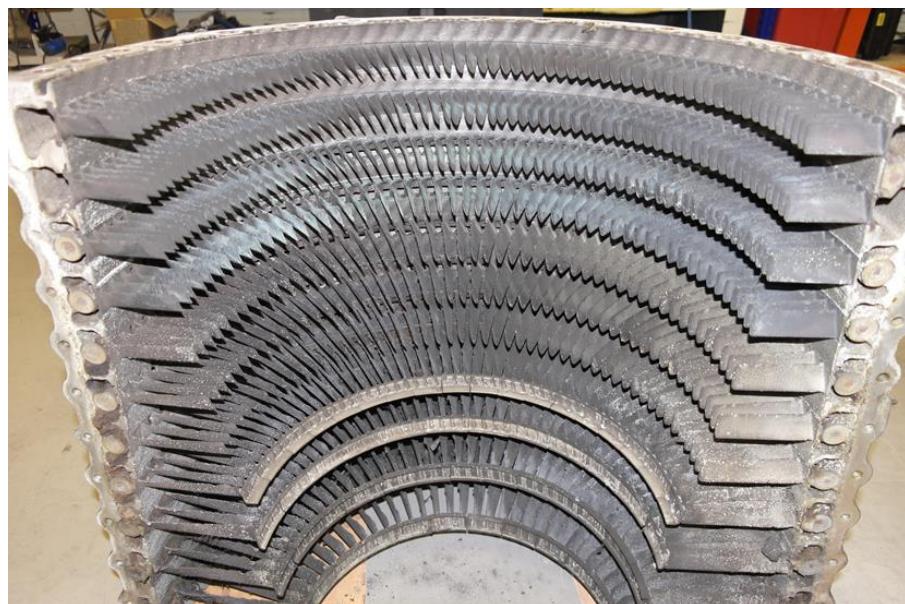
Figure 7: The top section of the compressor half casing. All the stator vanes are present but are coated in a layer of post-accident fire soot.

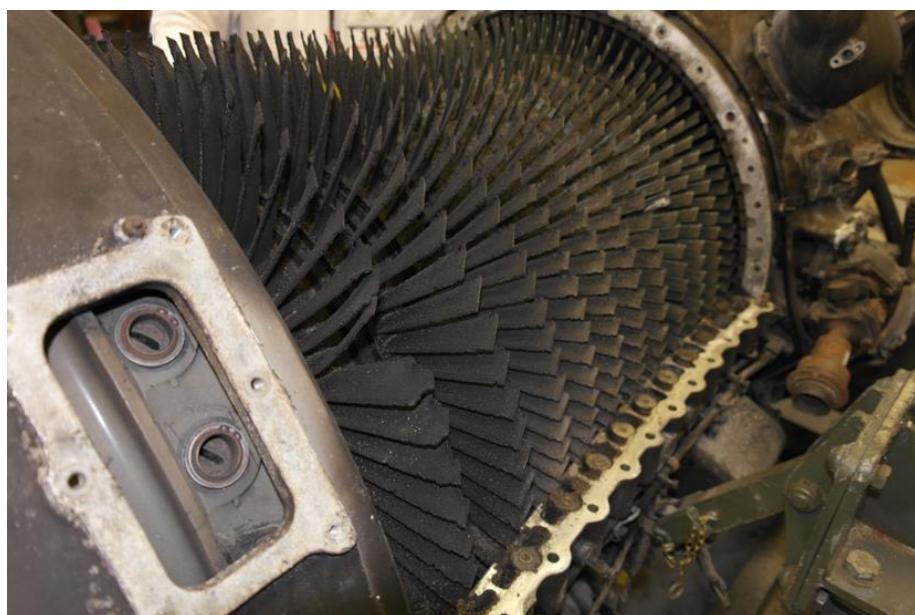
Figure 8: A general view of the compressor. Blade distress is clearly visible and the post-accident fire sooting is clearly visible.

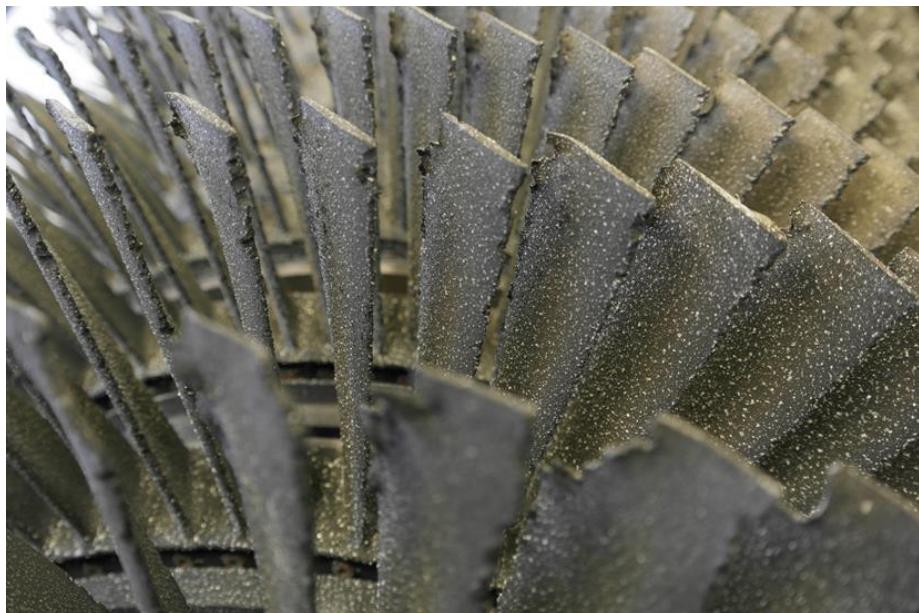
Figure 9: a close up view of the mid-stages of the compressor. Damage to the leading and trailing edges of all the blades can be seen.

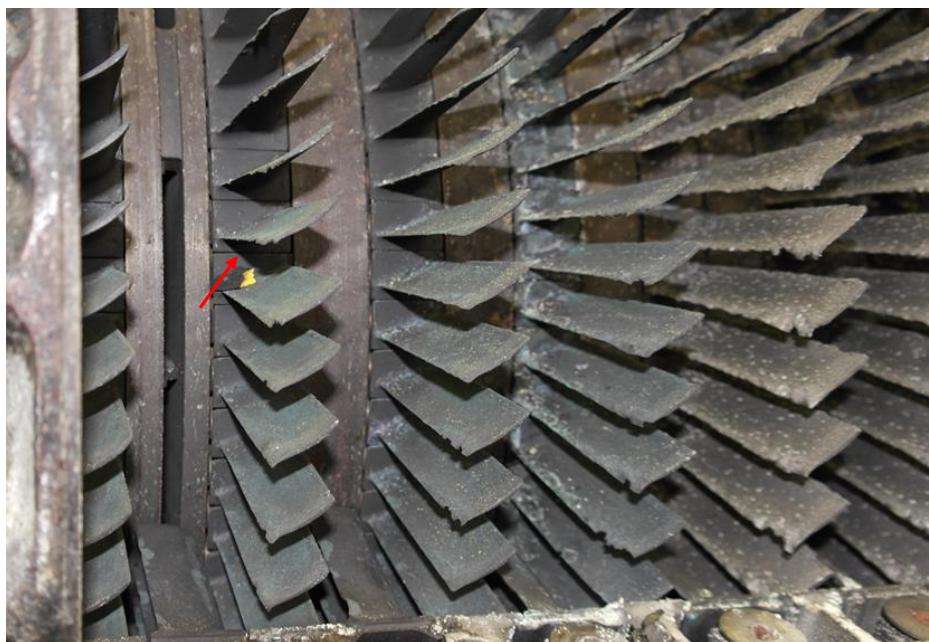
Figure 10: A piece of ingested debris was found within the stage 11 blades, (arrowed)

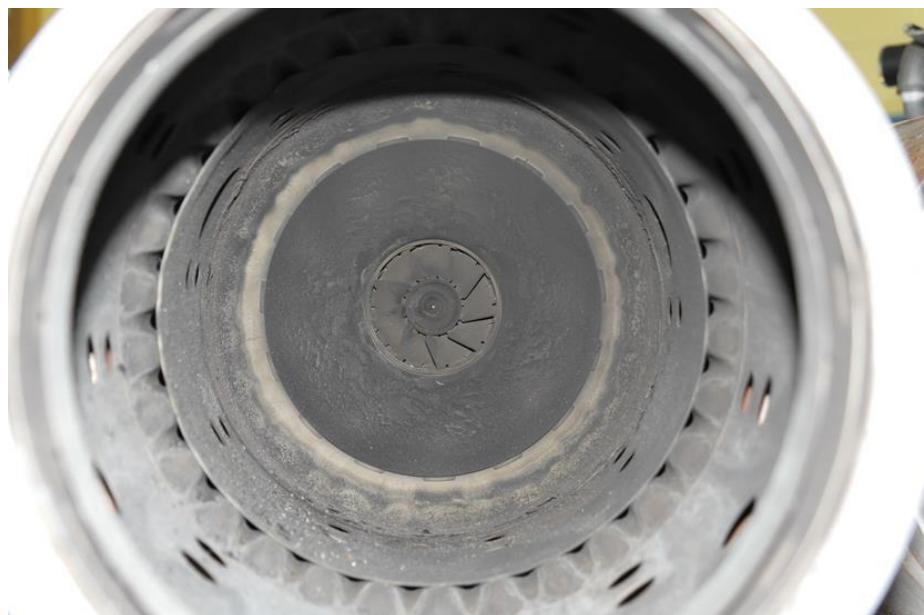
Figure 11: A general view inside one of the combustion chambers. All the inspected chambers were similar and considered satisfactory.

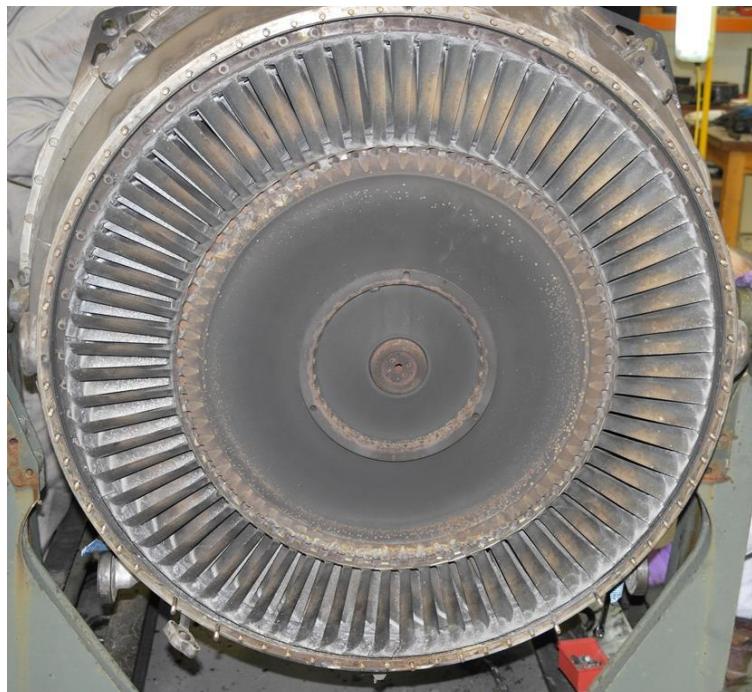
Figure 13: A general view of the 2nd stage (LP) turbine. All the blades were present and the general condition of the turbine was considered satisfactory.

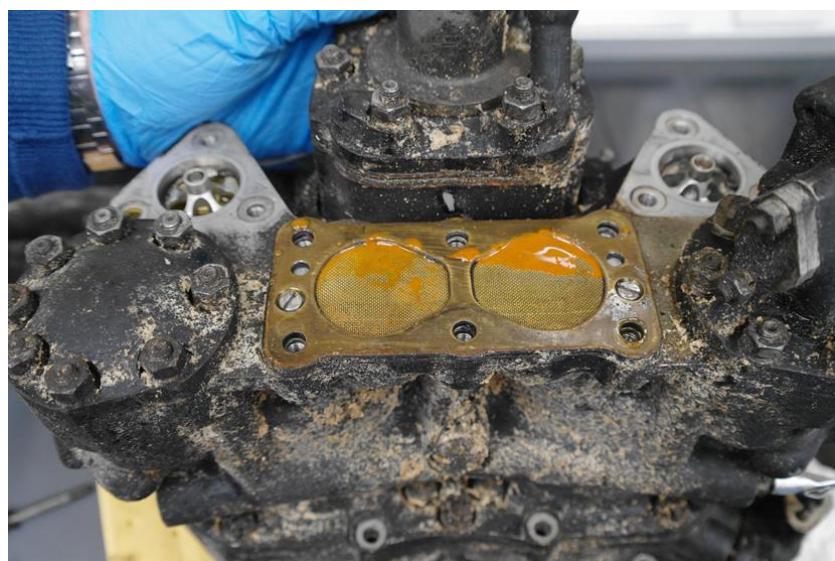
Figure 14: A general view of the dual fuel pump after removal of the fuel inlet cover. The orange coloured liquid is the result of post-accident water ingress.

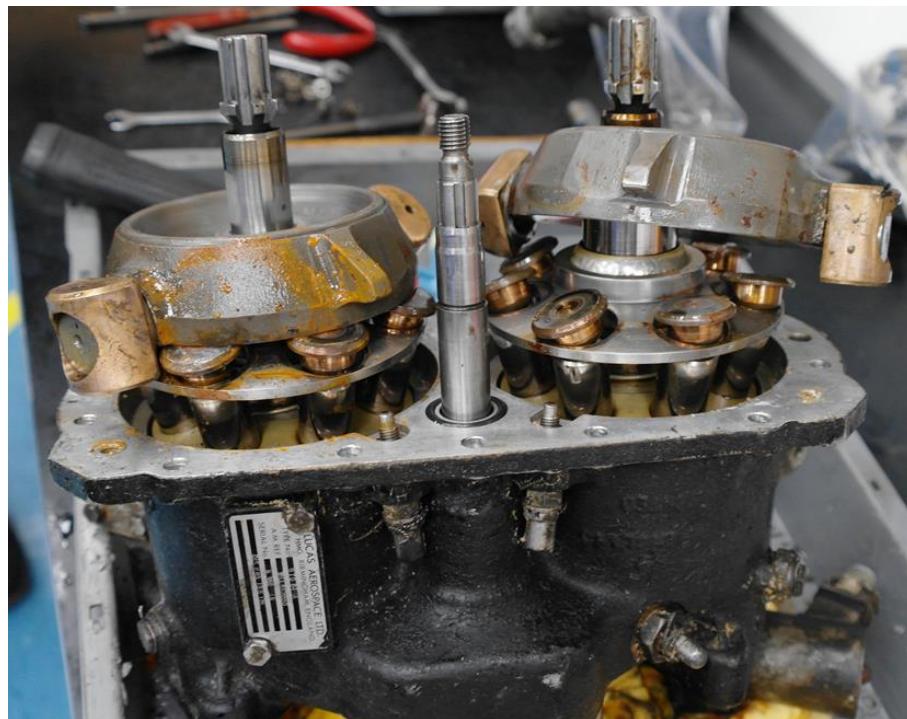
Figure 15: The condition of the pistons within each pump was satisfactory. The post-accident water damage is also evident.

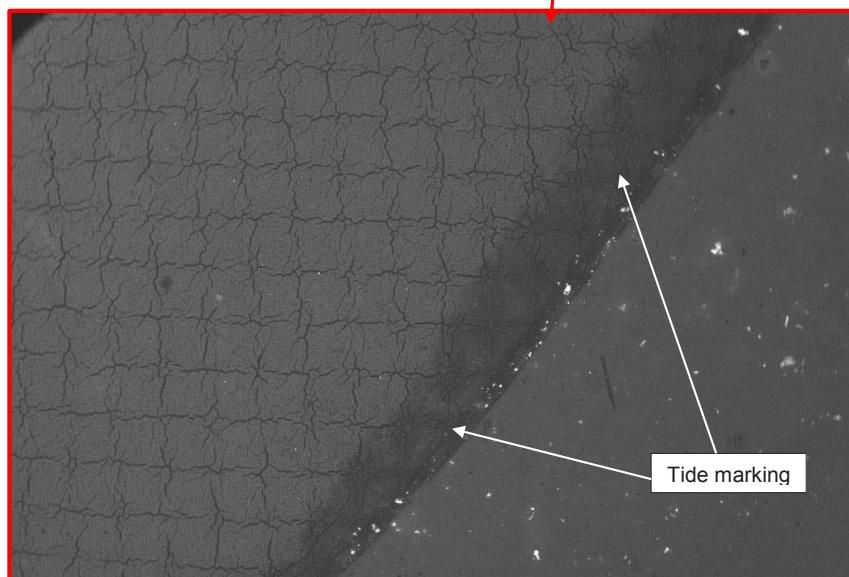
Figure 17: A close up view of the 'mud cracking' and tide marking seen in the convoluted section.

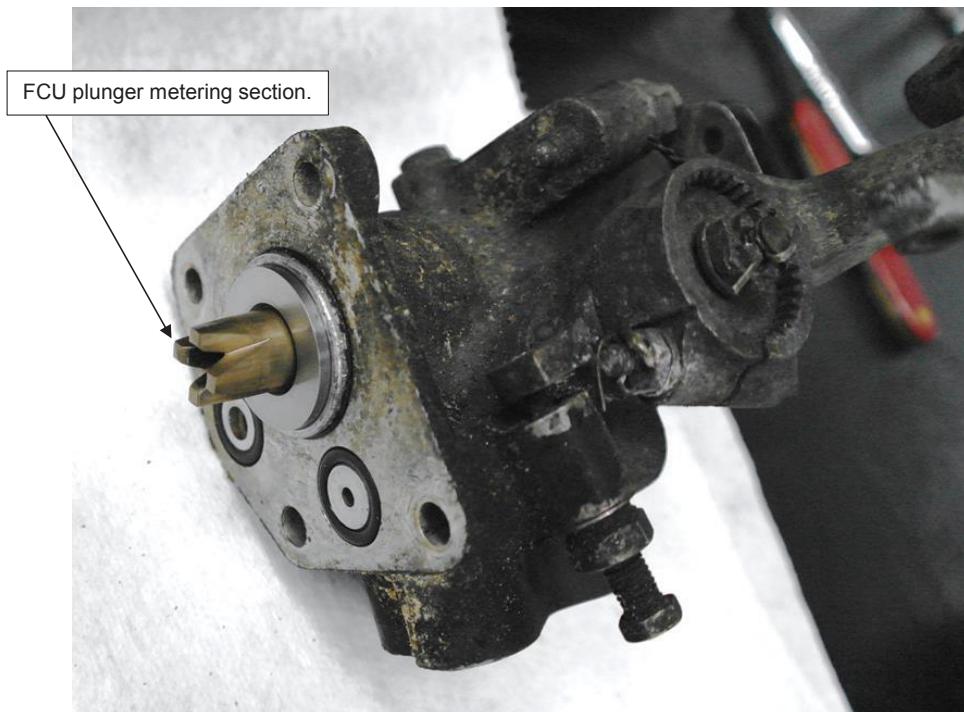
Figure 18: The metering section of the FCU plunger was clean and in a satisfactory condition.

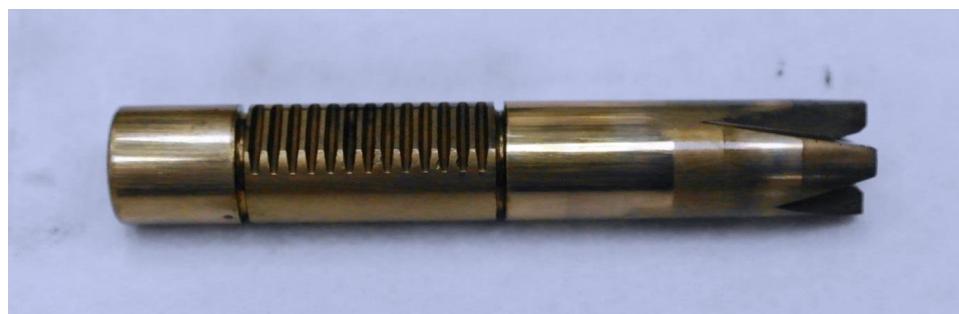
Figure 19: After removal of the metering plunger its general condition was considered to be satisfactory

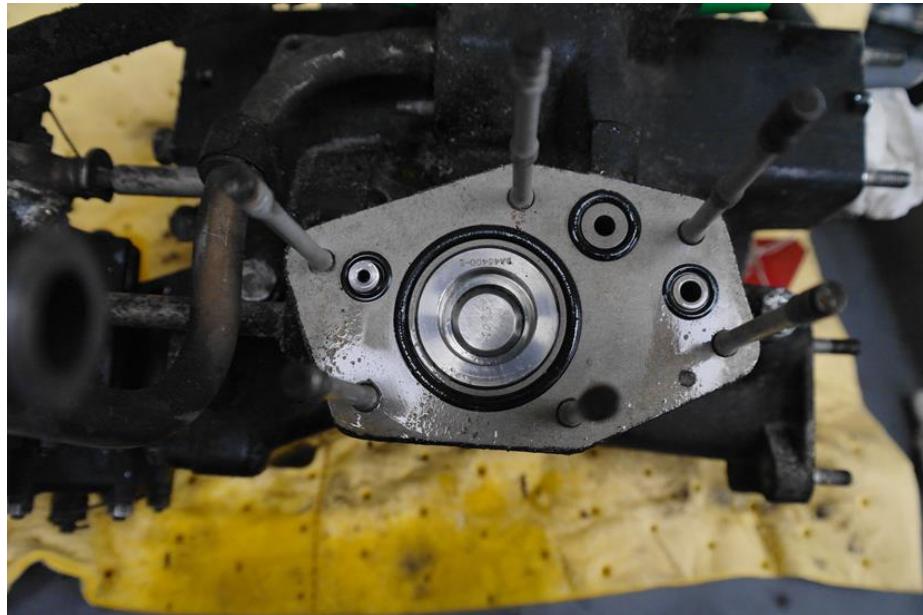
Figure 20: One half of the HP shut off cock housing. The internal components were clean and the 'O' ring seals were in a good condition.

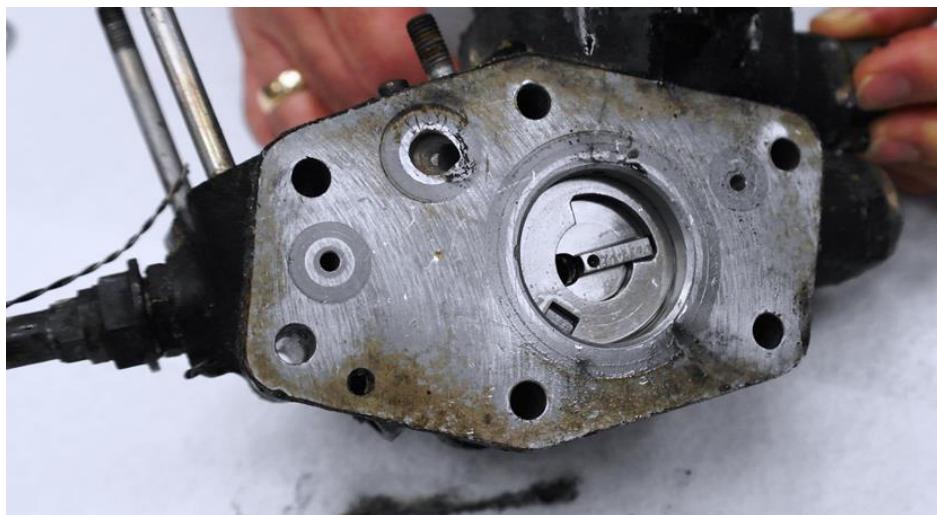
Figure 21: This is the opposite half of the shut off cock seen in figure 19. The valve was clean and its operation was smooth and unrestricted.

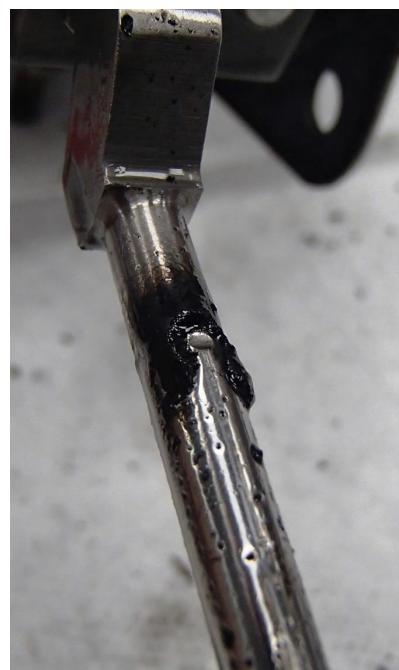
Figure 23: The pressure balance lever for the ACU which was considered to be in a good visual condition. The black deposit noted during the strip can be seen close to the needle roller contact point.

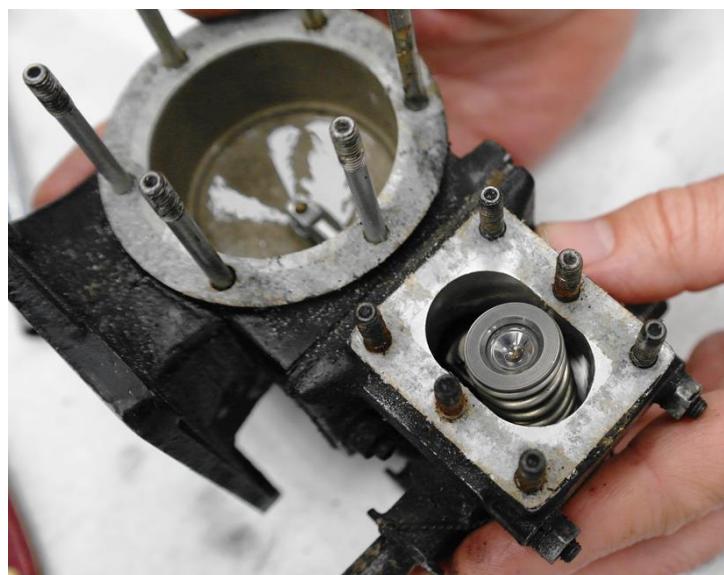
Figure 25: Another view showing the clean condition of the BPC adjustment housing.

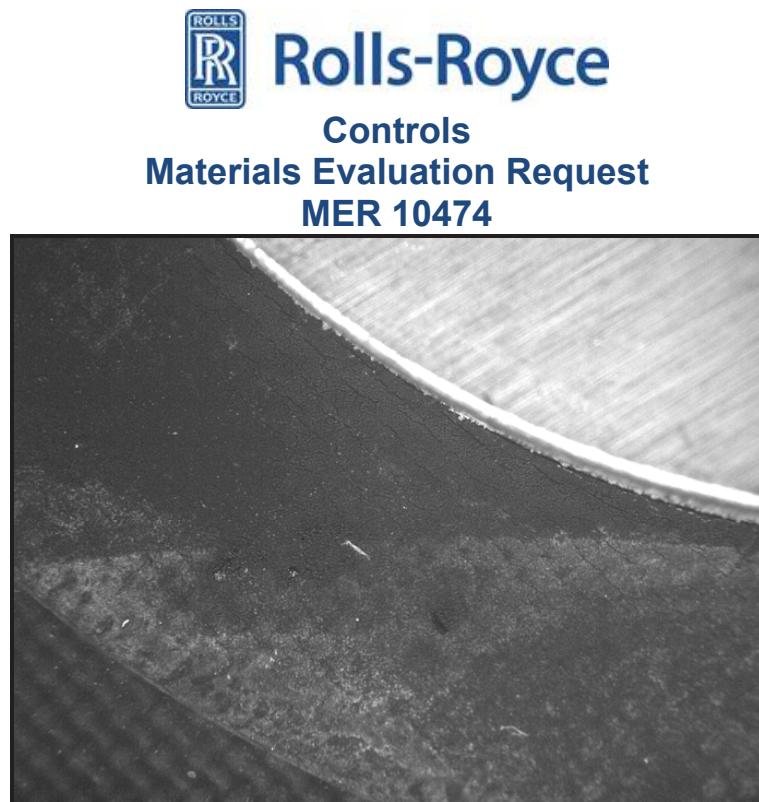
**Figure 3** [REDACTED] **GD64-1A Pump Diaphragm Tide Mark (Face-1)**

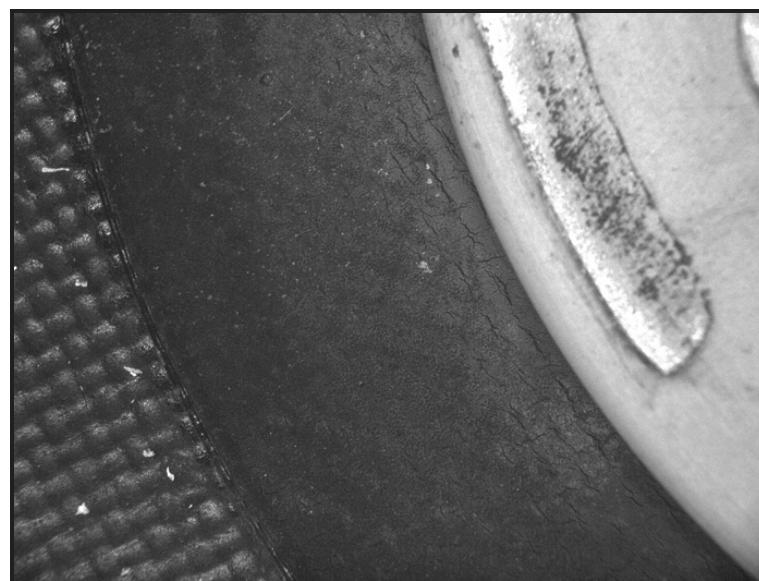
**Figure 4** [REDACTED] **GD64-1A Pump Diaphragm Cracking (Face 2)**

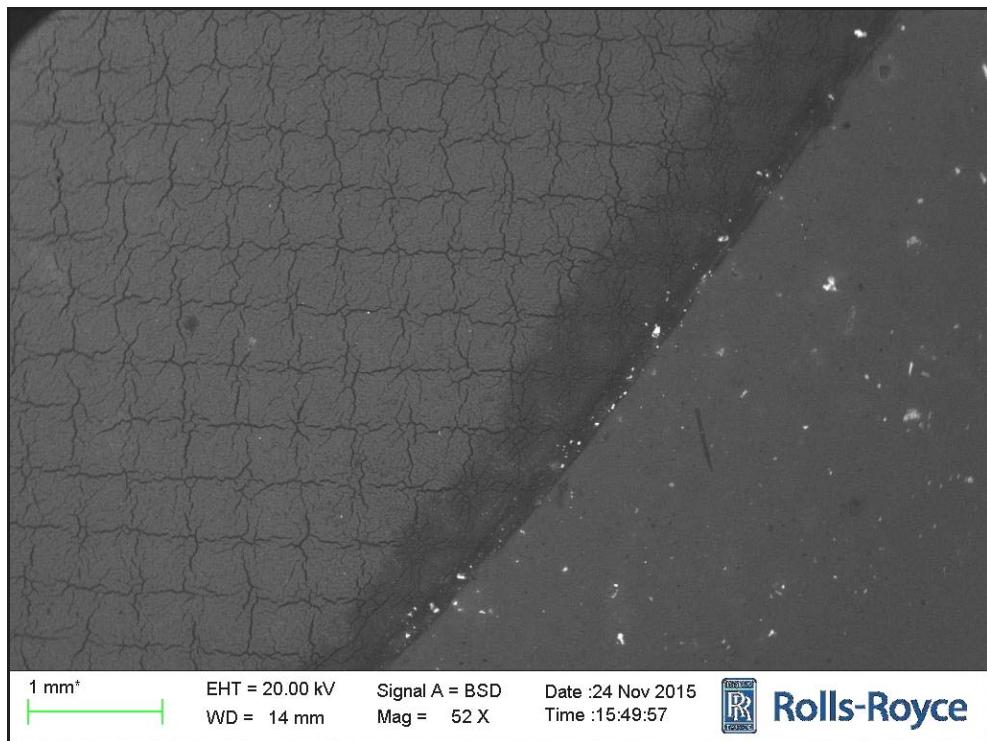
**Figure 5 [REDACTED] GD64-1A Pump Diaphragm “Tide Mark” Region (Face 1)**

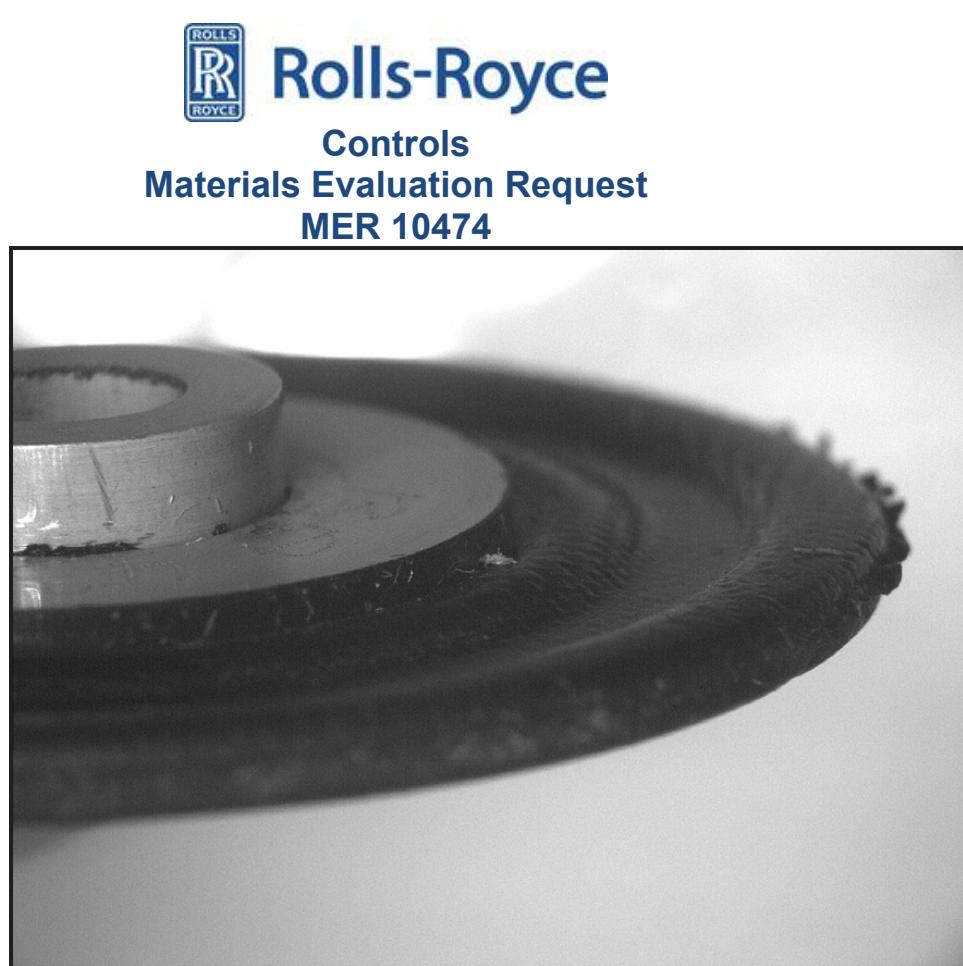
**Figure 15 Acceleration Control Unit Diaphragm – Bead Compression Set**

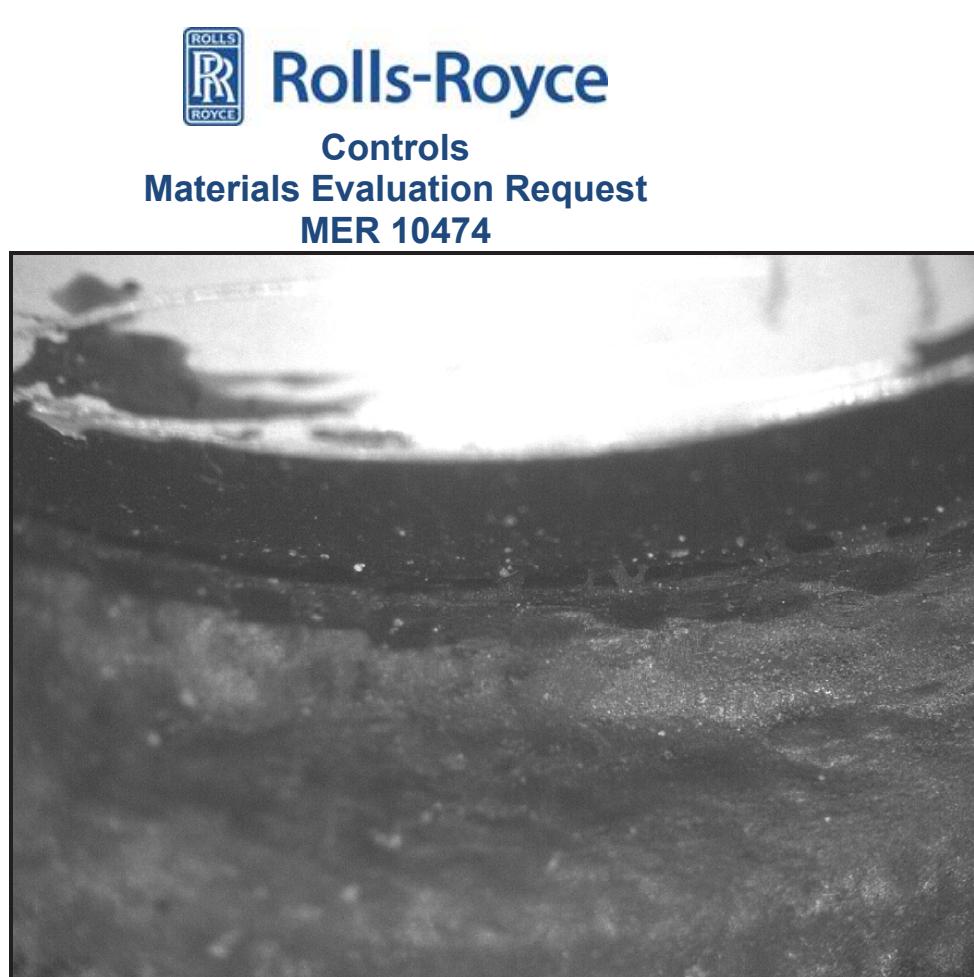
**Figure 16 Acceleration Control Unit Diaphragm – Adhesion Loss**
