The Airbus Safety Magazine

FEBRUARY 2009

Braking system cross connections
Thierry Thoreau 10

Avoiding dual bleed loss
Patrick Grave, Christophe Mathe 26

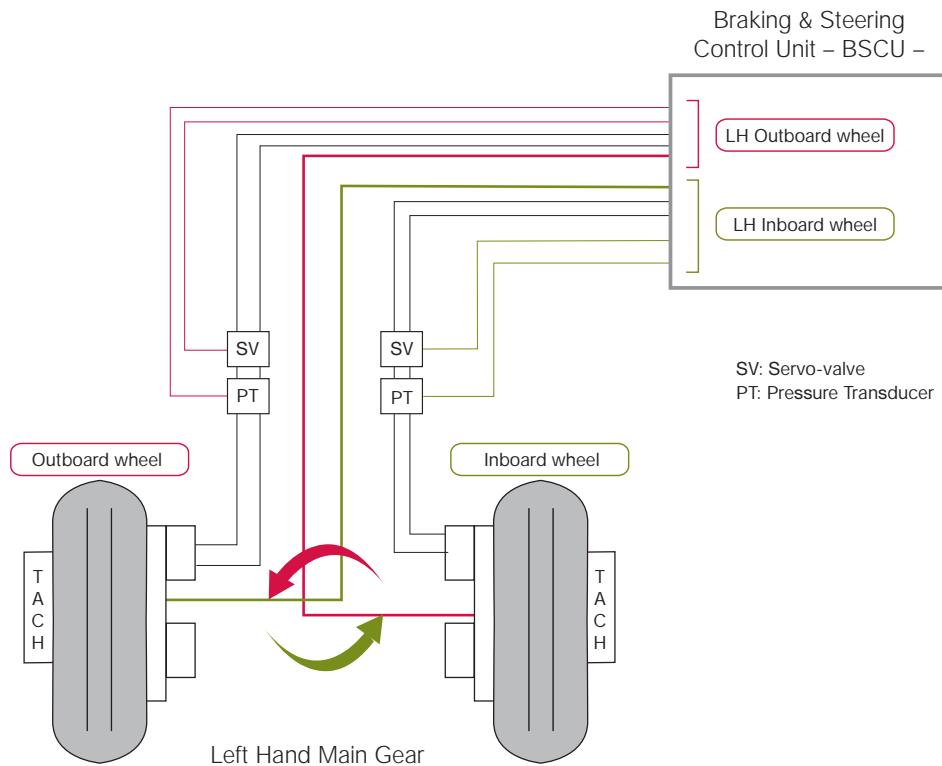
Figure 1: Schematic of tachometer cross connections

- A few cases of Main Landing Gear — MLG — tachometer cross connections have been reported. These cross connections were done at the level of the wheels axis, as shown on figure 1.

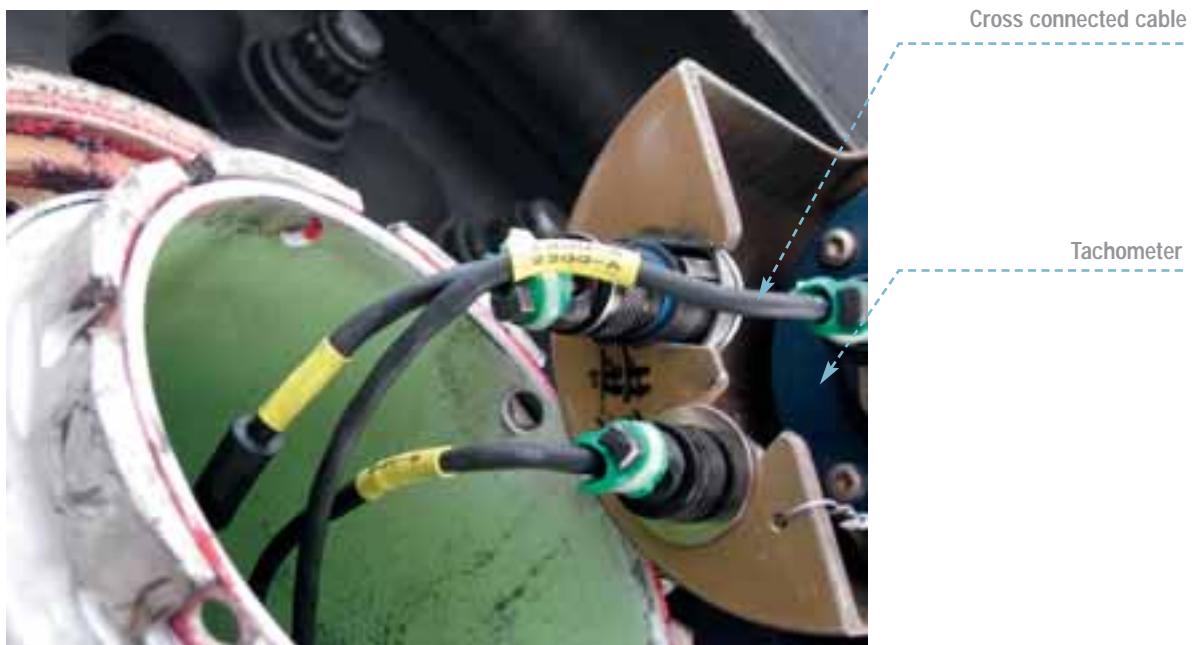
Figure 2: Picture of tachometer cross connections

Figure 2 shows an actual cross connection on the right hand side main gear. The cable labelled 19GG-A/22GG-A connected to the tachometer (the blue cylindrical equipment

which can be partially seen on the right hand side of the picture), should in fact have been the cable 20GG-A/21GG-A.

Crossed cables in the braking system have, in the past, caused incidents. It is therefore important to comply strictly with the published maintenance procedure.

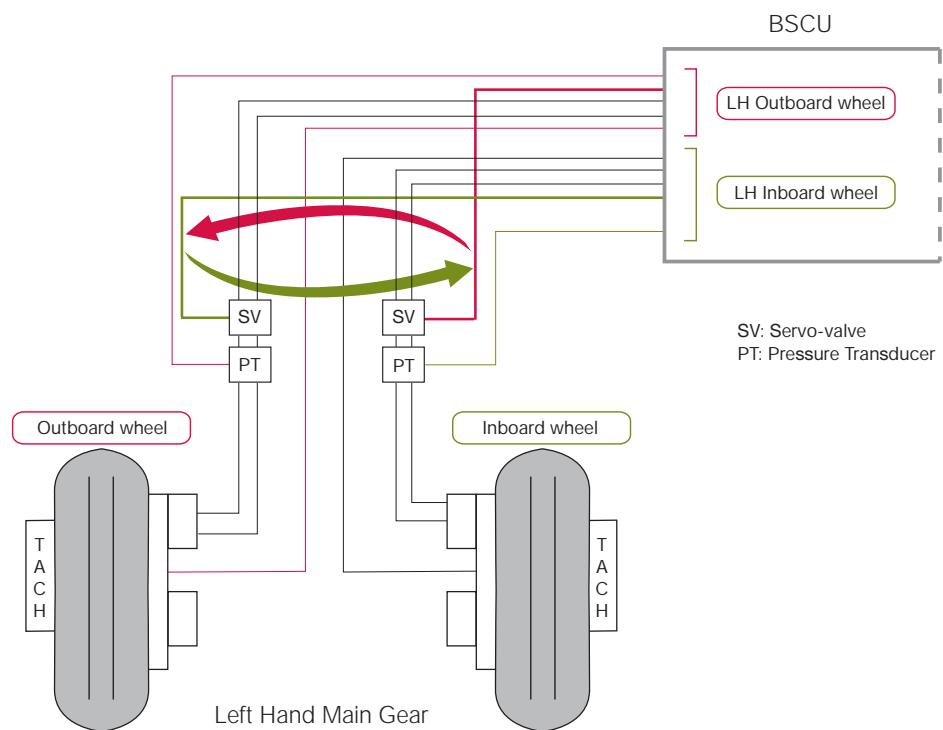
Figure 3: Schematic of servo-valve cross connections

It involves the connections to the servo-valves, as shown on figure 3.

The lower number of cases that have been reported can be explained by the fact that the flanges supporting the servo-valve cables have different lengths. This type of cross connections are thus more difficult to realize.

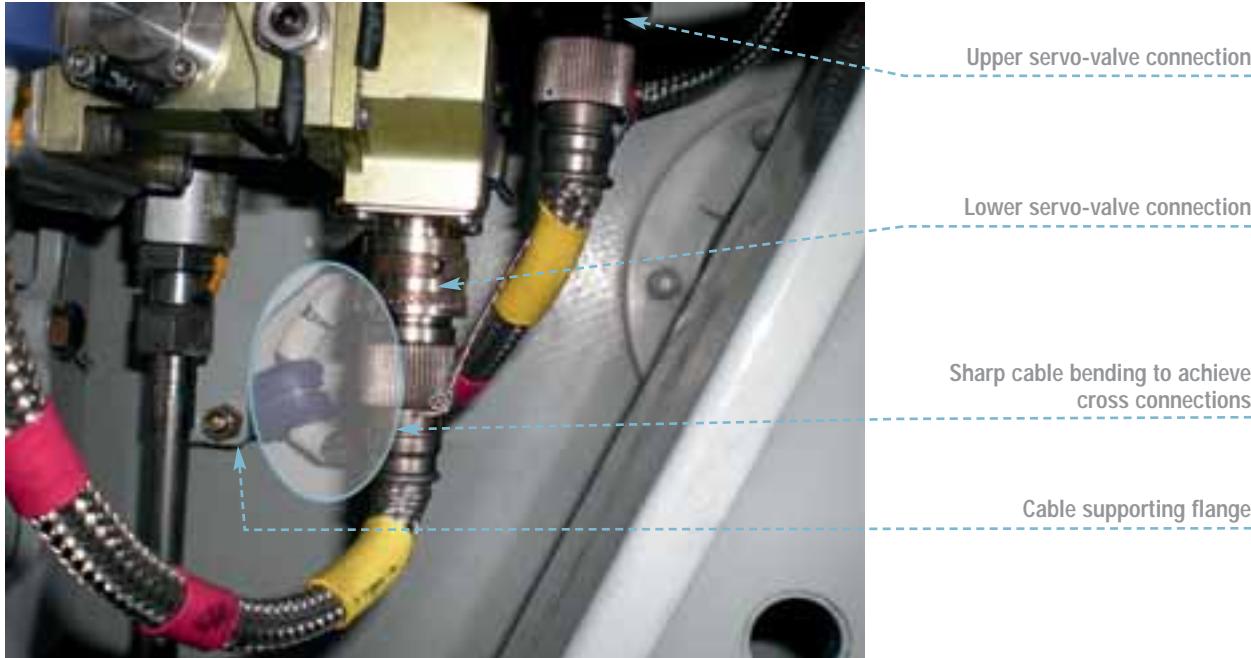
Figure 4: Picture of servo-valve cross connections

Figure 4 shows an example of servo-valve cross connections.

It shows that the flange supporting the cable to the lower servo-valve allows an easy connection only on the lower servo-valve. In this case, the flange forced the cable wrongly connected to the upper servo-valve to make an excessively sharp bend.
