January 2005

# HindSight

Putting Safety First in Air Traffic Management

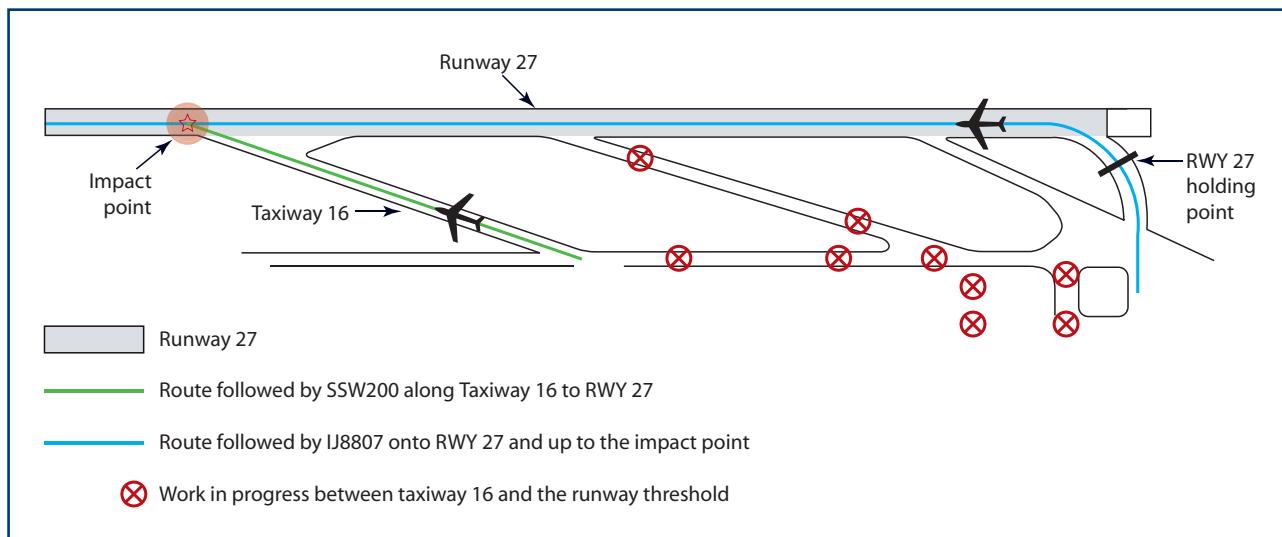
Shortly before impact, the Shorts 330 Captain noticed the MD 83 beacon lights and braked. About the same time, the MD 83 crew noticed the Shorts 330 on the edge of the runway. The aircraft had by then passed V1.

At 02:52:01 the left wing of the MD 83 collided with the right propeller and cut through the Shorts 330 cockpit.

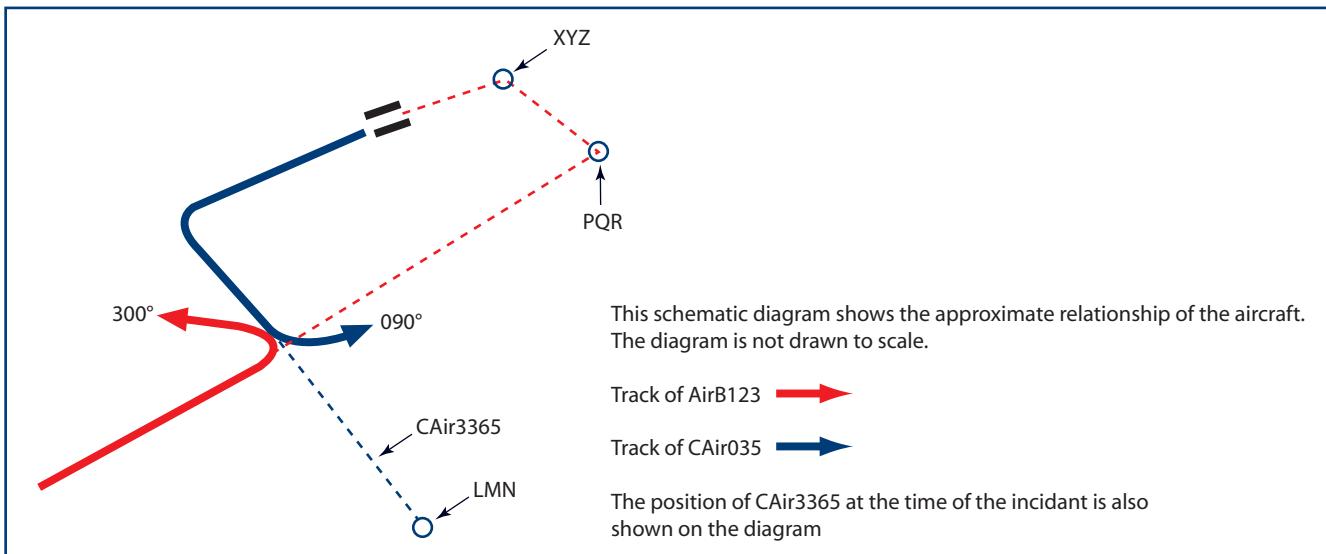
Two aircraft with callsigns CAir035 and CAir3365 departed from the same airfield on similar initial tracks within a few minutes of each other. The potential for call sign confusion (same prefix, two digits in each suffix the same, final digit in each suffix the same) was apparently not detected by the airline callsign deconfliction programme nor was it noticed by the controllers or the pilots of either aircraft.

The request from CAir035 for further climb was corrupt and the call sign was unclear. The DEP controller was expecting a climb request from CAir3365 and so assumed the call was from that aircraft and issued it with a clearance to climb to FL200 without first checking the call sign.

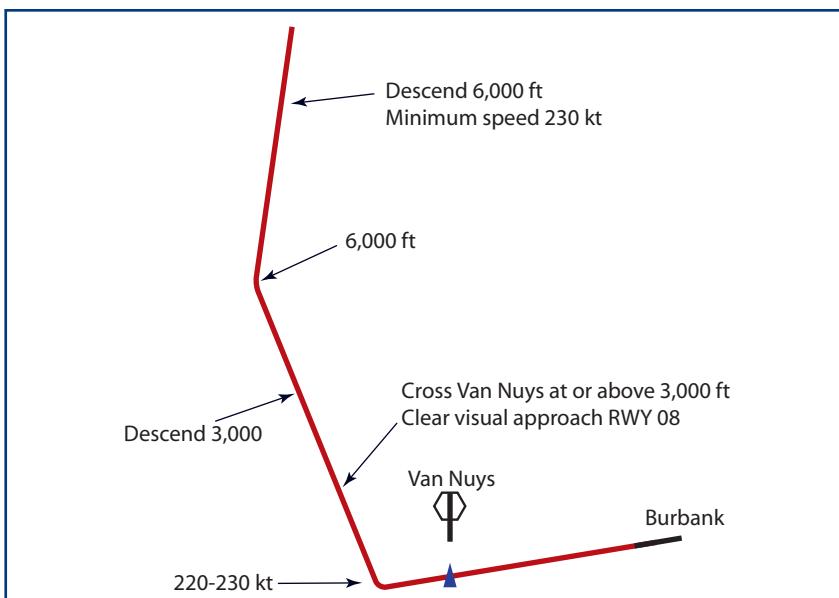
Vectoring for the approach continued with progressive descent clearances until 18:07:43 when the aircraft was cleared to 3,000 ft.

At 18:08:19 the flight was cleared to "cross Van Nuys at or above three thousand, cleared visual approach runway eight." This clearance effectively removed the speed restriction and the captain then commenced reducing speed. After the accident the captain stated that as the flight passed about 2 miles west of Van Nuys at 3,000 ft at approximately 220 kt to 230 kt, he deployed the speed brakes.

Further, the controller's instruction to "cross Van Nuys at or above three thousand" was ambiguous because the Van Nuys VOR is not on the aircraft's flight path. This ambiguous clearance may have caused the flight crew to delay descent longer than necessary.

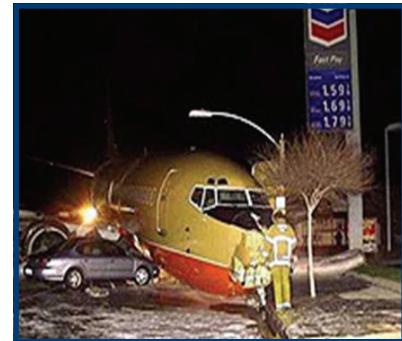
On 5th March 2000, at about 1811 local time, Southwest Airlines flight 1455, a Boeing 737-300, overran the departure end of RWY 8 after landing at Burbank Airport, California (BUR). The aircraft touched down at approximately 182 kt and about 20 seconds later, at approximately 32 kt, collided with a metal blast fence and an airport perimeter wall. The aircraft came to rest on a city street near a petrol station. 44 of the 142 persons on board were injured and the aircraft was extensively damaged.

"... the flight crew's excessive airspeed and flight path angle during the approach and landing and its failure to abort the approach when stabilized approach criteria were not met.

*The Southwest Airlines Boeing 737 which overran the runway at Burbank California.  
See page 18*
