National Transportation Safety Board

Aviation Accident Final Report

| Location: | Moncks Corner, SC | Accident Number: | ERA15MA259B |
| Aircraft: | LOCKHEED-MARTIN F-16CM | Aircraft Damage: | Destroyed |

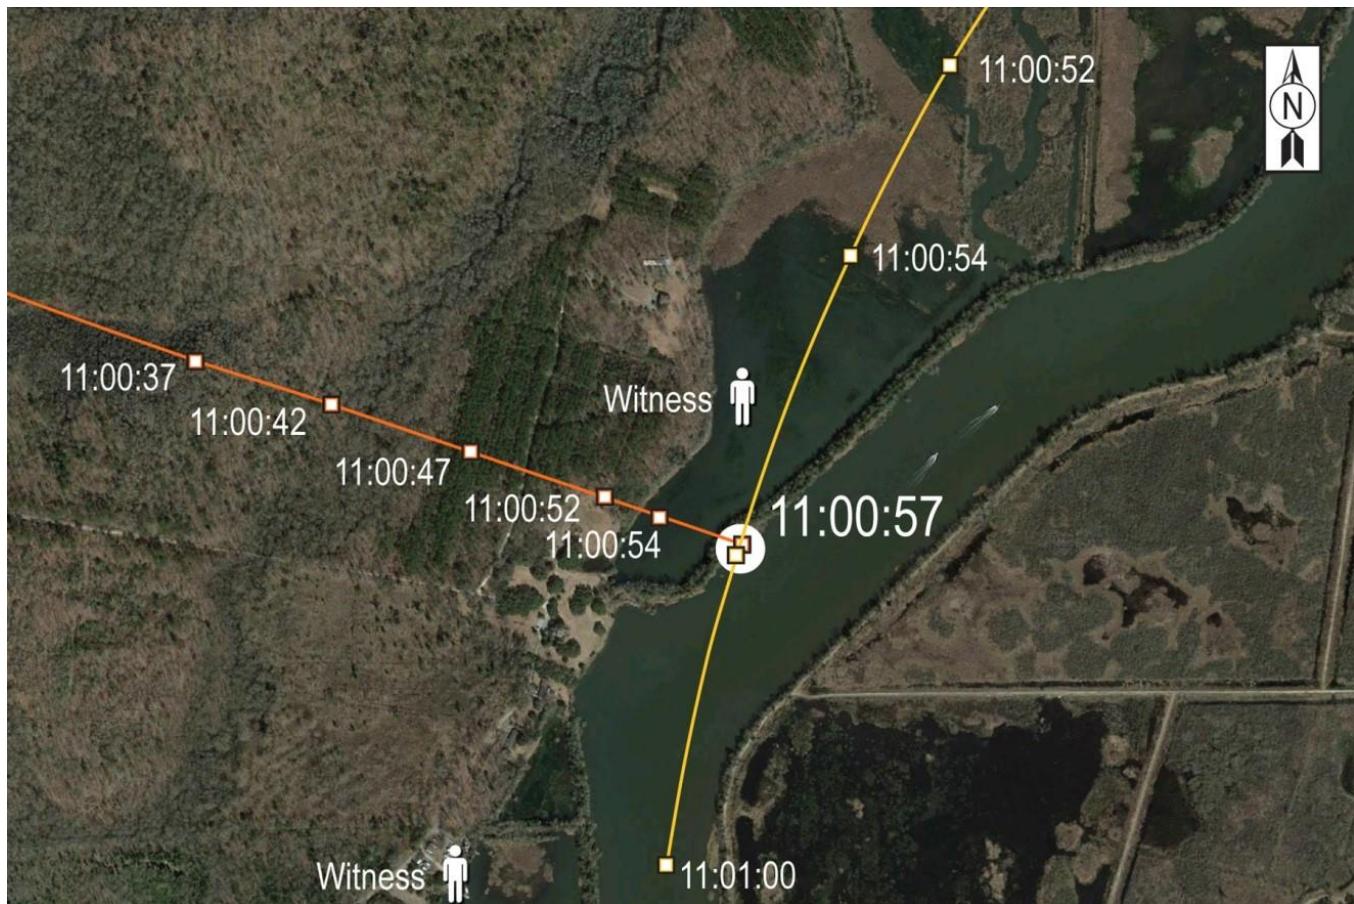
ATC radar continued to track the F-16 as it proceeded on a southerly course. After it descended to 300 ft, radar contact was lost at 1103:17 in the vicinity of the F-16 crash site. The F-16 pilot used the airplane's emergency escape system (ejection seat) to egress, incurring minor injuries as he landed on the ground under canopy. He was subsequently met by first responders. Figure 1 shows the calculated flight track for the F-16 and the Cessna.

Figure 1. Calculated flight track for the F-16 (yellow) and the Cessna (orange). (The first witness is located north of the collision point, and the second witness is located southwest of the collision point.)

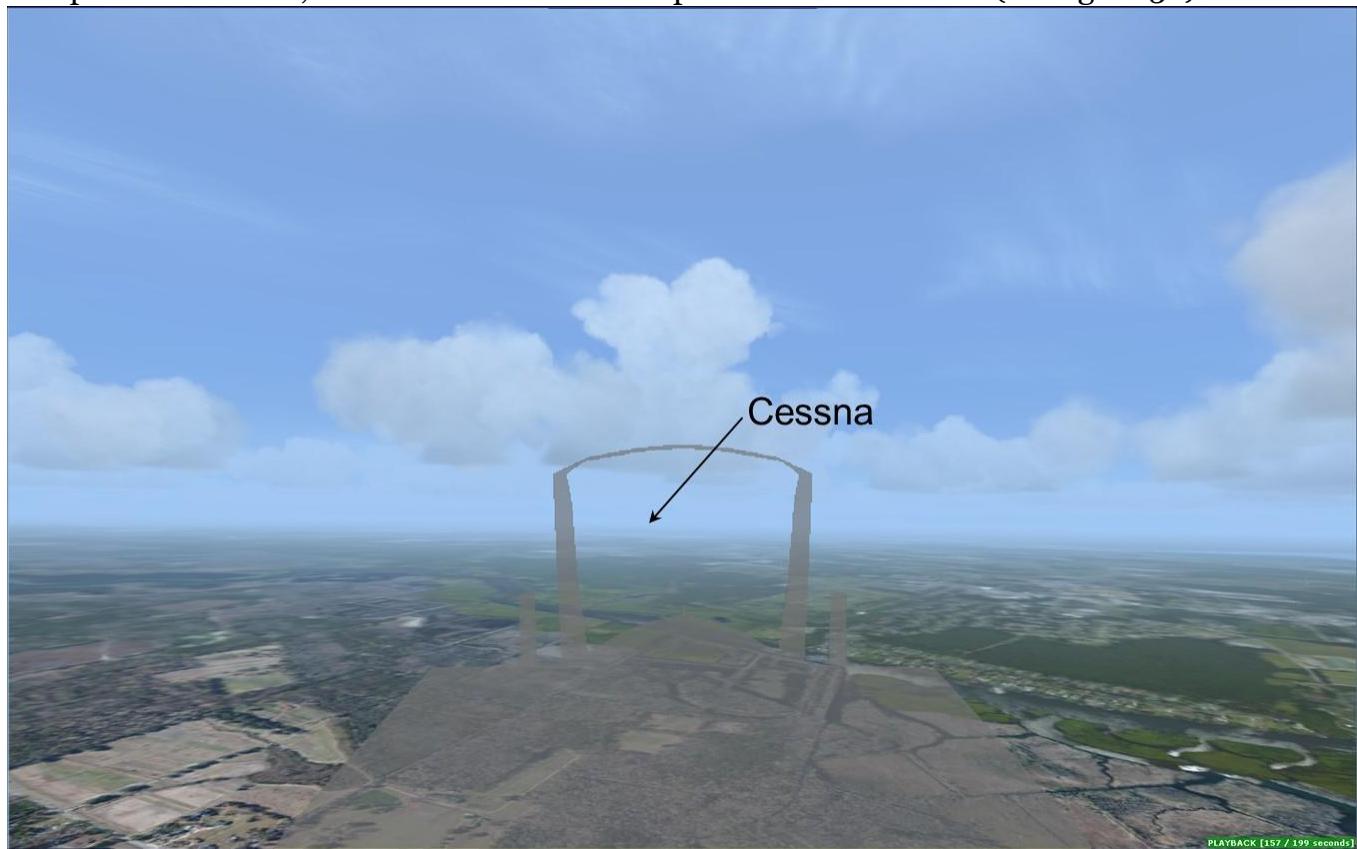
At 1100:16, when the controller provided the initial traffic advisory to the F-16 pilot, the F-16 was in a wings-level attitude, at an altitude of about 1,570 ft, on a ground track of 252°, and at a ground speed of 253 knots. The Cessna's calculated position was 3.25 nm from the F-16, at a position directly ahead (about 12 o'clock), and at an altitude of roughly 1,200 ft. The Cessna's ground track was 109°, and it was climbing at a rate of about 240 ft per minute. The aircraft performance and cockpit visibility study showed that, at 1100:18, the Cessna would have appeared to the F-16 pilot as a very small, stationary object just above the horizon and near the center of the airplane's heads up display (HUD) (see figure 3a); the F-16 would have appeared

Figure 3a. Simulated cockpit visibility from the F-16 at 1100:18, when the airplanes were 3.1 nm apart. (Transparent shadow masks depict areas where visibility is obscured by airplane structure.)

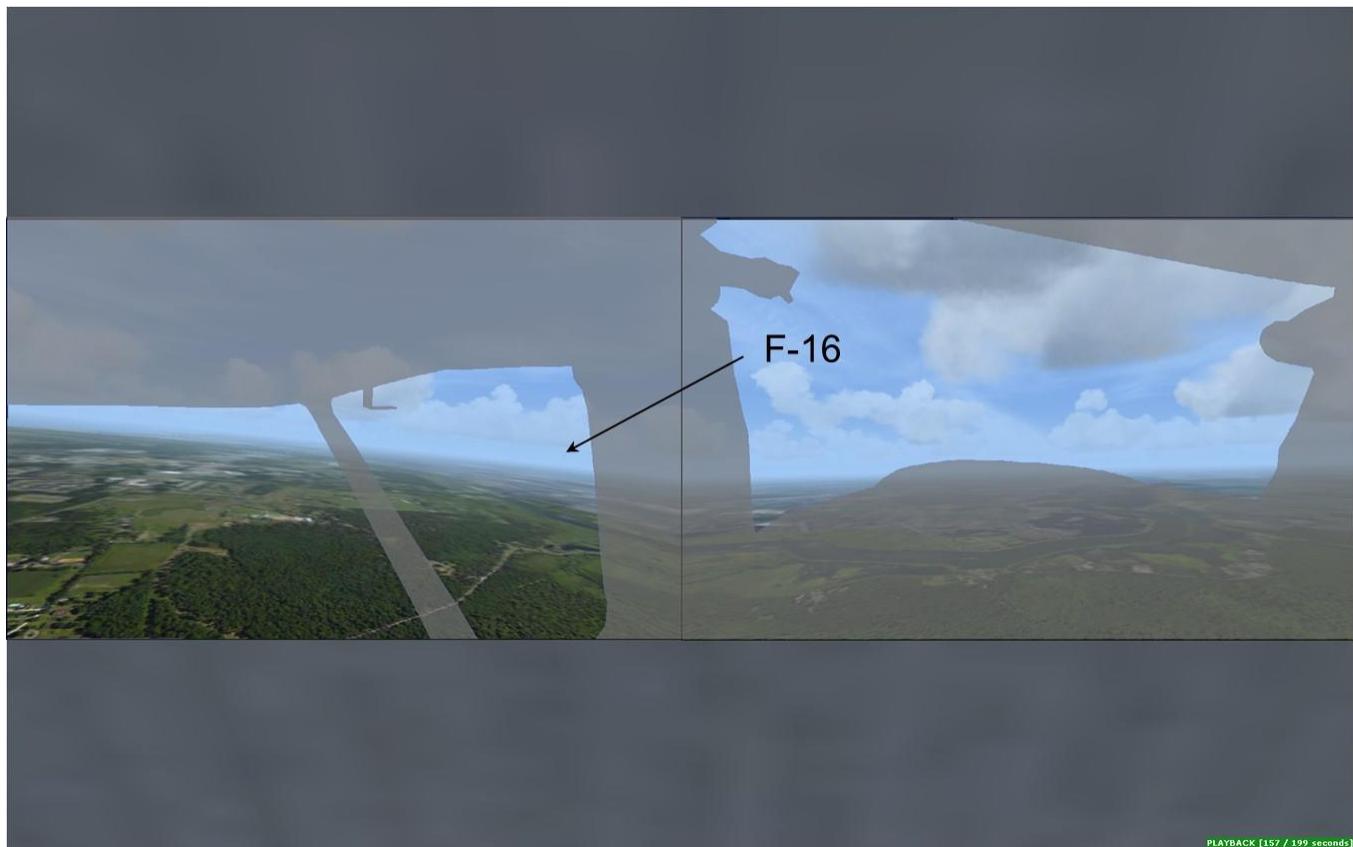
to the Cessna pilot as a small, stationary object just above the horizon, but outside of the left cockpit door window, near the forward vertical post of the door frame (see figure 3b).

Figure 3b. Simulated cockpit visibility from the Cessna at 1100:18, when the airplanes were 3.1 nm apart. (Transparent shadow masks depict areas where visibility is obscured by airplane structure.)

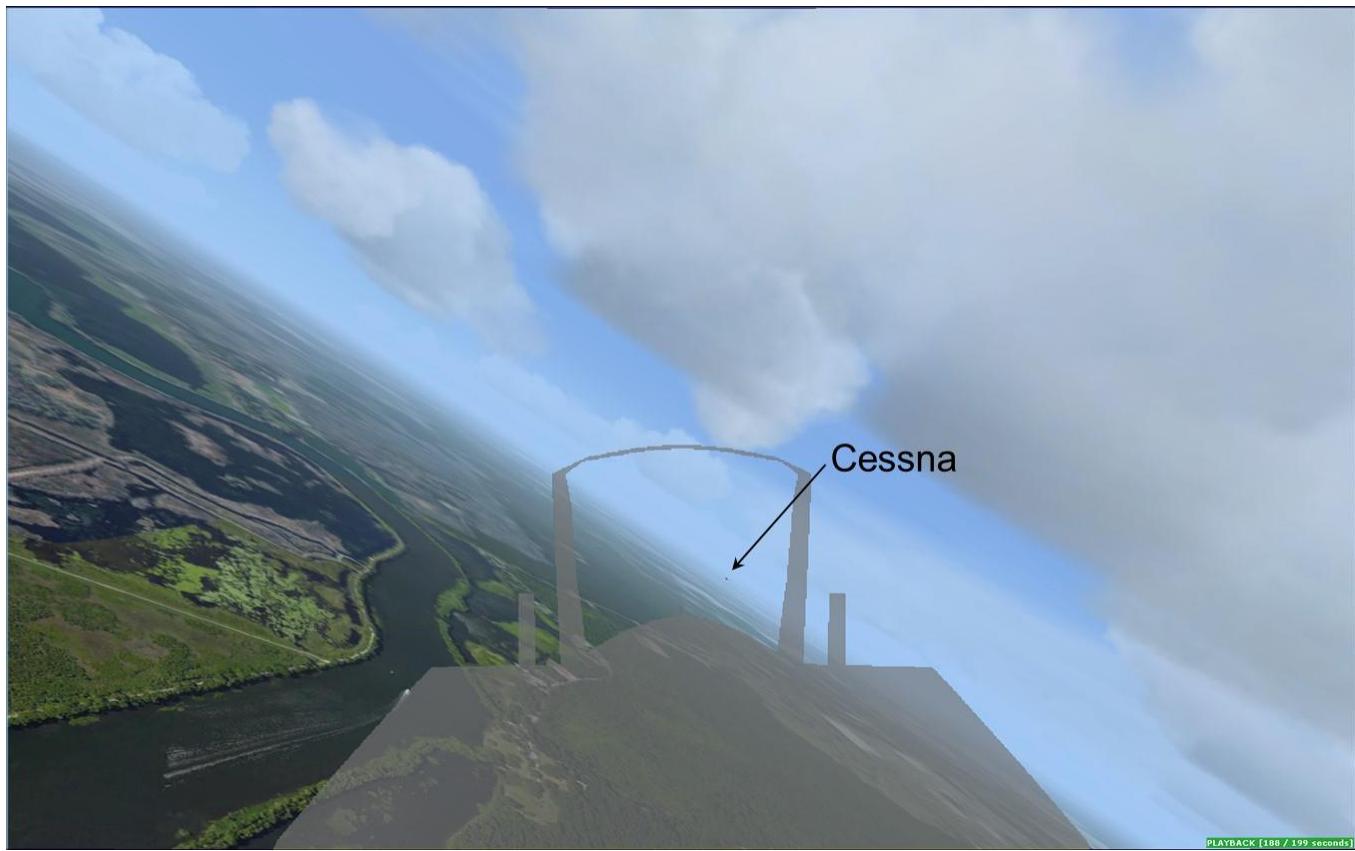
At 1100:49, as the F-16 was executing its left turn at a bank angle of 30°, the Cessna would have become more discernable in the lower right portion of the F 16 pilot's HUD (see figure 4a). The F-16 would also have become more discernable, visible through the Cessna pilot's left window at a point just forward of the wing strut attachment point (see figure 4b).

Figure 4a. Simulated cockpit visibility from the F-16 at 1100:49, when the airplanes were 0.6 nm apart.

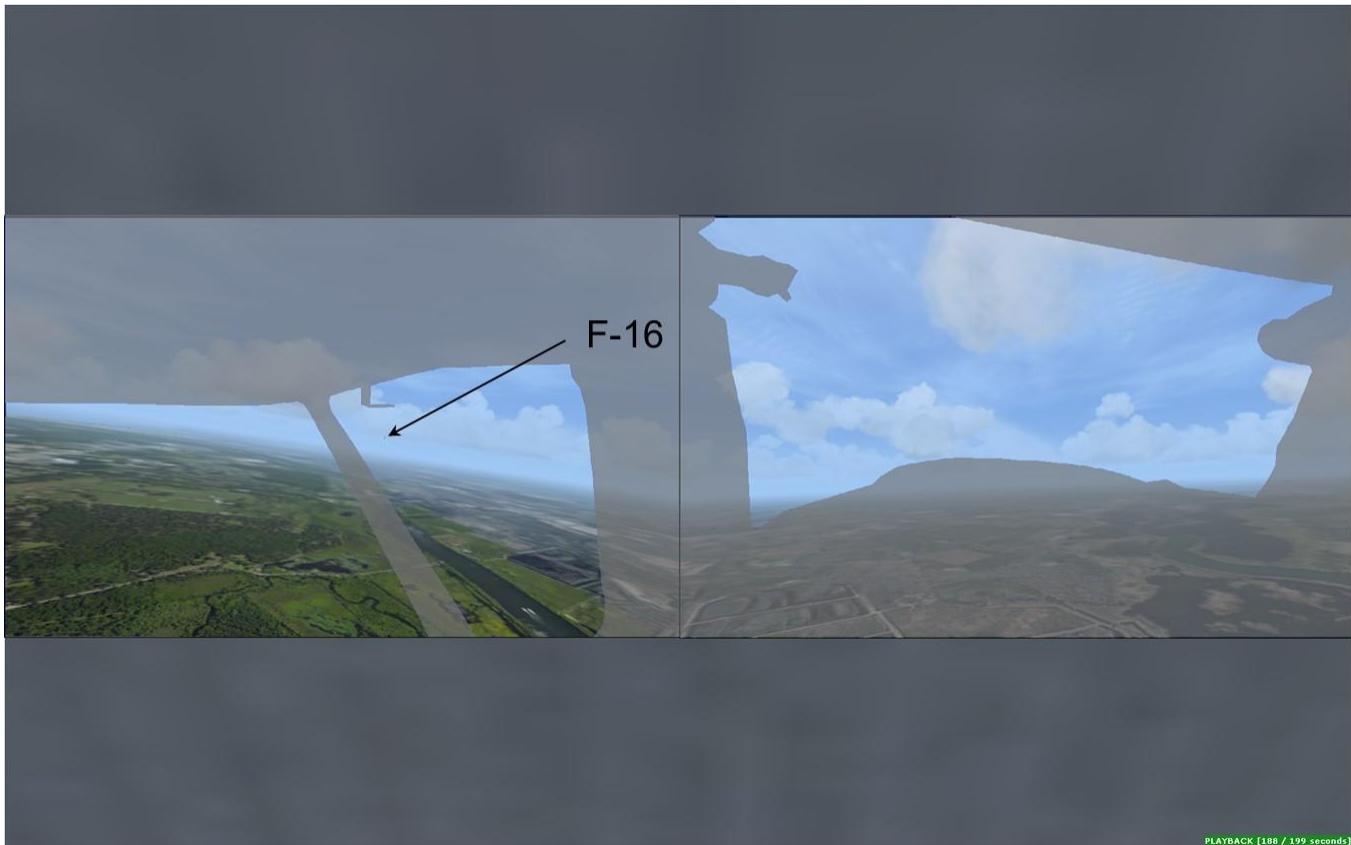
Figure 4b. Simulated cockpit visibility from the Cessna at 1100:49, when the airplanes were 0.6 nm apart.

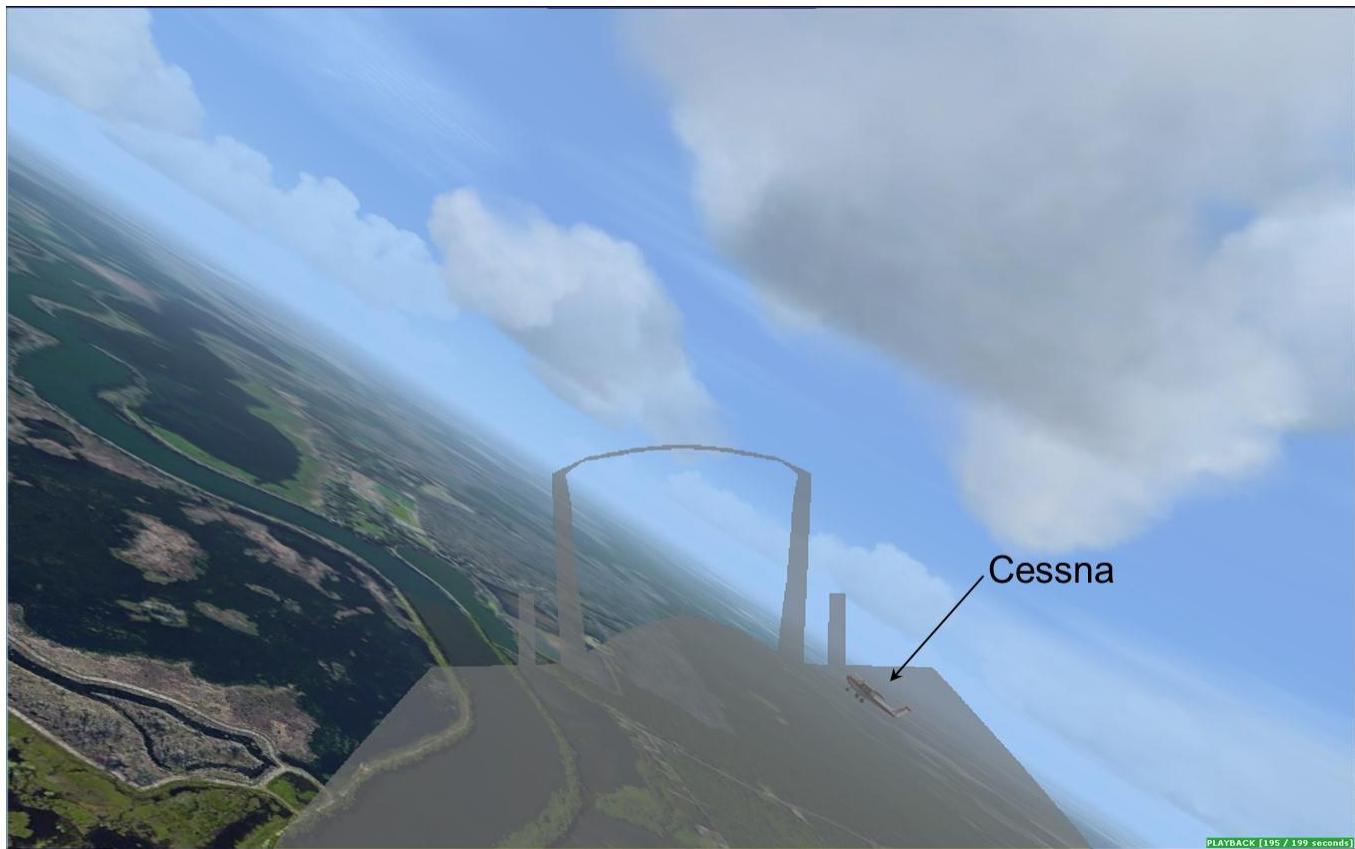
Over the next 3 seconds, the airplanes continued to approach each other, with the F-16 approaching the Cessna from its left and slightly above. The Cessna would have been completely obscured by the lower right cockpit structure of the F-16, as the airplane banked in its turn to the left (see figure 5a). The F 16 would have become partially obscured by the left wing strut (see figure 5b).

Figure 5a. Simulated cockpit visibility from the F-16 at 1100:56, when the airplanes were 260 ft apart.

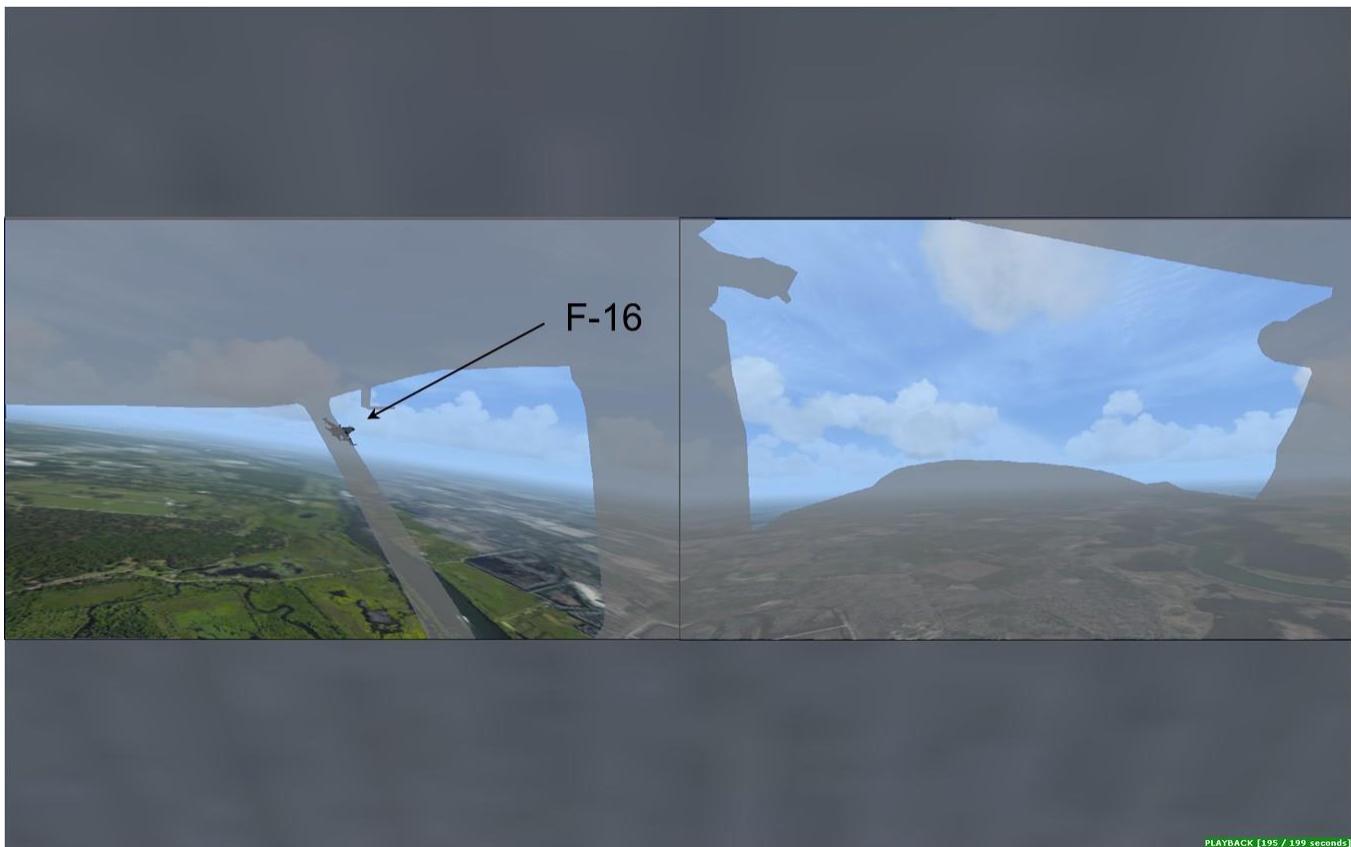
Figure 5b. Simulated cockpit visibility from the Cessna at 1100:56, when the airplanes were 260 ft apart.

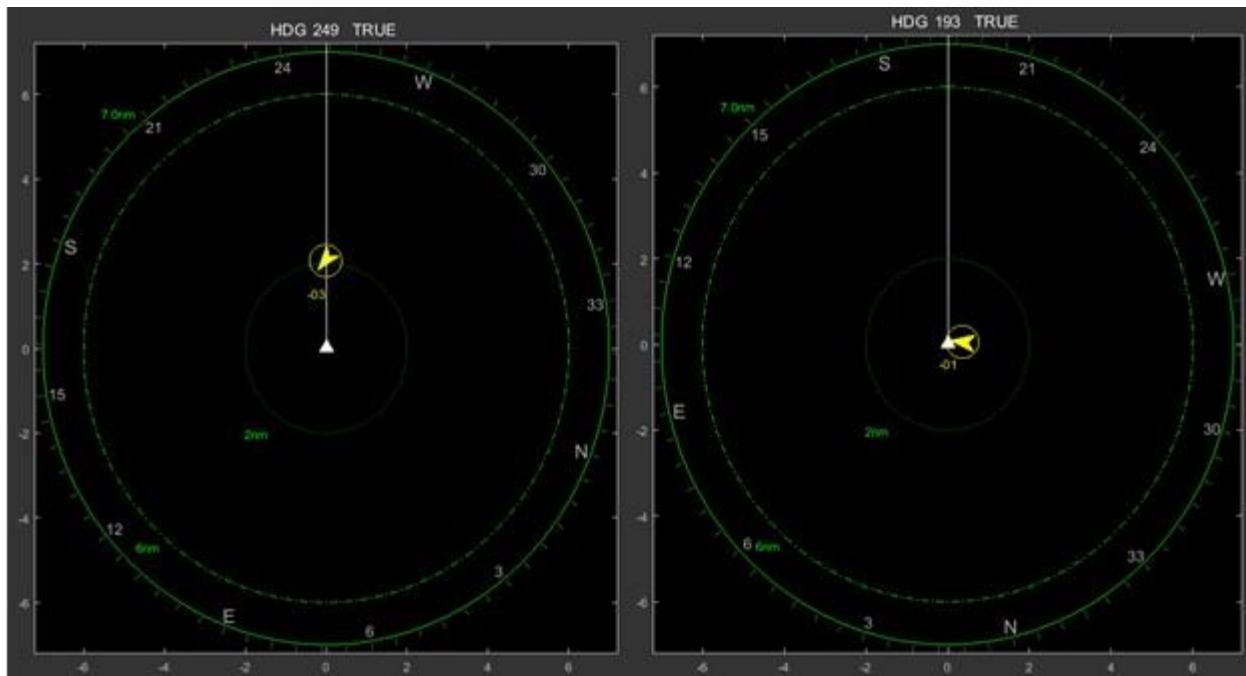
Consequently, an in-cockpit traffic display could have helped the F-16 pilot recognize the potential for a collision in advance of the controller's instruction to turn left. The earlier warning also could have provided him additional time to conduct his visual search for the Cessna and potentially take other preemptive action to avoid the collision. Had the F-16 been equipped with a system that was able to provide the pilot with resolution advisories, the F-16 pilot could have taken action in response to that alarm to avoid the collision, even without acquiring the Cessna visually.

At 1100:35, as the F-16 banked into its left turn toward the south, the pilot would have received an aural alert associated with the Cessna, which by then had closed within 2 nm horizontally and 300 ft vertically. The aural alert would have advised, "Traffic, 12 o'clock, low, 2 miles." As shown in figure 6, the Cessna symbol would have changed to a filled yellow arrowhead, enclosed by a yellow circle. As the F-16 continued in its left turn, the Cessna target would have rotated to the right side of the F-16's projected course, with its heading still projected to intercept that course. At 1100:56, one second before the collision, the F-16 would have received a second aural alert of "Traffic, 2 o'clock, same altitude, zero miles." The symbol representing the Cessna would have depicted it 100 ft below the F-16 (see figure 6).

Figure 6. Simulated in-cockpit traffic display for the F-16 at 1100:35 (left) and 1100:56 (right).

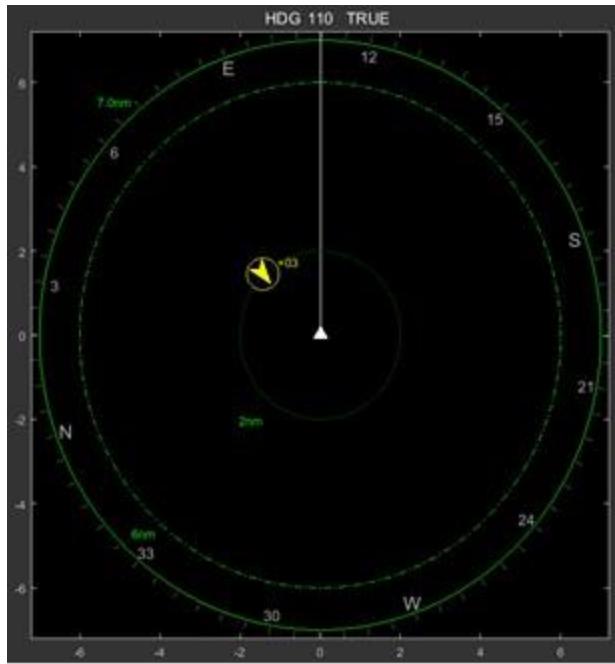
Because the Cessna pilot was not in contact with ATC and was relying solely on the see-and-avoid concept, an indication of approaching traffic might have allowed him to visually acquire the F-16 and take action to avoid it. While most systems are limited to aiding pilots in their visual acquisition of a target and do not provide resolution advisories (specific maneuvering instructions intended to avoid the collision), the augmentation of a pilot's situational awareness might allow the pilot to change the flightpath in anticipation of a conflict and, thus, avoid airplanes coming in close proximity to one another. The Cessna pilot might have noted the presence of the F-16 and its level altitude of about 1,600 ft as he continued his departure climb. With this information, the Cessna pilot might have arrested his airplane's climb as he began a visual search, thus creating an additional vertical buffer between his airplane and the approaching F-16.

At 1100:35, as the F-16 banked into its left turn toward the south, the Cessna pilot would have received an aural alert associated with the F-16, which by then had closed within 2 nm horizontally and 300 ft vertically. The aural alert would have advised, "Traffic, 11 o'clock, high, 1 mile." As shown in figure 7, the F-16 symbol would have changed to a filled yellow arrowhead, enclosed by a yellow circle. The Cessna would not have received a second aural alert for the F16, but the F-16 symbol would have remained in alert status (filled yellow arrowhead enclosed by a yellow circle) until the collision.

Figure 7. Simulated in-cockpit traffic display for the Cessna at 1100:35.
