AVIATION INVESTIGATION REPORT **A14Q0155**

Runway excursion

Air Canada

Airbus A330-343, C-GFAF

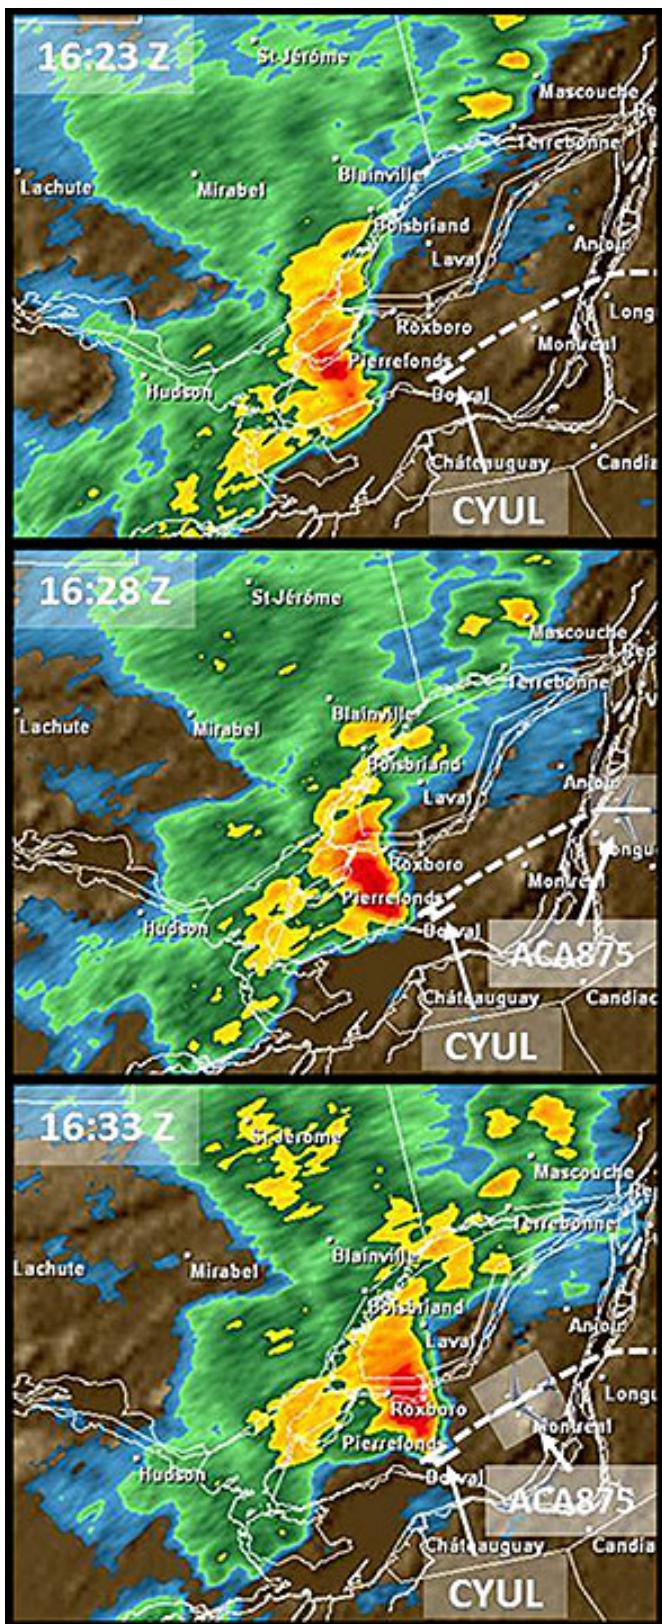
Figure 5. Movement of the thunderstorm shown on the Burlington Radar (Source: Environment Canada, with TSB annotations)

The strong precipitation to the north of the runway, the temporary drop in ground temperature, and the change in wind direction and strength all tend to confirm the presence of a downburst to the north of the runway at the time ACA875 was landing (Figure 5).

- A thunderstorm from the southwest of Montréal Island moved to just north of CYUL while intensifying between 1200 and 1300.
- The strong precipitation associated with the thunderstorm led to downbursts of wind that reached the ground, resulting in the strong gusts observed in the western sector.
- At 1234, the thunderstorm was located approximately 1 nm north of Runway 24R.

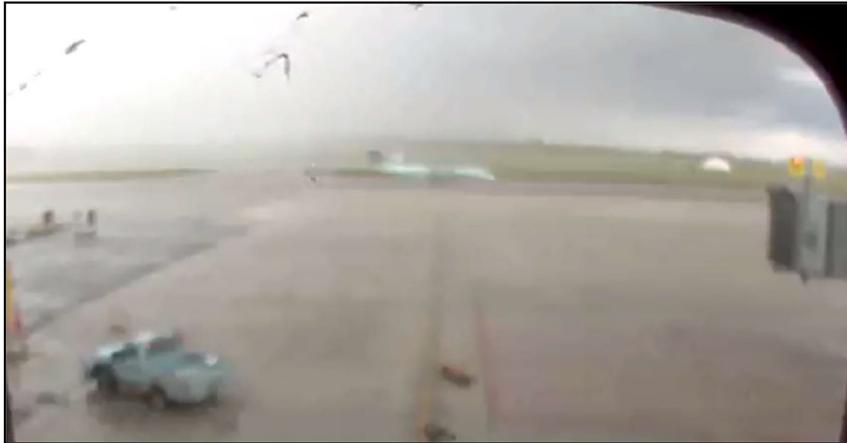
Figure 7. Weather conditions over Runway 24R at 1232:23 (Source: Aéroports de Montréal)

Figure 7 shows the weather conditions at 1232:23, i.e. 2.5 minutes before the landing; Figure 8 shows the weather conditions at 1233:56, i.e. 1 minute before the landing. The rain shower can be observed to have moved toward the threshold of the runway. Figure 9 shows the weather conditions at the time of the landing. Note that the aircraft is creating a plume of water during the landing roll.

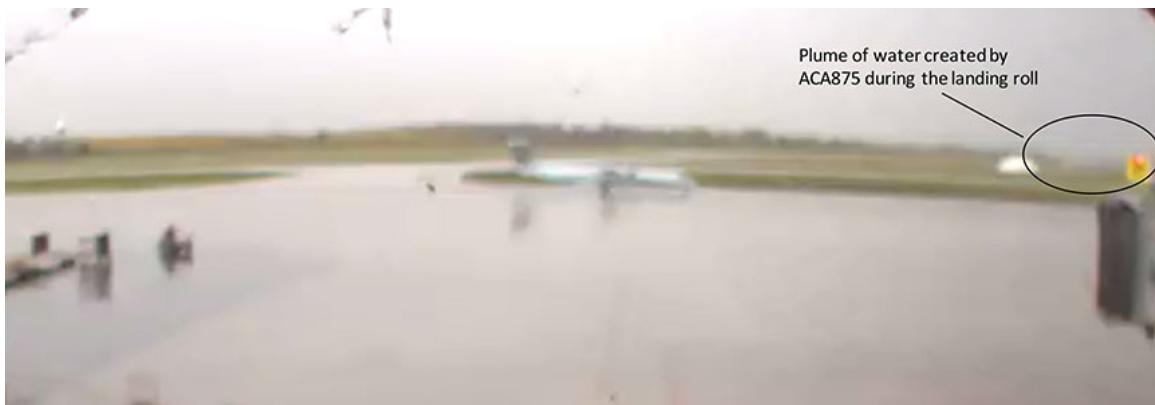
Figure 9. Weather conditions over Runway 24R (at the time of the landing; 12:35) (Source: Aéroports de Montréal with TSB annotations)

Note that at the time of the landing, the shower was passing the threshold of Runway 24R. Also note that the aircraft tires and possibly reverse thrust are spraying a significant plume of water behind the aircraft, indicating the presence of water on the runway.

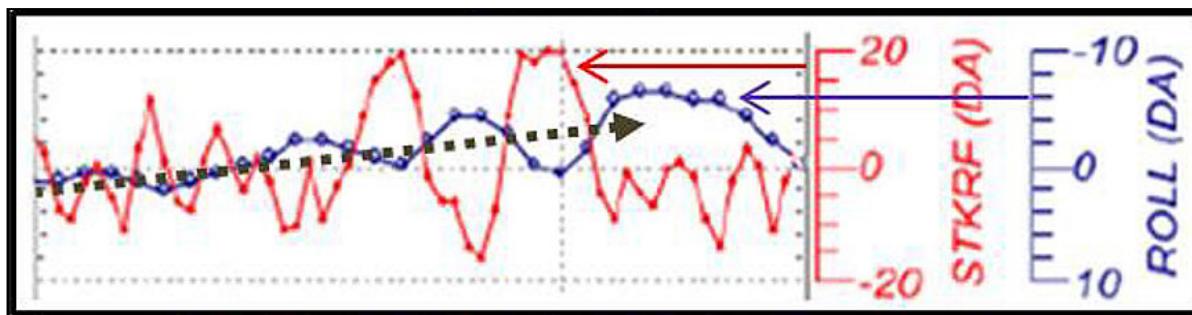
Figure 11. Data from the digital flight data recorder indicating the presence of pilot-induced oscillation

Analysis of the DFDR plots shows that at approximately 120 feet agl, the aircraft experienced 3 rolling oscillations, the amplitudes of which expanded progressively from 2° to 6° (Figure 11). At the same time, pronounced sideways movement of the co-pilot's side stick controller was observed, twice reaching the maximum deflection, and out of phase 90° with the rolling movement of the aircraft. These oscillations accompanied by the opposing deflections by the co-pilot indicate the presence of pilot-induced oscillation.

By definition, pilot-induced oscillation occurs only when the pilot performs actions with the side stick controller that have the effect of maintaining these oscillations. Since the pilot's actions are the source of these oscillations, generally halting all movement or letting go of the side stick controller is sufficient to stop pilot-induced oscillation.

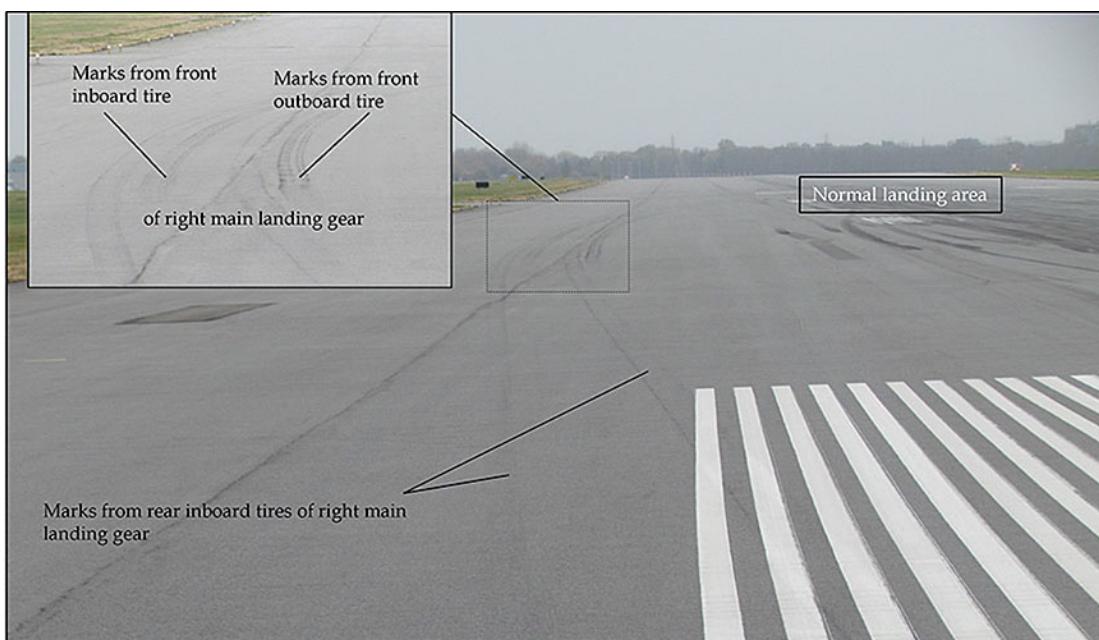
Figure 12. Tire marks on the runway

Tire marks from the main landing gear were visible on the runway (Figure 12). Before compression of the main gear, the rear wheels of the right gear (No. 7 tire and No. 8 tire) left marks that began 1332 feet from the runway threshold and 57 feet to the left of the centre of the runway. At that time, the left rear tire (No. 5 tire) of the left bogie was 97 feet from the centre of the runway and approximately 4 inches from the ground. The trajectory of these marks was shifted 2° to the left in relation to the runway centreline.

Before touching down, the right rear tire of the left main gear (No. 6 tire) struck a first runway edge light 1538 feet from the threshold. The first tire marks from No. 5 tire appeared on the grass 1708 feet from the threshold and 107 feet to the left of the centre of the runway. Subsequently, No. 6 tire struck another runway edge light and passed beside the next light, located 200 feet beyond.

Compression of the right main gear (Nos. 3, 4, 7, and 8 tires) occurred 1734 feet from the threshold and 68 feet to the left of the centre of the runway. Darker tire marks indicated a trajectory that clearly veered toward the right of the runway centreline. These marks suggest good adherence of the tires on the runway surface. No indication of hydroplaning on the runway was observed. At that time, the aircraft was banked approximately 0.5° to the right.

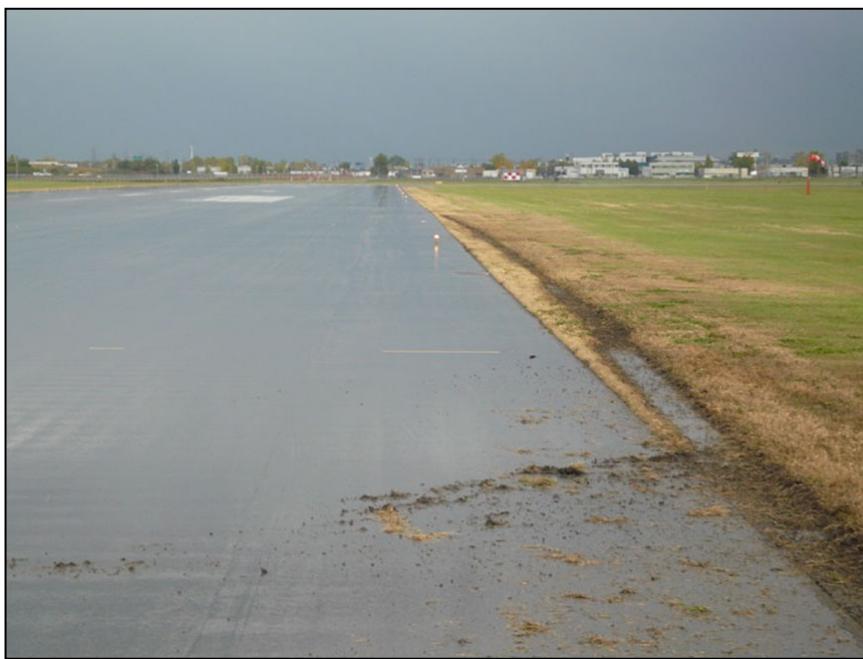
Figure 13. Tire marks on the grass

At 2130 feet from the threshold and approximately 107 feet to the left of the centre of the runway, an expansion of the marks was observed on the grass, corresponding to compression of the left main gear (Figure 13). At the same time, the right front tire of the left bogie (No. 2 tire) struck the runway edge light.

The last marks on the grass were 2215 feet from the threshold and 105 feet from the centre of the runway. The total length of the marks on the grass was 507 feet. The runway excursion covered a total distance of 677 feet (Appendix D).
