BULLETIN

Serious incident

BOMBARDIER INC. DHC-8-202

RUNWAY SNOW CLEARING VEHICLES

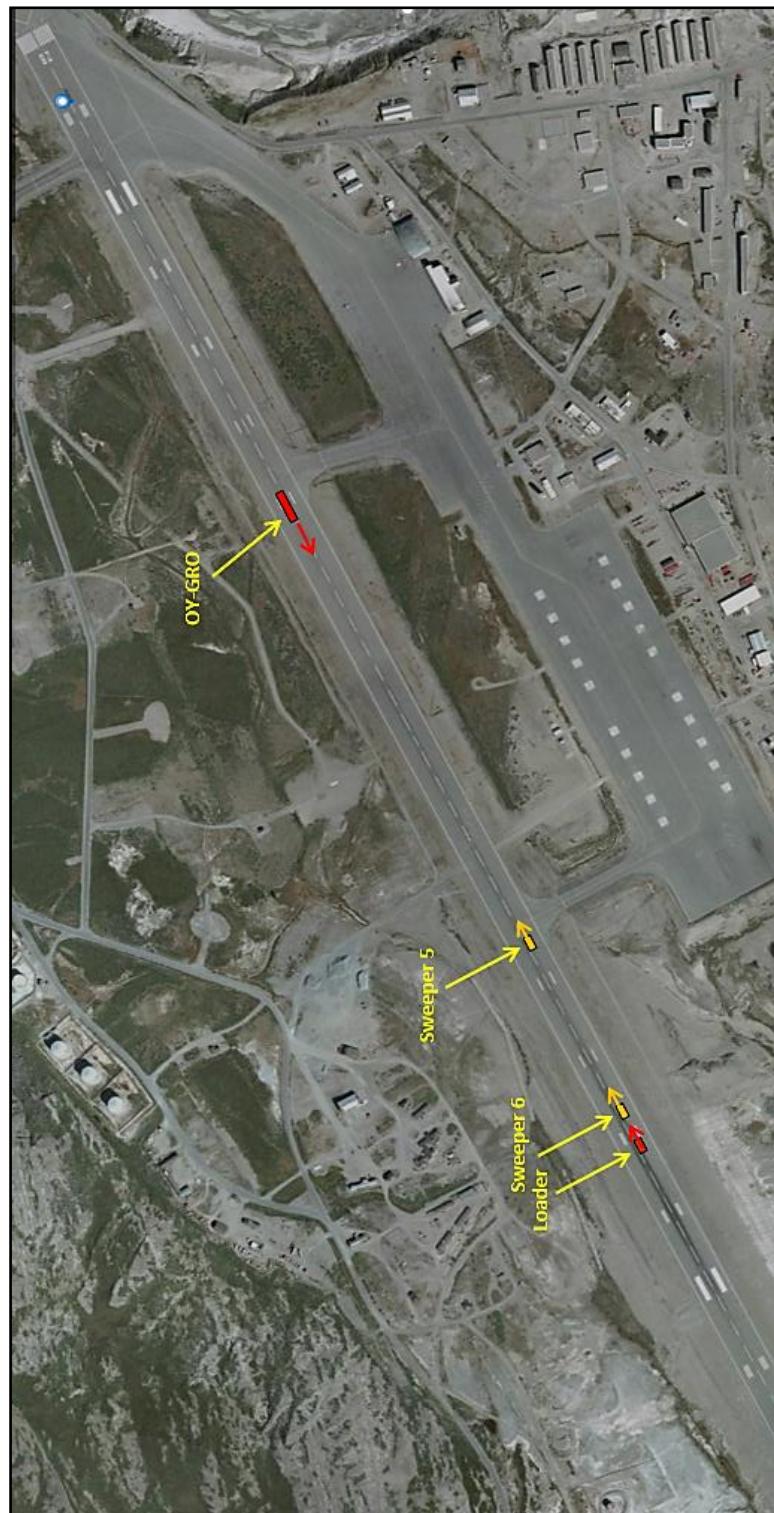
APPENDIX 1

When OY-GRO rotated, the horizontal separation to the nearest runway snow clearing vehicle on the runway was approximately 900 meters.

The vertical separation, when OY-GRO passed overhead the nearest runway snow clearing vehicle on the runway, was approximately 300 feet.

The downslope at the far end of runway 27 prevented the flight crew - when lining up the aircraft on runway 27 - from spotting the three runway snow clearing vehicles. To the flight crew, the runway seemed free.

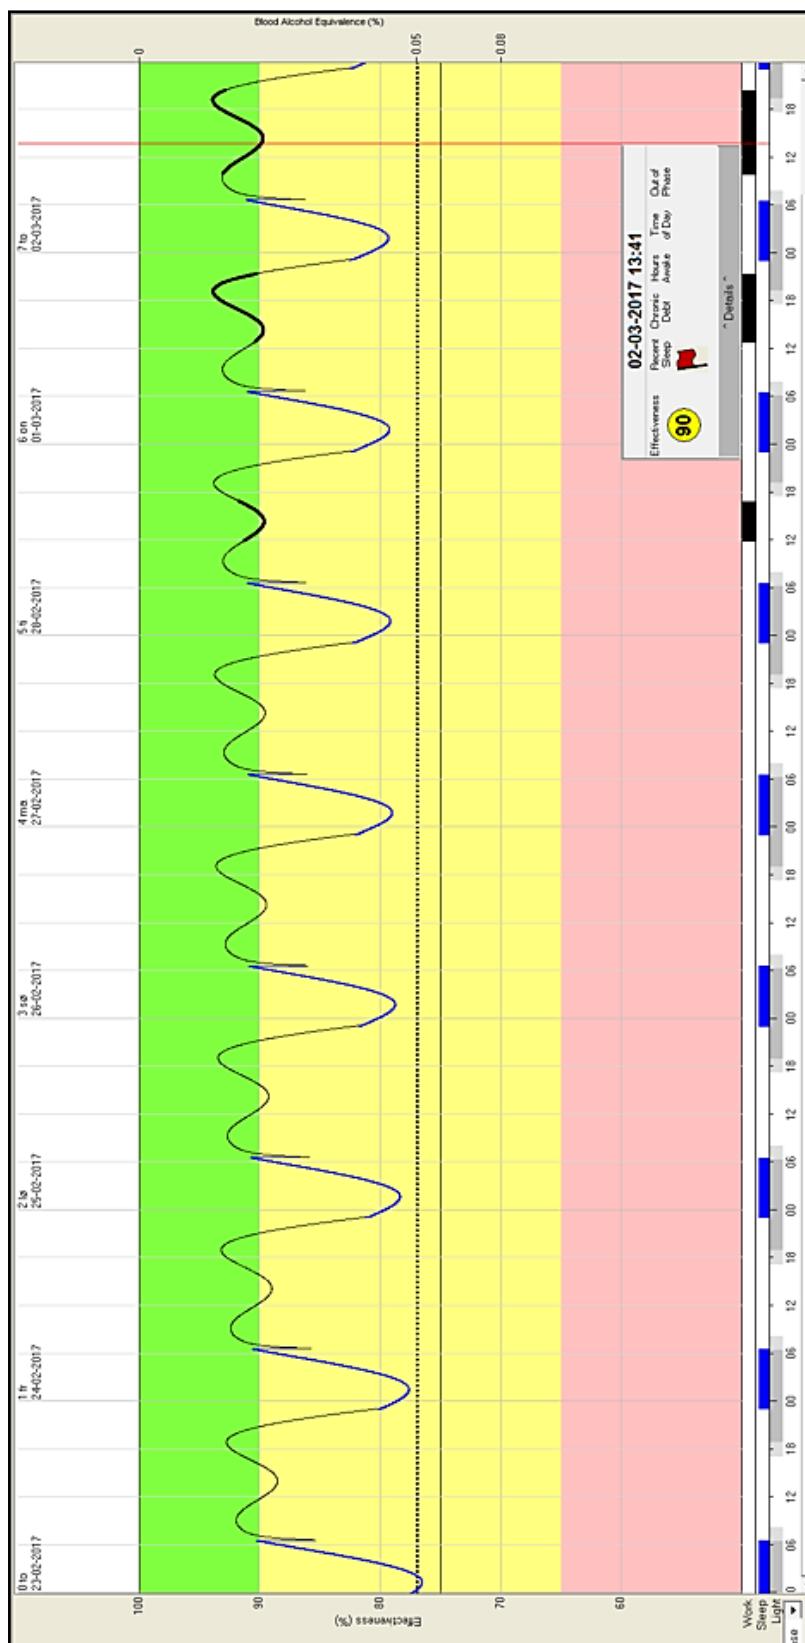
APPENDIX 4

By using a generic fatigue evaluation tool and taking into consideration the actual duty and rest periods and the flight crew reported sleep quantity, the AIB considers the flight crew to be well-rested in the morning on 2-3-2017. With reference to the output data of the fatigue evaluation tool, the flight crew neither suffered from accumulated nor acute fatigue.
