**SERIOUS INCIDENT TO AIRBUS A320-216, REGISTRATION 9M-AQA,
RUNWAY EXCURSION**

7 JULY 2014

**[AAIB BRUNEI 001/2014]
Air Accident Investigation Team
Brunei Darussalam
Ministry of Communication
21 May 2015**

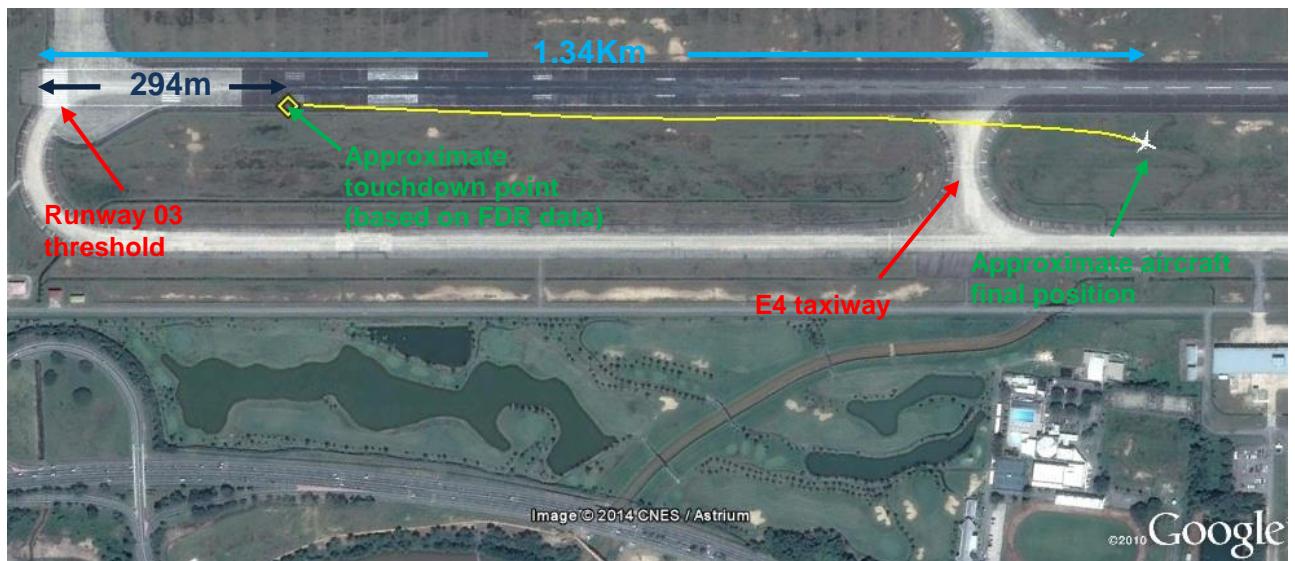
1.1.8 According to the aerodrome controller, at around 15:32 when the aircraft was approximately 1 Nautical Mile from the runway, the shower intensified and extended up to the area around the E4 taxiway (See Figure 1)

Figure 1: Yellow line shows path of aircraft
