Accident No: DCA17IA148

Accident Type: Office of Aviation Safety

Location: San Francisco , CA

Update August 2, 2017:

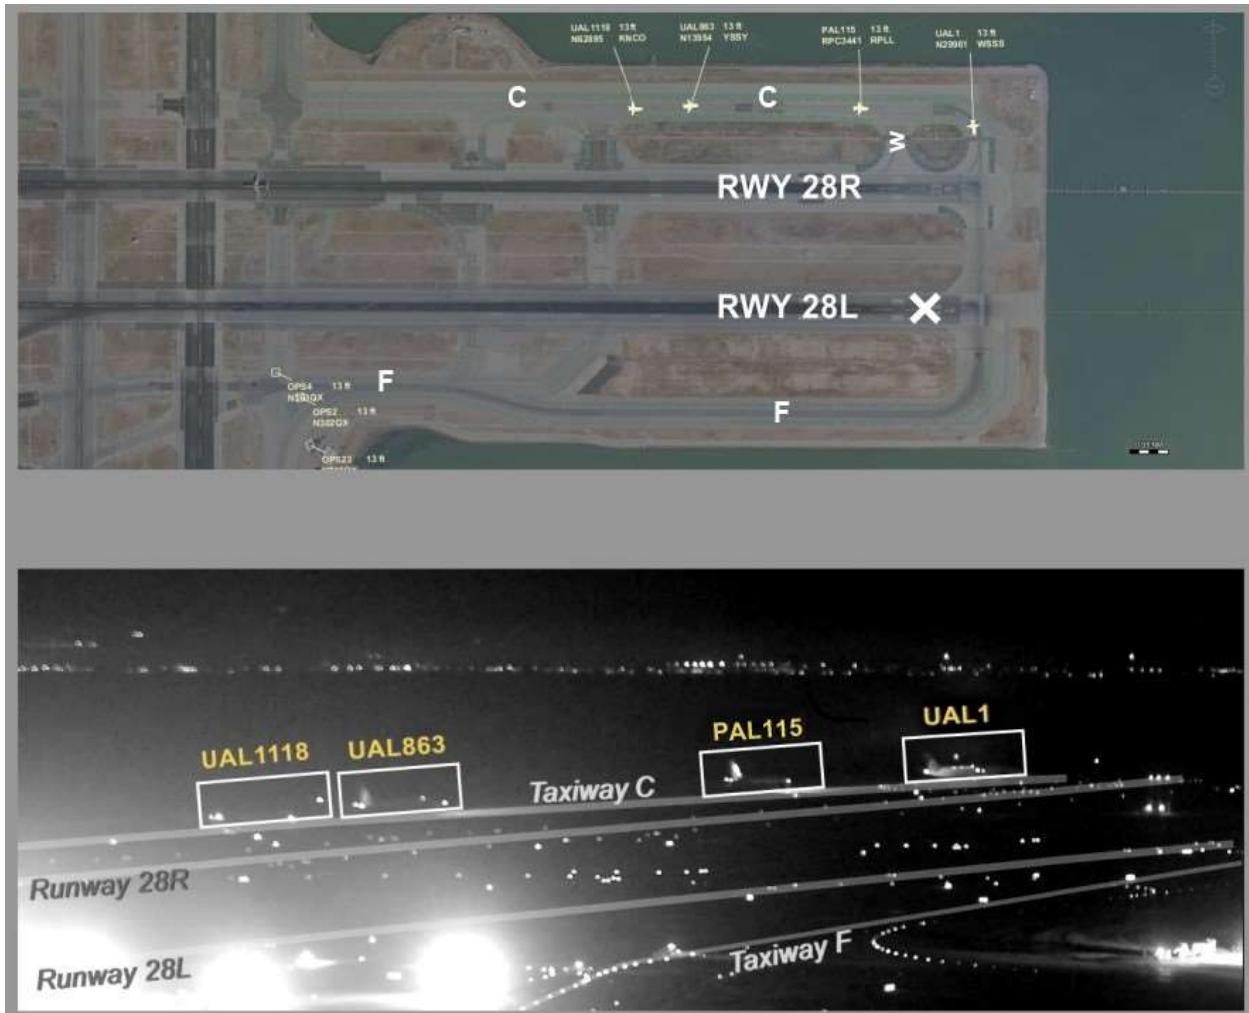
Figure 1 shows the positions of the airplanes on taxiway C. The top diagram is from Harris Symphony OpsVue radar track data analysis, and the bottom picture is from the SFO airport video. Altitudes are shown in mean sea level (msl); ground level is 13 ft msl. Airplanes in the top diagram are not to scale.

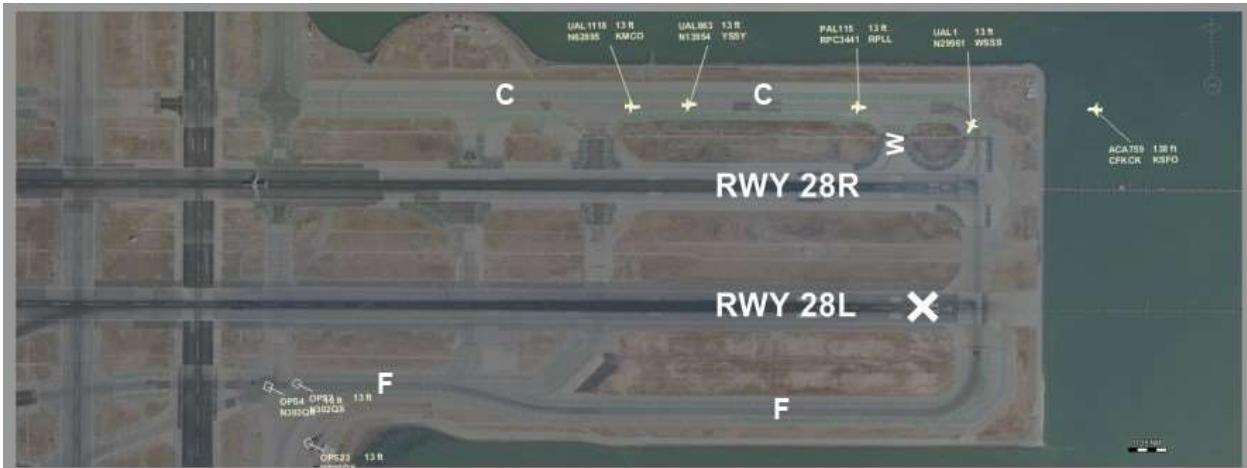
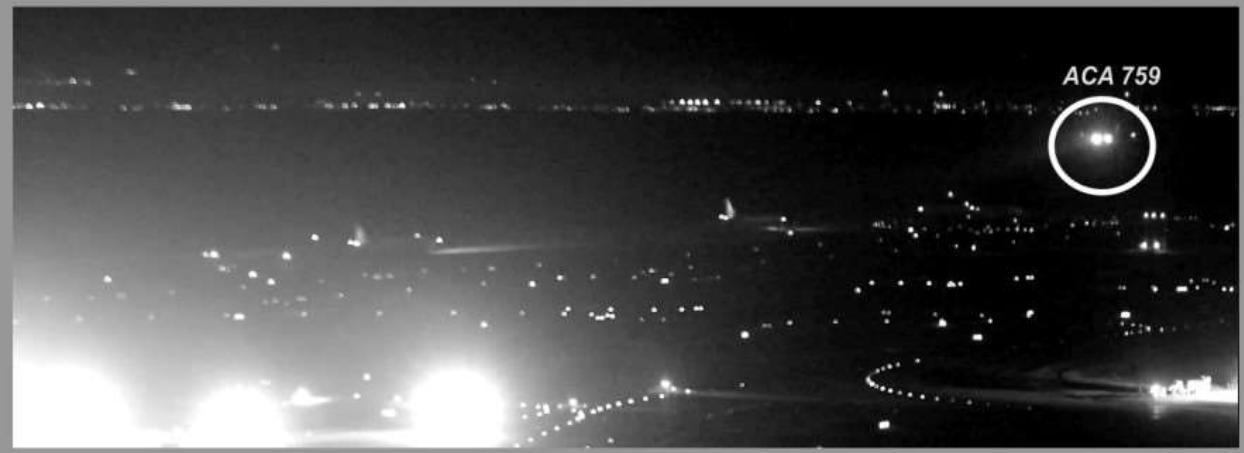
UAL1 (23:56:01): where's this guy going?

Figure 2 shows UAL1's transmission at 2356:01 and ACA759's position as it approaches the taxiway.

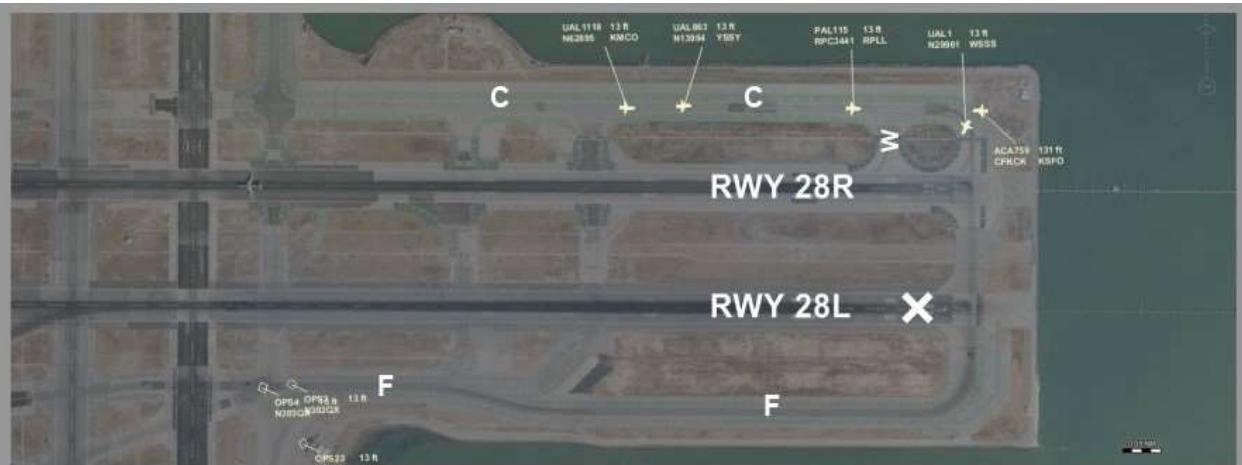
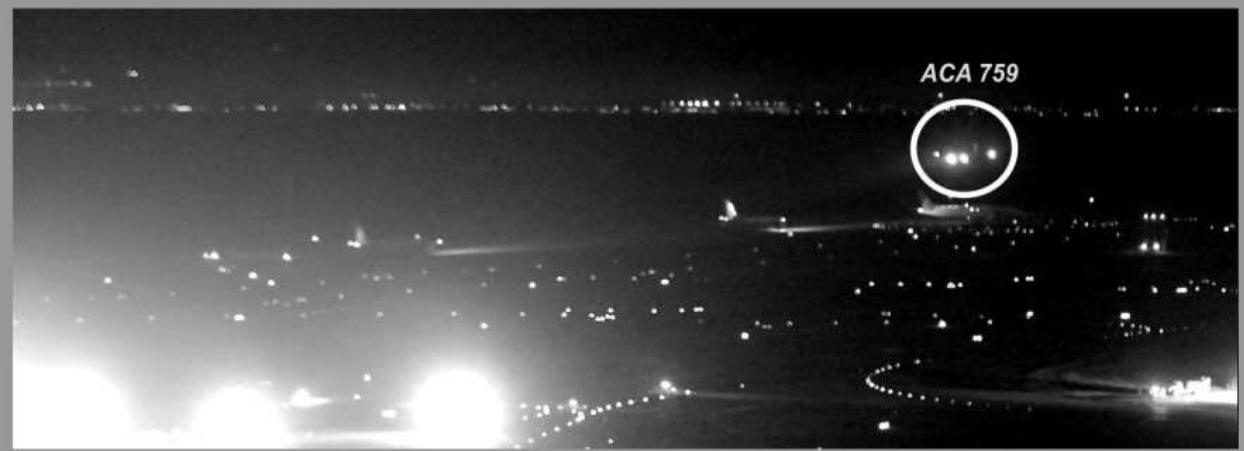
UAL1 (23:56:04): he's on the taxiway.

Figure 3 shows UAL1's transmission at 2356:04 and ACA759's position as it overflies the first airplane waiting on the taxiway; note that the second airplane has turned on its landing lights.

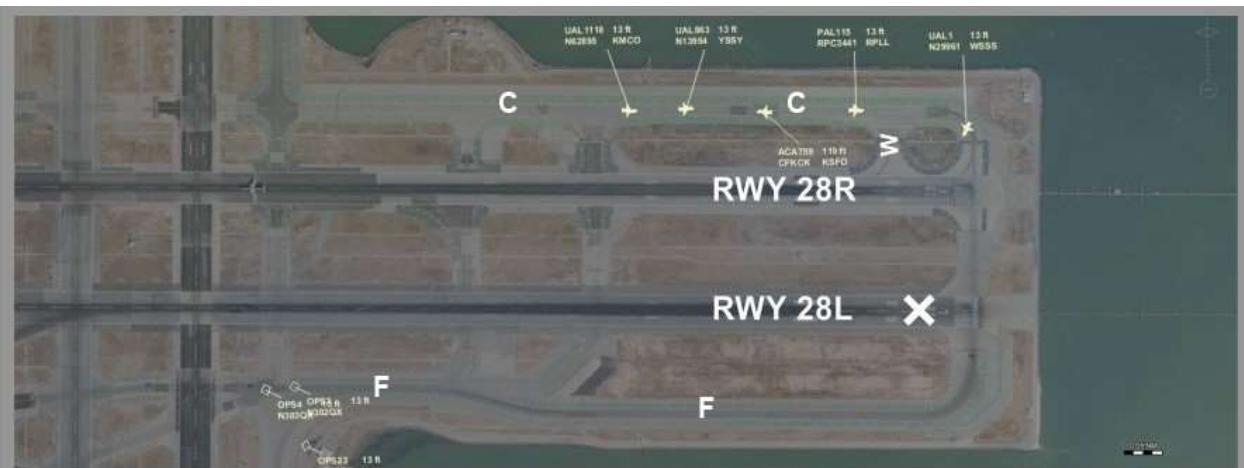
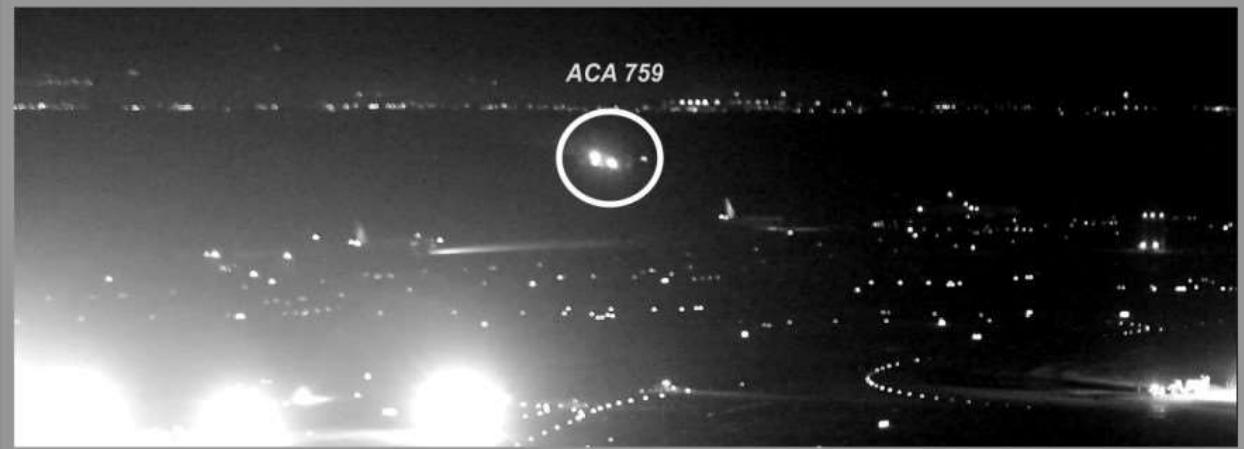
Local controller (23:56:10): air canada go-around.

- The incident pilots advanced the thrust levers when the airplane was about 85 ft agl. FDR data indicate that the airplane was over the taxiway at this time, approaching the vicinity of taxiway W.
- At 2356:04 PDT, ACA759 reappeared on the local controller's ASDE-X/ASSC display as it passed over the first airplane positioned on taxiway C.
- About 2.5 seconds after advancing the thrust levers, the minimum altitude recorded on the FDR was 59 ft agl.
- At 2356:10 PDT, the local controller directed ACA759 to go around. The airplane had already begun to climb at this point (see figure 4).

Figure 4 shows the local controller's transmission to ACA759 at 2356:10 to go around and ACA759's position after overflying two airplanes on the taxiway.
