**KOMITE NASIONAL KESELAMATAN TRANSPORTASI  
REPUBLIC OF INDONESIA**

**KNKT.17.08.25.04**

**Aircraft Accident Investigation Report**

**PT. Lion Mentari Airlines and PT. Wings Abadi Airlines**  
**Boeing 737-900ER; PK-LJZ and ATR 72-500; PK-WFF**

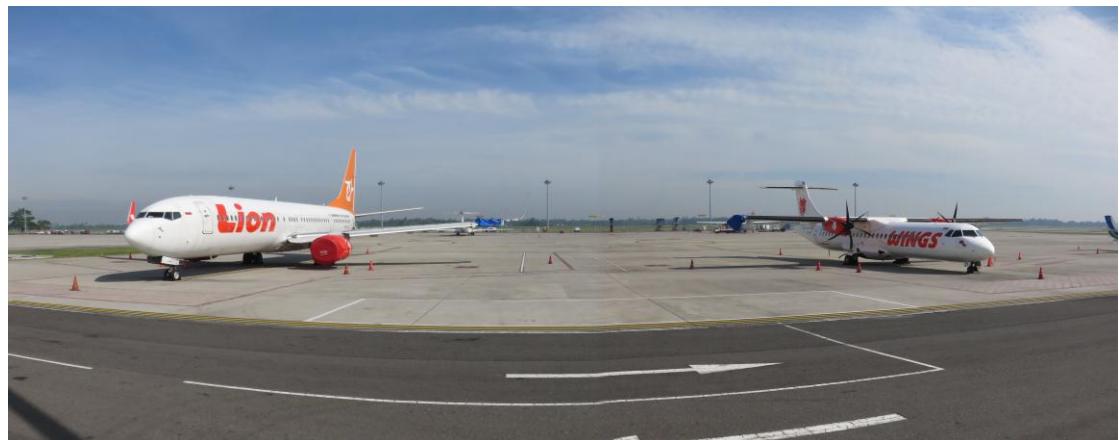
**Figure 2: PK-LJZ and PK-WFF after the accident**

Both aircraft were substantially damaged. The damages were found on the left wing of JT197 and the right wing of IW1252.

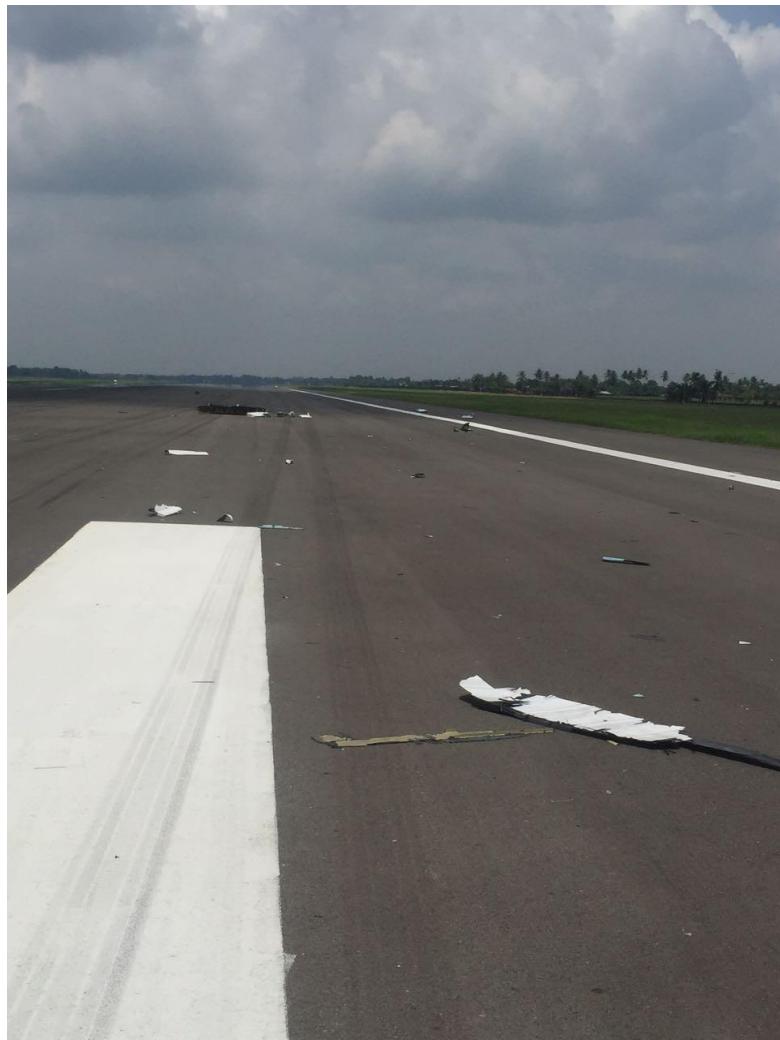
**Figure 3: The debris on runway**

Debris was found on the runway after the collision. The following figure was taken a few minutes after the collision.

The information of debris on runway has been informed to the Medan Ground controller by JT197 pilot and to Medan Tower controller by another departure aircraft pilot. Afterwards, there was one aircraft landed on runway 23 and then the runway was closed for debris removal. The debris on the runway is a hazard for takeoff and landing aircraft.

KNKT recommends air traffic controller to ensure all hazard on the runway is properly mitigated without delay prior to issue takeoff or landing clearance.

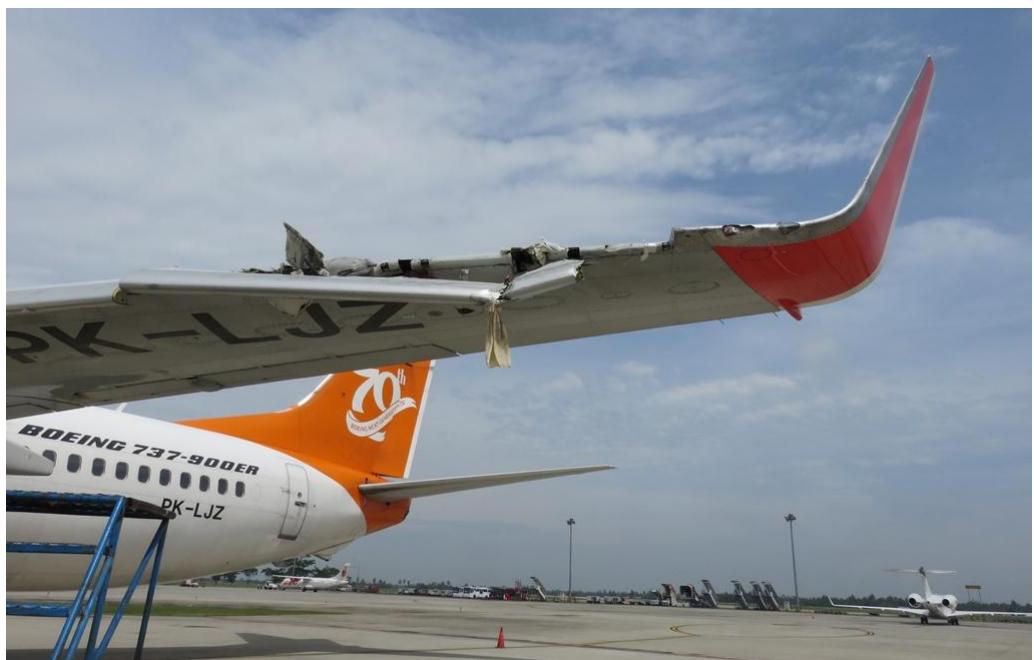
**Figure 4: The damaged wing of JT197**

The left wing was damaged on the wing leading edge approximately 3.4 meter long. The slat number 1 was damage approximately  $3.4 \times 0.4$  meters. Part of the slat with dimension approximately  $65 \times 40$  centimeters was detached.

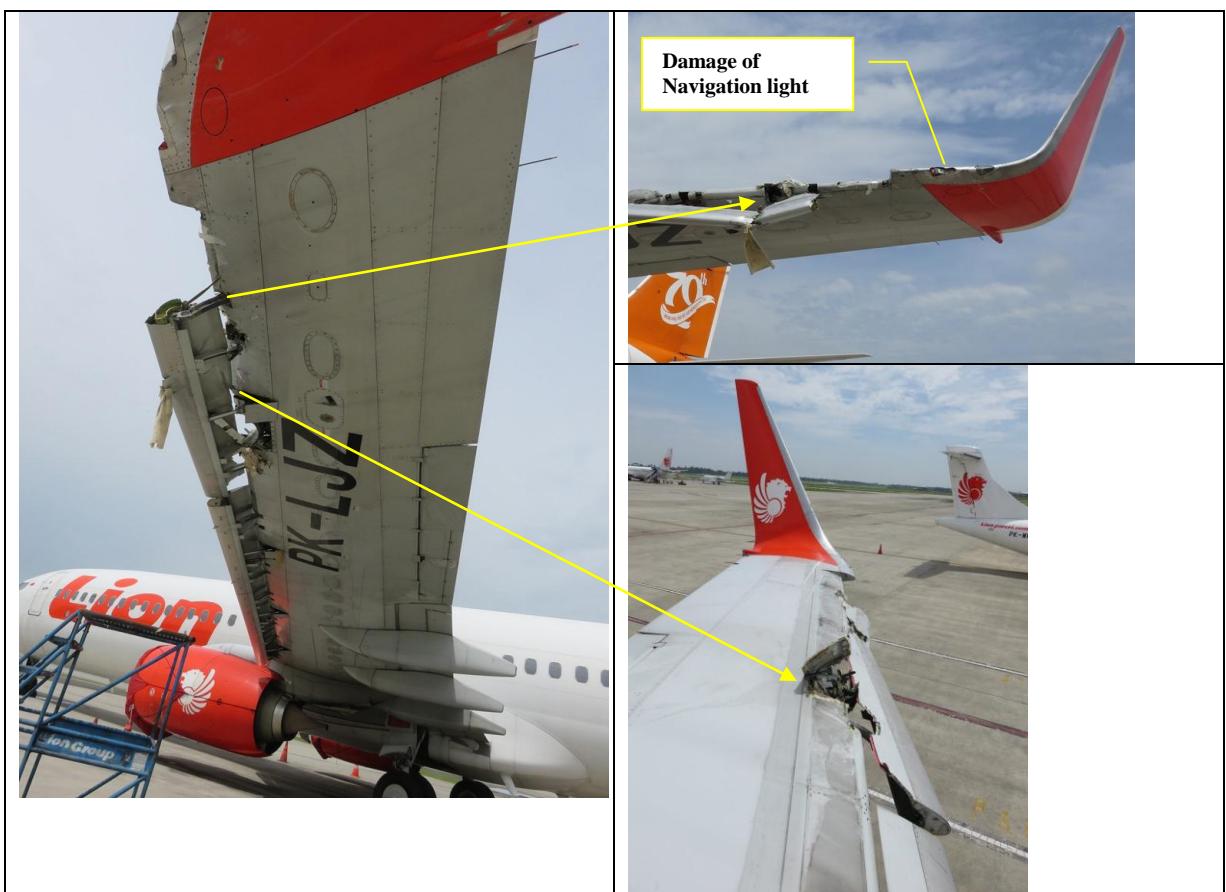
**Figure 5: The left wing damage location**

The wing let area had several dents including damaged on the navigation light. The damages are as follows:

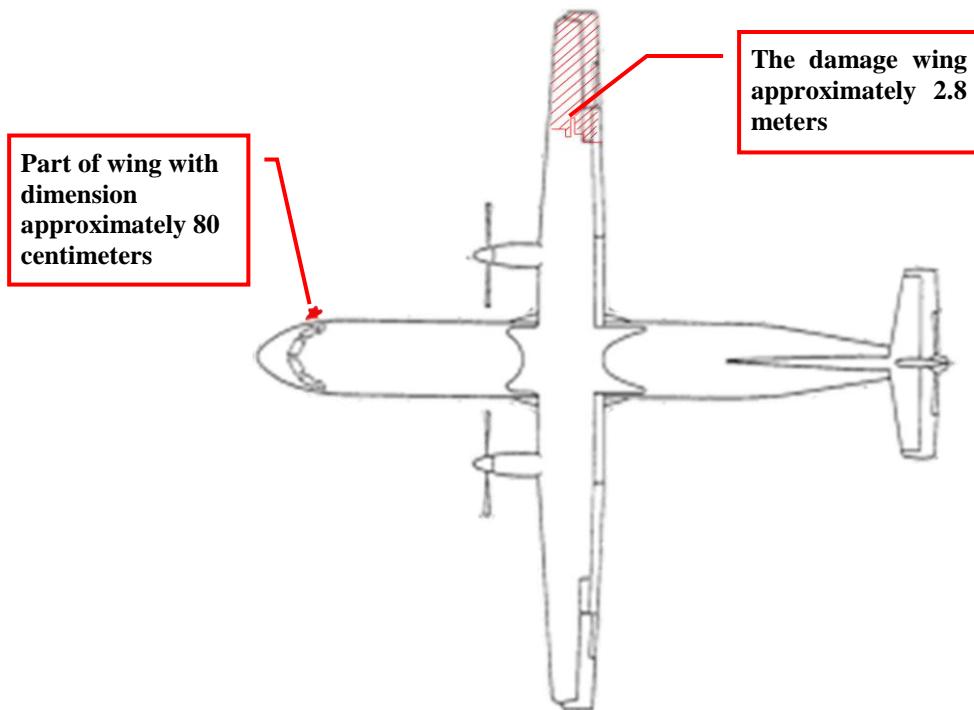
**Figure 7: The IW1252 damage**

The right wing from wing rib 24 until the wing tip with dimension approximately of 2.8 meter was broken and detached from the aircraft. Part of the damage wing was stuck at right pitot tube. The illustration of the damage is shown in the figure below.

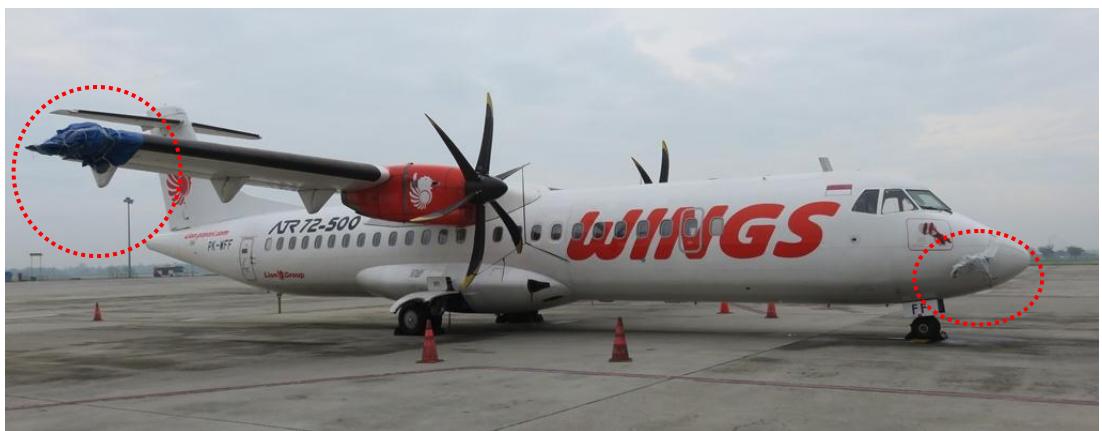
**Figure 8: Damages on the right wing and part of wing that stuck at the pitot tube**

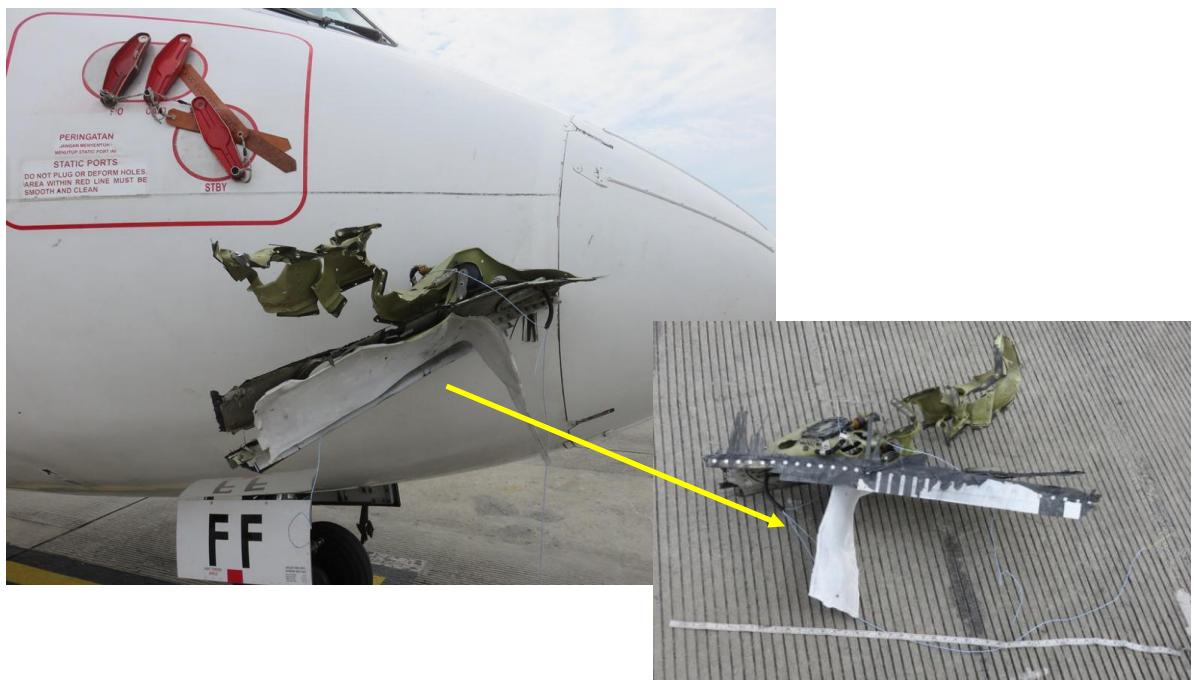
**Figure 10: Part of the damage wing that stuck at the pitot tube**

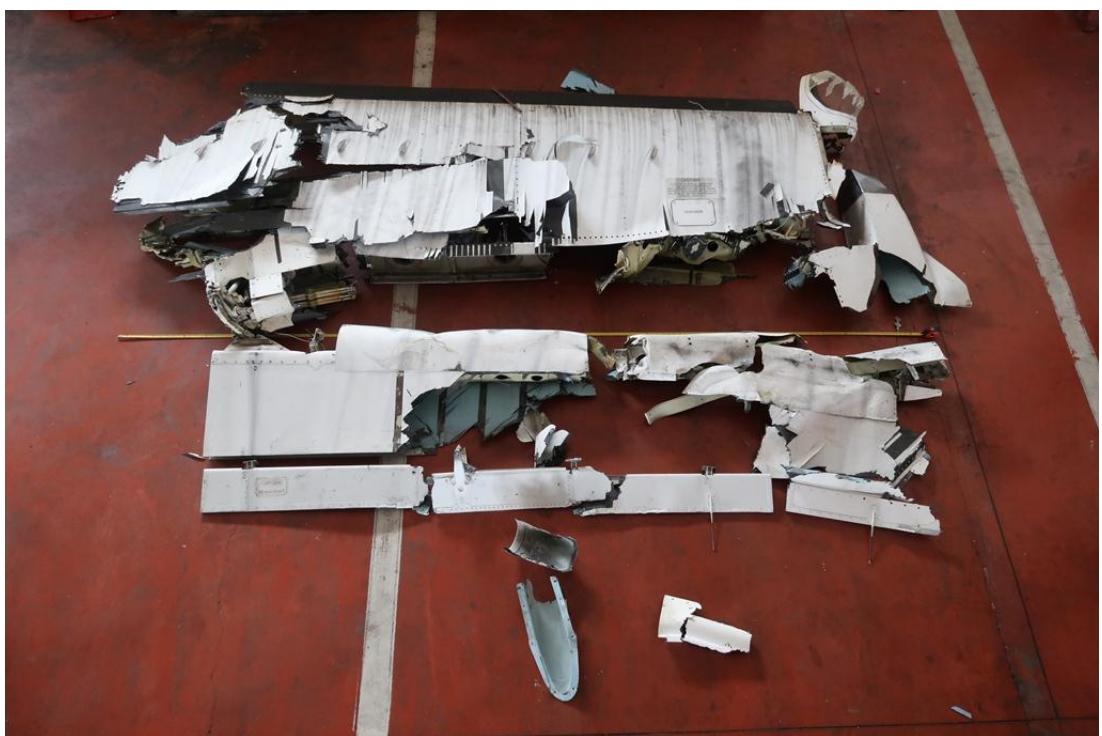
**Figure 11: The reassembled wing**

During the investigation, KNKT reassembled the right wing to have the better view of the damage. The reassembled wing is shown in the figure below.
