SERIOUS INCIDENT

Aircraft Type and Registration:	DHC-6 Series 310 Twin Otter, G-BVVK	
No & Type of Engines:	2 Pratt & Whitney Canada PT6A-27 turboprop engines	
Year of Manufacture:	1980 (Serial no: 666)	
Date & Time (UTC):	7 March 2017 at 1745 hrs	
Location:	Tiree Airport, Isle of Tiree	
Type of Flight:	Commercial Air Transport (Passenger)	
Persons on Board:	Crew - 2	Passengers - 7
Injuries:	Crew - None	Passengers - None
Nature of Damage:	No damage	
Commander's Licence:	Airline Transport Pilot's Licence	
Commander's Age:	55 years	
Commander's Flying Experience:	10,680 hours (of which 634 were on type) Last 90 days - 152 hours Last 28 days - 60 hours	
Information Source:	Aircraft Accident Report Form submitted by the pilot

Synopsis

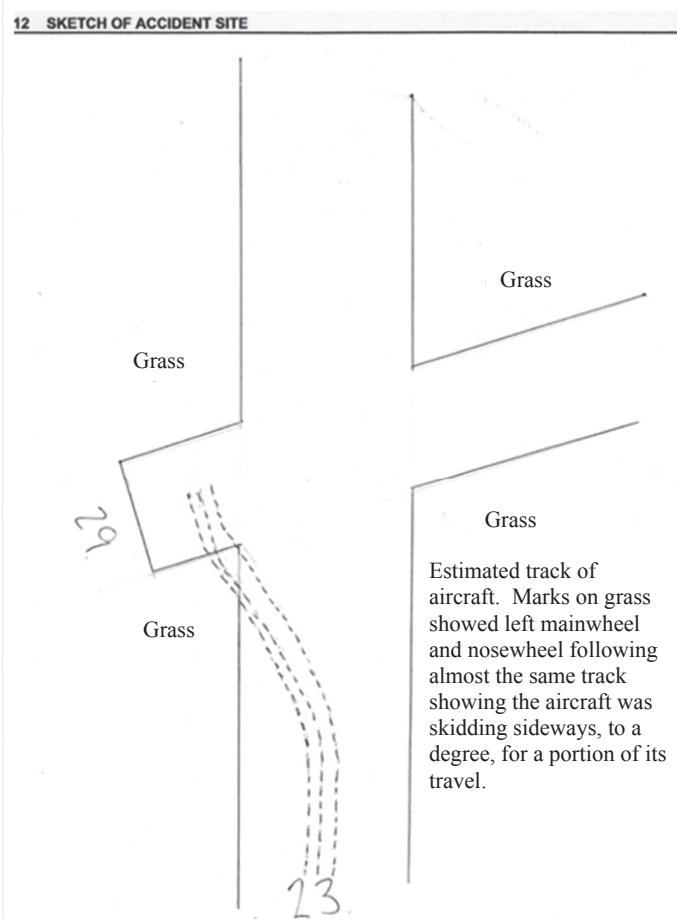
Figure 1
Commander's sketch of incident site

The aircraft was conducting a scheduled flight from Glasgow to Tiree. After landing in marginal weather, the aircraft veered off the left side of the runway, crossed a short section of grass and came to rest on the cross runway.

After shutdown, the captain accompanied airfield operations personnel while they checked the incident site. It became apparent that the aircraft had departed the paved area and crossed the grass (Figure 1). Consequently, the aircraft was taken out of service and remained at Tiree until an engineering inspection confirmed that there was no damage.

Given the information they received, the crew believed the wind was within their limitations for landing. However, it is highly likely that the aircraft was affected by a strong gust of wind from the left during the landing roll. The event was sudden and briefly overcame

the controls, which were reduced in effectiveness due to the low airspeed. As a result, the aircraft veered sharply left and departed the paved surface. There were no injuries and no damage to the aircraft or the airfield infrastructure.
