## Reconstruction of flightpath of B757-200 and TU154M according to radardata

AZ 001-1-2/02 BFU Flight Recorders

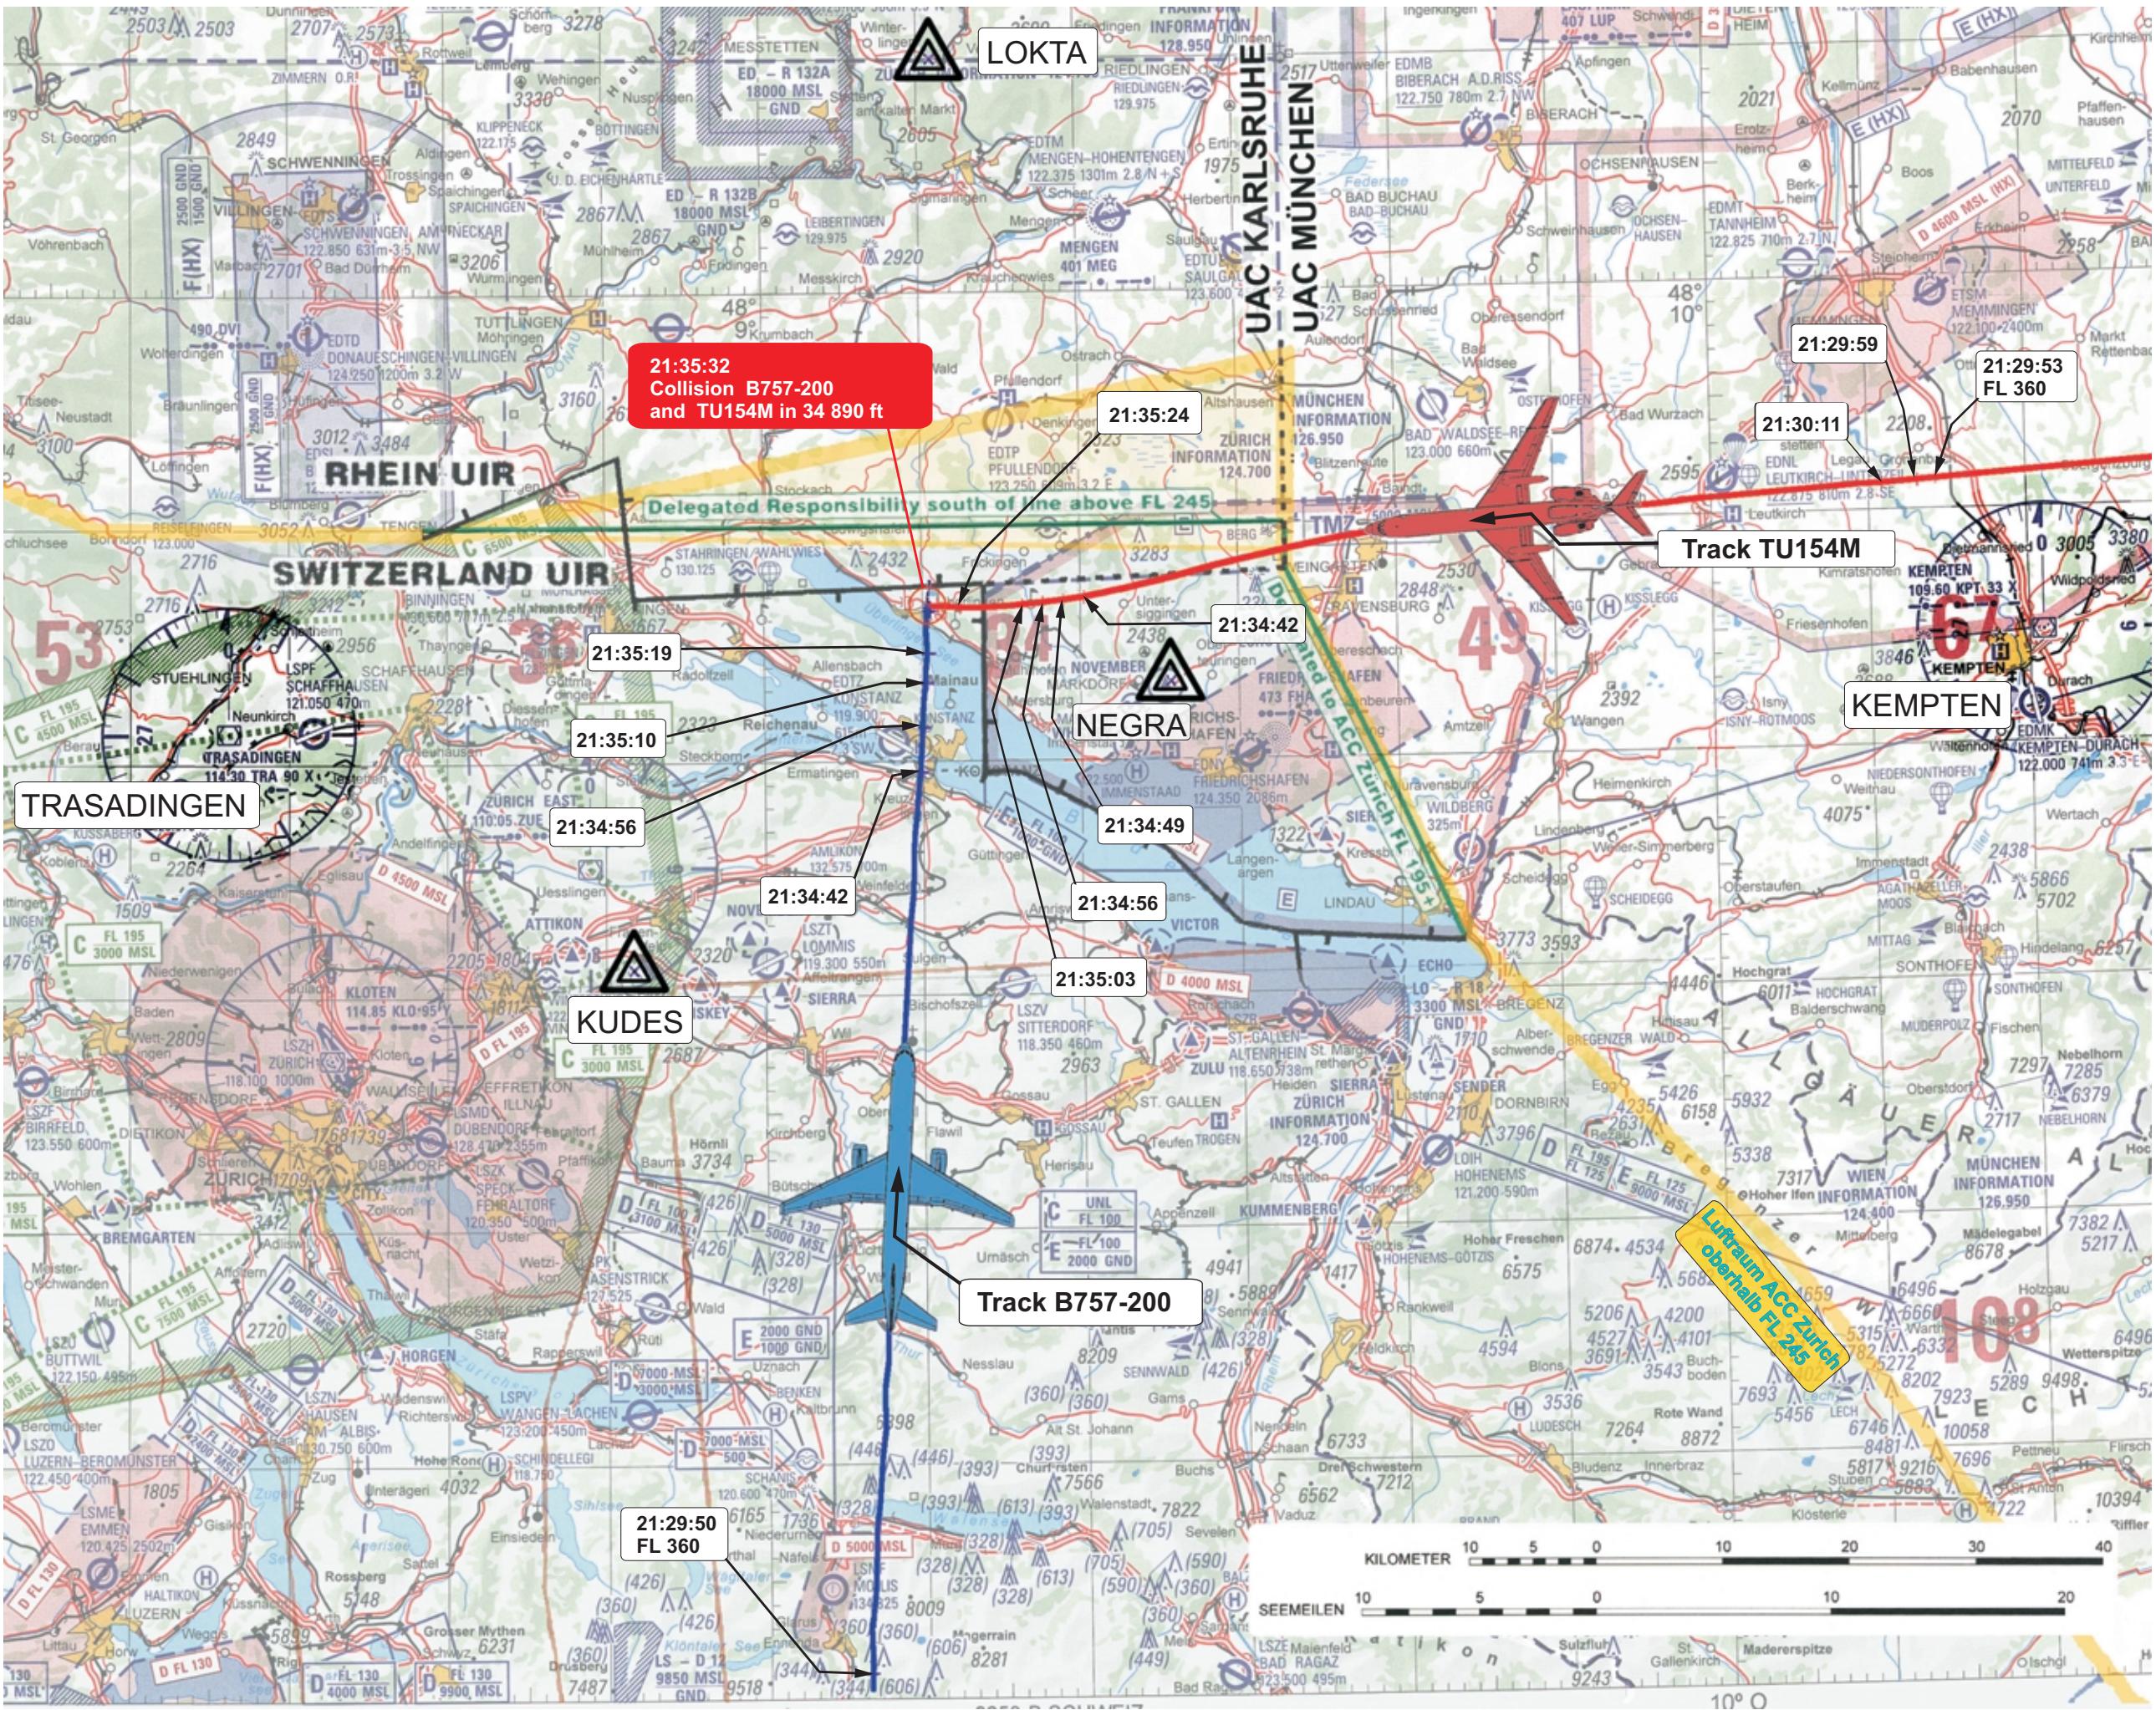
<b>Zeit UTC</b>	<b>Min Sek</b>	<b>Boeing B757-200 Flug DHX 611</b>	<b>Tupolew TU154 M Flug BTC 2937</b>
21:21:50	13:42	Initial call to ACC Zurich on 128.050 MHz at FL 260. The crew is instructed to switch the transponder to 7524, to climb to FL 320 and is cleared direct to Tango VOR. The crew requests a climb to FL 360. ACC Zurich announces the clearance in 4 to 5 minutes later.

21:26:36	8:56	The crew receives the instruction to climb to FL 360.	
21:29:50	5:42	The aircraft reaches FL 360.	
21:30:11	5:21		Initial call to ACC Zurich on 128.050 MHz at flight level FL 360. The crew is instructed to switch the transponder to 7520.

21:33:03	2:29		Start of a conversation within the cockpit about a TCAS-indication, which shows another aircraft in the same altitude.
21:34:24	1:08	The First Officer indicates to leave his seat in the cockpit and hands over the controls to the PIC. „Excuse I'll use the facilities“.

21:34:42	0:50	TCAS informs the crew of conflicting traffic (TA) ("Traffic, Traffic").	TCAS informs the crew of conflicting traffic (TA) ("Traffic, Traffic").

21:34:49	0:43		The radar controller instructs the crew to an expedite descent to FL 350. This instruction was given together with an information about conflicting traffic.. "B-T-C 2937, ..descend flight level 3-5-0, expedite, I have crossing traffic"

21:34:54	0:38		The crew initiates a descent.
21:34:56	0:36	The TCAS issues a RA to descend. The crew follows that command. The radar separation falls below 7 NM.	The TCAS issues a RA to climb. The crew continues in following ATC. The radar separation falls below 7 NM.

21:35:03	0:29		The radar controller of ACC Zurich repeats the instruction to an expedite descent to FL 350, because the first instruction had not been acknowledged. "B-T-C 2937, ..descend level 3-5-0, expedite descent". The crew now immediately acknowledges. „Expedite descent level 3-5-0, BTC 2-9-3-7“. After that the radar controller informs the crew of other traffic at FL 360 in the "2 o'clock position". "Ja, ... we have traffic at your 2 o'clock position now at 3-6-0".

21:35:10	0:22	The crew receives the TCAS command to increase the descent ("increase descent"). The First Officer is back to his seat.	
21:35:19	0:13	The crew reports to ACC Zurich that following a TCAS command they have initiated a descent ("TCAS descent"). "Dilmun six hundred... TCAS-descent"

21:35:24	0:08		The crew receives the TCAS command to increase the climb ("increase climb").
21:35:32	0:00	Collision with the Tupolev TU154M at 34 890 ft	Collision with the Boeing B757-200 at 34 890 ft

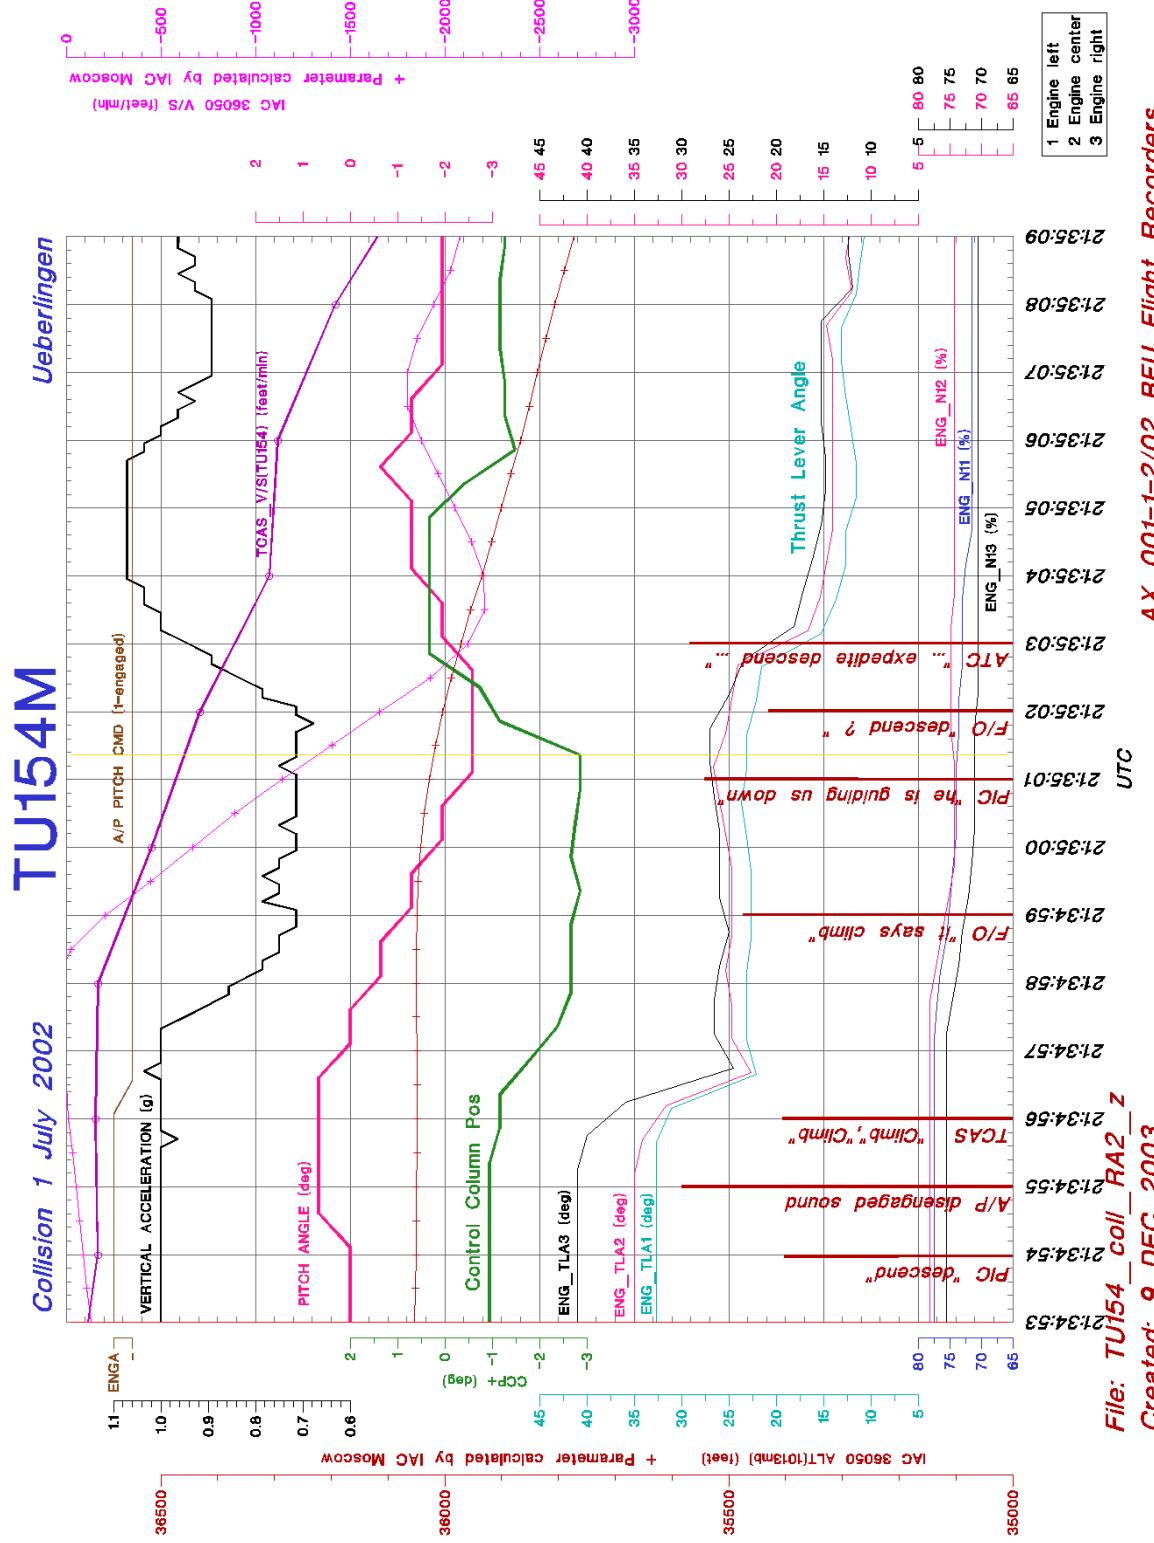
FDR data (extracts) of the TU154M (response to TCAS RA)

- *The TU154M crew followed the ATC instruction to descend and continued to do so even after TCAS advised them to climb. This manoeuvre was performed contradictory to the generated TCAS RA. The crew was unable to follow TCAS RA as by that time they were at 35 500 feet and the controller informed them about conflicting traffic above, at FL 360. The false ATCO's information on the direction towards the conflicting traffic (2 o'clock instead of actual 10 o'clock) and contradictory ATCO and TCAS instructions did not contribute to the correct decision of the crew as well.*

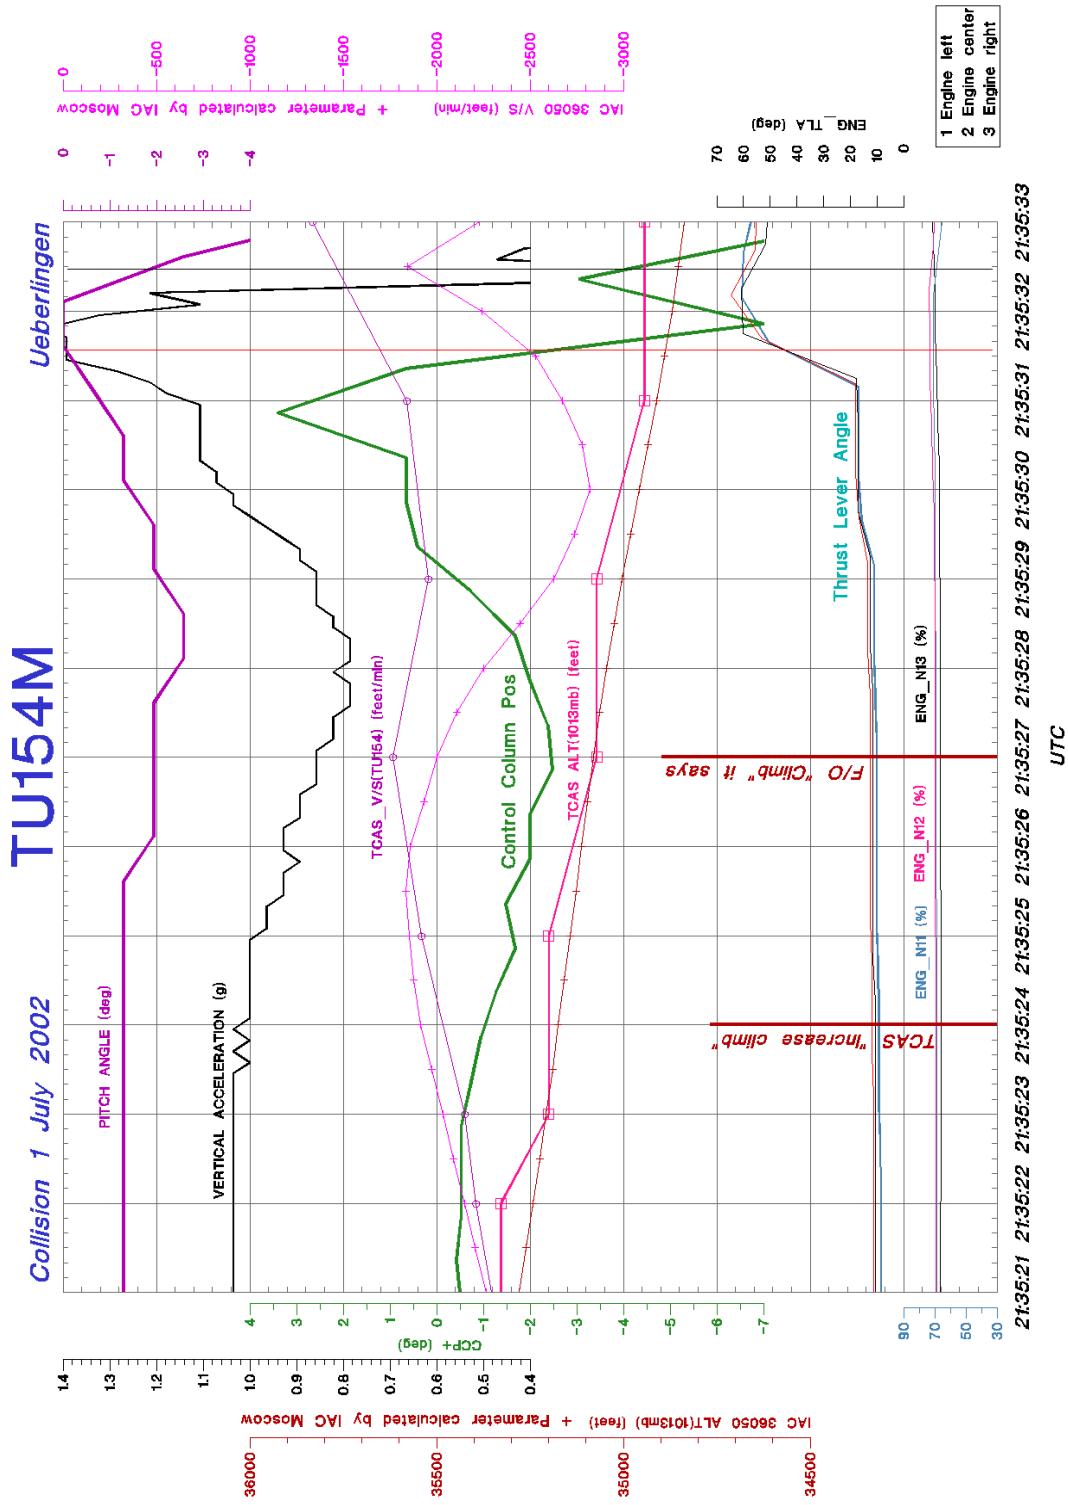
## FDR data (extracts) of the TU154M (descent and approach to FL 350)

- *When the TU154M, contrary to the instruction of the ATC, was descending through flight level 350, the airplane's rate of descent was approximately 1900 ft/min.*

- *When reaching flight level 350, the rate of descent of the TU154M was still approximately 1900 ft/min. Subsequently the crew of the TU154M descended below the flight level assigned by the air traffic control unit.*

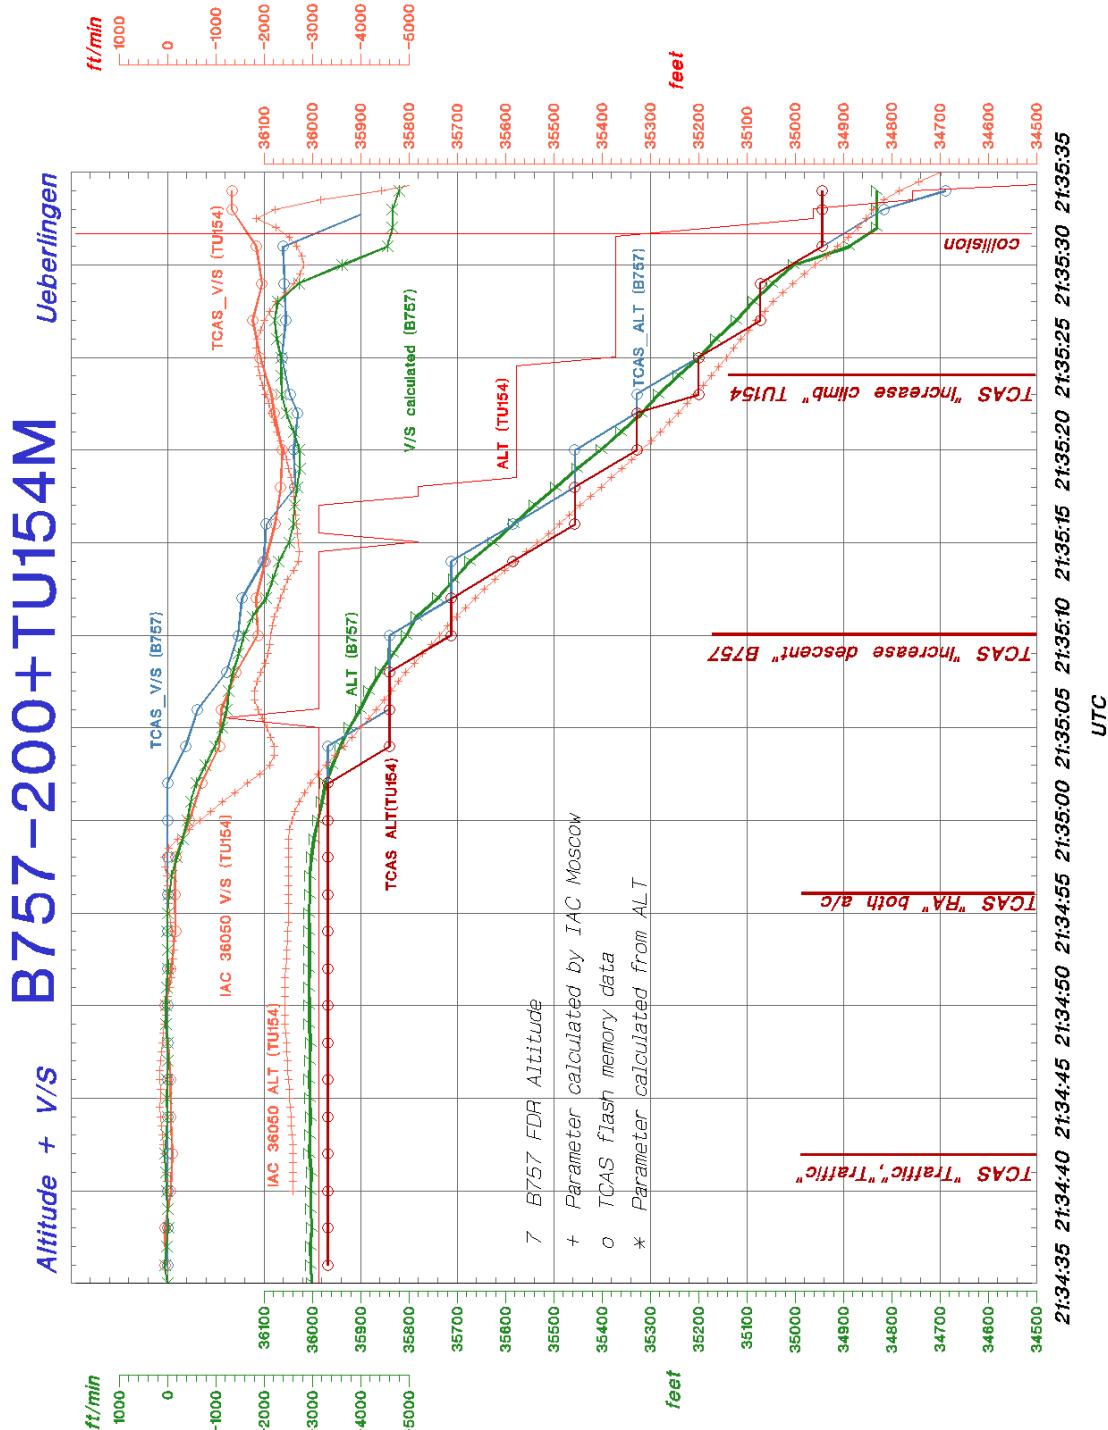
TCAS- and FDR-parameters (extracts) of B757-200 and TU154M

- *The simulation and the analysis of the alert sequence showed that the initial RA's would have ensured a safe vertical separation of both airplanes if both crews had followed the instructions accurately.*
