**Aircraft Accident Investigation Board (AAIB)**

# Accident Investigation Final Report

**State File Number:** 950330EPMOF  
**Type of Occurrence:** Accident  
**Date of Occurrence:** June 19<sup>th</sup> 2016  
**Place of Occurrence:** Khark Island Airport  
**Aircraft Type:** BAe146-300  
**Registration:** EP-MOF  
**Operator:** Mahan Airlines

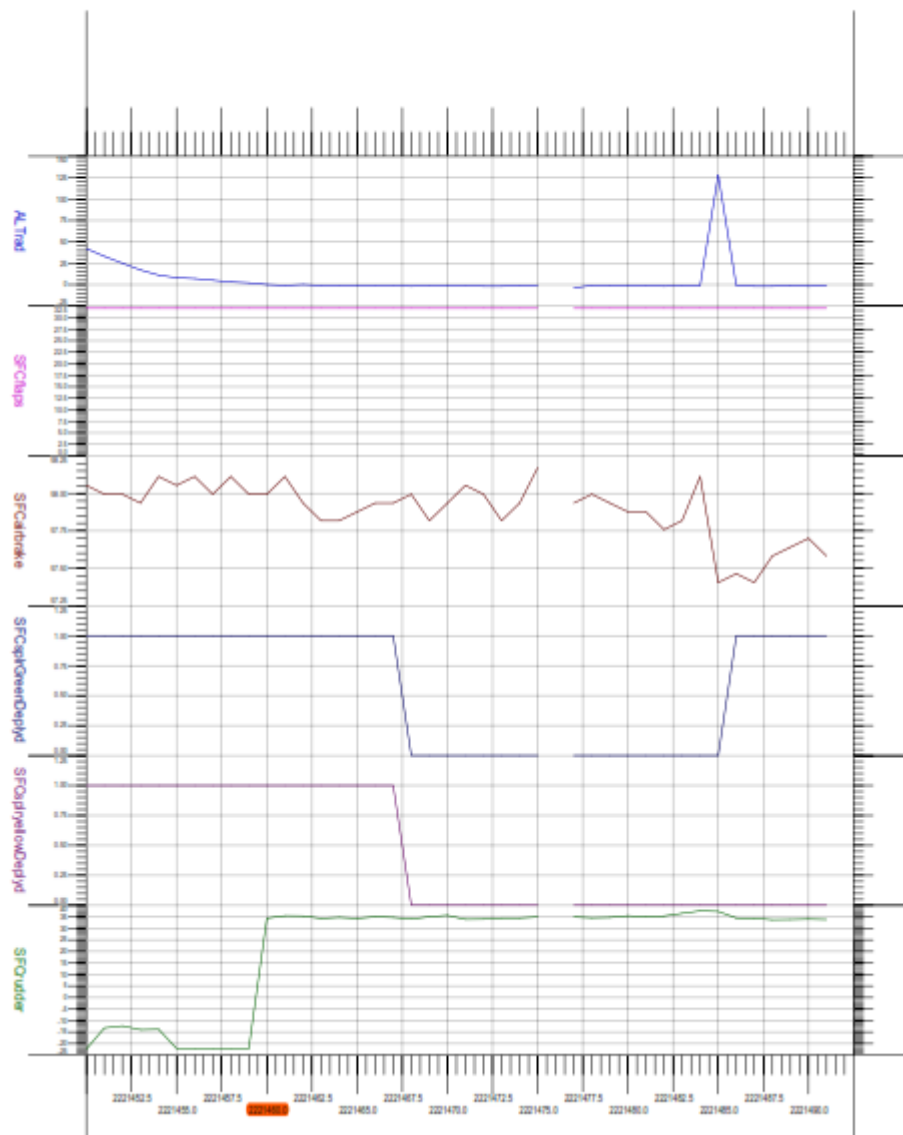
Spoilers had opened on IAS 112 after 7 seconds

In comparison to lift spoiler deployment time of 2 sample normal flights, in this landing was respectively 3 and 4 minutes of later deployment is observed in FDR records. In addition to that, 8 seconds of spoiler deployments seems to be later than limits mentioned in operation manual of the aircraft.

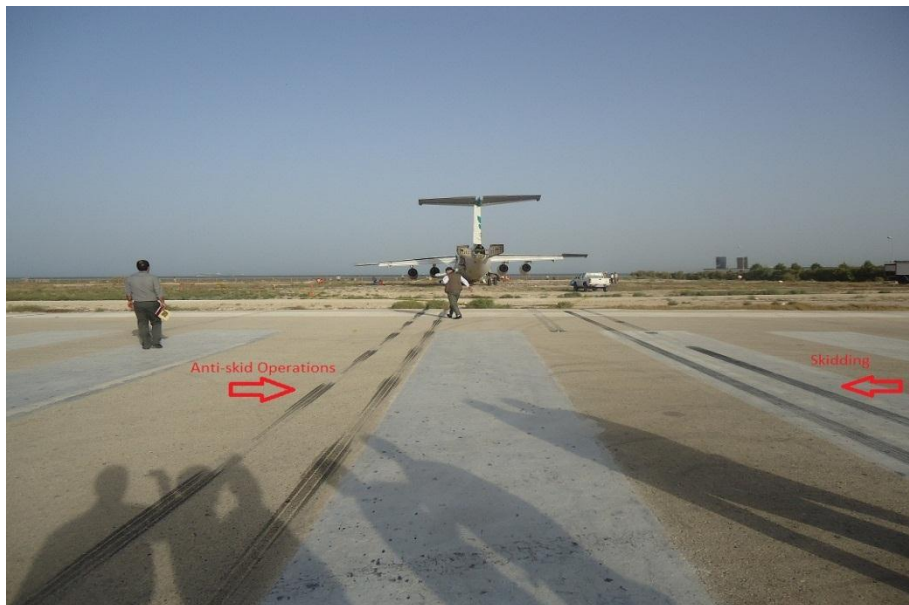
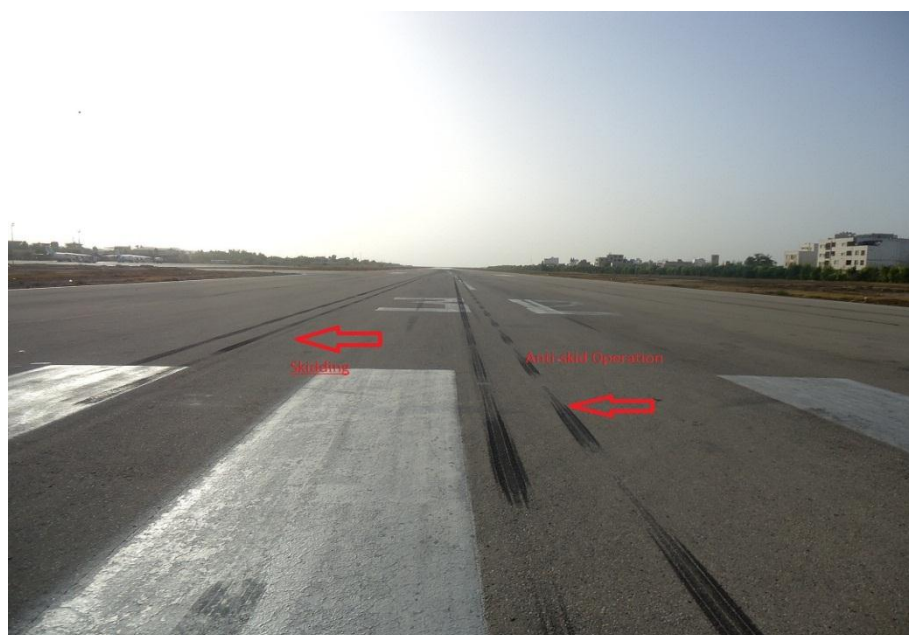
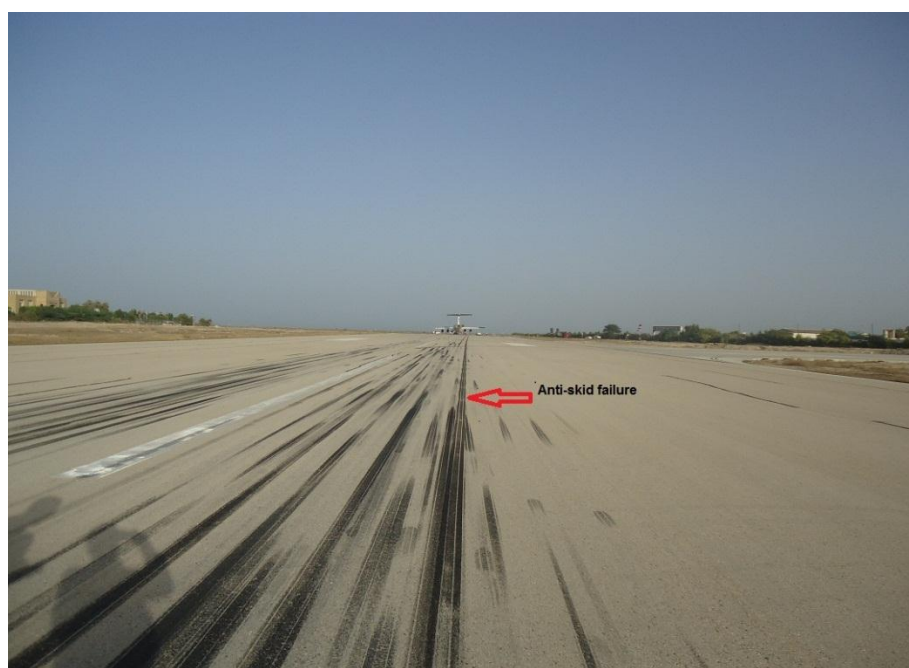
***Signs of anti-skid failure***

The conclusion of the test indicates the failure of Anti-skid System on the right main Landing gear.

- A un- stabilized approach was performed.
- Long distance of runway was passed at the time of touch down.
- The pilot used high brake effectivity to stop the aircraft but the failure of anti-skid on RH landing gear increased distance of landing.

- The manufacturer should investigate the possibility of improvement in the Cockpit for Anti-skid failure, which the cockpit crew can be warned about failure of the related system.

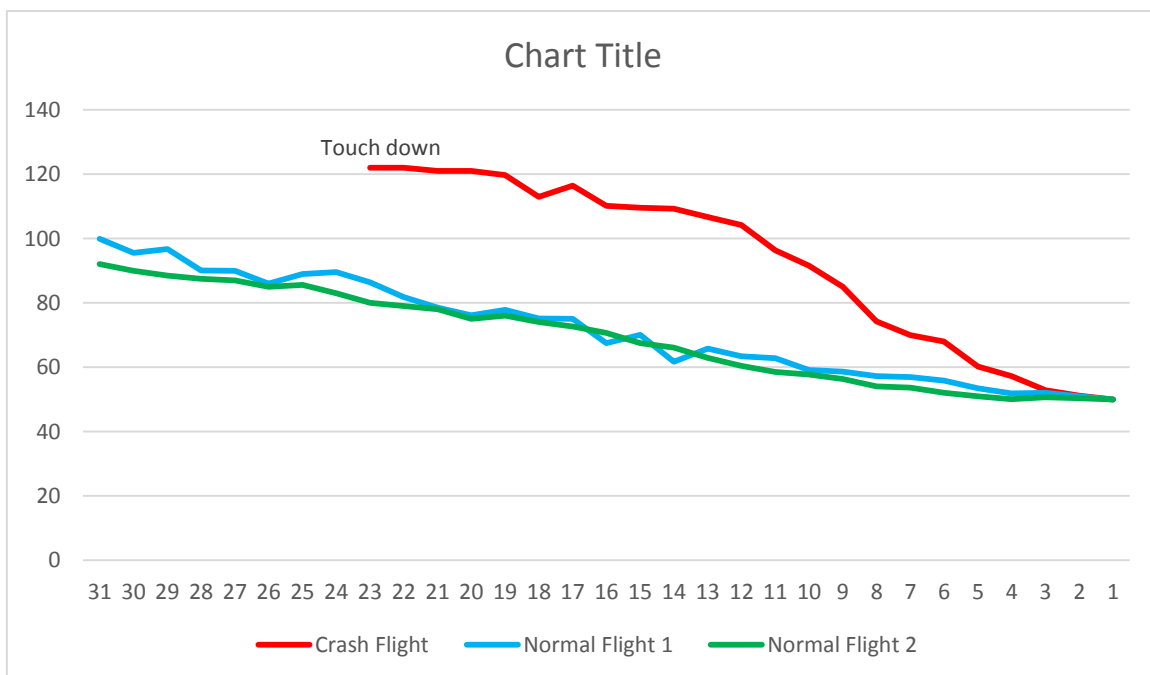
Figure 1. Deceleration Comparison of 3 flights

To examine the performance of run out deceleration systems, the period between touch down and reach point to 50 knot is studied. Table 1 illustrates speed decreasing of MOF during 3 flights in this period.

Apparent delayed touchdown was happened during crash flight. As it is shown by diagram, the aircraft touched the runway almost 8 seconds later than two other normal landings of itself. Therefore, a part of Landing Distance Available (LDA) was missed. Due to relatively short length of Khark runway, it could be a very effective factor to restrict safe landing assurance.
