## **Aircraft Accident Investigation Final Report**

**Aircraft type:** AN.140-100

**Registration:** EP-GPA

**Crash Near Airfield Following Aircraft One Engine  
Failure Just Upon Lift-Off**

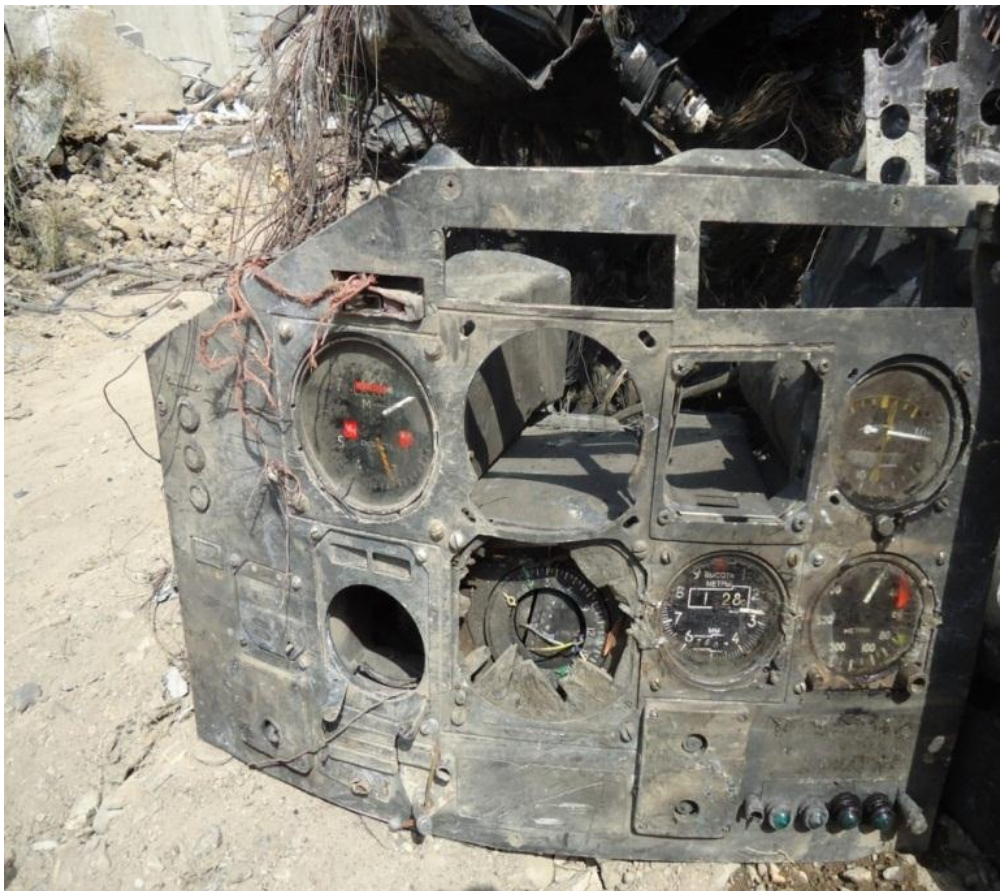
Figure 4. AN-140-100 control panel after accident.

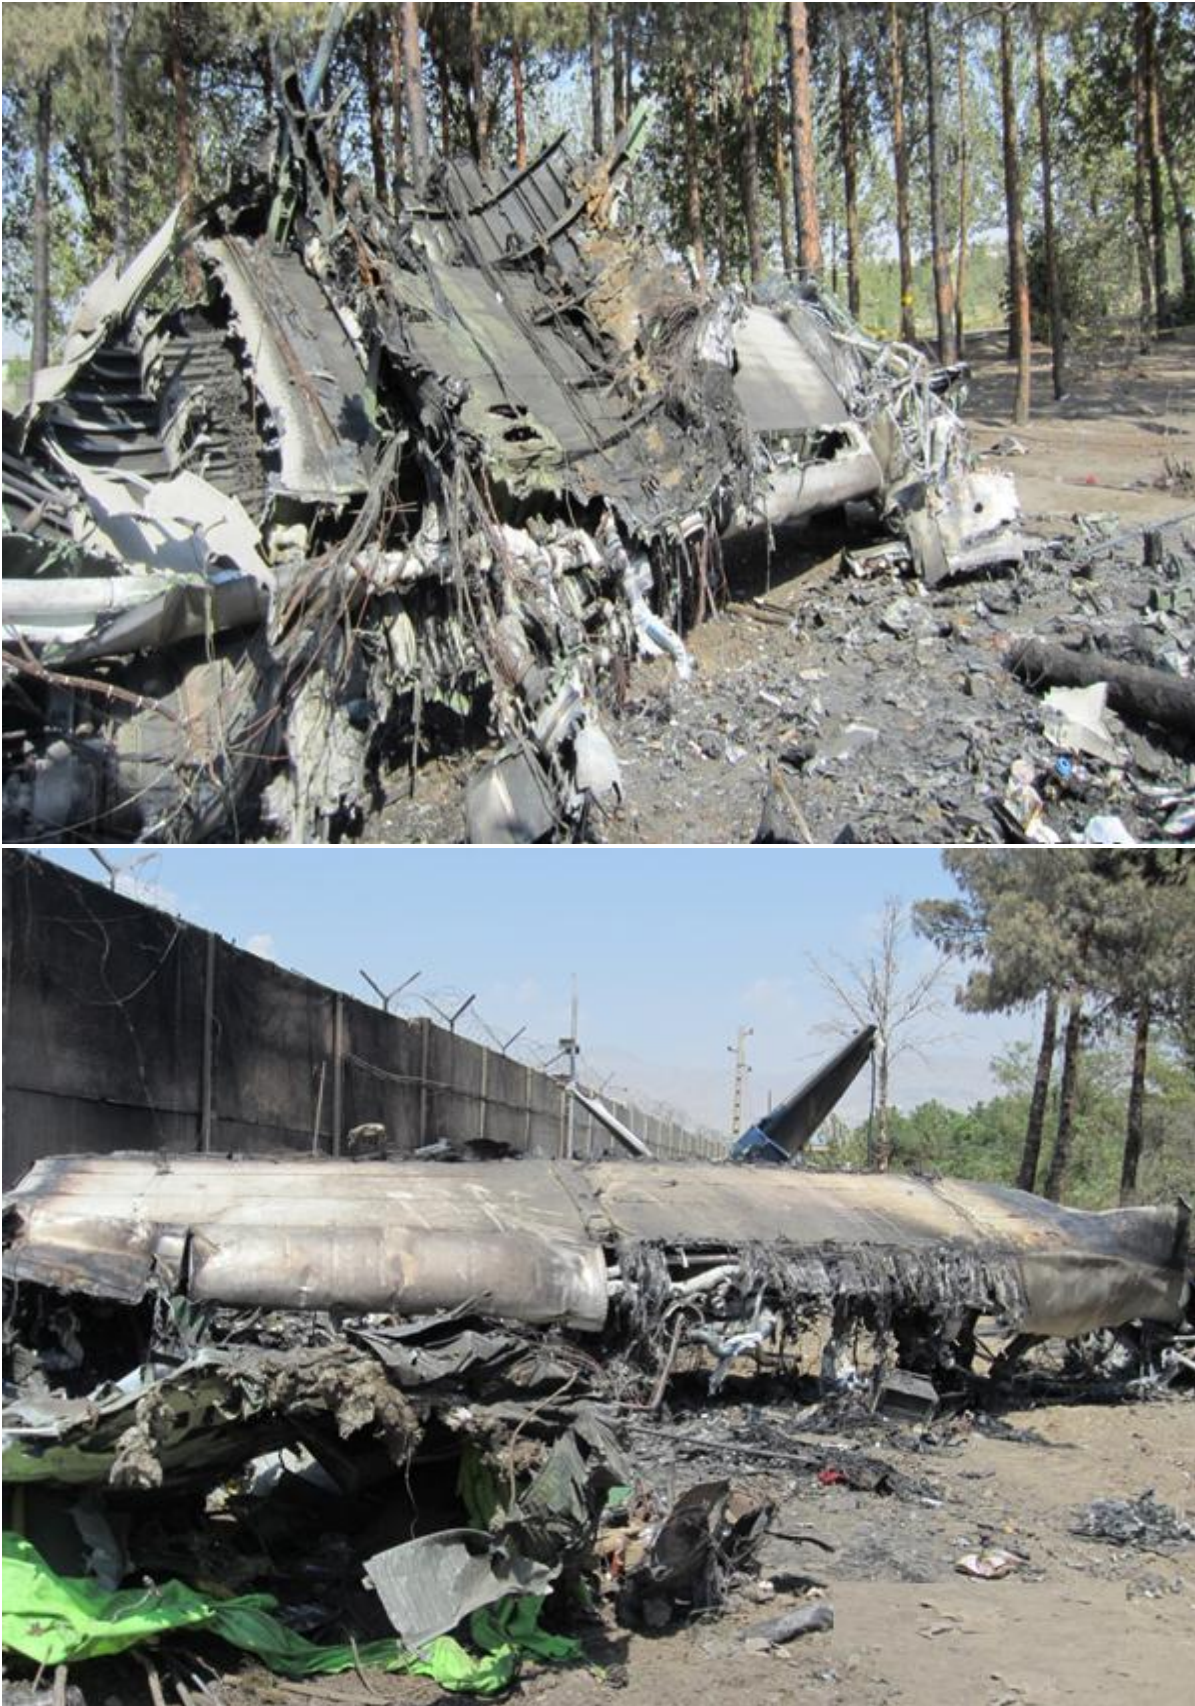
By the results of the crash site inspection, it was concluded that the initial collision with the ground was by the right wing with a significant right bank. Also the kind of damages of trees is indicating significant right bank. Right outer wing was not found on the crash site. At the crash site, due to the fuel spill was surface fire (there are burn marks on the ground). Left and right engines were detached from attaching points and located under the center wing. Crew cabin burnt. The central part of the fuselage burnt out as a result of ground fire. Aft fuselage as well as vertical and horizontal stabilizers were seriously damaged. Nose landing gear leg and main landing gears were in an extended condition (were not retracted). Flap position was about 10 degrees and an APU ramp in open position.

Figure 8. AN-140-100 wreckage

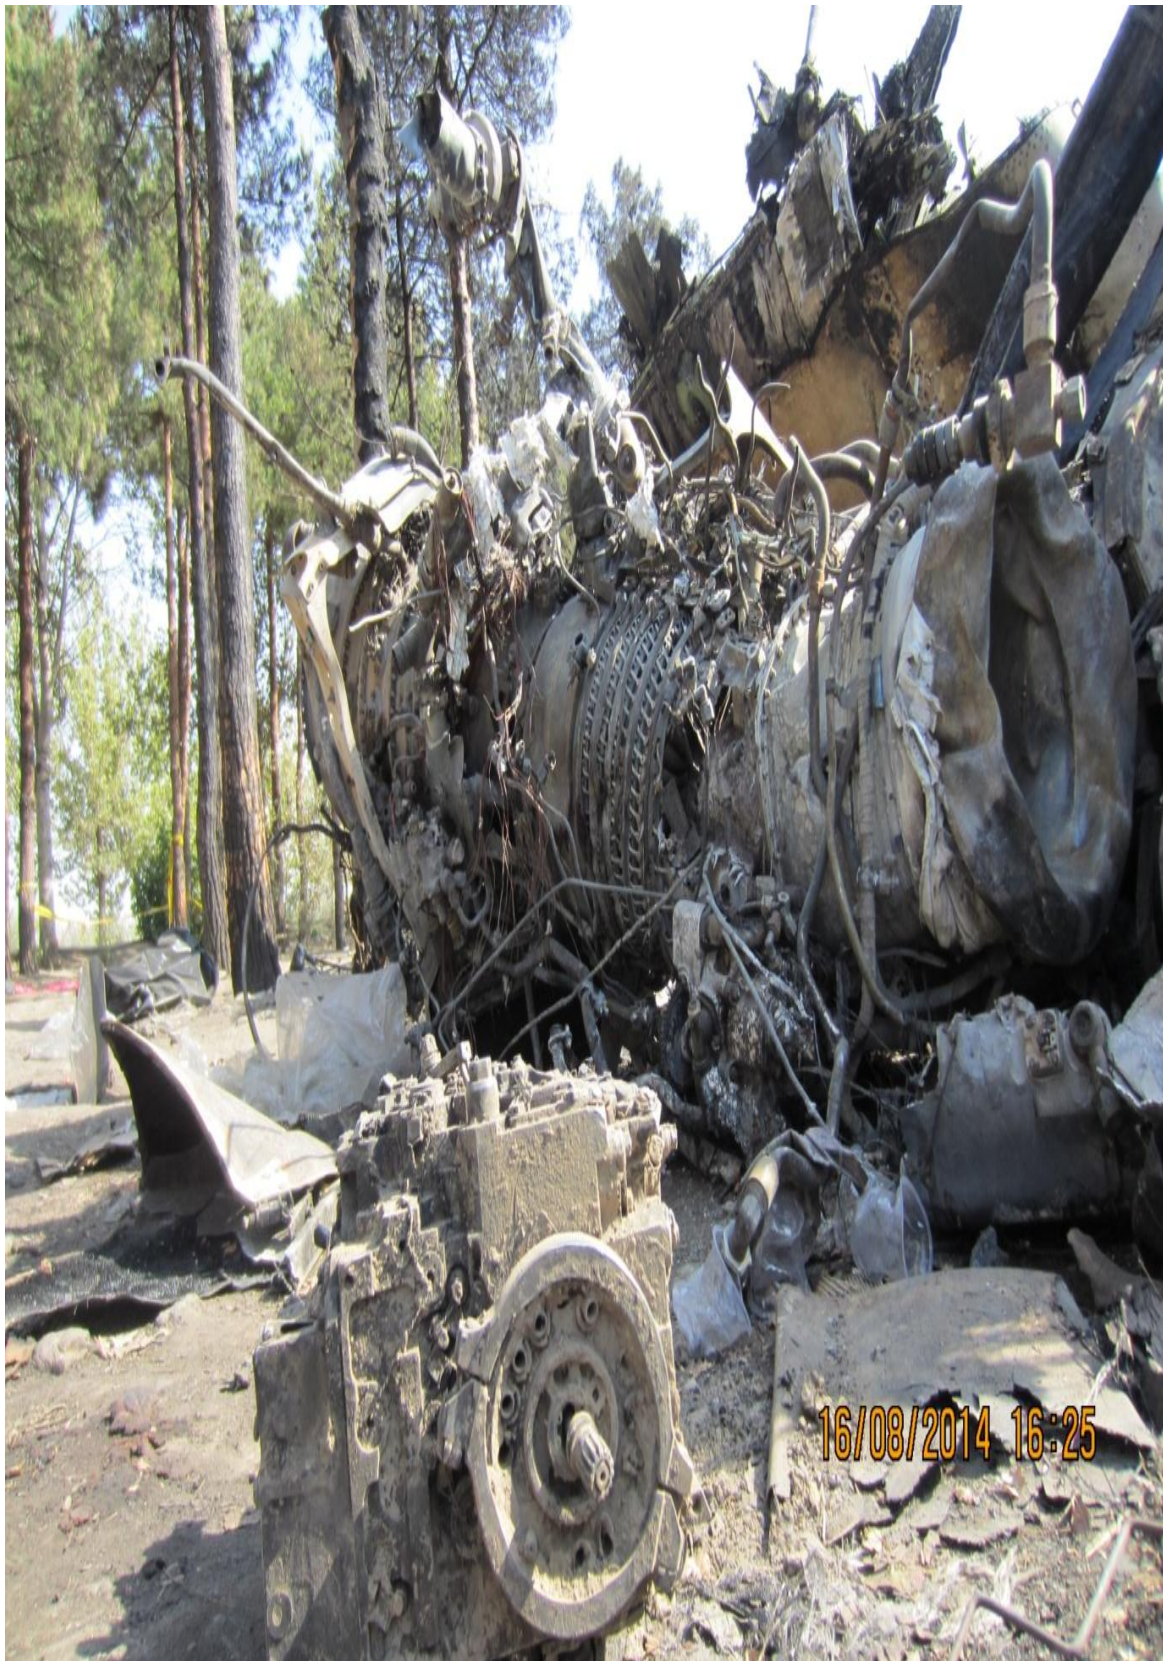
There are multiple damages on the engines from the collision with obstacles and the ground. There are traces of surface fire impact on the engine structure. The left engine propeller blades damage suggests that the engine was in operation until collision with the ground.

The left engine was damaged to a larger extent and has traces of extensive fire in the area of accessory drive gearbox and front support casing; almost all large sized vendor items are shifted from their mounting points;

Figure 9. AN-140-100 wreckage-engine

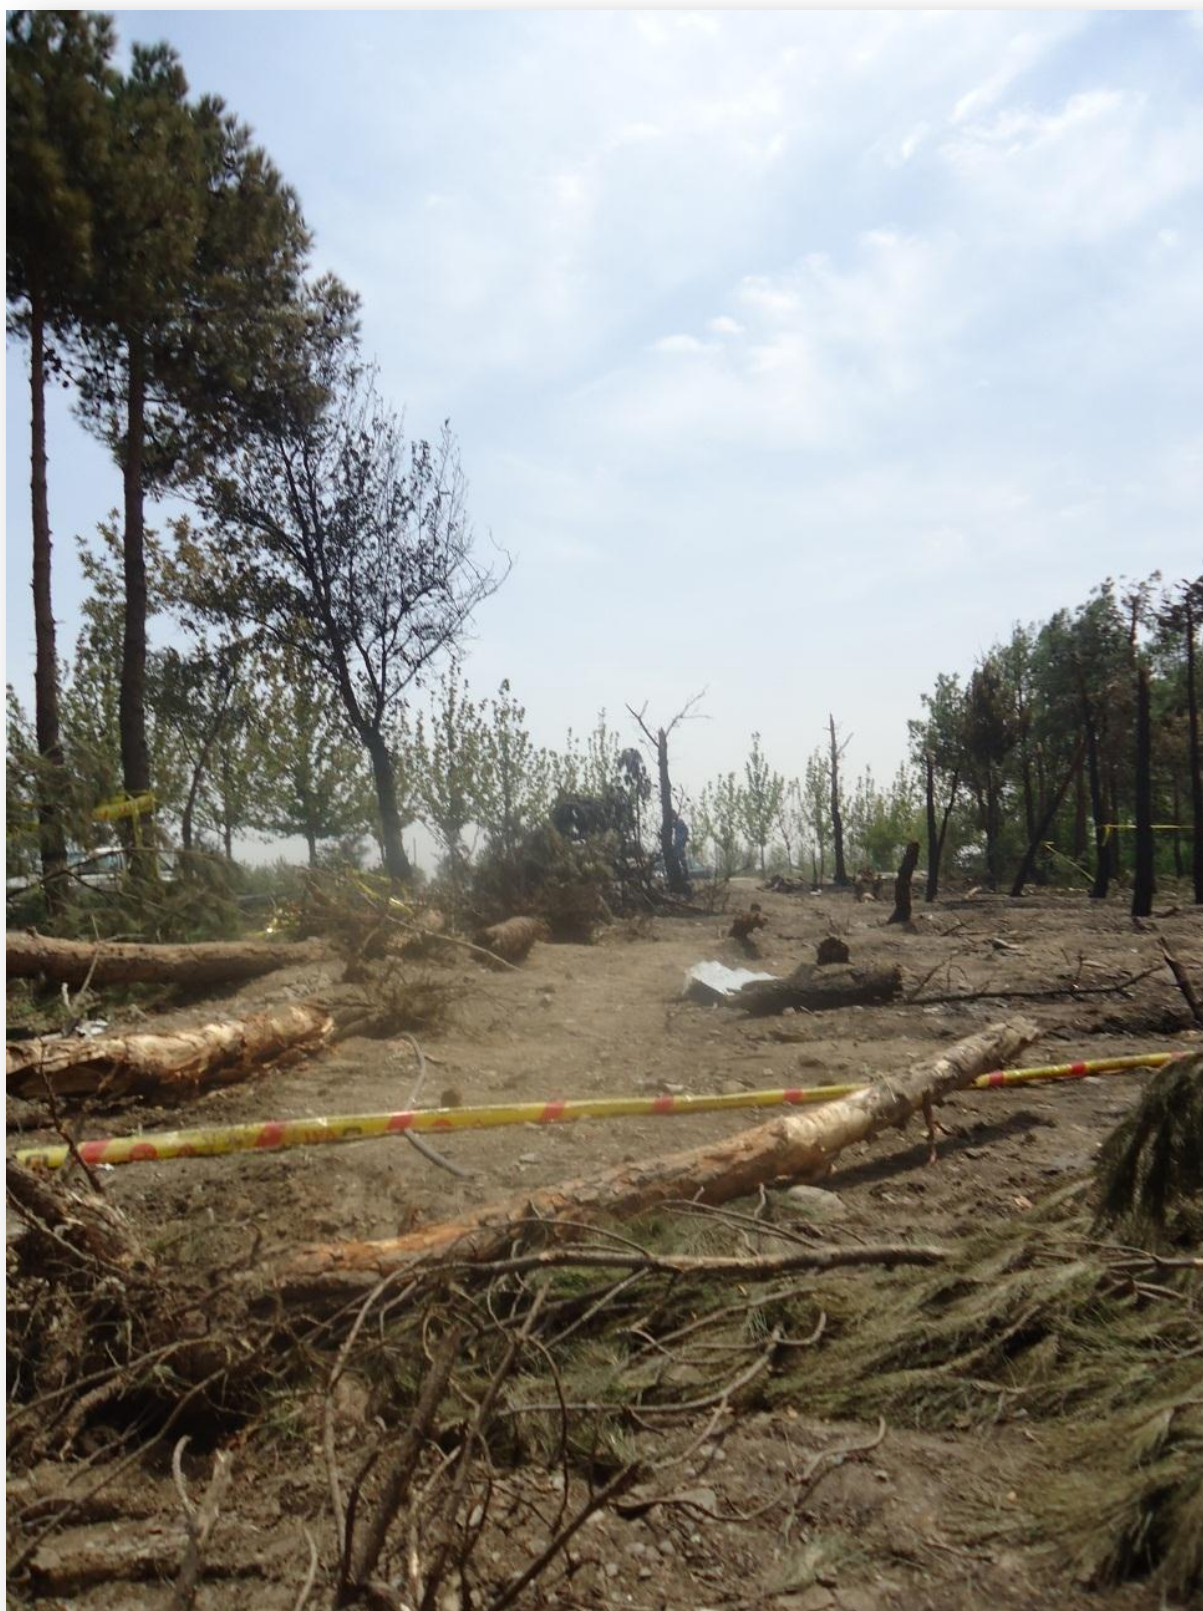
Figure 10. AN-140-100 Direction of impact

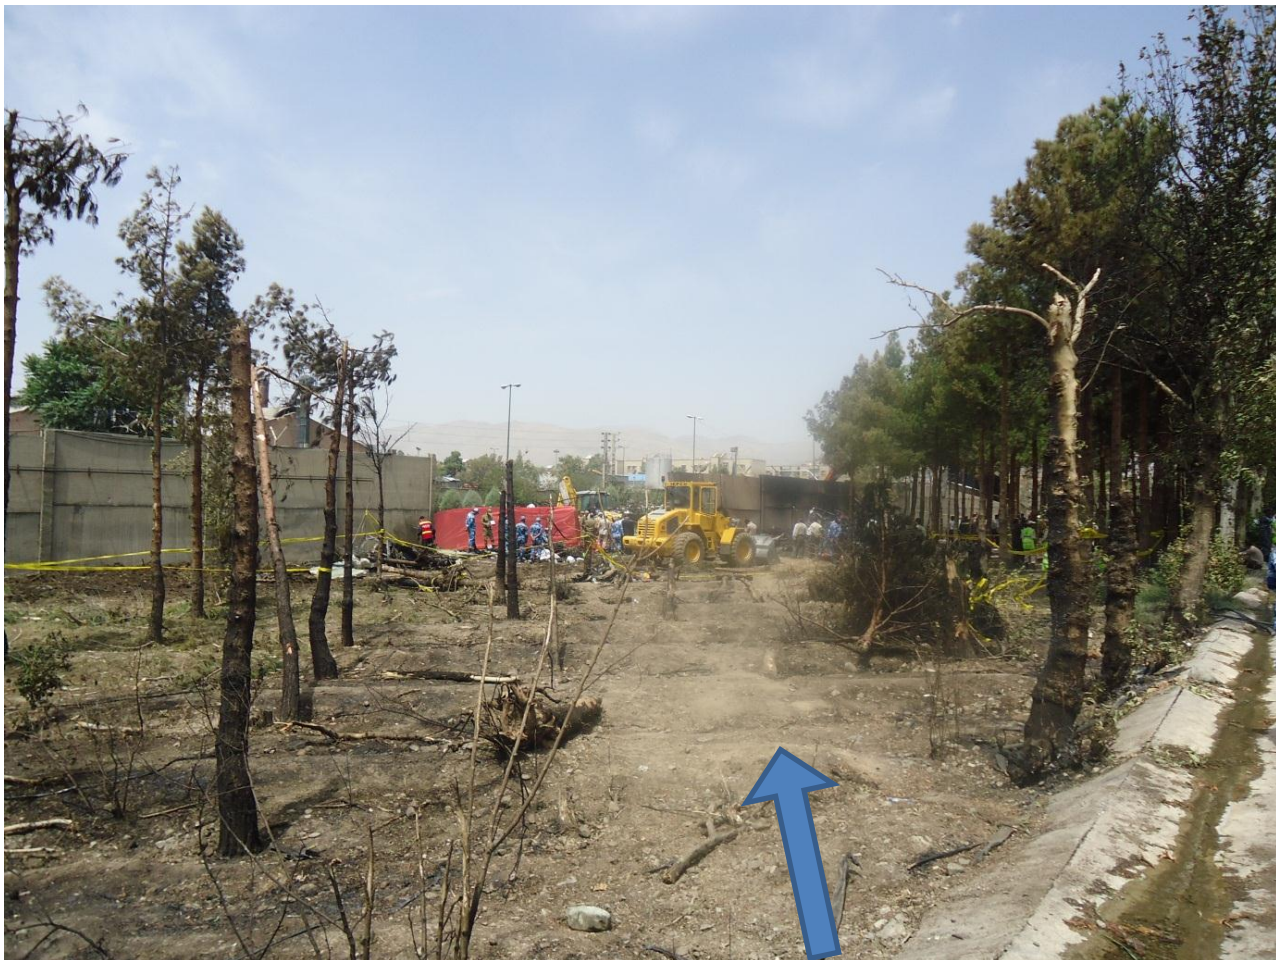
Figure 11. AN-140-100 Direction of Impact and rescue operation

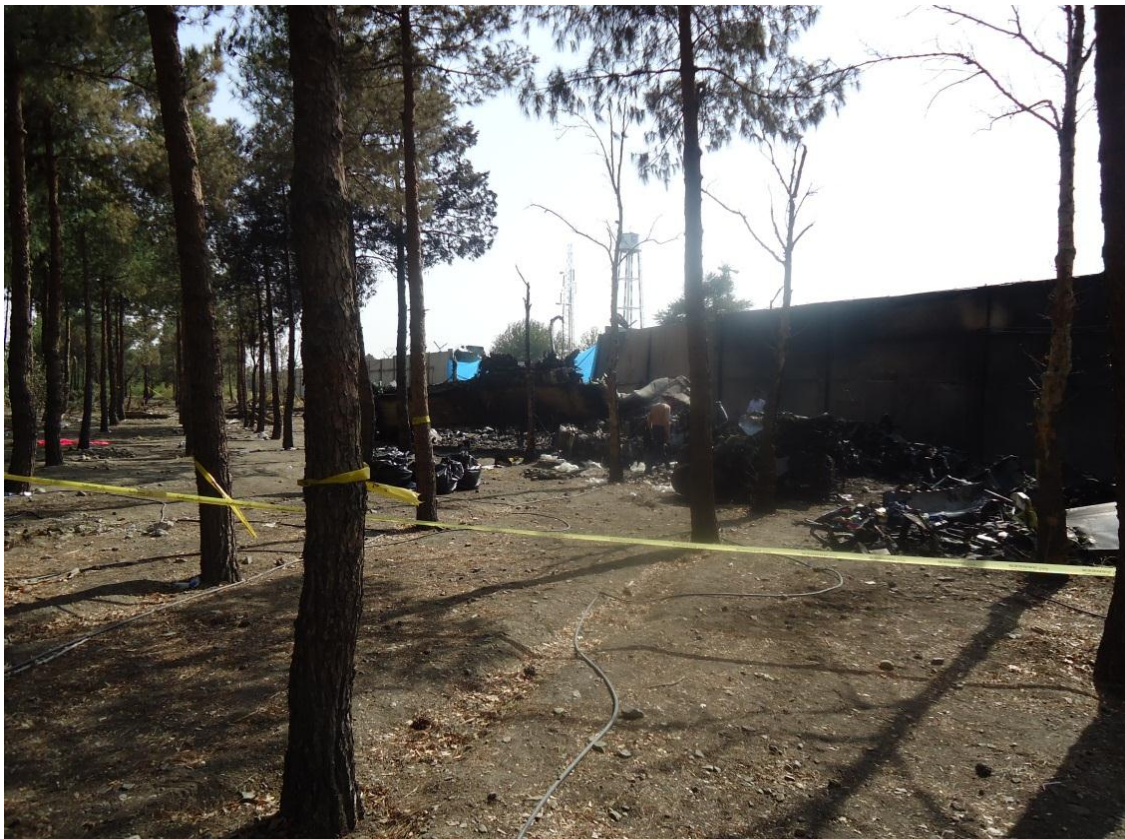
Figure 12. AN-140-100 Impact point (rear view)

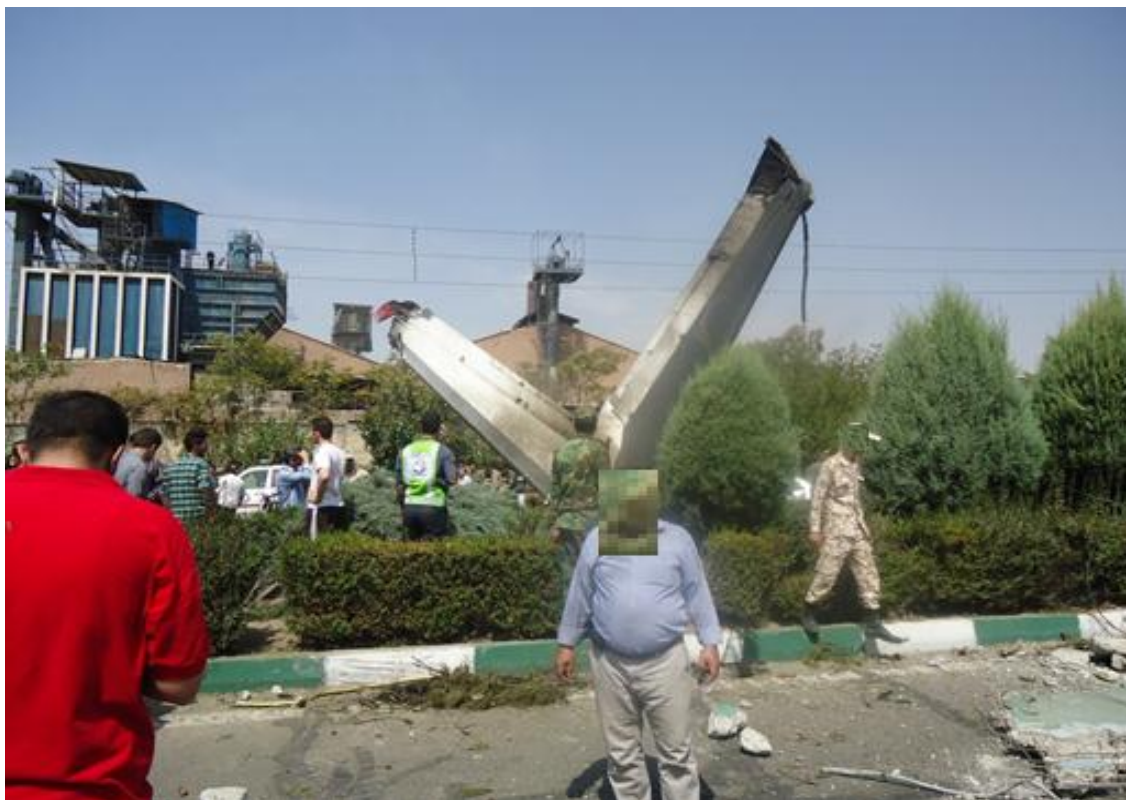
Figure 13. AN-140-100 Wreckage of tail section

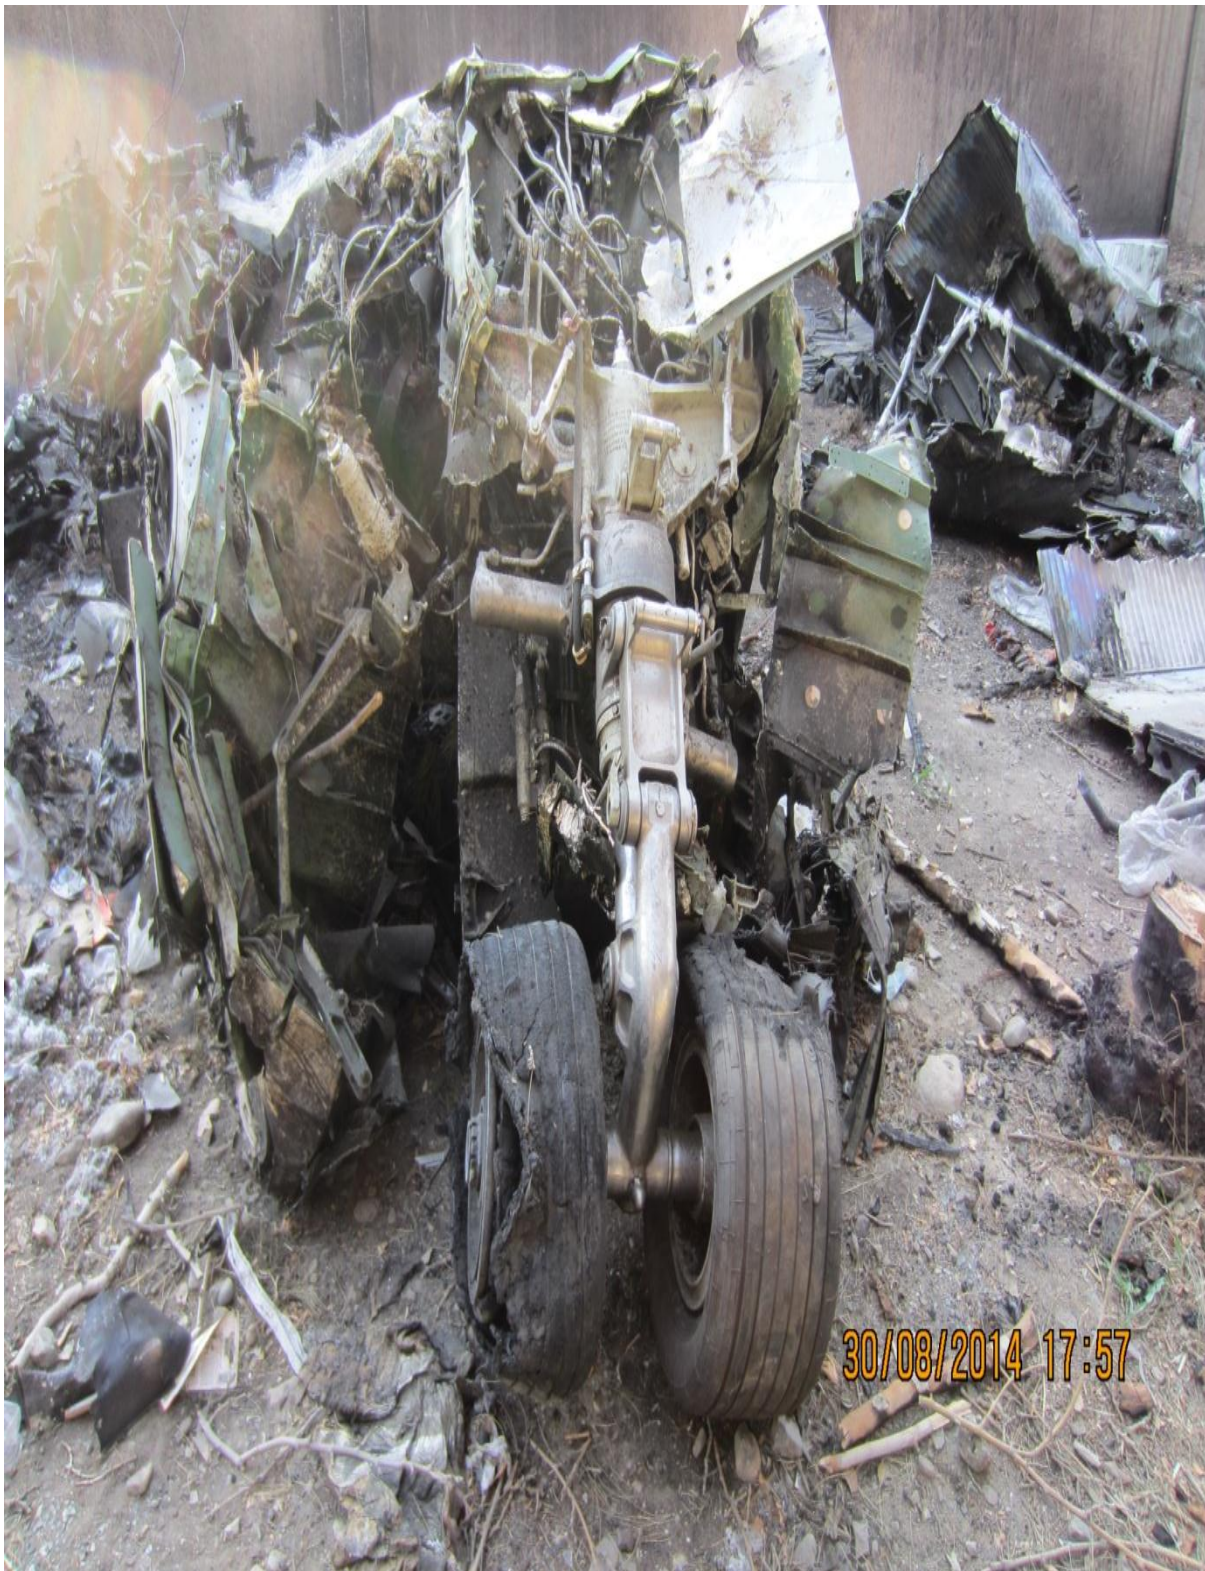
Figure 14. AN-140-100 Wreckage—landing gear

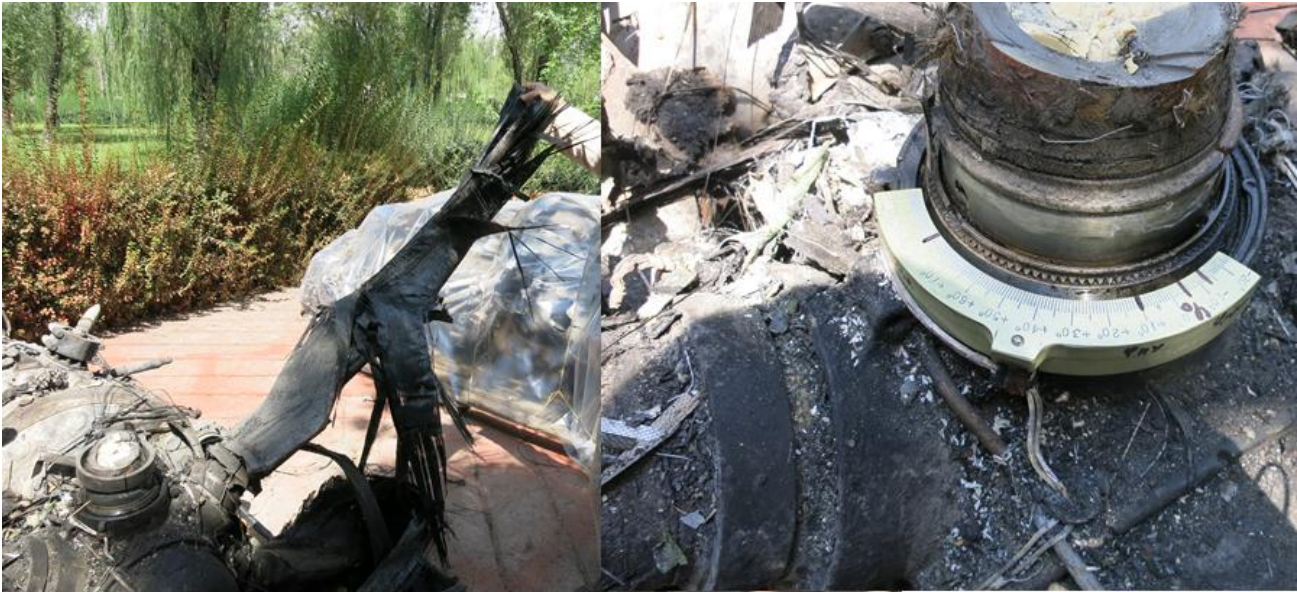
The propeller blades are burnt and partially broken; two blades are located outside the propeller and are not burnt. The propeller blades position recorded on the BUR-92A, also the propeller blades position, measure with a special tool directly on the propeller hub, which indicates the propeller blades were feathered at 84° to 85°. The engine was exposed to ground fire (the accessory gearbox and part of the compressor were burnt out).

Figure 15. AN-140-100 Wreckage –propeller

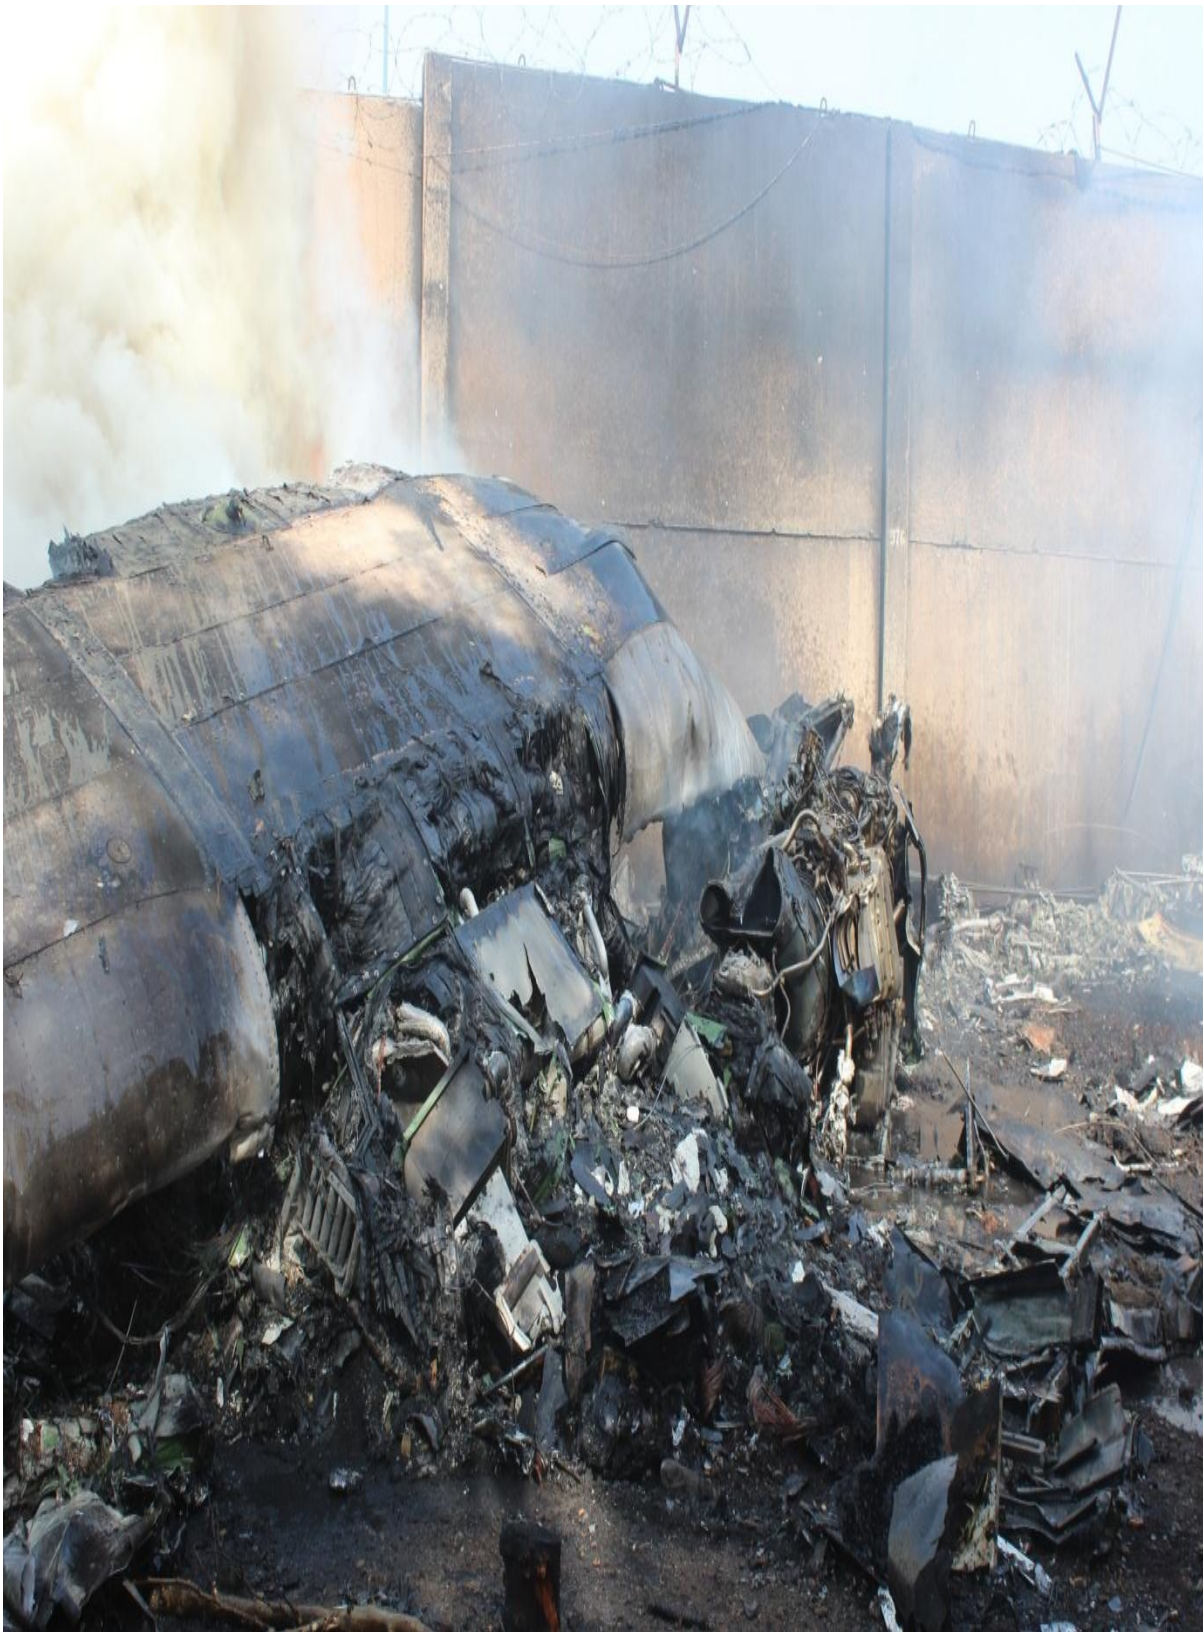
Examination of the accident site and the airplane's fuel tanks showed no evidence of Pre-crash fire involving fuel. Skins were burned away, and the fire did penetrate internal insulation and mechanisms into the cabin. However, below the cabin floor in the cargo bay, severely burned.

The post-crash fire likely originated from the ignition of the fuel that was released or spilled from the aircraft fuel tanks when the aircraft impacted the ground.

Aircraft fuel was about 500 kg more than required fuel for the accident flight. After aircraft impact, remaining additional fuel aggravated the fire.

Figure 16: fire damage to the airplane.

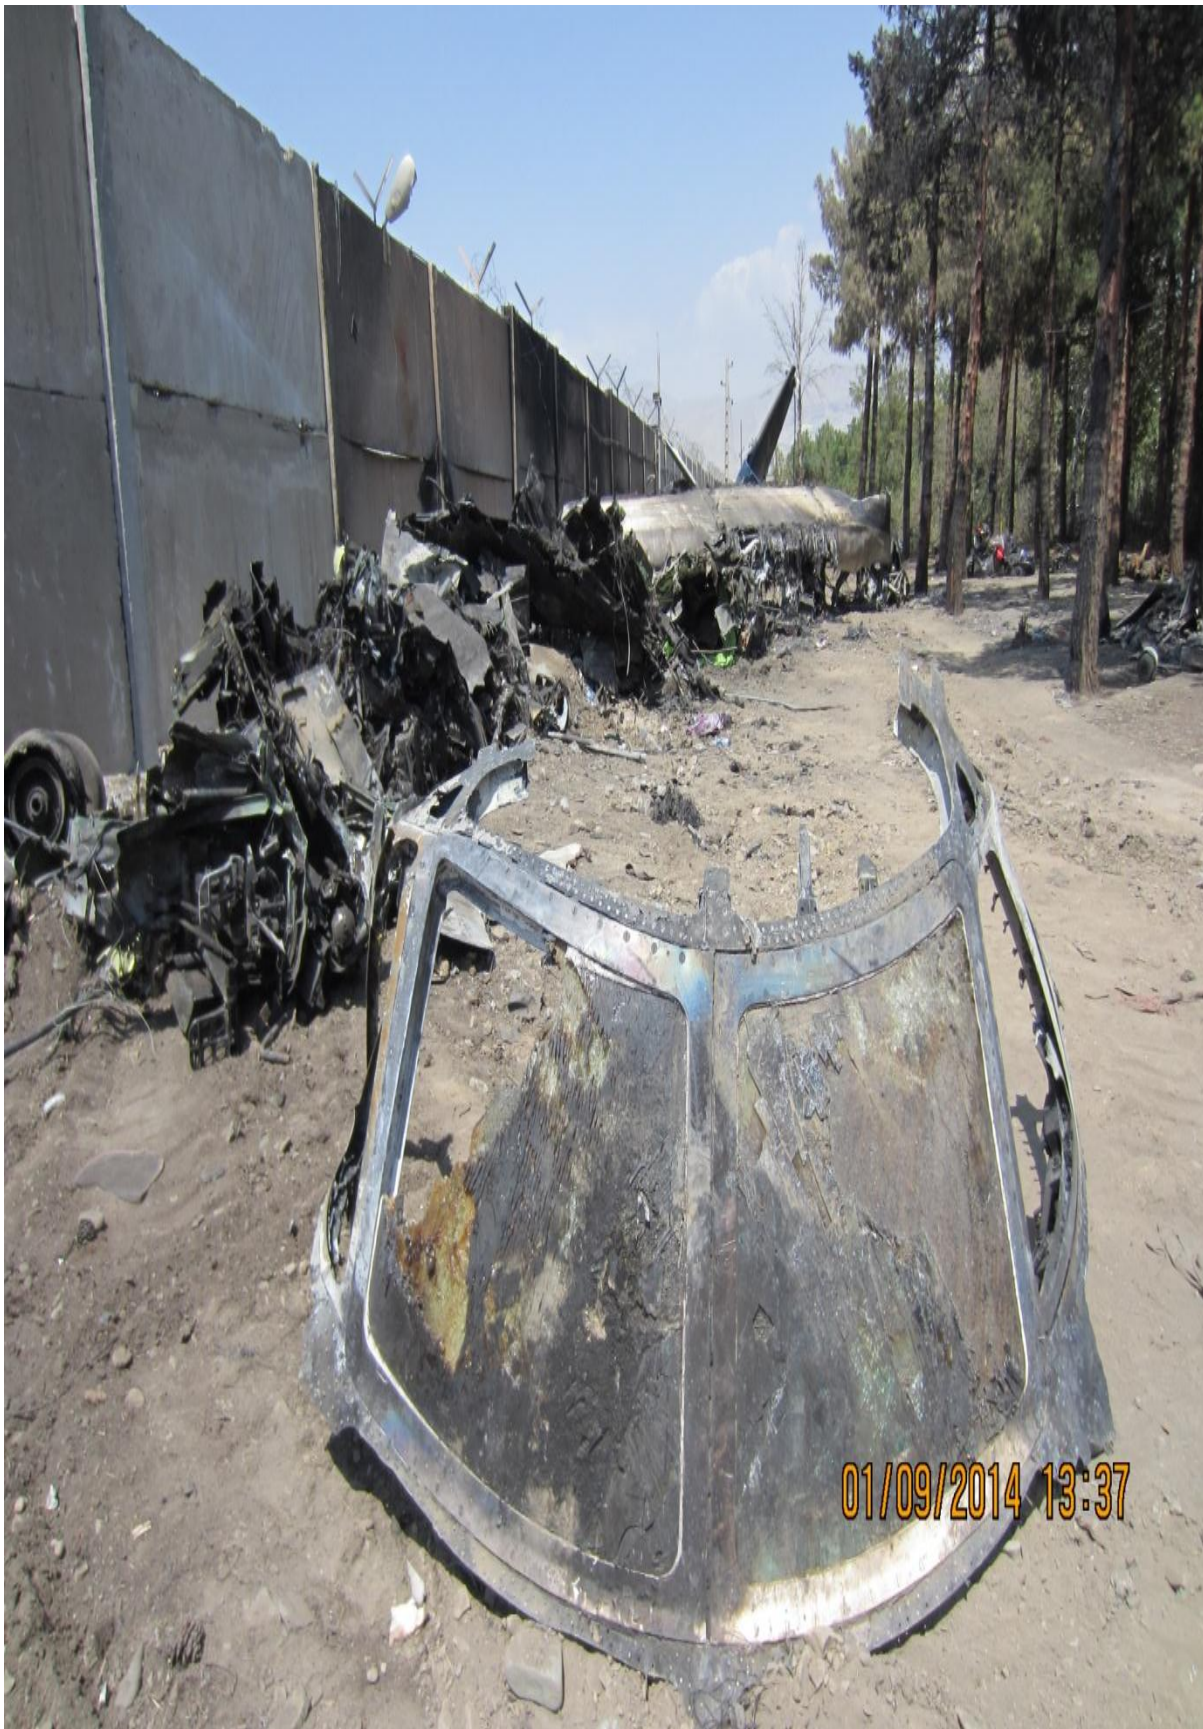
**Figure 17.** Fire damage to the fuselage

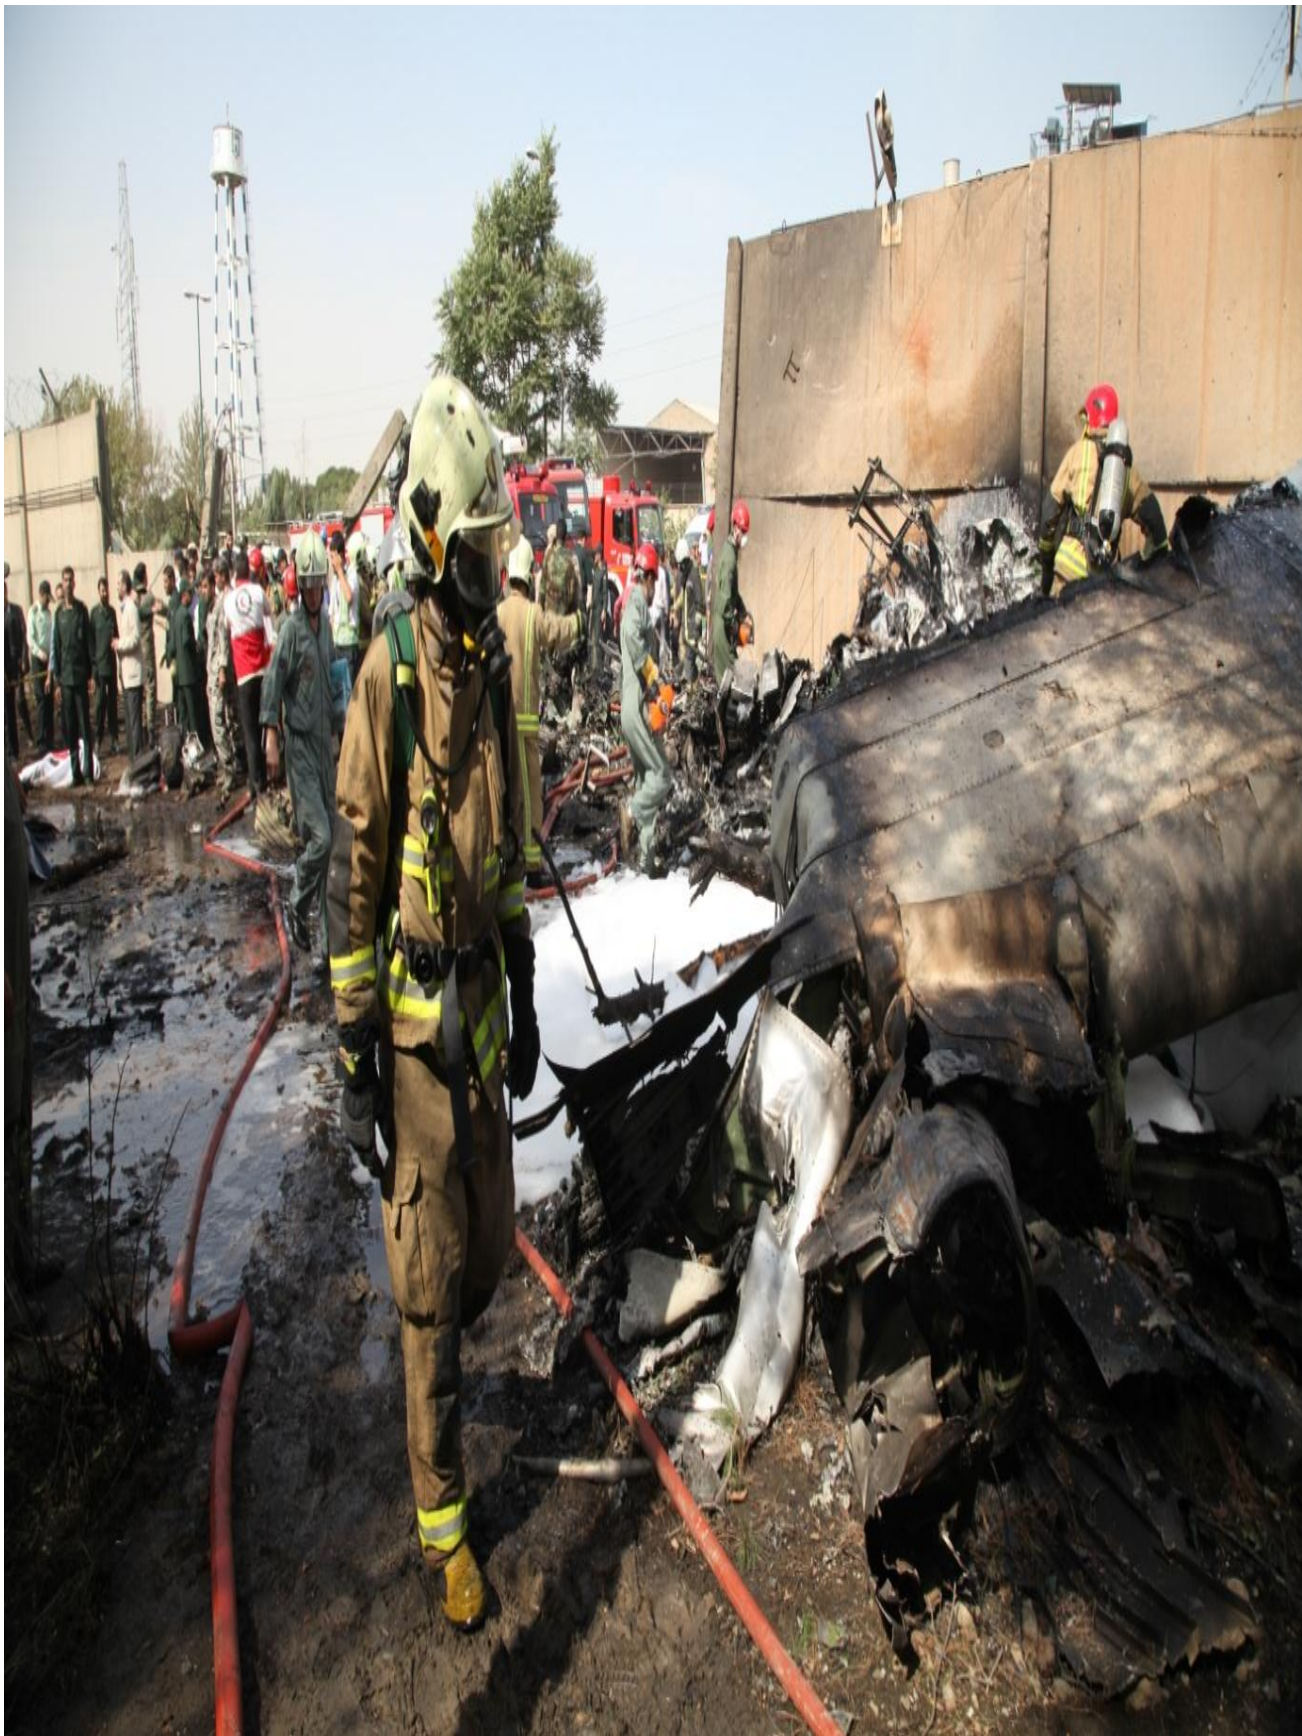
Figure 18. Firefighting operation and Location where occupants were found.

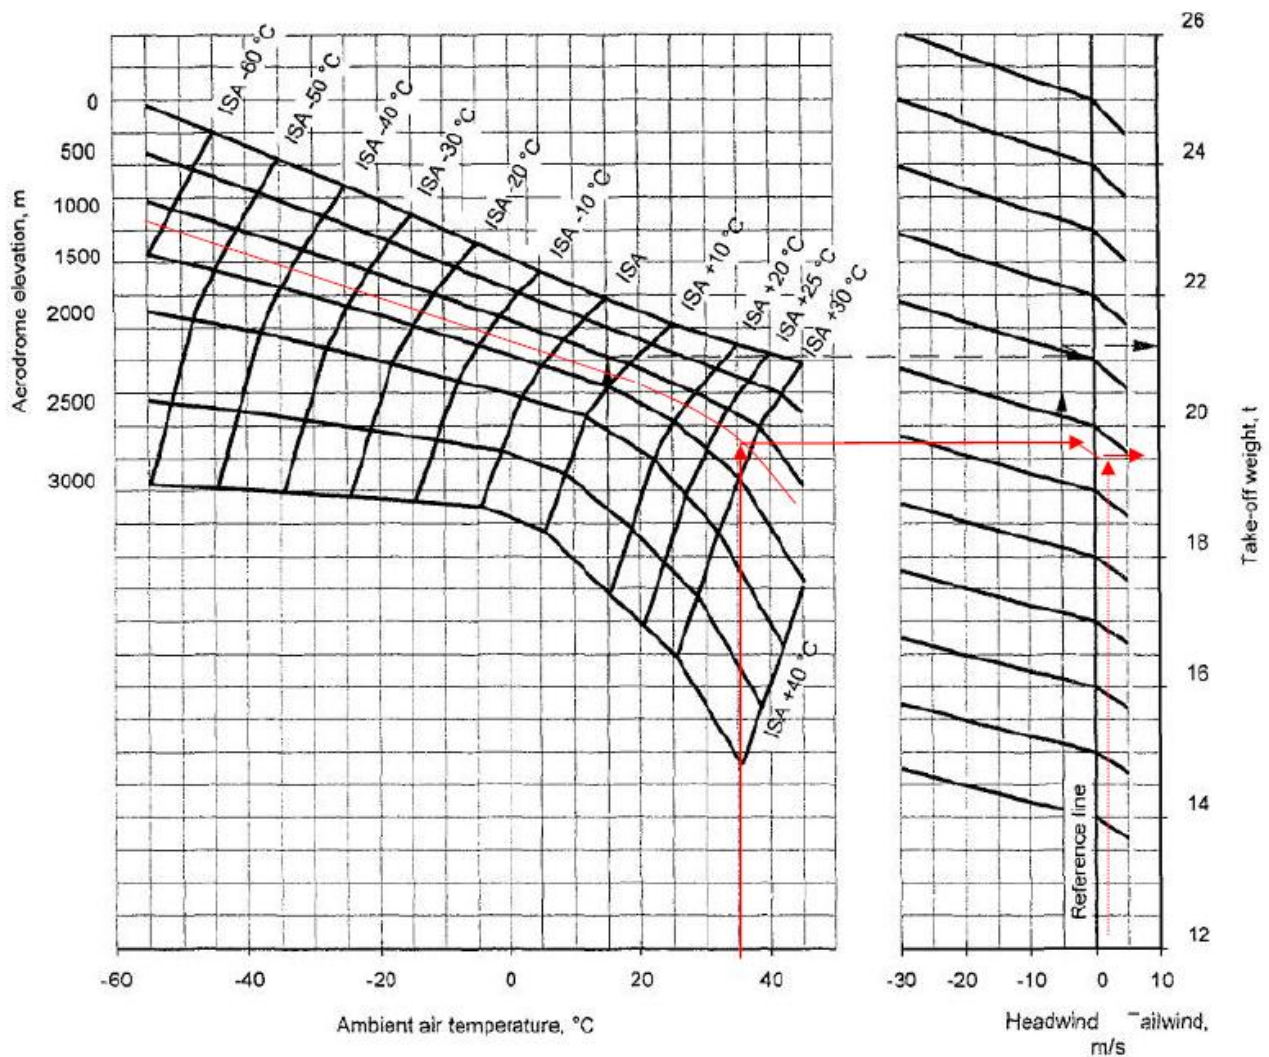
AFM confusing performance chart caused and resulted the pilots relying on performance calculation that, significantly overestimate the aircraft MTOM.

Figure 21: MTOM calculation chart
