AIRPROX REPORT No 006/07

<u>Date/Time</u> :	26 Jan 1825	NIGHT
<u>Position</u> :	5118N 00017E	(9nm ESE BIG)
<u>Airspace</u> :	LTMA	(<u>Class</u> : A)
	<u>Reporting Ac</u>	<u>Reported Ac</u>
<u>Type</u> :	LR45	SR22
<u>Operator</u> :	Civ Comm	Civ Pte
<u>Alt/FL</u> :	↑5000ft (QNH 1023mb)	4000ft (QNH 1025mb)
<u>Weather</u>	IMC KLWD	IMC IICL

AIRPROX REPORT No 083/07

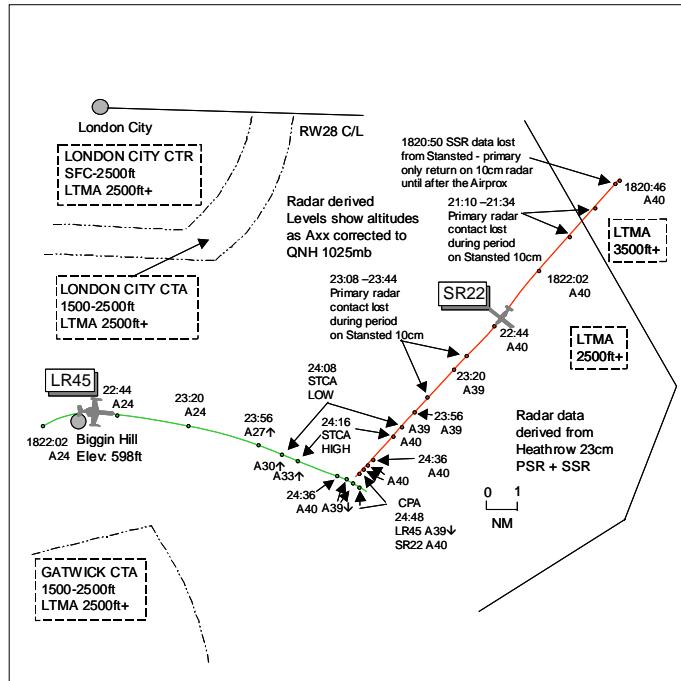
At the time the crew of the LR45 was instructed to change frequency (1823:56) the ac was passing 2700ft, in the climb to 5000ft, with the SR22 in its 11 o'clock at a range of 5.3nm. Twenty-five seconds after being instructed to change frequency the pilot of the LR45 called the TC Biggin controller and reported *"London LR45 c/s's with you climbing to altitude correction now altitude five thousand feet heading one zero seven"*. In the background the words *"Traffic Traffic"* can be heard from the TCAS. The TC Biggin controller immediately responded with *"LR45 c/s avoiding action turn right now heading one eight zero degrees descend immediately altitude three thousand feet descend now"*. The radar recording shows that as this transmission was being made (1824:36) the SR22 was converging and in the 10 o'clock position of the LR45 at a range of 1.3nm with both ac indicating 4000ft. The LR45 commenced a descent and the SR22 passed 0.6nm behind the LR45 and 100ft above it.

[UKAB Note (1): The LR45 crosses through the SR22's 12 o'clock range 0.6m 100ft below with the CPA occurring on the next sweep (1824:48) as the LR45, at 3900ft, diverges ESE bound in the SR22's 10 o'clock rang 0.4nm which is at 4000ft.]

Cause: The LTCC Thames Radar Controller climbed the LR45 into conflict with the SR22, whose SSR label was no longer displayed on the radar in use (Stansted 10cm).

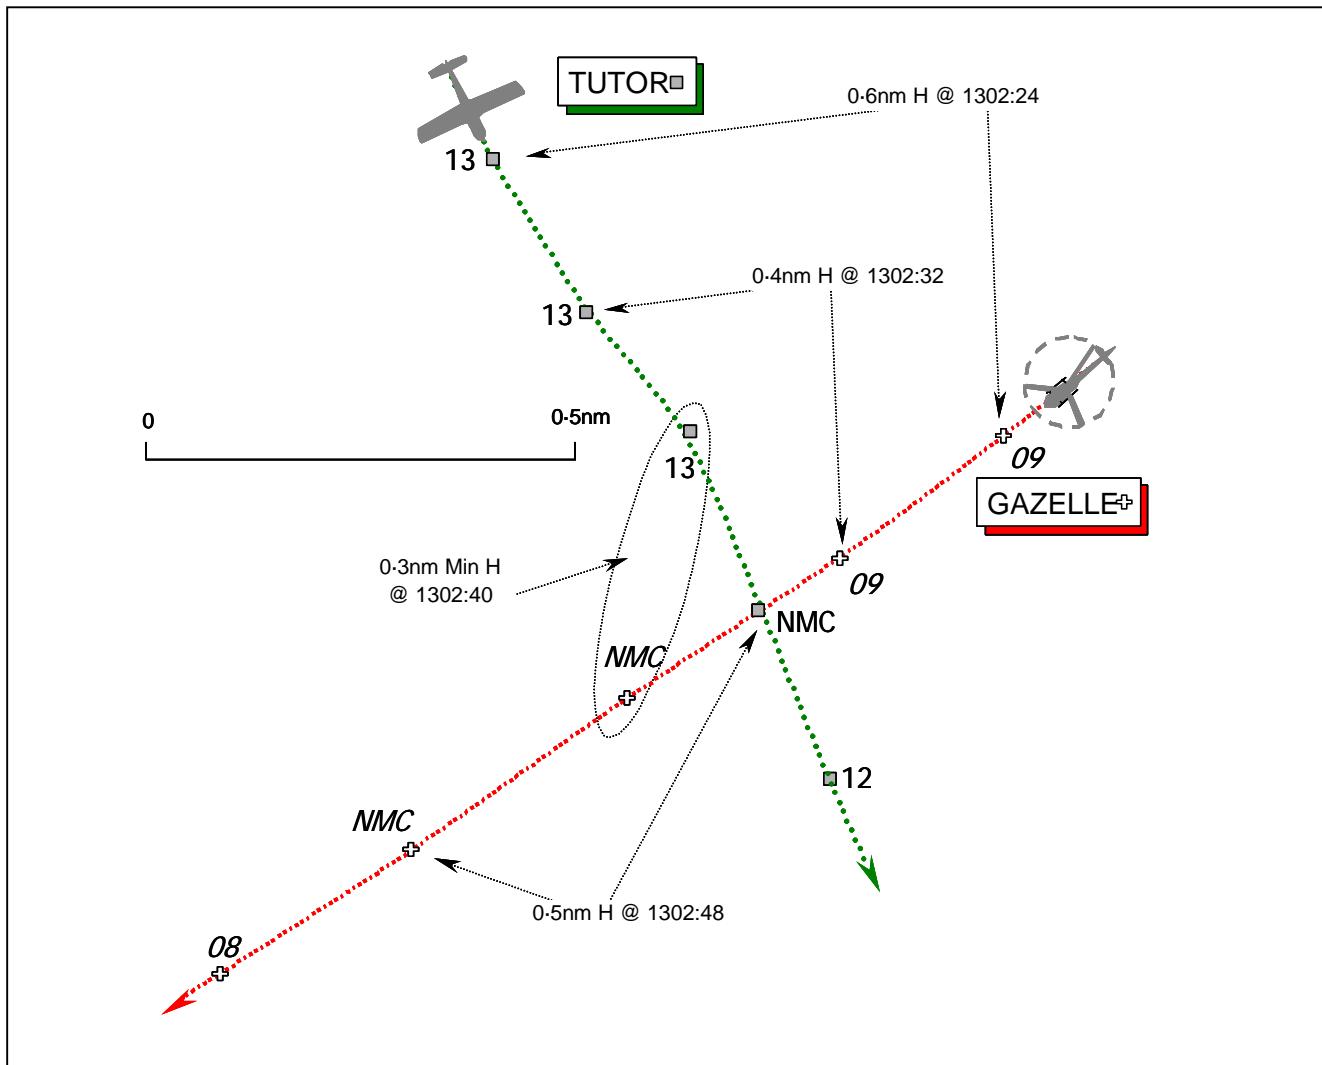
UKAB Note (1): The Claxby radar recording shows the Grob Tutor inbound to Church Fenton FINALS for RW16 at 1302:24, indicating 1300ft (1013mb) – broadly 1180ft QFE (1009mb), with the Gazelle maintaining a steady SW'ly course indicating 900ft (1013mb) – about 780ft QFE (1009mb). The Gazelle appears to be broadly following the track of the A64 road and a course perpendicular to the FAT for RW16. Just before the Gazelle crosses ahead of the Grob Tutor in between radar sweeps the helicopter is shown at a minimum of 400ft unverified Mode C beneath the Grob Tutor maintaining 1300ft Mode C in conformity with the instructions issued by TD. Minimum horizontal separation occurs on the next sweep at 1302:40, when the Gazelle is shown at a range of 0.3nm as the Grob starts to draw astern of the helicopter; NMC is shown thereafter by both ac.

Cause: Conflict in the vicinity of the final approach to RW16 at Church Fenton, resolved by ATC.

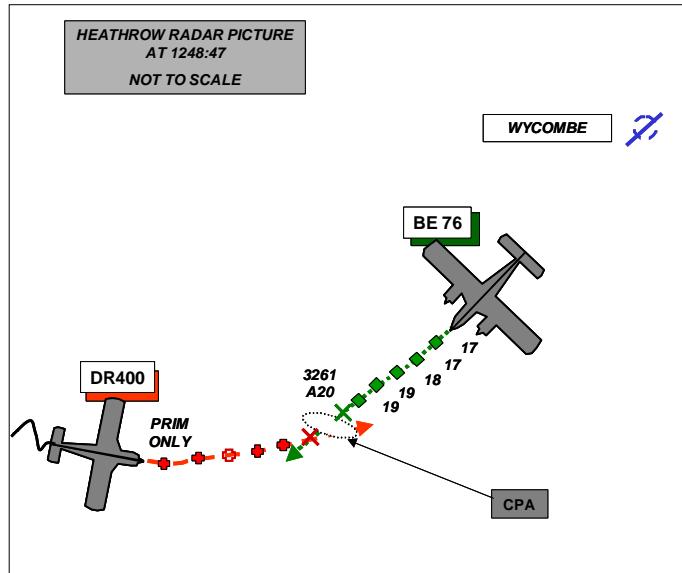
UKAB Note (2): The recording of the Heathrow radar shows the incident. The DR 400, which was not SSR equipped, crosses from R to L ahead of the BE76 that is climbing through an alt of 2100ft on the London QNH of 1020. The DR400 disappears on the sweep before the CPA, but it is assessed that it passes 250m ahead (closing); the vertical separation cannot be calculated.

Cause: Late sighting by both pilots.
