FINAL REPORT

Investigation of a serious incident related to a loss of separation, realized on September 8, 2016 with involved Airbus by A321-211 aircraft, registration marks TC-ATF, and Boeing B737-8F2 aircraft, registration marks TC-JVS in the controlled air space of the Republic of Bulgaria.

2017

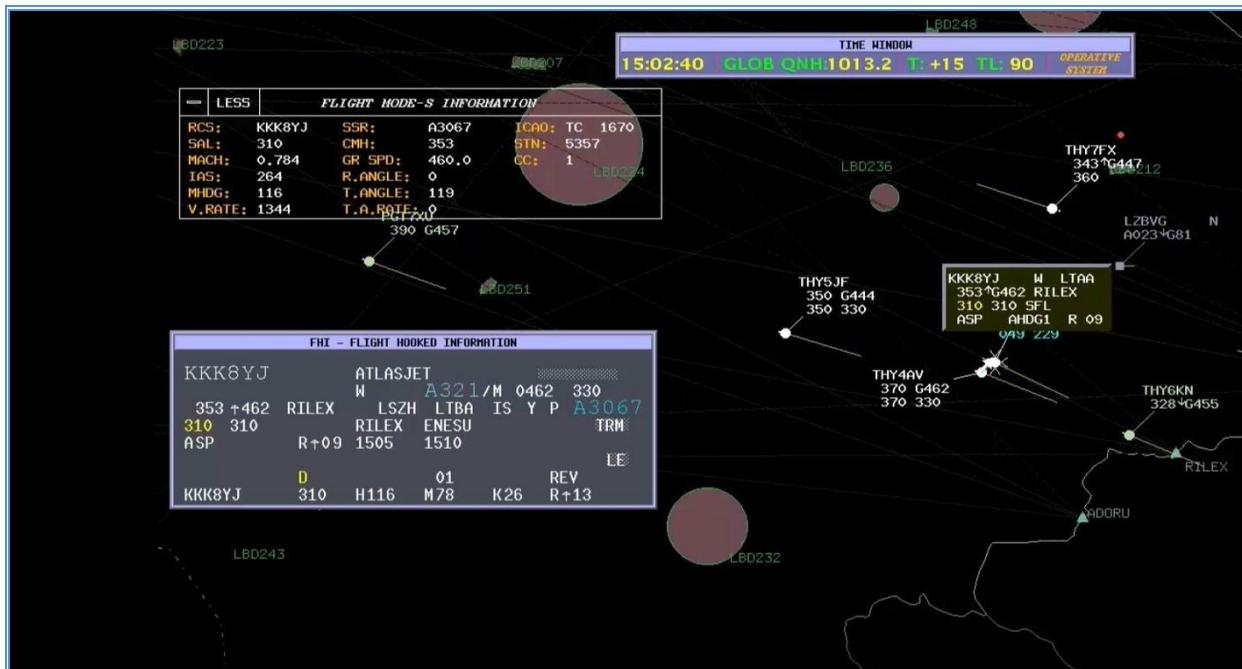
Fig. 1

According the radar information it is visible, that at 15:02:29 A321-211 aircraft KKK8YJ started climbing instead of implementing a descent to FL310 as instructed. The distance between KKK8YJ and THY4AV at that moment was 1,9 NM, and the vertical separation was 1900 ft. (See Fig. 1)

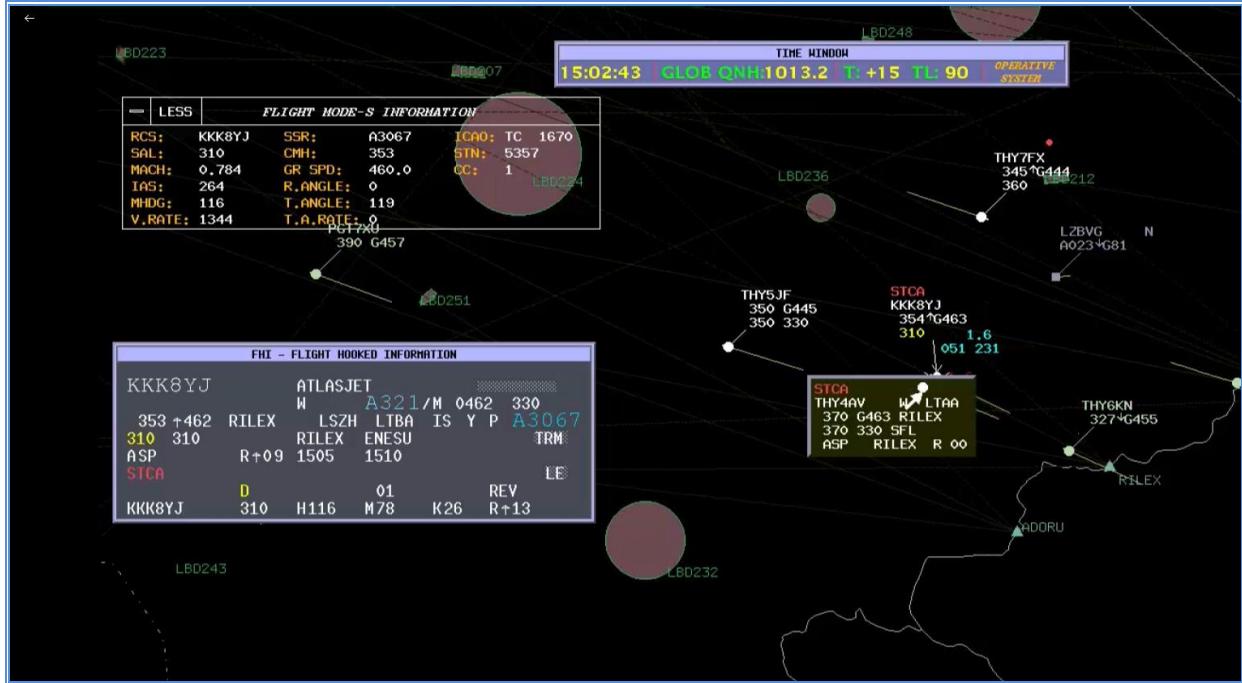
Fig. 2

to FL330, specifying a V/S of -1000 ft/min or less. Again, there was no confirmation from the crew of THY4AV. At this point KKK8JY was already crossing FL357 in climb to unknown flight level with a V/S of +1500 ft/min, the distance between both aircraft was 1,5 NM and the vertical separation was 1247 ft. (See Fig. 2)

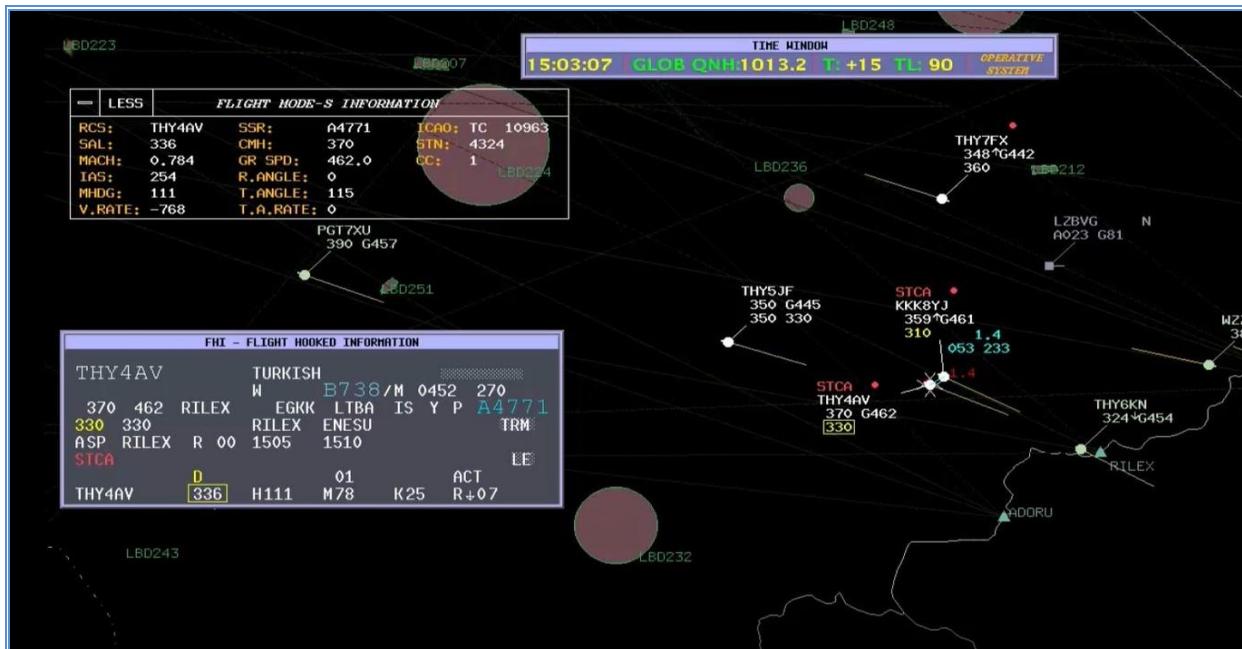
Fig. 3

At 15:03:07, the standard for minimum radar separation was infringed. THY4AV was descending and crossing FL368 with a V/S of -1300 ft/min, and KKK8JY was crossing FL360 in climb with V/S of +1500 ft/min. The distance between both aircraft was 1,5 NM and the vertical separation was 852ft. (See Fig. 3)

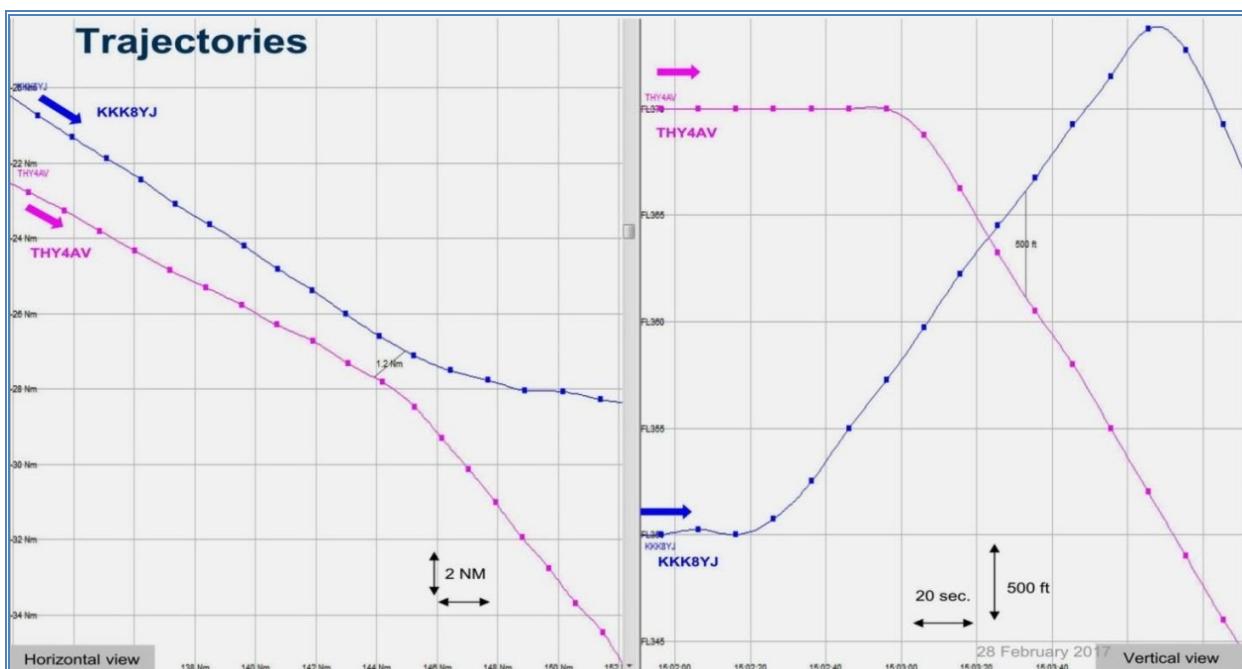
Fig. 4

According to the simulation performed (Annex 2), the closest point of approximation occurred at 15:03:33 h. The horizontal distance between both the aircraft was 1.24 NM and the vertical was 500 ft. (See Fig. 4)

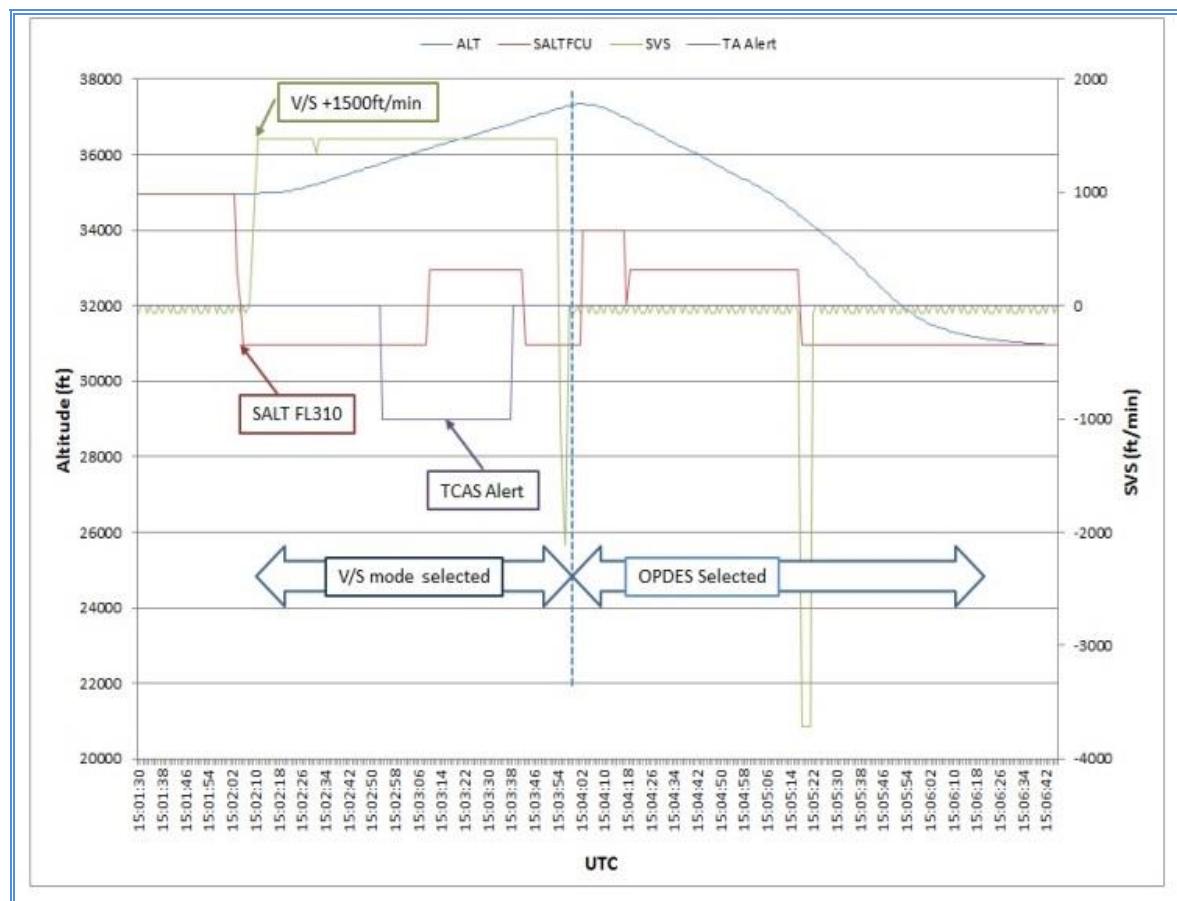
On the Fig. 5 a diagram with the parameters of descent of KKK8JY with TC-ATF registration marks is shown as it was presented in the report of Airbus (Reference GSI 420.1037/17) following DFDR flight analysis:
