**COMISIÓN DE
INVESTIGACIÓN
DE ACCIDENTES
E INCIDENTES DE
AVIACIÓN CIVIL**

Report IN-040/2016

Incident involving an Airbus A-319-111, registration CS-TTD, operated by TAP Portugal, on approach to the Santiago de Compostela Airport (Spain) on 10 October 2016

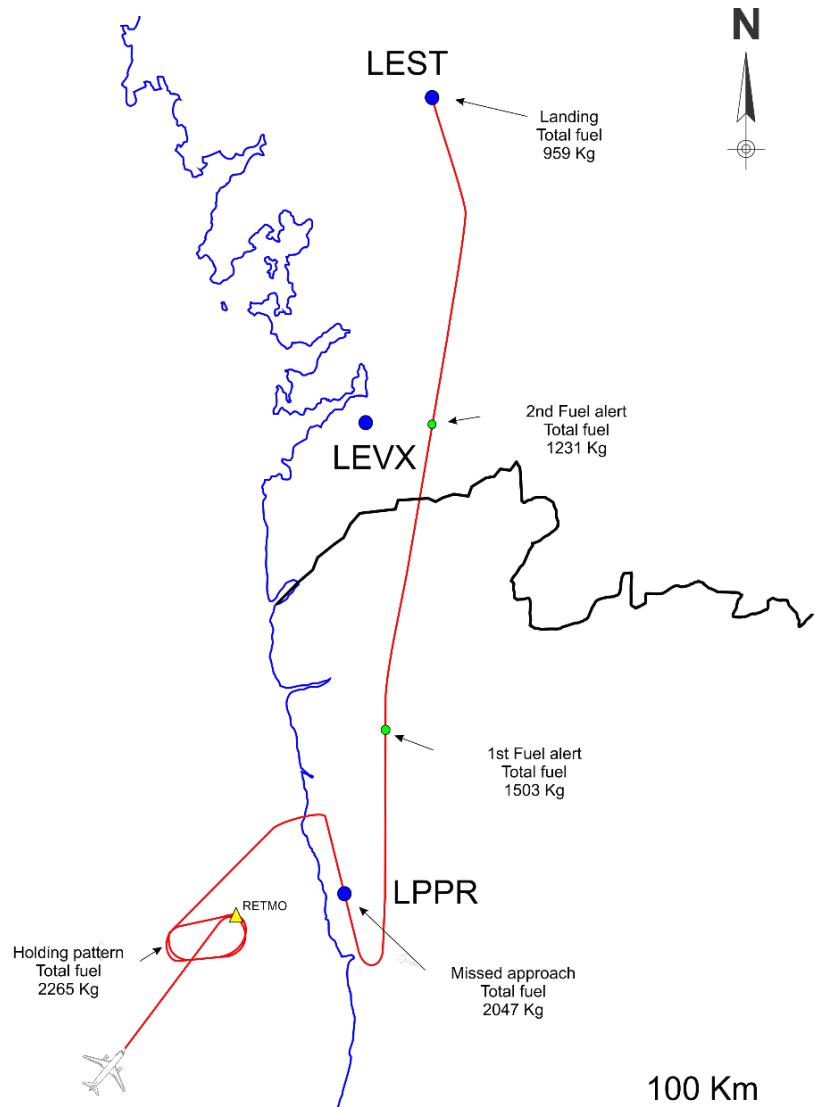
Figure 1 - Aircraft's flight path.

At 08:00:11, the crew exited the pattern and started the approach maneuver to runway 17 at the Porto Airport with 2265 kg of fuel. Two minutes later, while executing the maneuver, the crew informed approach control of their intention to proceed to Vigo should they be forced to execute a go-around.

At 08:11:44, the crew decided to go around and proceed to the planned alternate when they did not acquire the required visual reference upon reaching the approach minimums. In their message to the tower controller, they reiterated their request to proceed to the Vigo Airport.

At 08:18:28, after coordinating with Santiago approach control, the Porto approach controller reported that the Vigo Airport was at full parking capacity and that they would have to proceed to the Santiago de Compostela Airport. As a result, they were cleared direct to point NOLMU and transferred to Santiago approach.

At 08:26:34, the crew, in contact with Santiago approach, declared a fuel emergency after estimating that the amount of fuel remaining upon landing would be below final reserve fuel, which the OFP specified as 989 kg.

After flying the VOR approach to runway 35 at Santiago, the aircraft landed at 08:38:20 without incident with 959 kg of fuel remaining. The crew were instructed to proceed to parking stand 04.

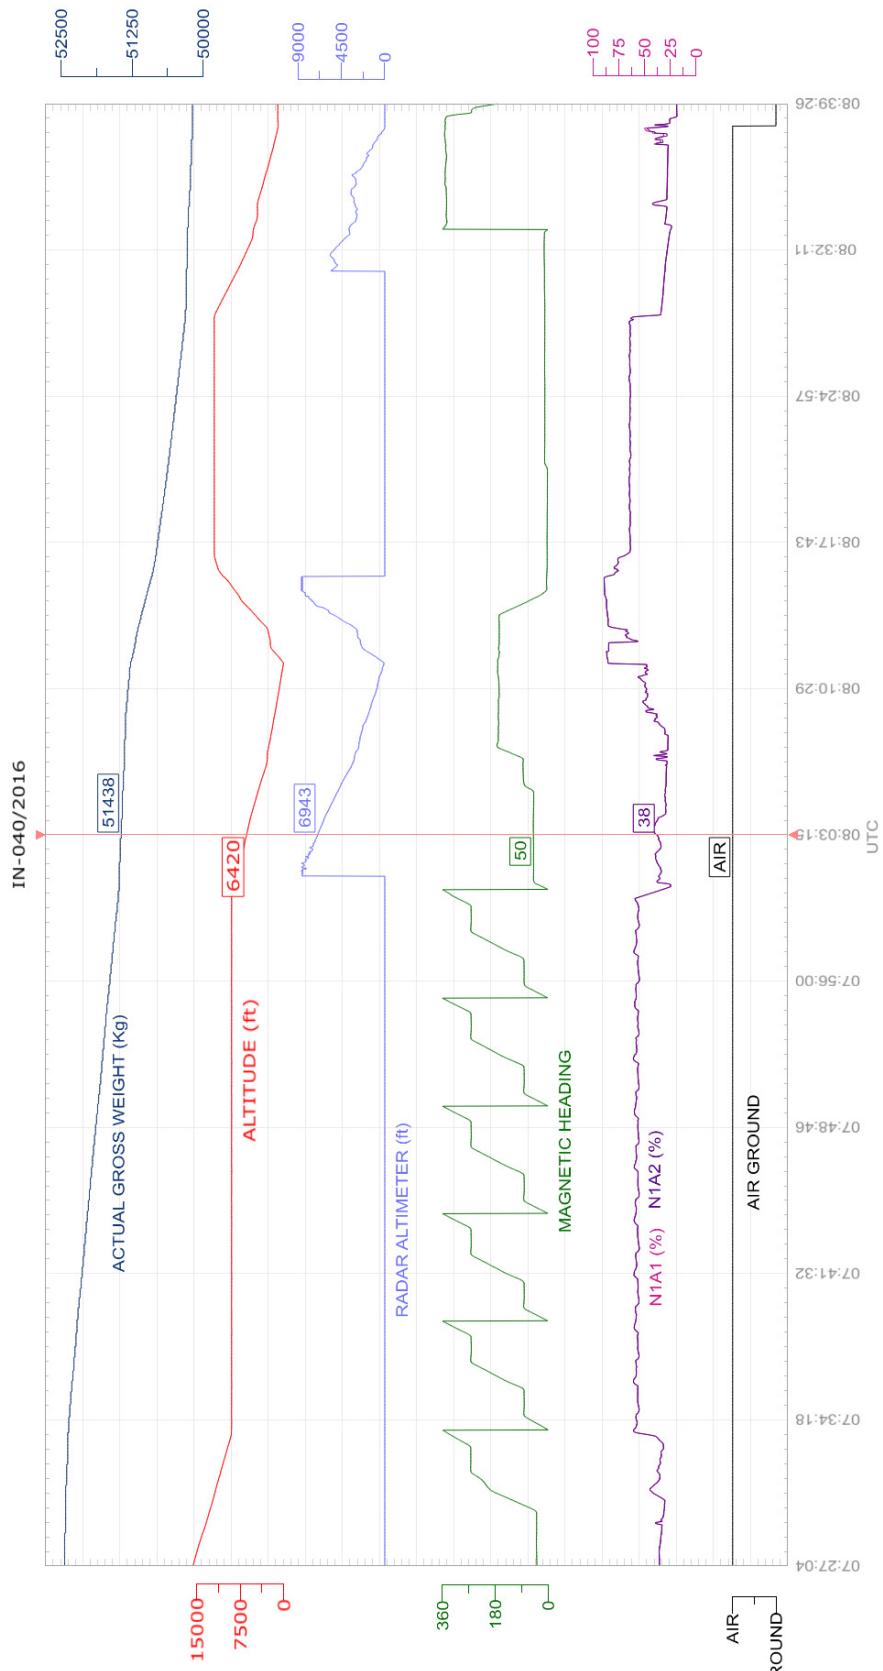
Parameters recorded in the QAR

At 08:19:15, a "FUEL L WING TK LO LVL" alert was received, indicating a low fuel level in the left wing, and at 08:25:25 a second alert was received, this time for the right tank: FUEL L+R WING TK LO LVL.
