# Incident Investigation Final Report

**State File Number:** 950524EPTTA  
**Type of Occurrence:** Serious Incident  
**Date of Occurrence:** August 13, 2016  
**Place of Occurrence:** Tehran Mehrabad Airport  
**Aircraft Type:** A320  
**Registration:** EP-TTA  
**Operator:** Atrak Airlines

**Final Report**

State File Number: S950523EP-TTA  
Type of occurrence: Serious incident  
Date of occurrence: August 13, 2016  
Place of Occurrence: Islamic Republic of Iran (Mehrabad International Airport)  
Aircraft Model: A320-231  
Registration: EP-TTA  
Operator: ATRAK Air

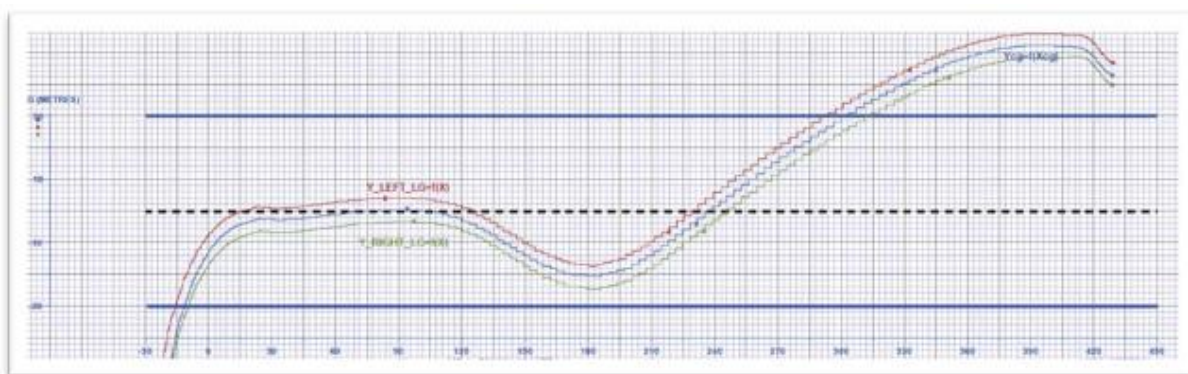
### AIRCRAFT TRAJECTOGRAPHY

As per computed trajectography, the aircraft exited the runway at about 300m after runway threshold and 47m from the runway centerline.

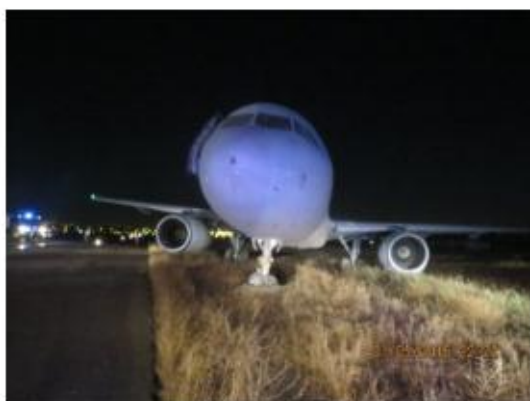
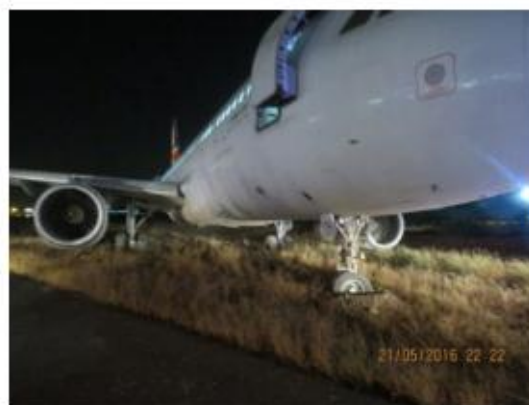
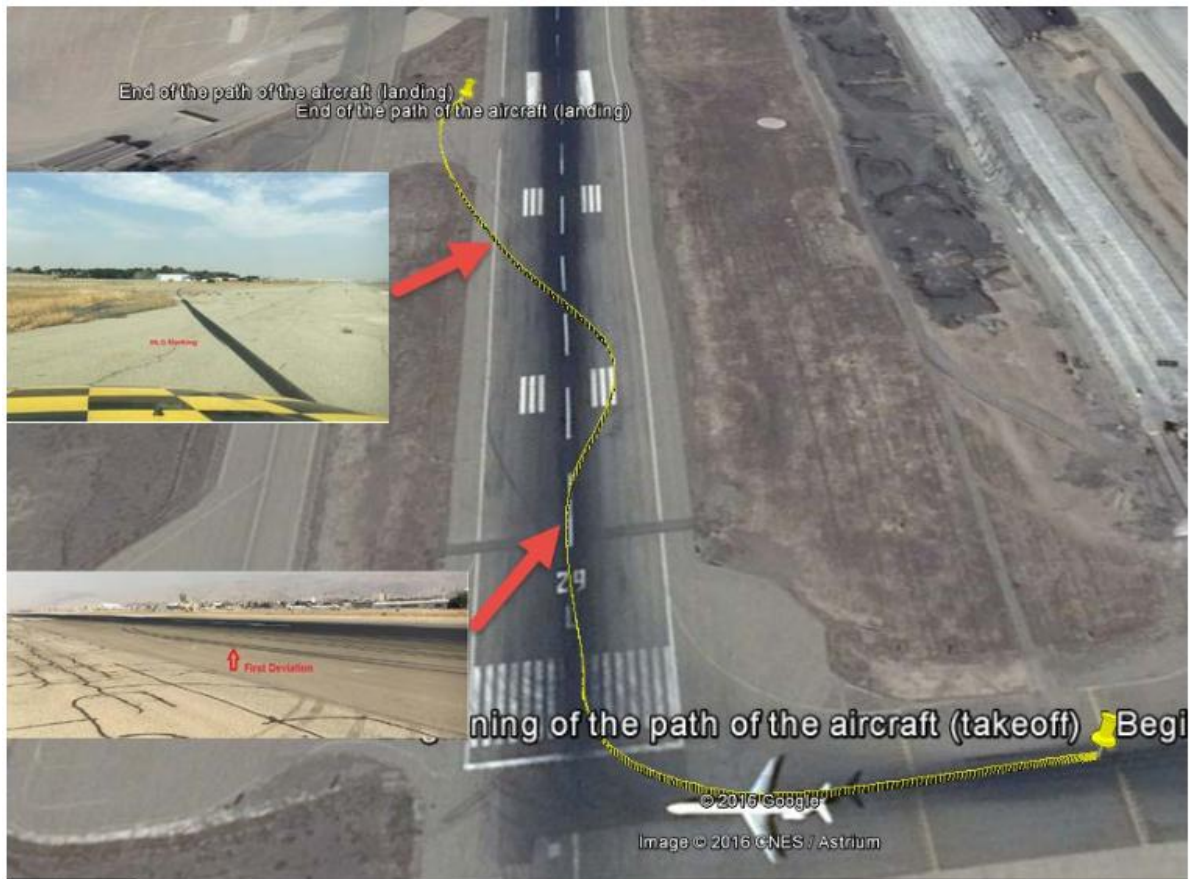
Below is the trajectory and provided photographs of the incident site which are taken shortly after the event.

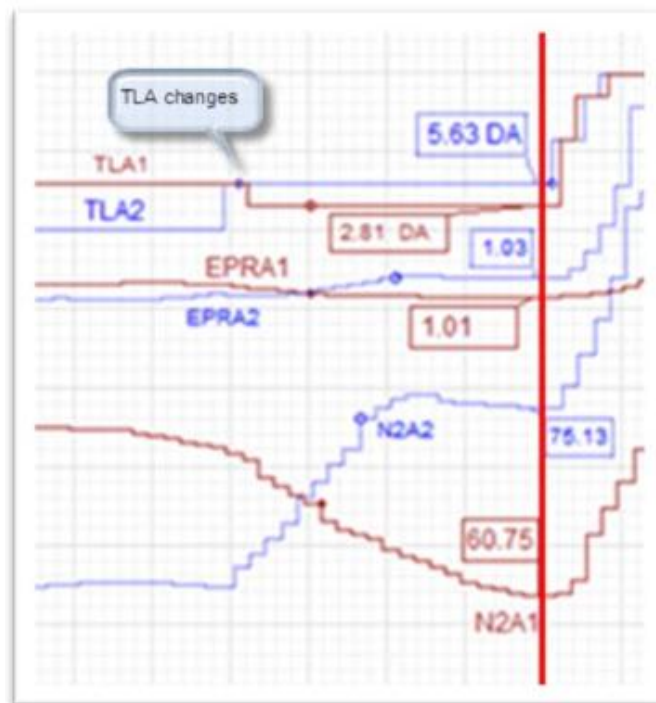
## A. ALIGNMENT TO RUNWAY

**17:38:30 UTC:** A/C was stopped on the runway 29L (QFU = 285° / HDG=286.2°) with the following configuration:

*The aircraft completed its taxi on to the runway, coming to a standstill once aligned with the runway centerline. TLA1 was reduced to 2.81° while TLA2 was increased to 5.63°, resulting in respective changes in engine N2A and EPR parameters. Ground speed remained zero during these TLA changes.*

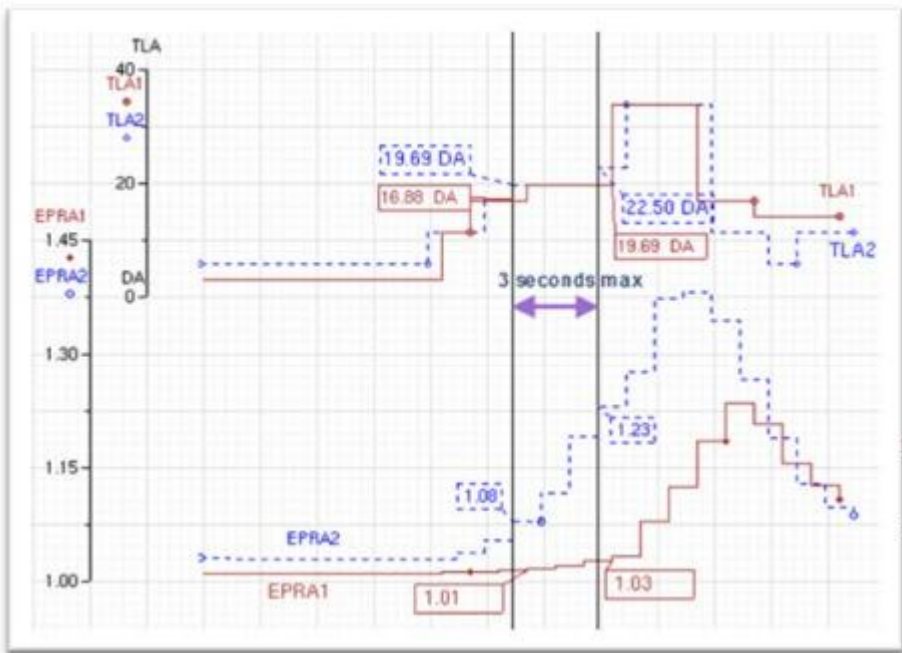
Both TLAs were symmetrically pushed up towards the MCT/FLEX notch (33°) over a duration of 6s:

- EPRA2 increased immediately, EPRA1 increased at a slower rate

*Both TLAs were advanced, pausing momentarily for between 2s and 3s (taking into account the sampling rate) at 20°, just before the Climb gate. During that time, EPRA1 increased from 1.01 to 1.03 while EPRA2 increased from 1.08 to 1.24.*

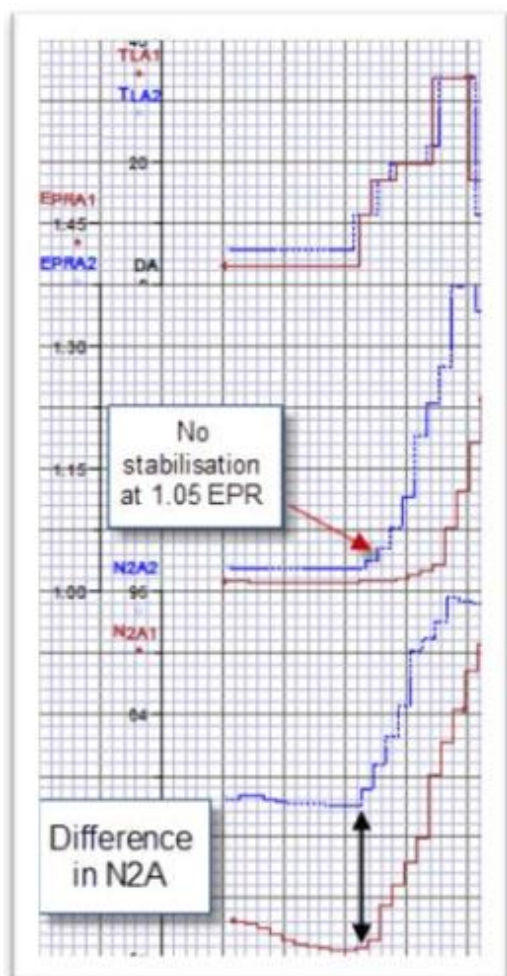
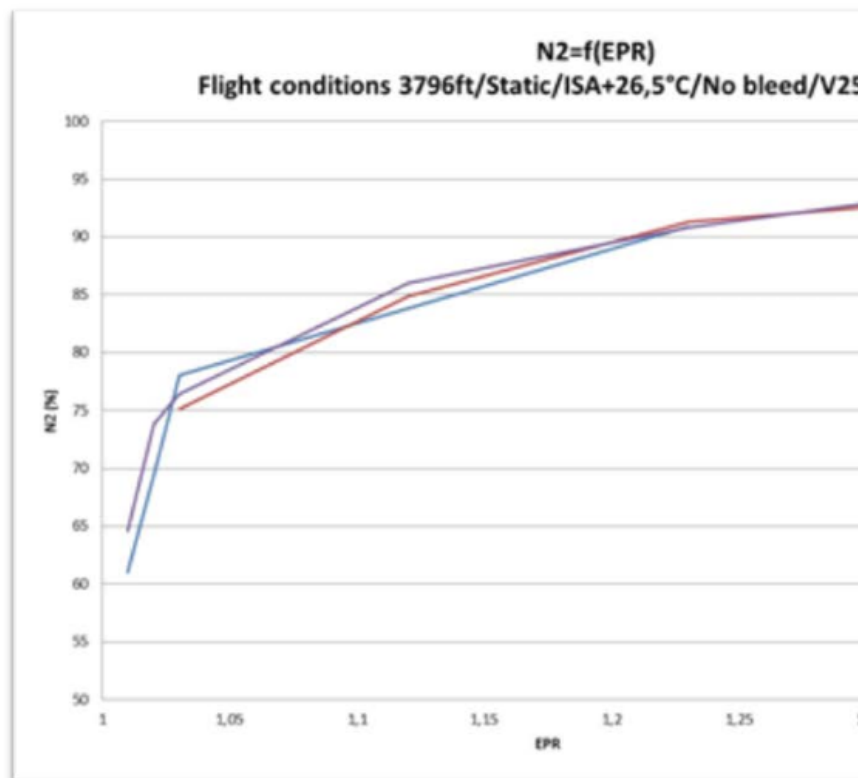
### 2.3.1 Engine Spool Up:

Following the asymmetric engine spool up, to ensure that there was no engine related issues, an analysis of engine behavior during the event was completed. the graph below presents the N2 vs EPR for both engines compared to the Airbus stabilized model.

Considering the sampling, the use of the stabilized model in transient phase and the engine to engine variability, both engines are consistent with the model, showing no abnormal behavior.

The EPR delta between the engines during the take-off roll is due to the longer acceleration of engine 1, which is normal due to its lower initial N2 level.

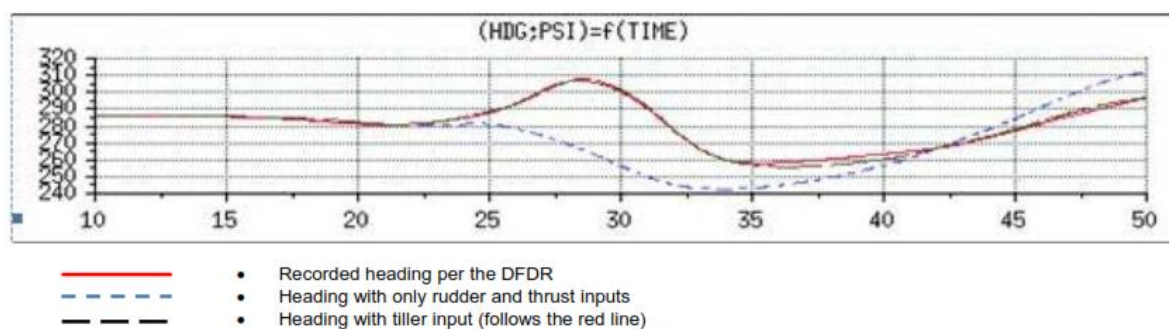
An engineering simulation was performed to simulate the trajectory with the rudder inputs, symmetrical braking and engine power levels as recorded on the DFDR. The Airbus simulation of the aircraft trajectory is shown below.

The trajectory shown with the blue dashed line is a simulation performed at Airbus using only the rudder pedal inputs and the engine thrust as recorded in the DFDR.

It can be seen above that the actual recorded trajectory is not possible using only the rudder and thrust inputs.

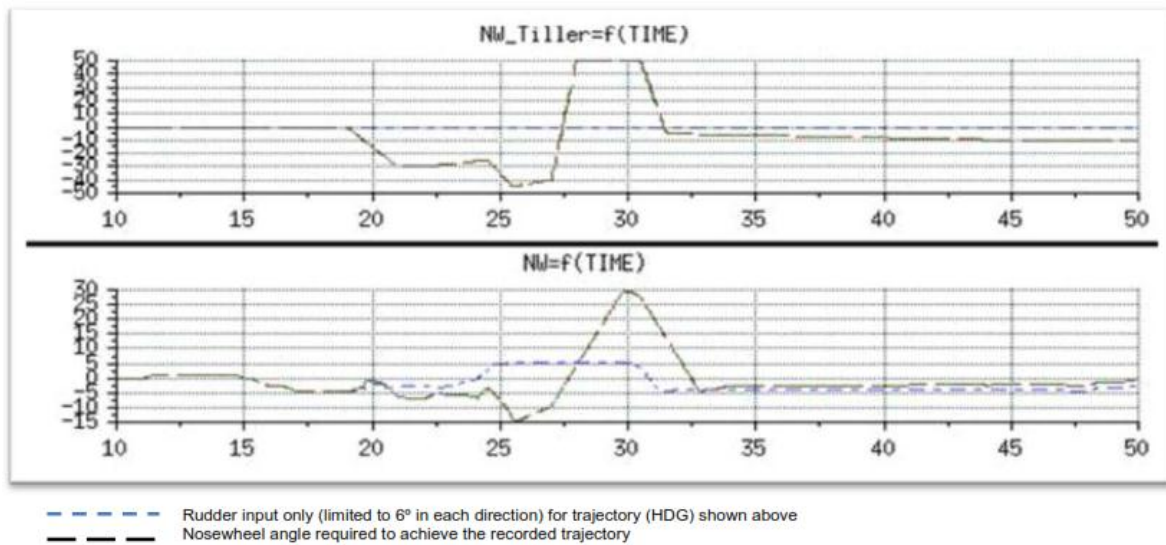
## Nose wheel and tiller angles vs time

The above simulation was performed using the Airbus engineering models.

The objective of the simulation was to determine whether the tiller was used, and ascertain the nose wheel steering functionality during the event. The simulation concludes:

- That the actual trajectory is only possible with the use of the NW tiller deflection of the nose-wheel steering is commanded, firstly to the left and then to the right.
