SERIOUS INCIDENT

Aircraft Type and Registration:	Saab-Scania SF340B, G-LGNB	
No & Type of Engines:	2 General Electric Co CT7-9B turboprop engines	
Year of Manufacture:	1990 (Serial no: 340B-216)	
Date & Time (UTC):	5 June 2017 at 1415 hrs	
Location:	During climb after departure from Edinburgh Airport	
Type of Flight:	Commercial Air Transport (Passenger)	
Persons on Board:	Crew - 3	Passengers - 33
Injuries:	Crew - None	Passengers - None
Nature of Damage:	None	
Commander's Licence:	Airline Transport Pilot's Licence	
Commander's Age:	34 years	
Commander's Flying Experience:	6,638 hours (of which 6,387 were on type) Last 90 days - 109 hours Last 28 days - 49 hours	
Information Source:	AAIB Field Investigation

Synopsis

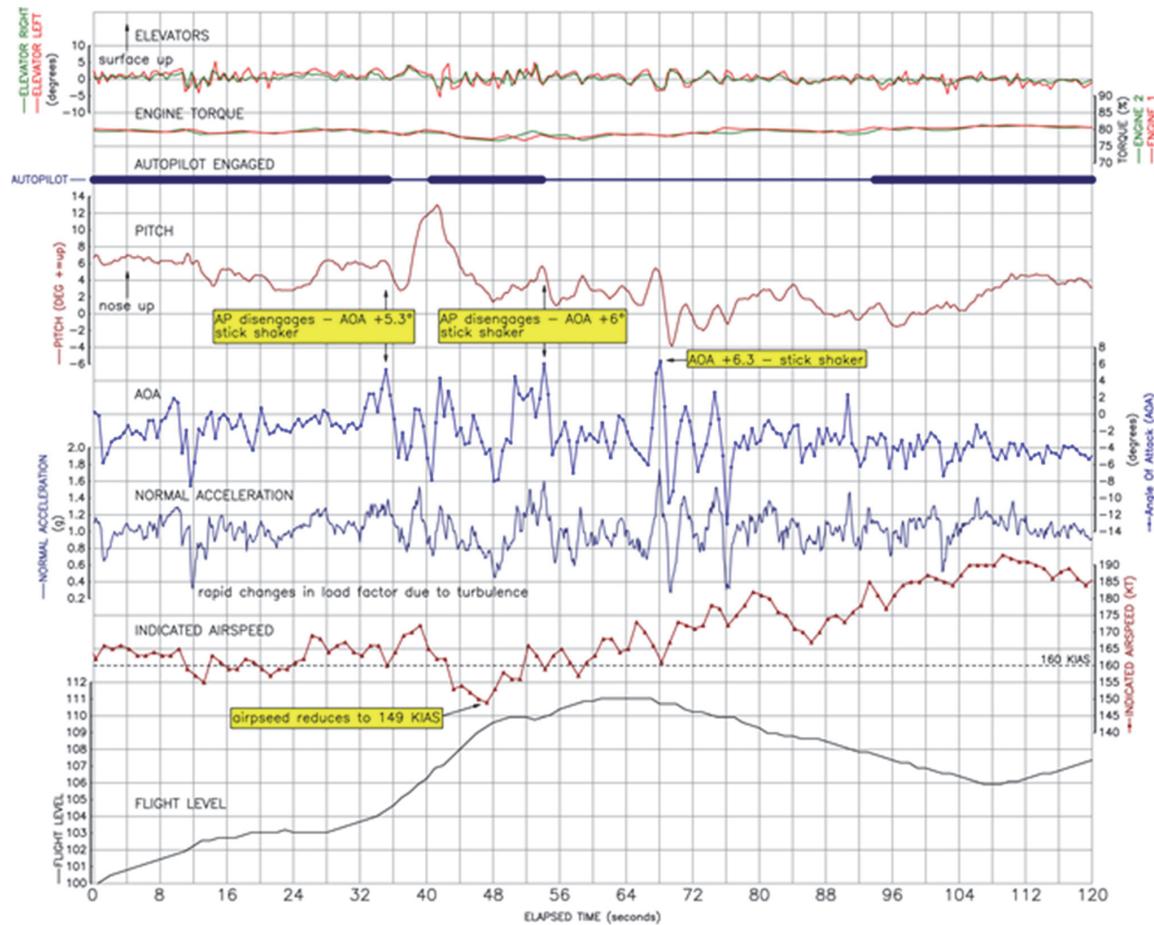
Figure 1
FDR data overview of event

Figure 1 shows salient parameters during the period when the aircraft experienced an increase in turbulence during the climb and the autopilot disconnected.

About eight minutes after takeoff, as the aircraft climbed through FL100, perturbations of normal acceleration started to increase, consistent with the aircraft encountering light turbulence. The OAT was -5°C. The turbulence then continued to increase in intensity, with variations in AOA that closely correlated with changes in load factor, pitch attitude and airspeed; the average airspeed was 162 KIAS at this time. The aircraft then briefly levelled off at FL103, before climbing again. Shortly afterwards, the AOA increased rapidly over one second from just over 0° to a recorded value of +5.3°, which coincided with the autopilot disconnecting; the airspeed was 160 KIAS and the pitch attitude was 6.3° nose-up. The coincident disconnection of the autopilot meant that the peak AOA value was in excess of the 5.3° recorded.

The pitch attitude then reduced quickly to 2.8° nose-up, before increasing to 13° nose-up in four seconds. During this period, the recorded AOA also varied rapidly, reducing to a minimum of -7°. The autopilot was then re-engaged and the pitch attitude reduced to about 2° nose-up. The airspeed reduced to 149 KIAS, after which it started to increase towards 160 KIAS.

Thirteen seconds later the aircraft pitched up quickly to 5.6°, the recorded AOA also increased rapidly, reaching a recorded 6°, and the autopilot disconnected again; the airspeed was 159 KIAS. The aircraft then briefly levelled off, during which the pitch and AOA both increased rapidly again, with the recorded AOA peaking at 6.3°. The aircraft then descended about 500 ft to FL105, during which the airspeed progressively increased to about 190 KIAS. At no time during this period of the flight was engine power increased to the 'maximum continuous' setting. The autopilot was then re-engaged, which coincided with a reduction in turbulence, and the aircraft climbed to its cruise altitude of FL170.

The FDR data was provided to the aircraft manufacturer for analysis. It was concluded that the rapid changes in pitch attitude and AOA were caused by turbulence. The aircraft did not enter an aerodynamic stall at any point, and the activation of the stall warning system was triggered by the AOA threshold being momentarily exceeded.

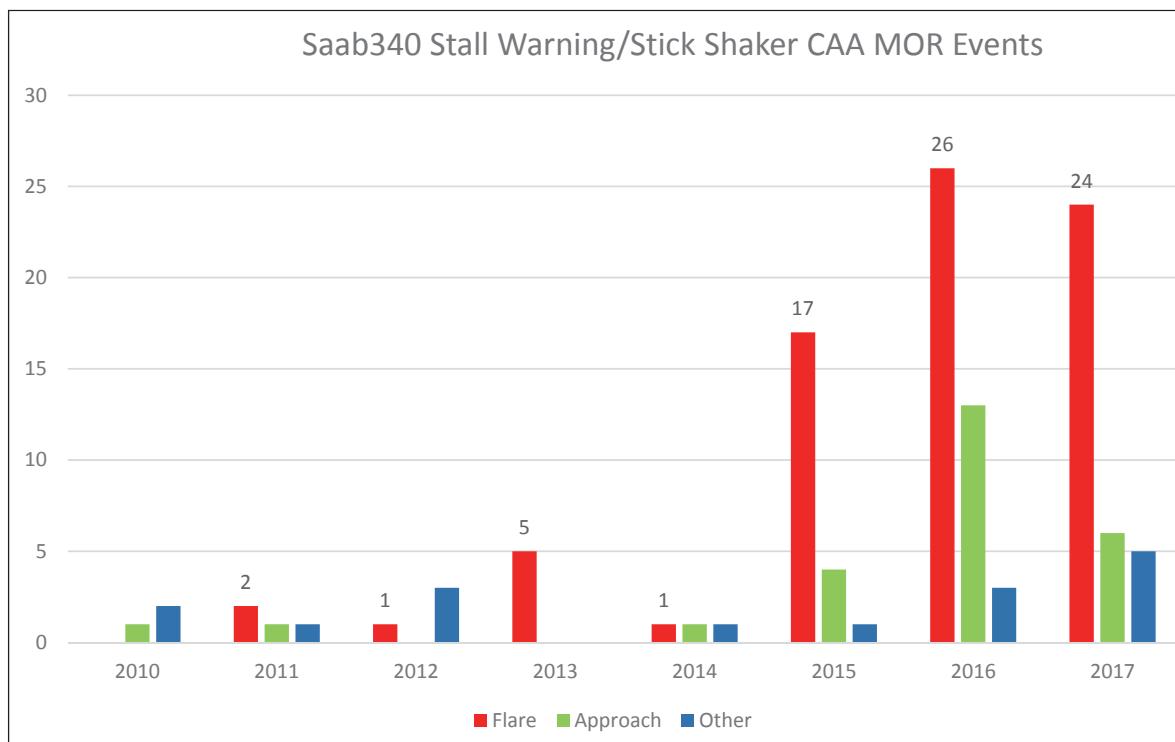
**Figure 2**

Analysis of Saab340 stick shaker events reported to the CAA via the MOR⁴ system revealed that, after the introduction of the stall warning modification, the number of reported events increased from an average of 3.8 per year between 2010 and 2014 to 22 in 2015, 42 in 2016 and 35 in 2017 (Figure 2). These events were particularly prevalent in the approach and landing phase of flight.

The operator believed that this increase in events was directly related to the requirements of the stall warning computer modification and the trigger AOA being significantly lower than before. If the aircraft is in turbulence, or there is a sudden gust of wind at touchdown, the pitch of the aircraft can alter rapidly, triggering the stick shaker.

Saab340 Stall Warning/Stick Shaker CAA MOR Events 2010 to 2017

EASA, the operator and the manufacturer considered making deactivation of the ICE SPEED logic independent of the requirement to maintain the engine anti-ice system on for five minutes after leaving icing conditions. This change, considered feasible by the manufacturer, would address the concerns about repeated activation of the stick shaker in the latter stages of an approach and in the flare.

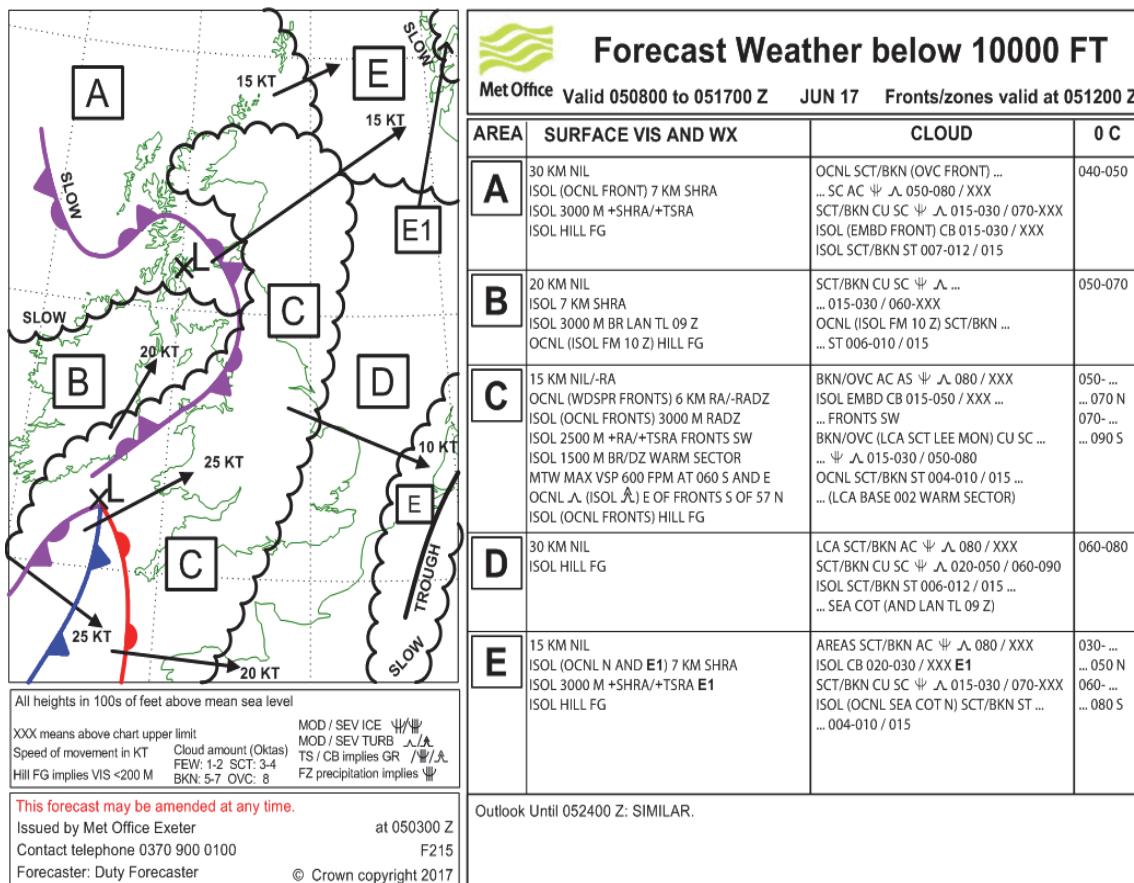
Figure 3

The crew received a briefing pack when they reported for duty. This pack included the route, NOTAMS, weather at departure and destination as well as charts of wind, weather and temperature along the intended route. The Met Office chart F215 details the weather in the UK below 10,000ft. The chart for 0800 hrs to 1700 hrs issued on the day of the incident is shown at Figure 3.

Chart F215 Valid 1200UTC on 5 June 2017 produced by the UK Met Office

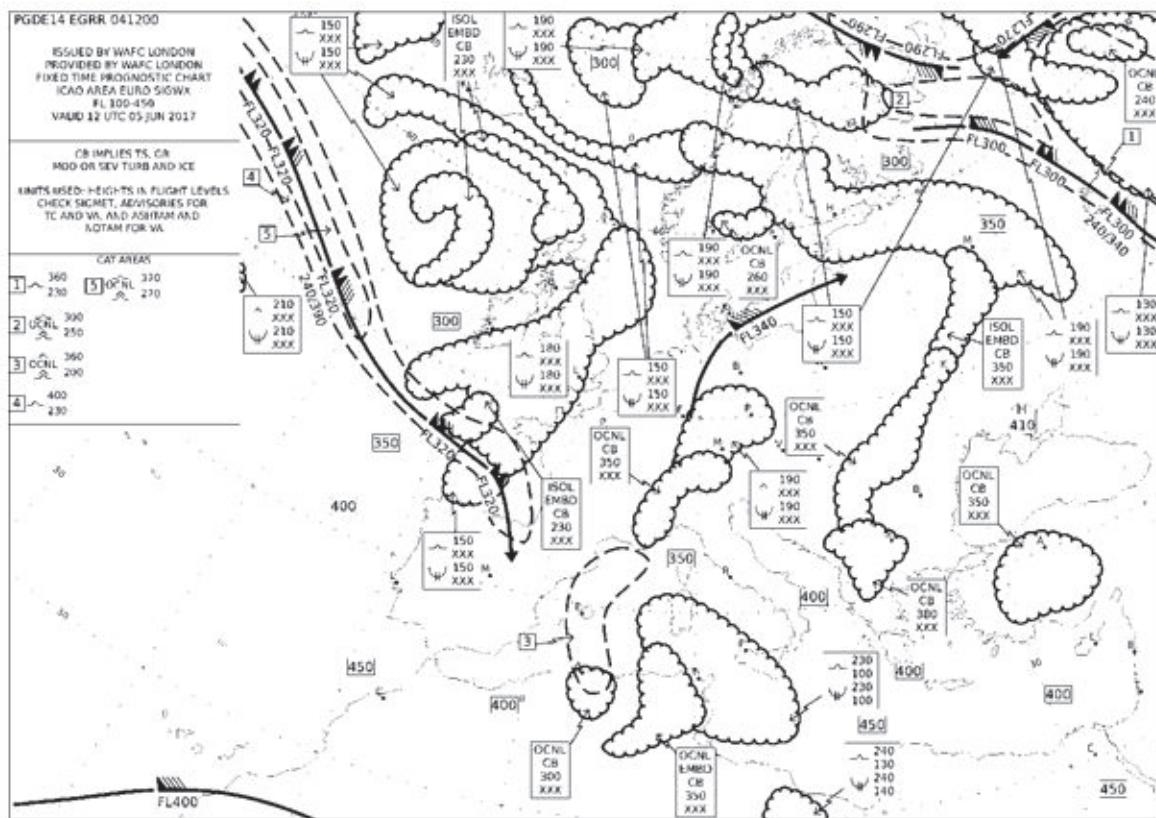
access to was not produced by the UK Met Office, it was generated from the data supplied by them. Figure 4 shows the Met Office chart for 5 June 2017.

Significant Weather Chart Valid 1200UTC on 5 June 2017 supplied by the UK Met Office
