Investigation Report

Type of Occurrence:	Accident
Date:	20 January 2015
Location:	Nuremberg Airport
Aircraft:	Transport aircraft
Manufacturer / Model:	Fokker Aircraft B.V. / F28 Mark 0100
Injuries to Persons:	None
Damage:	Aircraft severely damaged
Other Damage:	None
State File Number:	BFU AX001-15

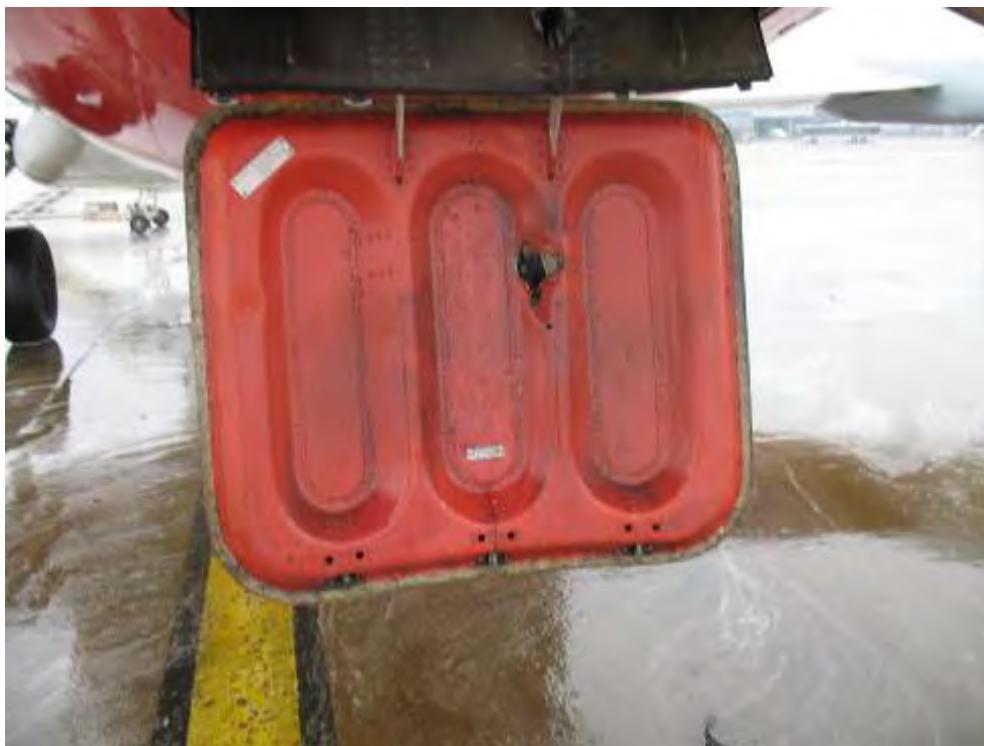
The airplane stood at the parking position 30 on the apron. Fracture and small metal pieces which could be correlated with the APU and its periphery were found beneath the tail section of the airplane. The maintenance door, which allows access to the APU, was punctured and open (Appendices Image 1).

Image 1: Open maintenance door with puncture

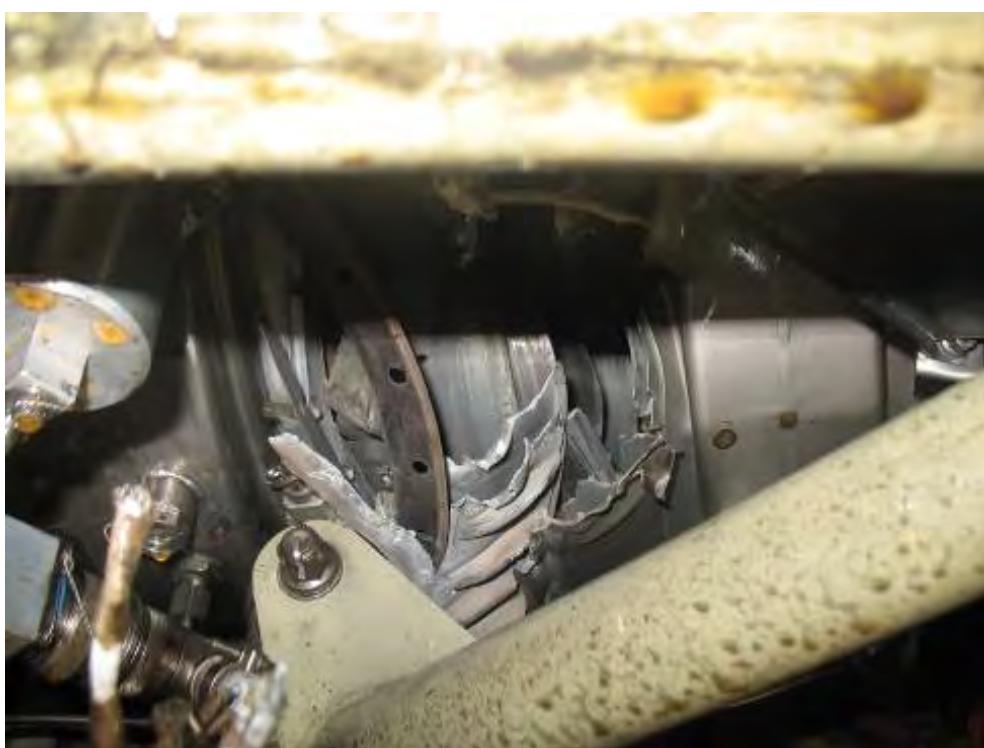
The APU housing was torn open and allowed a view of the interior (Image 2). The turbine wheel was severely damaged and the compressor wheel shattered. Image 3 shows the area on the right side of the tail section where the air intake for the APU is located and the APU exhaust exits the fuselage.

Image 2: Destroyed Auxiliary Power Unit (APU)

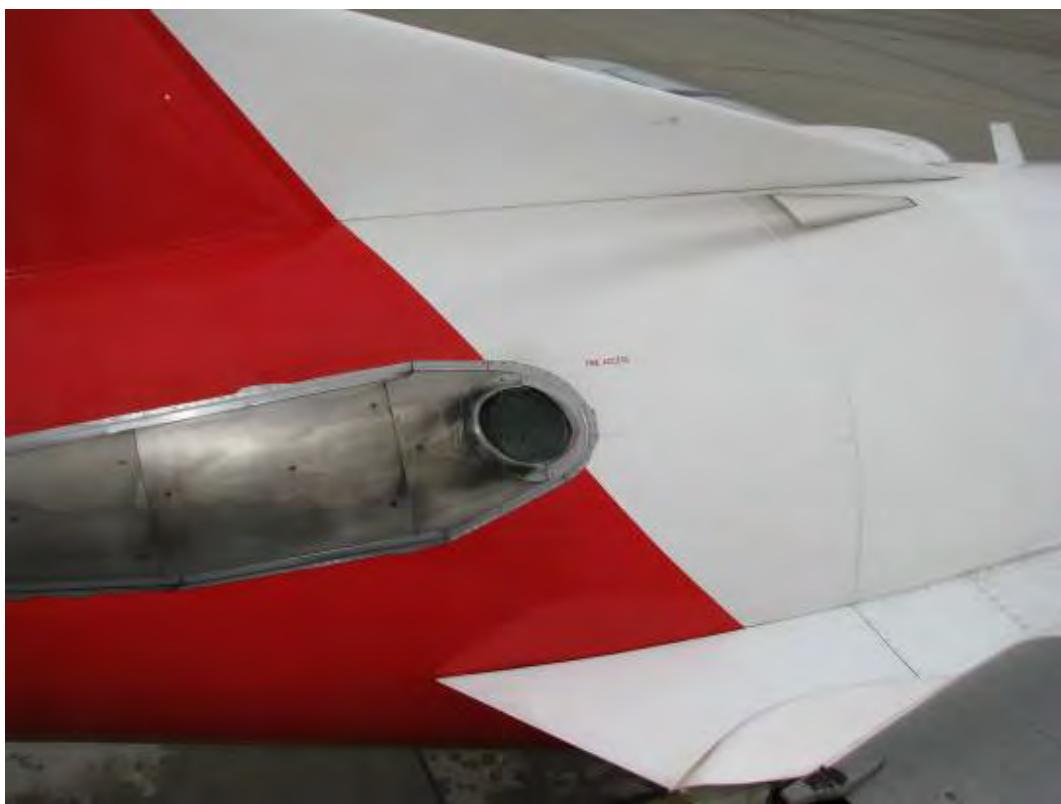
The area of the air intake was not marked. Smoke residue was found around the closed air intake hatch. The area around the exhaust was clearly silhouetted against the white fuselage surface due to the heat-resistant sheet metal used. In addition, the area to the upper right of the exhaust carried the marking FIRE ACCESS.

Image 3: Airplane tail section with APU air intake (upper right) and exhaust (centre)

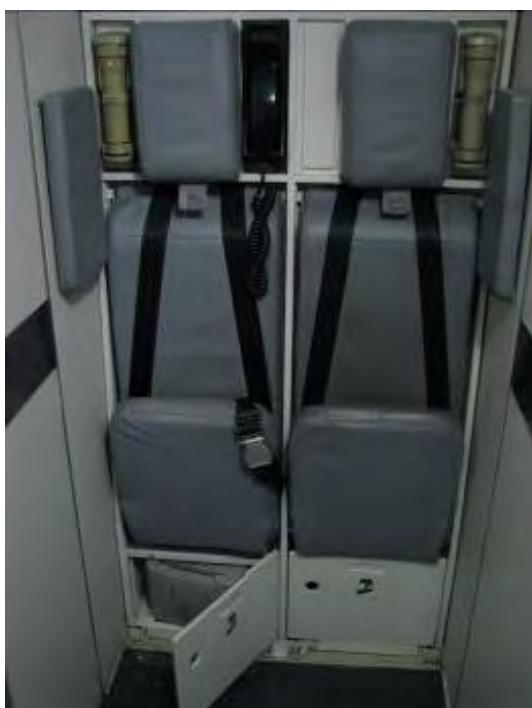
The two aft seats for the flight attendants were located at the back wall of the cabin which is also the pressure bulkhead (Image 4). A bin beneath the seats contained the smoke hoods for the flight attendants. A fracture piece of the compressor wheel punctured the area below the right flight attendant seat (Image 5). It left a hole of approximately 100 mm in diameter in the pressure bulkhead. The fracture piece itself had melted into the bottom of the bin. The back wall of the bin had been torn open.

Image 4: Aft flight attendant seats
(viewed from the opposite flight direction)

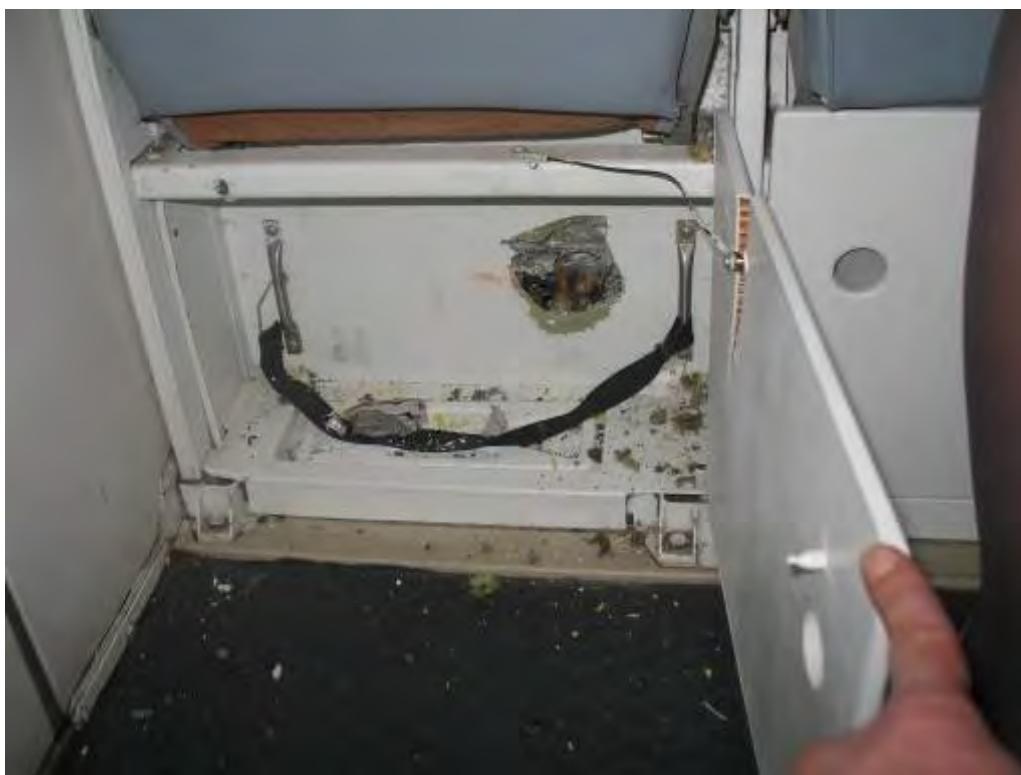
Subsequently, parts of the compressor wheel penetrated the aft pressure bulkhead in the area beneath the flight attendants' seats. The hot fracture piece was found embedded in the container for the smoke hoods. Smoke in the aft part of the cabin was the result. Passengers and cabin crew were prompted to move to the front part of the airplane. During a similar occurrence in the past almost the same area of the pressure bulkhead was penetrated. The BFU is of the opinion that in case the APU ruptures for other reasons it cannot be ruled out that the same area of the pressure bulkhead would be penetrated again.

Image 5: Punctured bulkhead below the right aft flight attendant seat

Fracture piece of the compressor wheel in the bottom of the bin

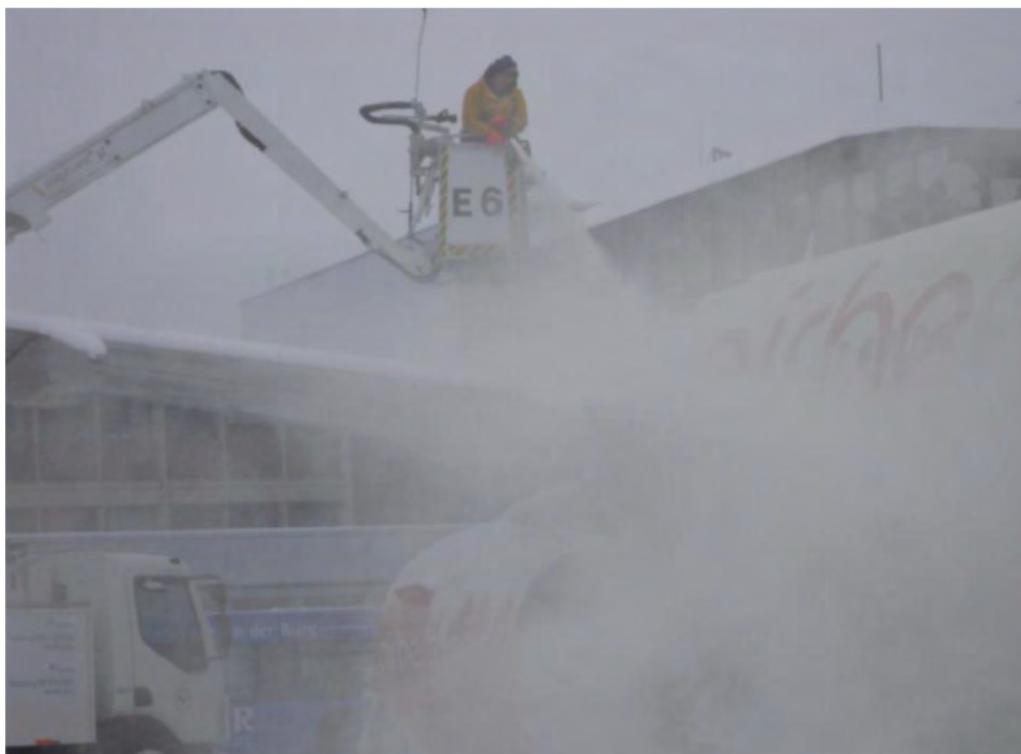
During the de-icing process the de-icing fluid has a temperature of up to 70° when it leaves the steel pipe. Fog is the result due to the lower temperatures of the outside air, and the aircraft parts. This fog restricts the field of vision of the de-icing personnel (Image 6).

Image 6: Fog development during de-icing

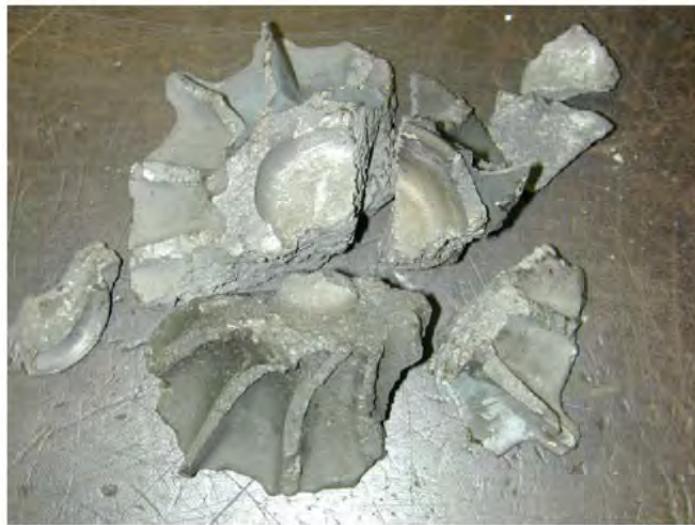
The turbine wheel was broken up into at least four major pieces. All of the vanes were broken off. The pieces of the turbine wheel were forwarded to Honeywell for metallurgical examination in the Materials Laboratory.

Photo 1: Turbine wheel broken into several pieces (American)

The results of Honeywell's Materials Laboratory examination of the APU's turbine wheel were reported in Materials Analysis report No. 229723. The report stated that the examination revealed the turbine wheel had separated due to overload caused by the overspeed. There was no evidence of fatigue on any of the fracture surfaces. The examination also did not detect any evidence of the deicing fluid. Energy dispersive x-ray analysis identified several areas on the fracture surfaces that were rich in tantalum that is indicative of unbonding. The report stated that the unbonded areas would have provided a path for the fracture, but was not the primary cause of the fracture.

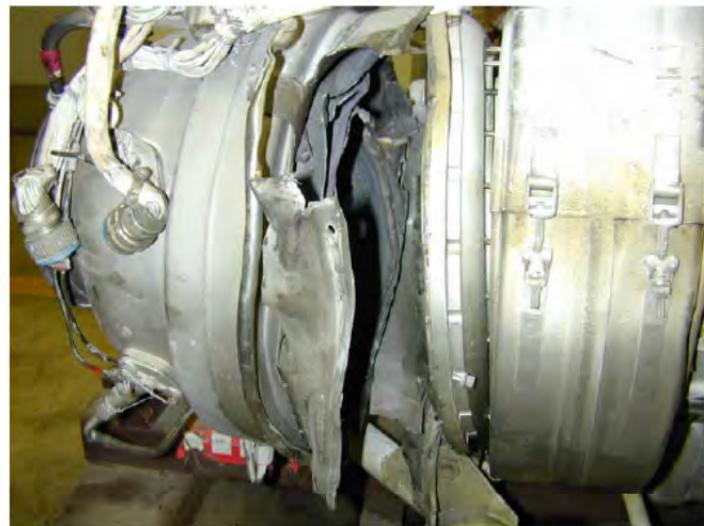
The compressor case was ruptured with two 3-inch wide holes at 1 to 6 and 10 to 12 o'clock.² The remainder of the exterior of the engine was intact and there was no evidence of a fire or any other uncontainments.

Photo 2: External view of APU showing ruptured compressor case (American)

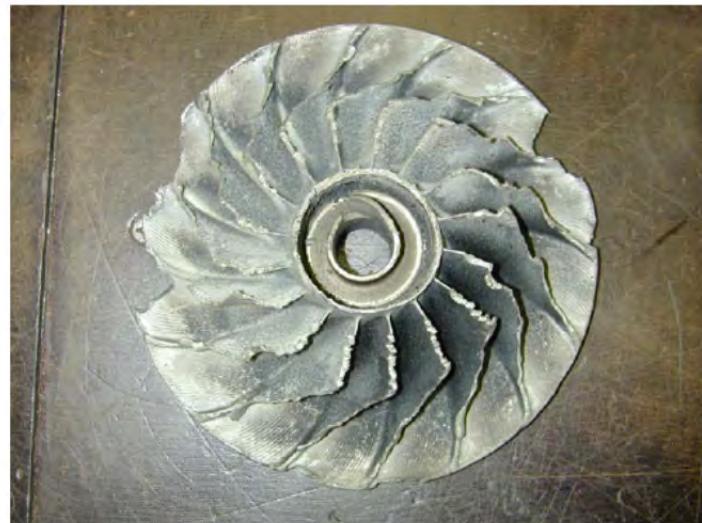
The compressor impeller was intact except for a 4-inch long section of the rim up to $\frac{3}{4}$ -inch deep that was missing. The impeller vane leading edges had nicks and gouges and were bent opposite the direction of rotation.

Photo 3: Compressor impeller (American)
