# AIRCRAFT ACCIDENT REPORT 2/2018

Report on the serious incident to  
**Boeing 737-86J, C-FWGH**  
Belfast International Airport  
on 21 July 2017

### Air Accidents Investigation Branch

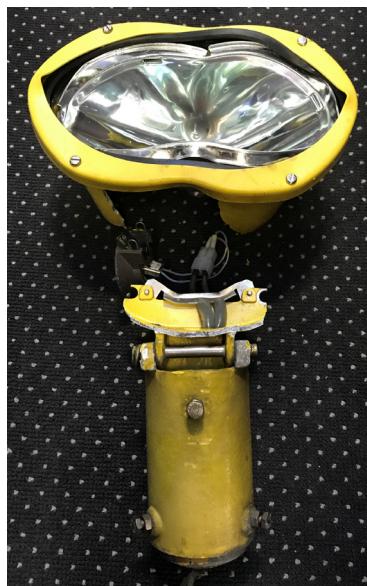
**Figure 2**  
Supplementary approach light damage

One supplementary approach light for Runway 25 at BFS was found damaged (Figure 2). The light was found crushed and lying on the ground having been knocked from its mounting<sup>10</sup>.

The runway inspection found one of the Runway 25 supplementary approach lights lying on the ground with substantial damage evident (Figure 2). The damage was reported to the tower and to the duty electrician at 1620 hrs. A discussion between staff in the tower and airport operations concluded that the light had been blown over due to jet blast of the engines. This had happened previously in BFS, although with much larger aircraft and generally at the beginning of the runway behind an aircraft as it began its takeoff roll.

Following a shift change, the new airfield duty manager observed the damage to the light and the rubber deposits on it and suggested that, rather than the light being blown down by jet blast from the aircraft, it had been hit by a tyre. These concerns were reported to the tower by the duty manager. The BFS ATC watch manager then contacted the watch manager at ScACC to request that the ACC try and contact the pilots of C-FWGH. However, the aircraft had long since left ScACC airspace, so the watch manager attempted to contact the operator. The ScACC log showed that, at 1908 hrs, they were told that the aircraft may have hit a light. The watch manager at ScACC contacted the operator in Canada who agreed to contact the crew who had already arrived at their destination.

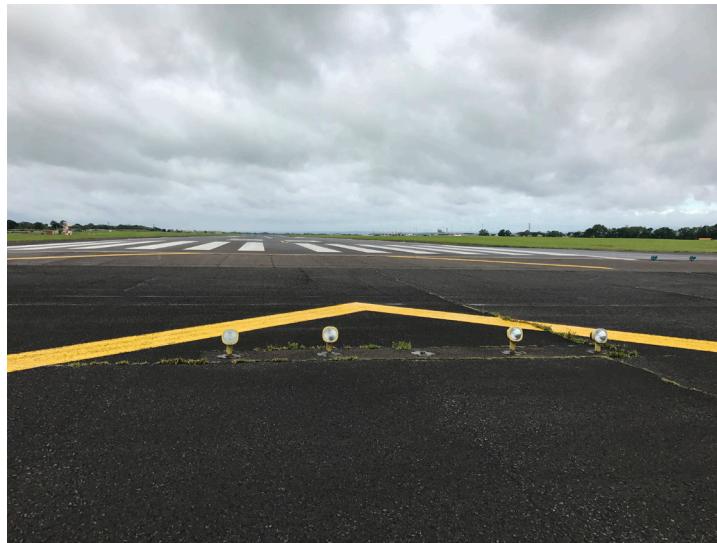
**Figure 6**

Within the stopway were two sets of supplementary approach lights for Runway 25. Each of these sets had thirteen lights set out in three groups across the tarmac. These lights were positioned 36 cm above the stopway surface. The first set of lights was 29 m beyond the end of Runway 07, with the stopway ending 60 m beyond the end of Runway 07. The aircraft struck the centre light within the first set of supplementary approach lights. Figure 5 shows the layout of the lights, together with the dimensions of the stopway and indicates the direction of travel of the aircraft and the light the aircraft struck. Figure 6 shows the view from the stopway with the centre light missing.

The view from the stopway showing the centre light missing

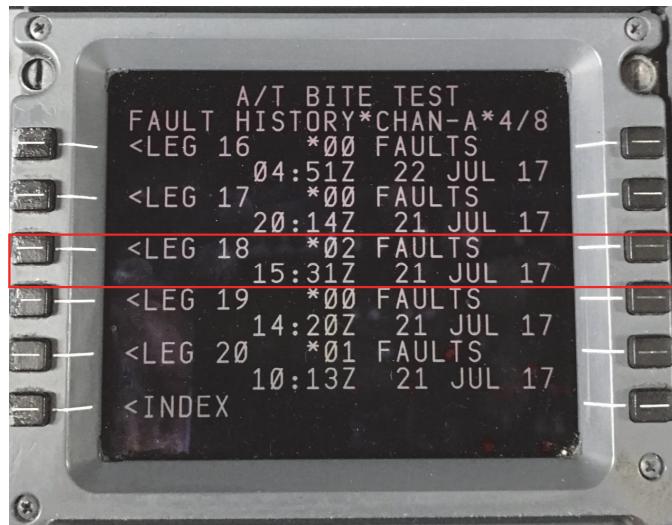
**Figure 7**  
CDU autothrottle BITE history

The CDUs support an interface to Built-in Test Equipment (BITE) for various aircraft systems, including the autothrottle system. The AAIB examined the autothrottle BITE data on the CDUs and this showed that two faults<sup>14</sup> had been logged for the incident sector (see the red box in Figure 7).

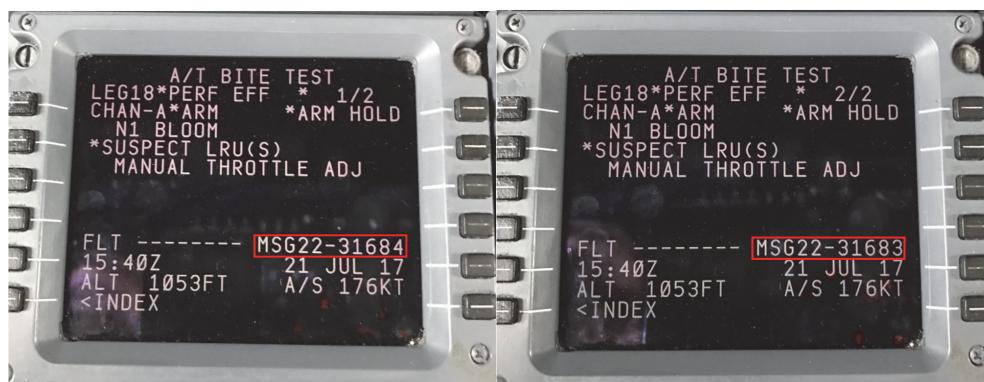
**Figure 8**  
Detailed CDS fault pages for both faults logged

These faults related to the initial climb-out from BFS, and the CDS pages for them are shown in Figure 8. Both messages relate to an 'N1 Bloom' and the message identification numbers are highlighted by red boxes in Figure 8.

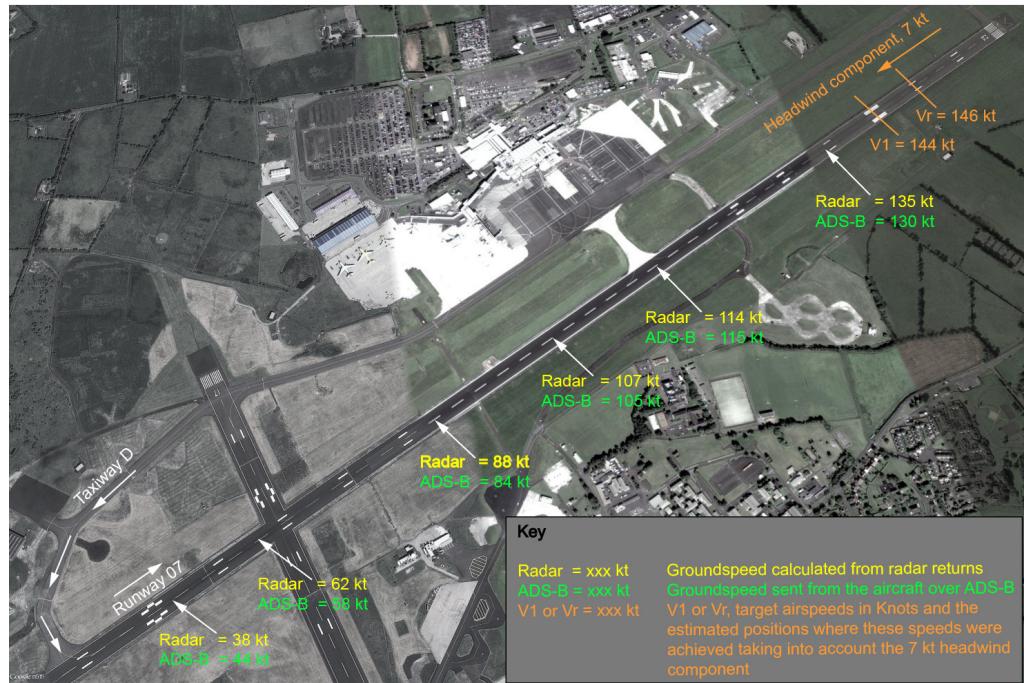
**Figure 10**

The radar installation at Belfast International Airport tracked C-FWGH along Runway 07 and during initial climb-out, when altitude data also became available from the aircraft's transponder. The radar returns allowed groundspeed for the aircraft to be calculated which was supplemented by both groundspeed and altitude data transmitted from the aircraft over its Automatic Dependent Surveillance – Broadcast (ADS-B) datalink. This data is shown in Figure 10 for the ground roll, where the text in yellow represents calculated groundspeed data from the radar track and, in green, the received ADS-B groundspeeds. Orange lines show the approximate position where the aircraft achieved airspeeds equivalent to the EFB-calculated  $V_1$  and  $V_R$ , considering the 7 kt headwind component.  $V_R$  would have been achieved approximately 300 m from the end of the runway.

Groundspeed data for the takeoff in relation to the EFB calculated  $V_1$  and  $V_R$   
 © 2017 Google, Image © 2017 DigitalGlobe

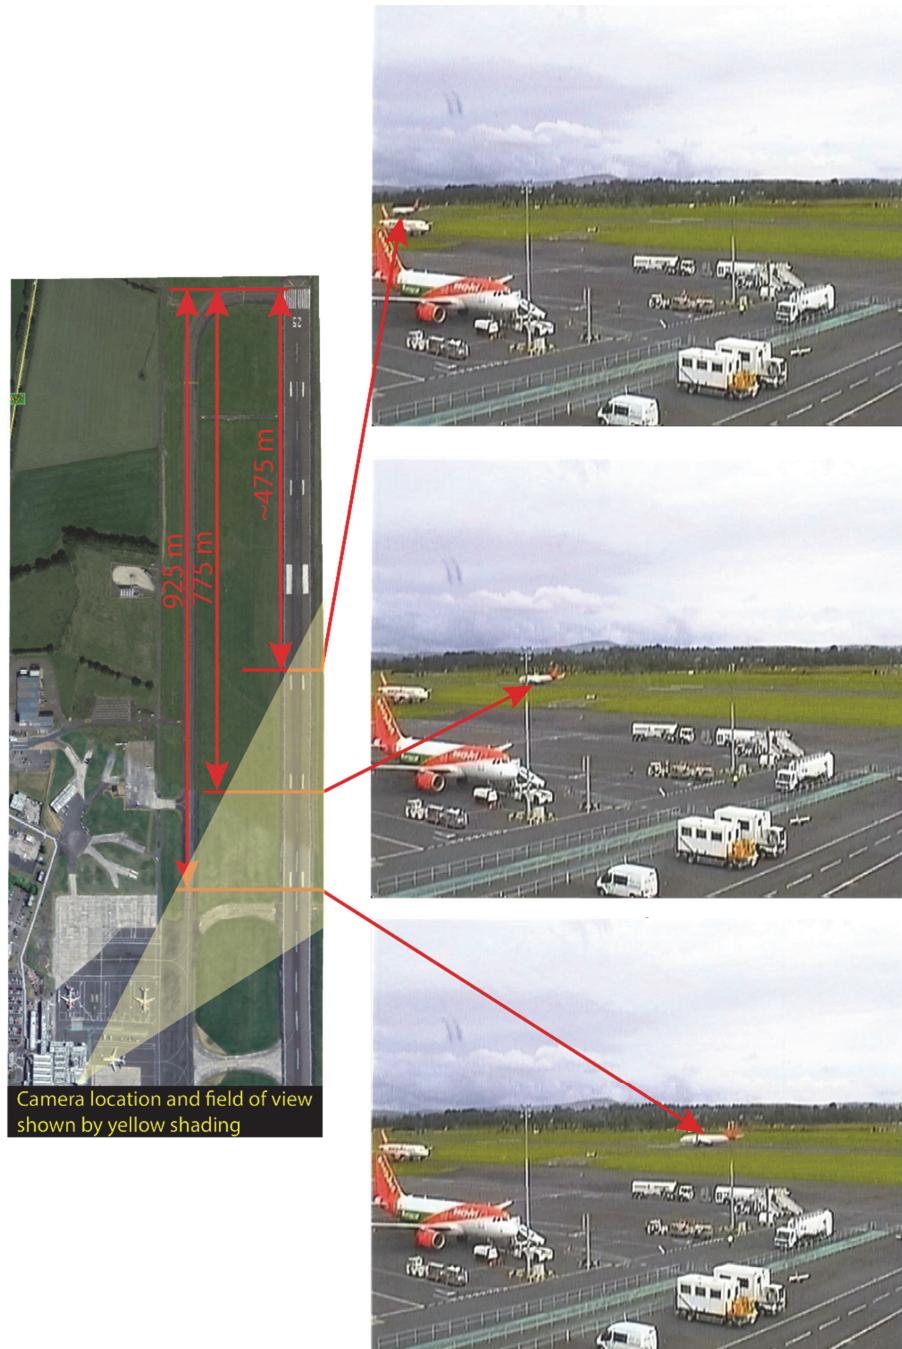
**Figure 12**  
The first CCTV recording showing C-FWGH's takeoff

The airport operator provided the AAIB with closed-circuit television (CCTV) recordings of C-FWGH's takeoff from two cameras. The first camera's field of view recorded the segment between 1,000 m and 475 m from the departure end of Runway 07. At the end of this segment, C-FWGH had not rotated (Figure 12).

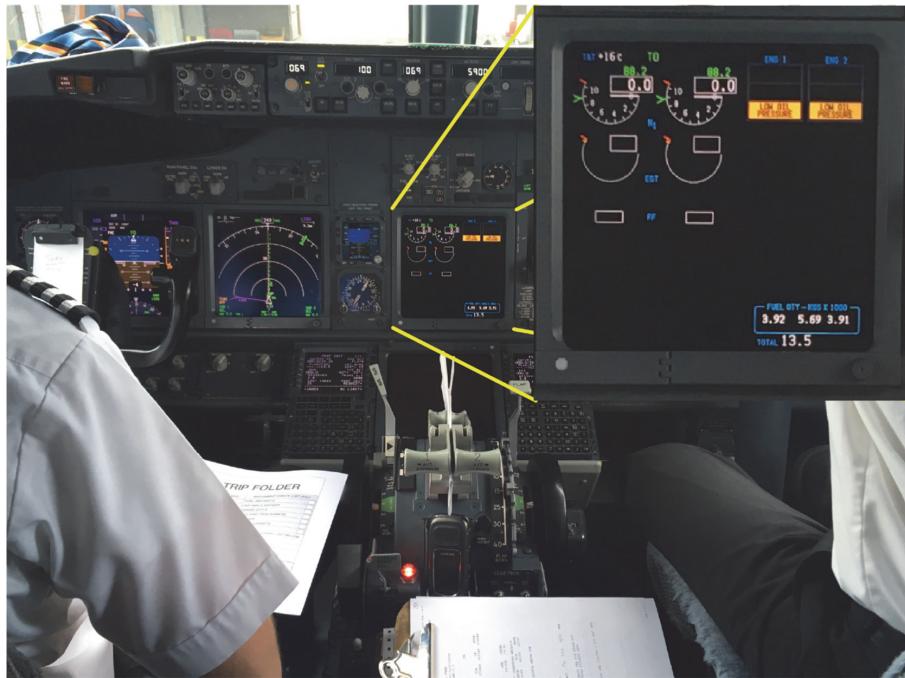
**Figure 14**

Cockpit photo and N<sub>1</sub> display prior to first pushback

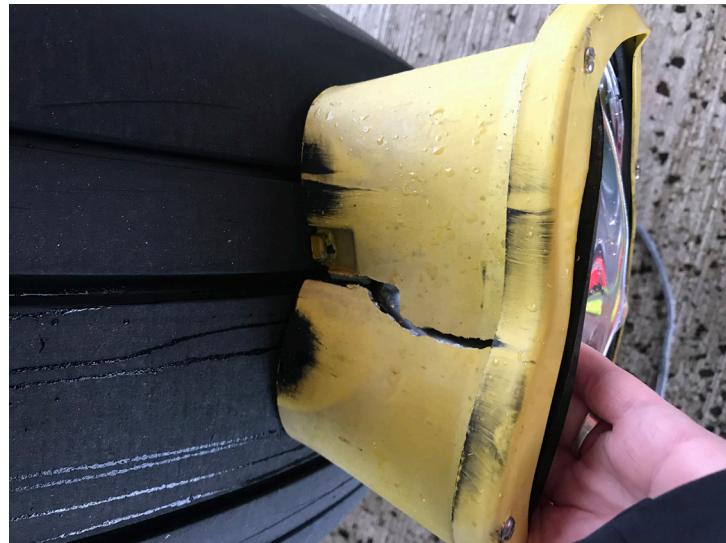
**Figure 16**  
Tread pattern comparison with main gear tyre

One of the supplementary approach lights within the Runway 07 stopway was found lying on the ground during the runway inspection. Closer examination revealed that the light had significant impact damage with evidence of black rubber deposits.

When compared with the tread on the tyres on C-FWGH, the pattern of rubber deposits indicated that the light had probably been struck by one of the main gear tyres. Chemical analysis of the rubber deposit was unable to confirm whether a main or nose landing gear tyre struck the light (Figure 16).

Aerodrome lights are designed to be frangible. If stuck by an aircraft they are to break causing minimal or no damage to the aircraft. The crew were unaware that they had struck a runway light and there was no damage to the aircraft structure or tyre from striking the light.

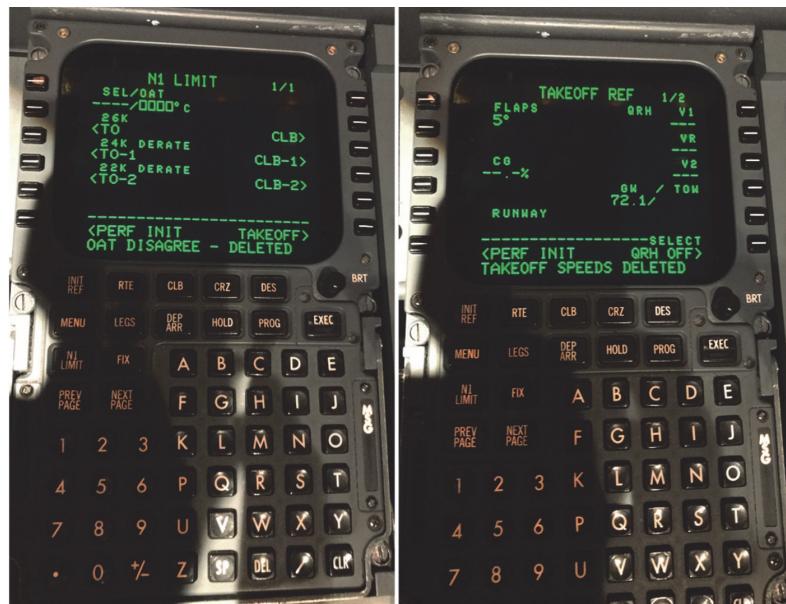
**Figure 17**

CDU messages associated with the FMC OPS U12.0 OAT crosscheck

In addition to the release of the FCOM bulletin, the manufacturer added a crosscheck function to revision U12.0 and later versions of the FMC OPS software. The crosscheck compares the OAT entered by the crew, or accepted by the crew in the case of a data-linked OAT, against either that sensed by the Electronic Engine Controls or, on some older Boeing 737s (including the -100 to -500 series that pre-date Boeing 737NG aircraft), by the aspirated Total Air Temperature probe. The crosscheck runs once, approximately one minute after first engine start, and establishes whether a difference of more than six degrees in temperature exists between the value accepted by the FMC and that sensed by the external temperature sensor. If the difference is more than six degrees, it deletes the OAT entry, removes any assumed temperature or fixed derate that has been selected and deletes the takeoff reference speeds. It also displays two messages and illuminates the 'MSG' indicator on both CDUs to warn the crew that data has been deleted from the FMC; the messages shown are OAT DISAGREE – DELETED and TAKEOFF SPEEDS DELETED (Figure 17).

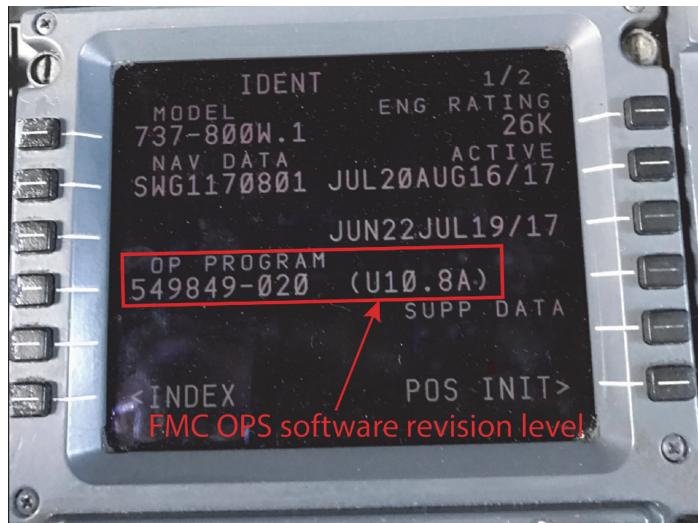
**Figure 18**  
CDU IDENT page of C-FWGH

At the time of the serious incident, C-FWGH had an earlier revision of FMC OPS software installed, U10.8A (Figure 18), which did not include this crosscheck.

Revision U12.0 of the FMC OPS software was promulgated to operators in February 2016, via Boeing Service Bulletin 737-34-2600, although U12.0 was embodied on production line aircraft from November 2015. Subsequently, this service bulletin was amended and re-released as Revision 1 on 10 January 2017. Revision 1 of the service bulletin states:
