National Transportation Safety Board

Aviation Accident Final Report

Location:	Las Vegas, NV	Accident Number:	DCA15FA185
Date & Time:	09/08/2015, 1613 PDT	Registration:	G-VIIO
Aircraft:	BOEING COMPANY BOEING 777-236	Aircraft Damage:	Substantial
Defining Event:	Uncontained engine failure	Injuries:	1 Serious, 19 Minor, 150 None
Flight Conducted Under:	Part 129: Foreign

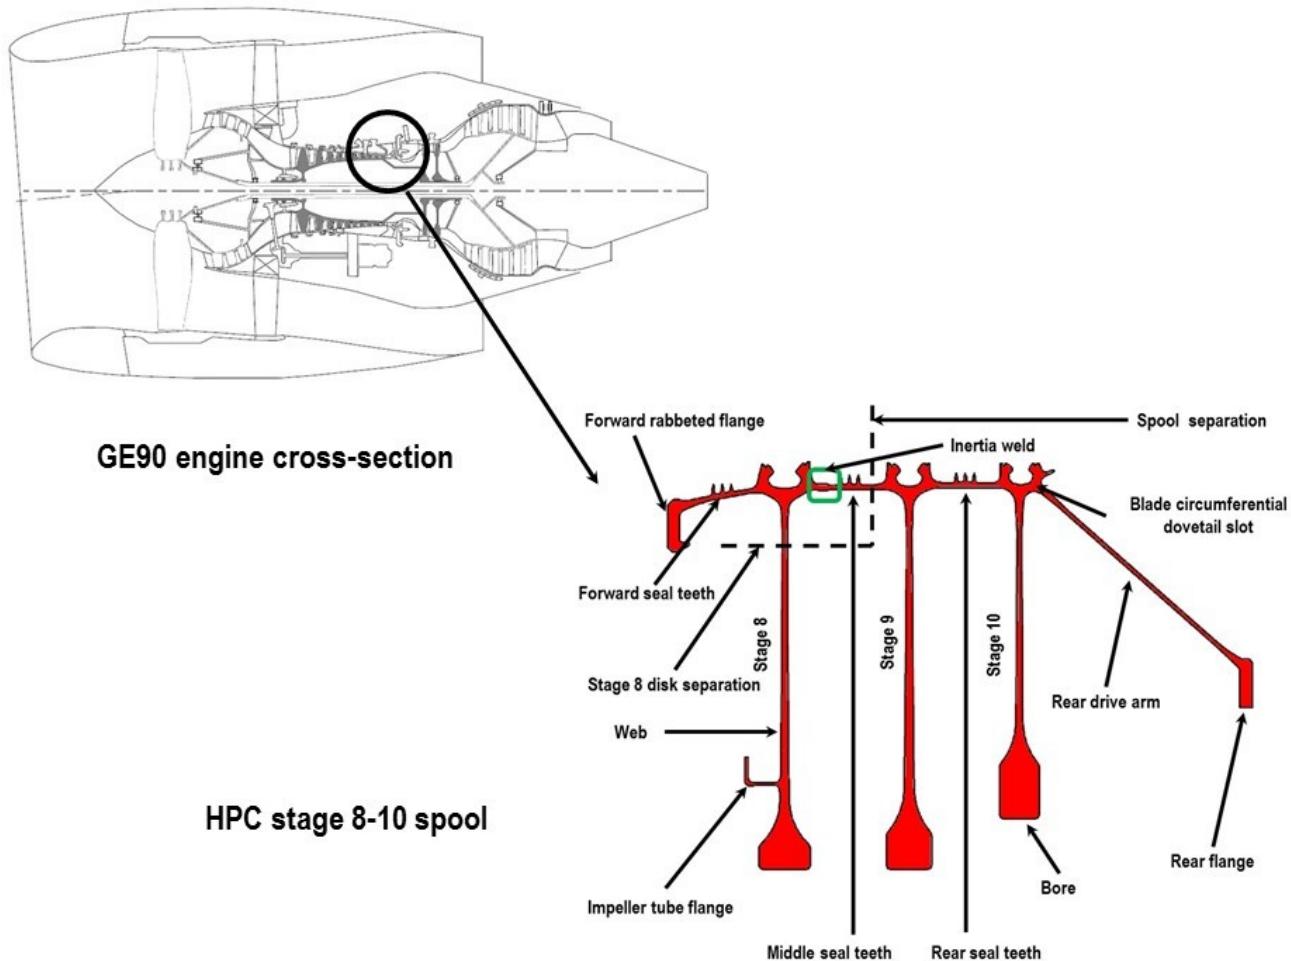
On-scene examination of the left engine revealed that the HPC aft extension case was breached from about the 11:30 to the 5:00 position (58 inches circumferentially), exposing the internal HPC parts. The examination also found that the HPC stage 8-10 spool separated aft of the middle seal teeth between the stage 8 and 9 disks and that the stage 8 disk separated below the circumferential blade slot, as shown in figure 1. Other noteworthy damage included the following:

Figure 1: GE90 engine cross-section with the locations of the HPC stage 8-10 spool separation and stage 8 disk separation.

Disassembly of the engine was performed at GE's facility in Evendale, Ohio. The HPC aft extension case was cut to access the HPC stage 8-10 spool. The HPC stage 8 disk was fully detached from the stage 7 and 9 disks and was fractured about 200° circumferentially at the transition radius of the web to the blade circumferential dovetail slot rim. About 37 inches of the dovetail slot rim remained attached to the stage 8 disk. The impeller tube assembly was fractured and detached from the front side of the stage 8 disk, and the impeller tubes were fractured, splayed open, or mostly intact. Most, but not all, of the stage 8 disk forward rabbeted flange had fractured from the stage 8 disk and remained attached to the stage 7 disk. The rear drive arm of the HPC stage 8-10 spool was fractured and had fully separated near the compressor discharge pressure seal land.

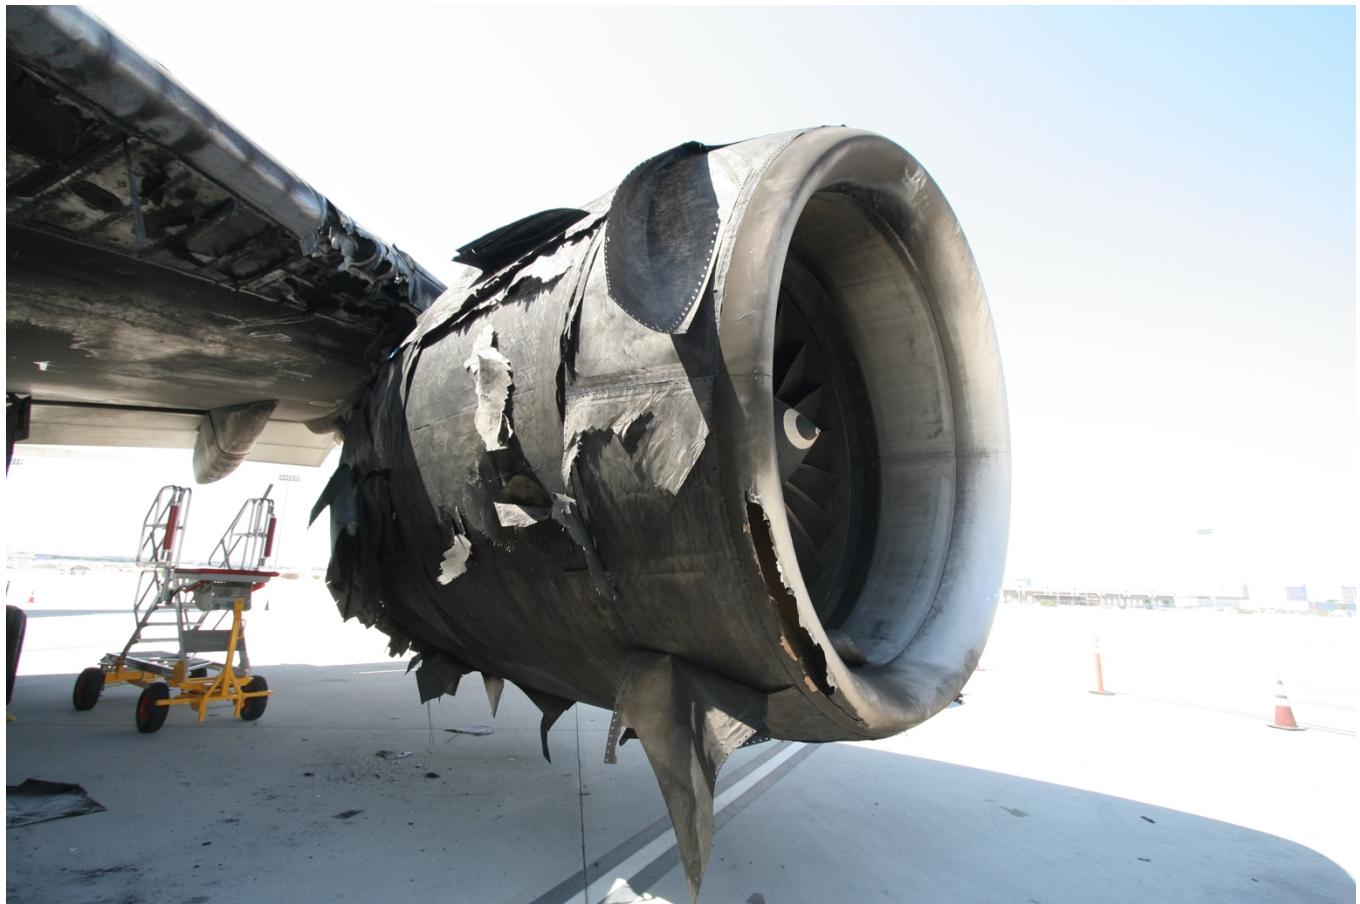
Thermal damage on the exterior of the airplane was concentrated along its midsection, from the left engine to the right side of the fuselage. On the left engine, the cowling was thermally damaged from the 4:00 to 12:00 positions (as viewed from the front of the engine). The thermal damage between the 6:00 and 12:00 positions (the inboard side of the left engine, as shown in figure 2) caused the composite cowling to delaminate and the aluminum leading edge of the cowling to partially melt along the 7:00 to 8:00 positions. The interior of the left engine had soot on some surfaces but no significant thermal degradation to the components.

Figure 2. Inboard side of left engine

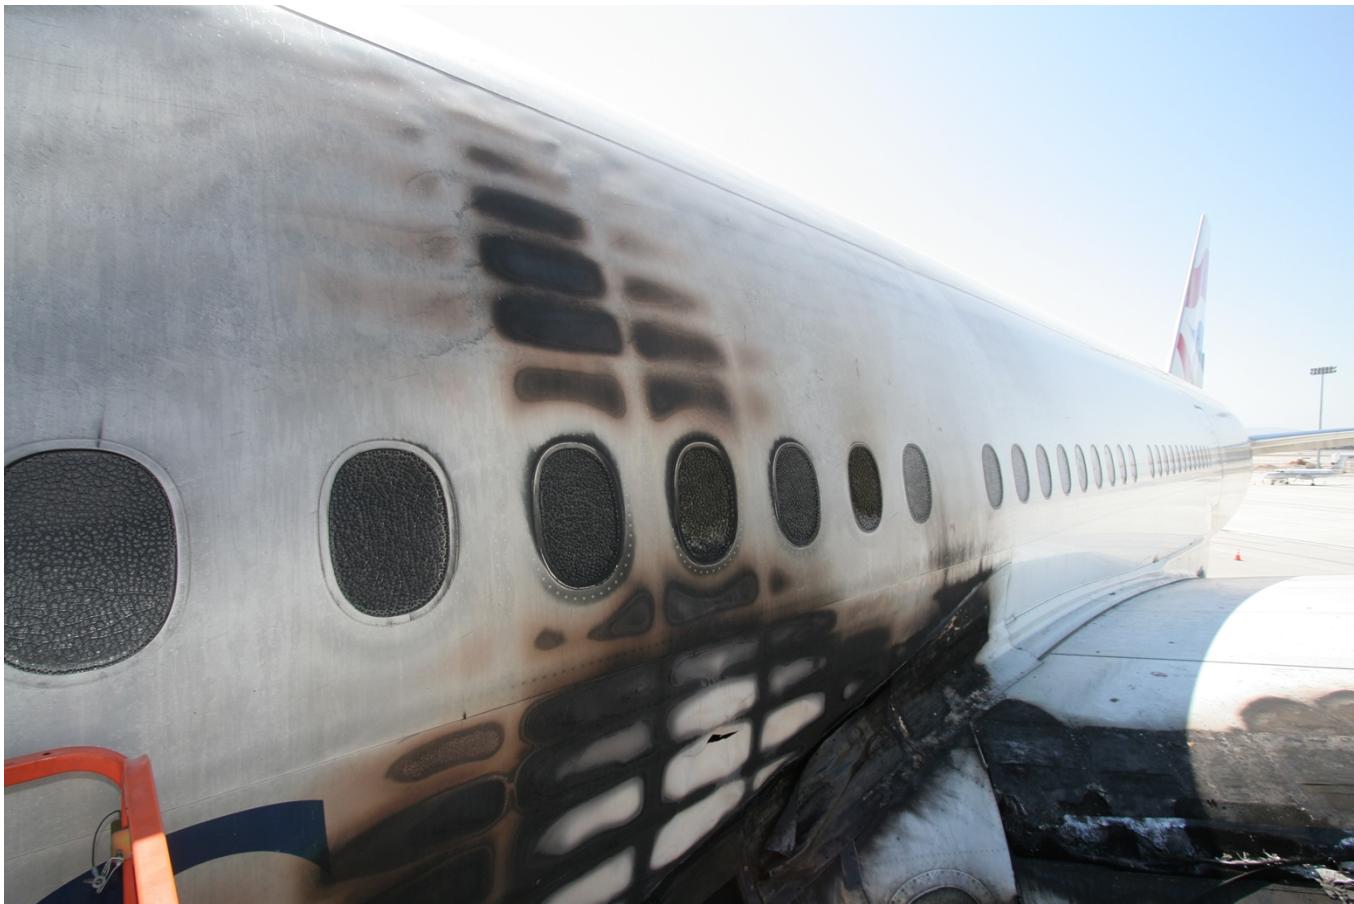
The left-side fuselage skin exhibited thermal damage (missing and charred paint) from just aft of the 2L door to just past the wing leading edge, and the center of this thermally damaged area exhibited buckling and cracks in the skin, the longest of which was about 12 inches. The cracks in the skin coincided with the area of most severe thermal damage to the wall panels in the interior of the airplane. There were 13 thermally crazed windows on the fuselage that extended from the 2L door to about mid-span of the wing, as shown in figure 3.

Figure 3. Thermally damaged fuselage skin and thermally crazed windows

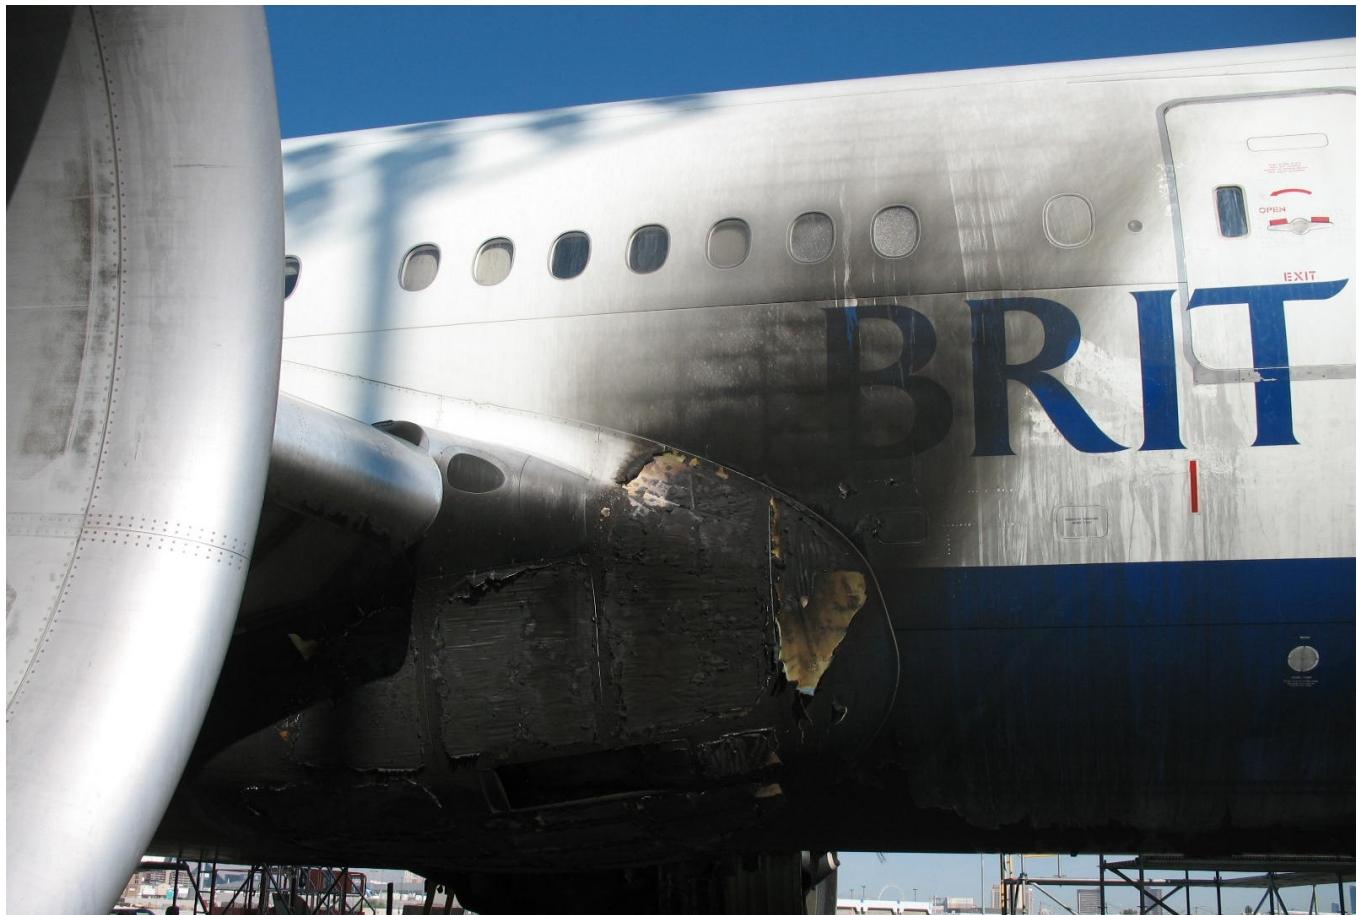
Soot appeared on the right-side fuselage above the wing-to-body fairing, as shown in figure 4. Buckling that created a tactile waviness to the aluminum skin was found in the area. Two of the windows above this area exhibited thermal crazing.

Figure 4. Soot and thermal damage to the right-side fuselage

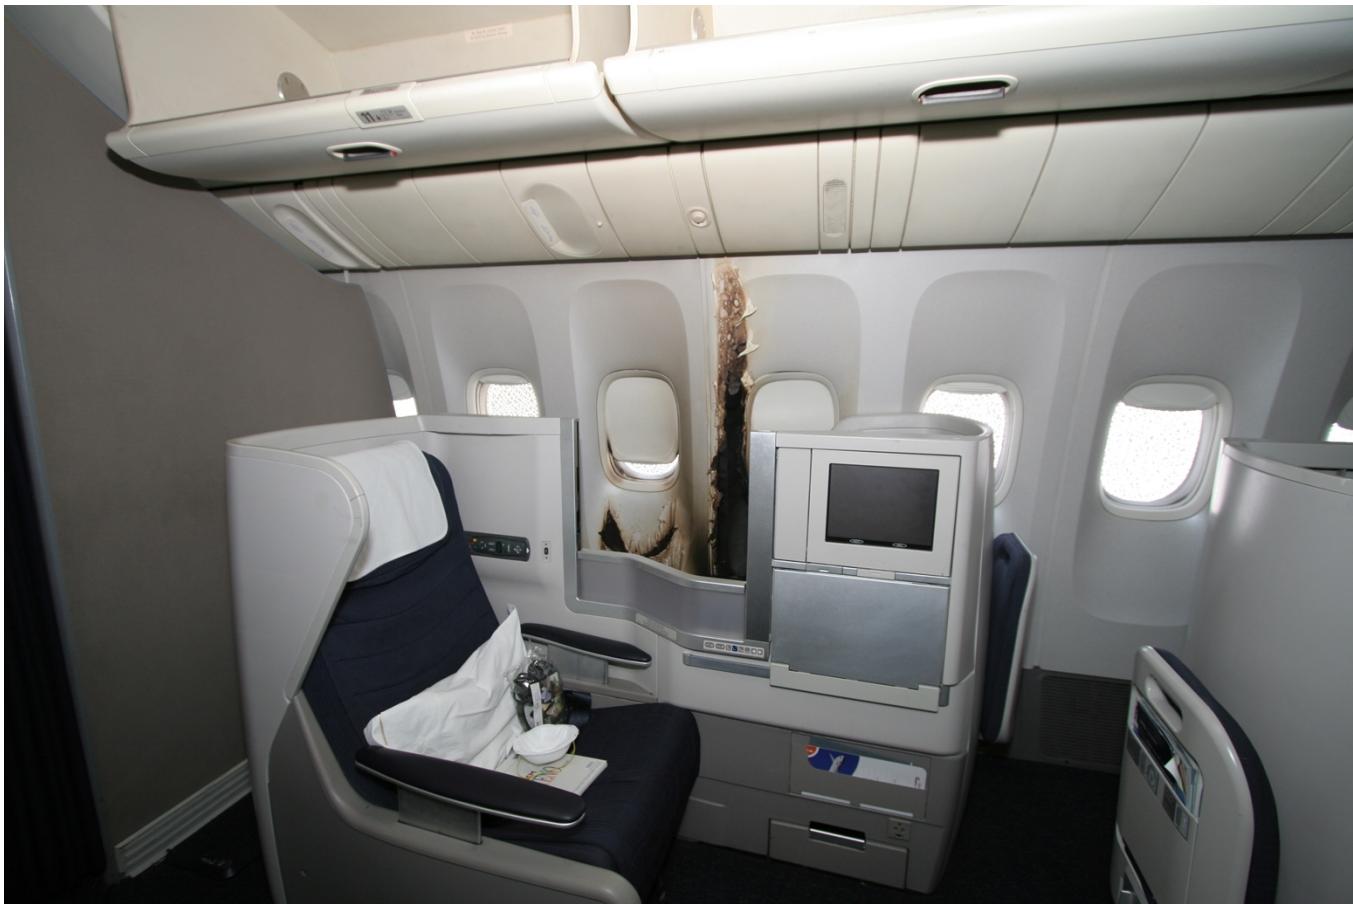
Thermal damage to the interior cabin was confined to the wall panels at the location of seat 11A, as shown in figure 5. The thermal damage consisted of blistering and charring on the wall panels; no soot was observed on any adjacent surfaces. The damage was consistent with thermal decomposition and charring and not flaming combustion on the inboard surfaces of the damaged panels.

Figure 5. Cabin interior at seat row 11

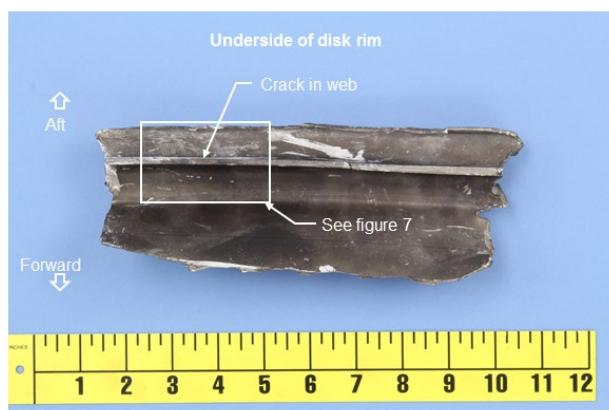
The uncontained left engine failure resulted from a fatigue crack in the high-pressure compressor (HPC) stage 8 disk. The fatigue crack started on the aft face of the disk web and progressed through the web and in the circumferential direction. The fracture region had an intergranular appearance near the aft face of the web and a transgranular appearance farther away from the initiation site. The transgranular area exhibited striations consistent with low-cycle fatigue crack growth. GE considered worst-case conditions (highest stresses and temperatures and minimum material properties) in predicting the low-cycle fatigue crack initiation lifetime at the stage 8 disk aft web faced and found that it had a low-cycle fatigue initiation life of about 29,800 cycles. (A fatigue fracture can be divided into an initiation phase and a propagation phase. During the initiation phase, the material structure is changing due to the cyclic loads, but no cracks have formed. Eventually a crack forms and begins to grow, indicating the onset of the propagation phase. FAA Advisory Circular 33.70-01 uses the concept

The fracture surfaces of the fragments were examined to determine where the engine failure initiated. The web of one of the stage 8 disk rim fragments had a feature, located about 0.90 inch inboard of the blade slot bottom at the thinnest (about 0.12 inch) part of the web, that

indicated the presence of a tinted/discolored flat fracture region. This region was about 0.63 inch wide in the circumferential direction and extended from the aft face of the web to within 0.004 inch of the forward face of the web. The orientation of the fracture region was consistent with a crack initiating on the aft face of the web, and the tinted appearance was consistent with high-temperature oxidation of the fracture surface. Figure 6 shows the underside of the disk rim and the location of the crack. The flat fracture region transitioned to a 45°-inclined tinted/discolored region that was consistent with cyclic tensile loading. The region with cyclic tensile loading extended circumferentially from both sides of the flat fracture region over a total length of about 1.7 inches, after which the appearance of the fracture surface was consistent with tensile overstress.

Figure 6. Location of crack in HPC stage 8 disk web

On February 12, 2016, GE issued SB 72-1146, which indicated that a one-time on-wing ultrasonic inspection of the stage 8 web needed to be performed on all HPC stage 8-10 spools with the same part number as the accident spool that were not covered by SB 72-1145. On June 10, 2016, GE superseded SB 72-1146 with SB 72-1151, which expanded the inspection population to include HPC stage 8-10 spools with a different part number than the accident spool. SB 72-1151 also recommended a repetitive inspection within every 500 cycles until an ECI was performed instead of a one-time on-wing ultrasonic inspection. On June 24, 2016, the FAA issued AD 2016-13-05, which required an ultrasonic inspection or ECI of the stage 8 aft web upper face between 8,000 and 9,000 cycles since new or within 500 cycles in service after the effective date of the AD (July 29, 2016), whichever occurred later.

In addition, due to the shot peening irregularity found on the event part (and the examination of two similar spools that found the same irregularity), GE issued SB 72-1149, "HPC Stage 8-10 Spool Web and Spacer Arm Shotpeen Repair," on March 29, 2016, to provide a one-time shot peen repair for all GE90 stage 8-10 spools to address possible shot peening inconsistencies. (According to GE, this repair was not incorporated into the engine manual because the repair was to be conducted one time only.) Also, GE modified the print drawing for HPC stage 8-10 spools in production to include a check of the shot peen intensity in the outer web areas. This change became effective in February 2016.

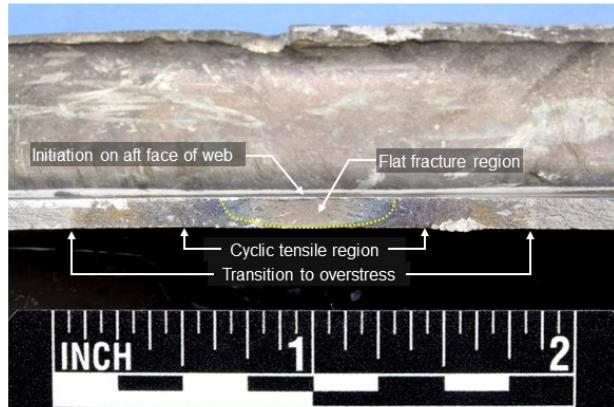
Examination of the flat fracture region using a scanning electron microscope (SEM) showed that the region had an intergranular appearance near the crack initiation site (the aft face of the web) and a transgranular appearance farther away from the initiation site. (The disk material, made from a nickel-based superalloy, had an internal structure that consisted of microscopic crystals called grains. The planar intersection of two grains is called a grain boundary. Cracks that follow grain boundaries are intergranular and cracks that cut across grains are transgranular.) The transgranular regions exhibited striations (linear features on a fatigue fracture surface that indicate how far a crack advanced with each stress cycle) consistent with low-cycle fatigue crack growth. (In airplane engines, low-cycle fatigue is associated with one striation per flight cycle.) Figure 7 shows an image of the underside of the HPC stage 8 disk rim at the location shown in figure 6.

Figure 7. Optical image of underside of HPC stage 8 disk rim
